ST. MARY DIVERSION FACILITIES GEOTECHNICAL STUDIES FOR THE ST. MARY RIVER SIPHON CROSSING

JUNE 2012

Montana DNRC
Water Resources Division

**GEOTECHNICAL REPORT
ST. MARY RIVER SIPHON CROSSING
ST. MARY DIVERSION AND CONVEYANCE FACILITIES**

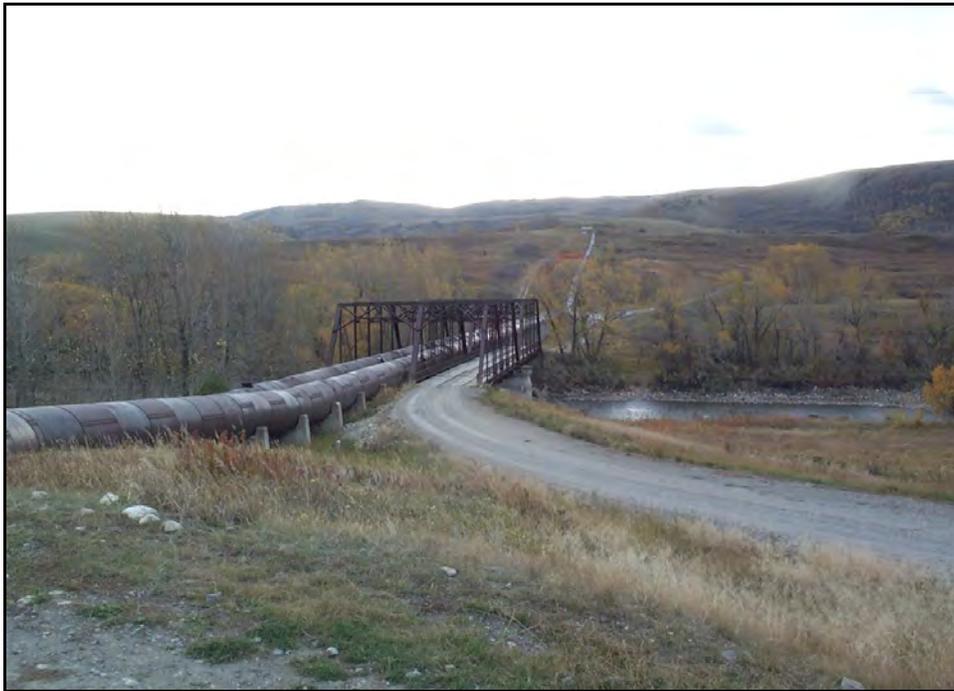
Photo 1 View of the St. Mary River Bridge carrying the siphon, looking downstream (southeast). The old bridge shown was replaced up river with a new bridge constructed during the winter of 2008 and 2009 (06/04/04)

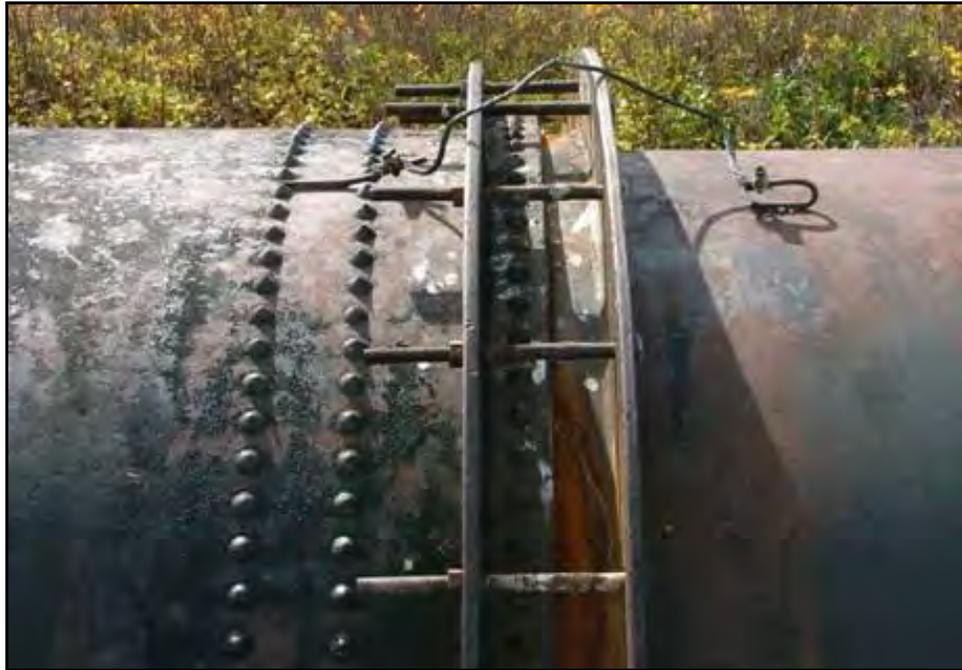
Photo 2 St. Mary River Siphon – Typical expansion/contraction joint, including cathodic protection continuity cable (10/26/04)

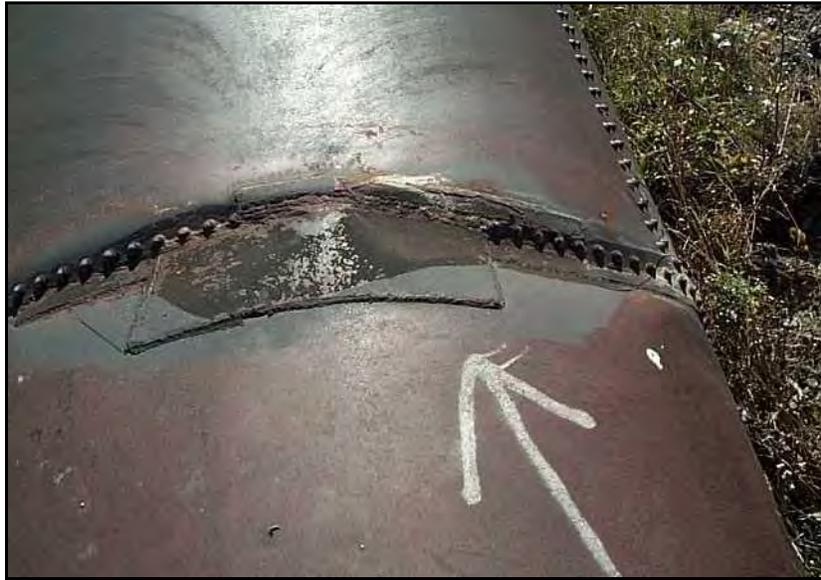
In 1954, a section of the left pipe was replaced and steel plates were installed where corrosion had damaged the steel. Typical siphon repairs due to deflection and corrosion are shown in Photos 3 and 4. Also, there appeared to be seepage from the canal which moved along the siphon support foundation at both pipes. The left pipe was further unearthed and a perforated drain pipe installed,

Photo 3 Typical siphon repair due to deflection and/or corrosion (10/13/04)

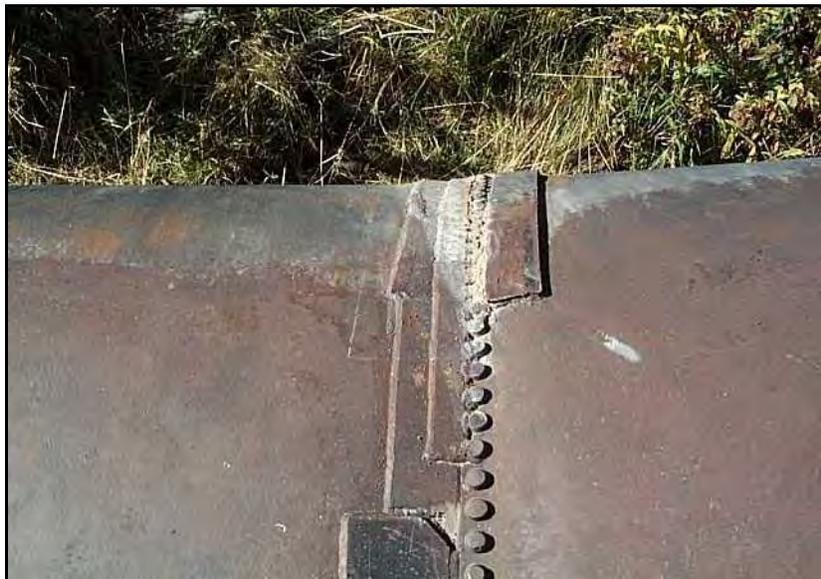
Photo 4 Typical siphon repair due to deflection and/or corrosion (10/13/04)

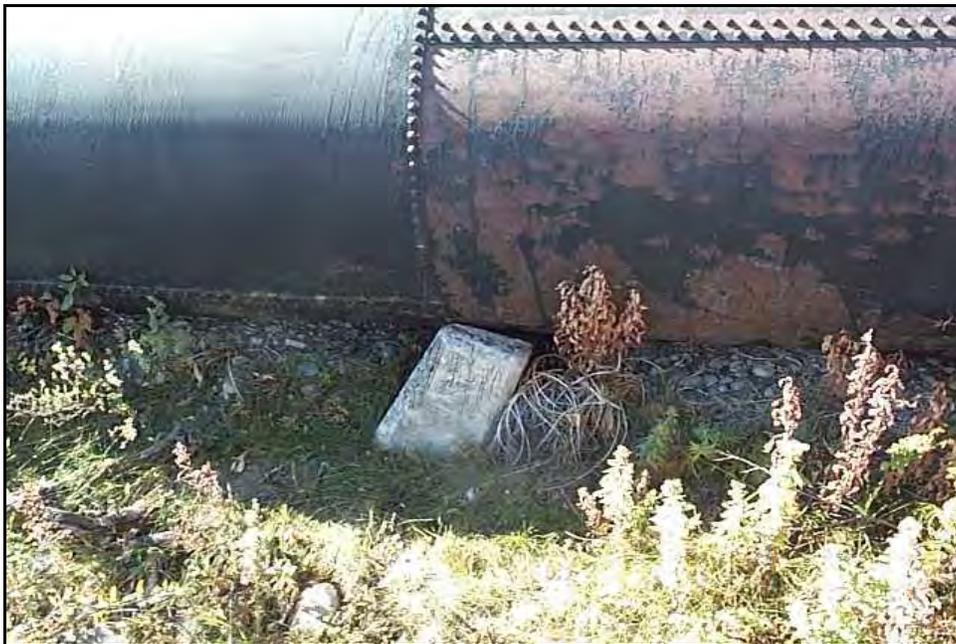
The left siphon between Station 512+30 (location of the most downstream pipe anchor) and Station 518+21 (downstream end of steel pipe) historically has been a major problem area. Part of this section has moved up to 4.5 feet downslope since the pipe was constructed. The movement caused major compression buckling near Station 513+00. An inspection in the Fall of 1996 revealed complete closure of all the expansion joints in the left siphon, which resulted in compression buckling. This also caused the pipe supports to rotate downslope which created a point-load bearing condition. This resulted in up to 6-inch indentations in the pipe at the points of the concentrated load (Photo 5).

Photo 5 Photo shows ground movements right to left causing rotation of concrete support and point-loading of siphon which can lead to buckling (10/13/04)
