# ST. MARY DIVERSION FACILITIES STRUCTURAL EVALUATION OF CANAL BRIDGES

## FINAL REPORT

AUGUST 2007

STRUCTURAL EVALUATION OF CANAL BRIDGES

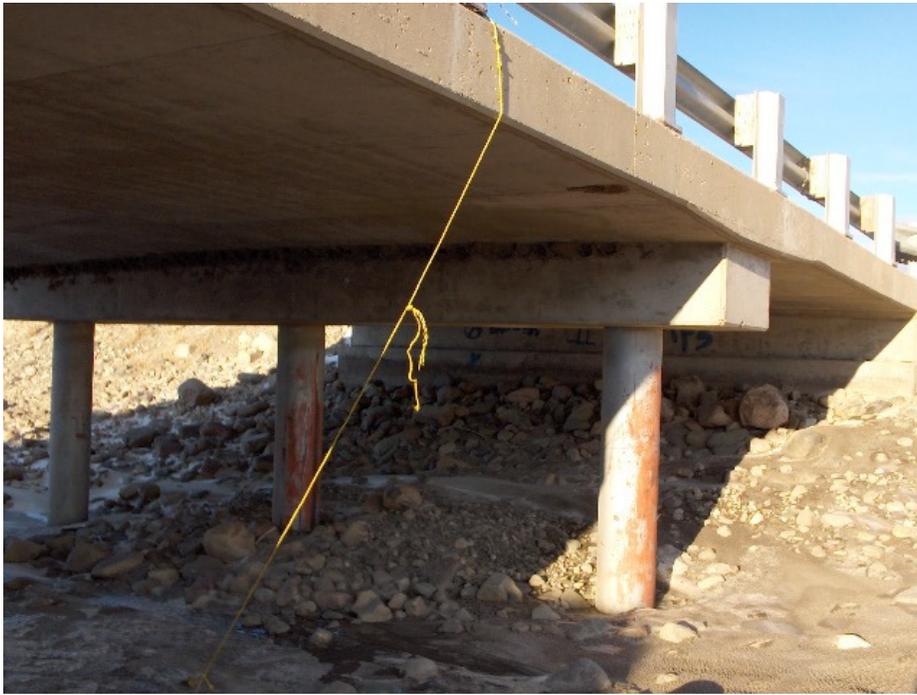
The bridge is in excellent shape. Concrete shows no sign of rebar rusting, spalling, or deterioration. No significant cracks were found in the deck or foundation elements. Piles have some localized paint loss, but show no signs of significant rust.

Photo 1.2 – East Pier & Steel Pipe Piles.

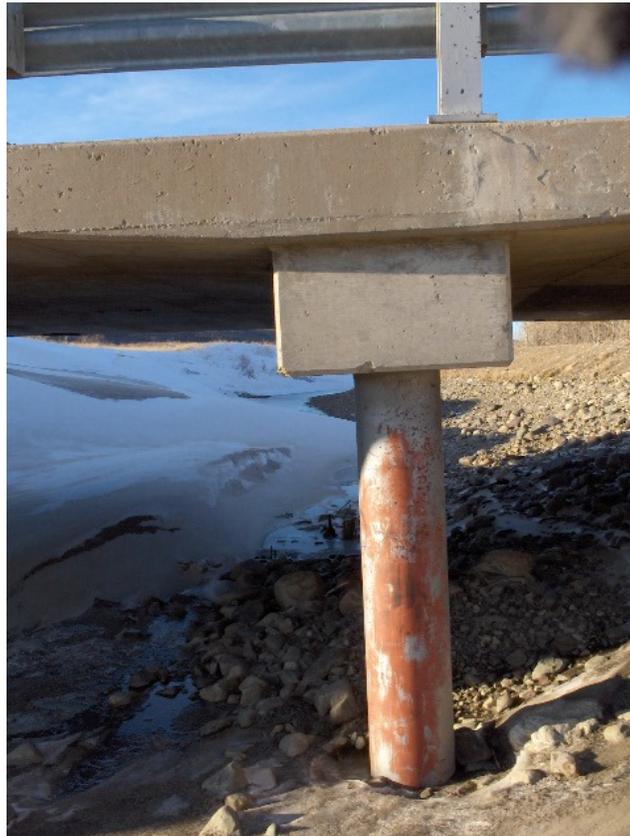
Photo 1.7 - East Pier & Steel Pipe Piles

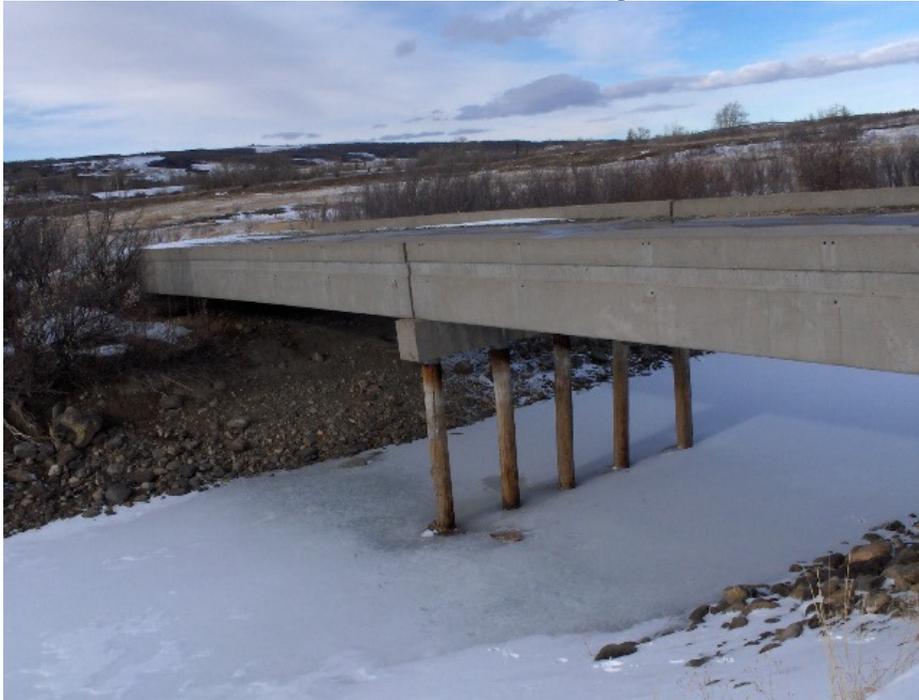
Timber piles are approximately 9 inches in diameter. They appear to be in satisfactory shape, but they are leaning significantly. It appears that the displacement-style piles may not have been driven to a proper embedment depth, especially since the soil conditions are gravelly with large cobbles and boulders. Large forces from bridge deck selfweight and heavy truck traffic at the center pier will overstress the five timber piles. In addition, the out-of-plumbness of these piles is a great concern for the general stability and soundness of the bridge.

Photo 2.1– Bridge Profile Midspan Pier w/ Timber Piles

The existing structure and foundation exhibit potential long-term concerns regarding stability and performance. To avoid potential liability from any canal improvements, this structure is recommended to be replaced with a single span structure to avoid channel obstructions. Since this bridge serves as a private access, the need for a single or two traffic lanes can be debated.

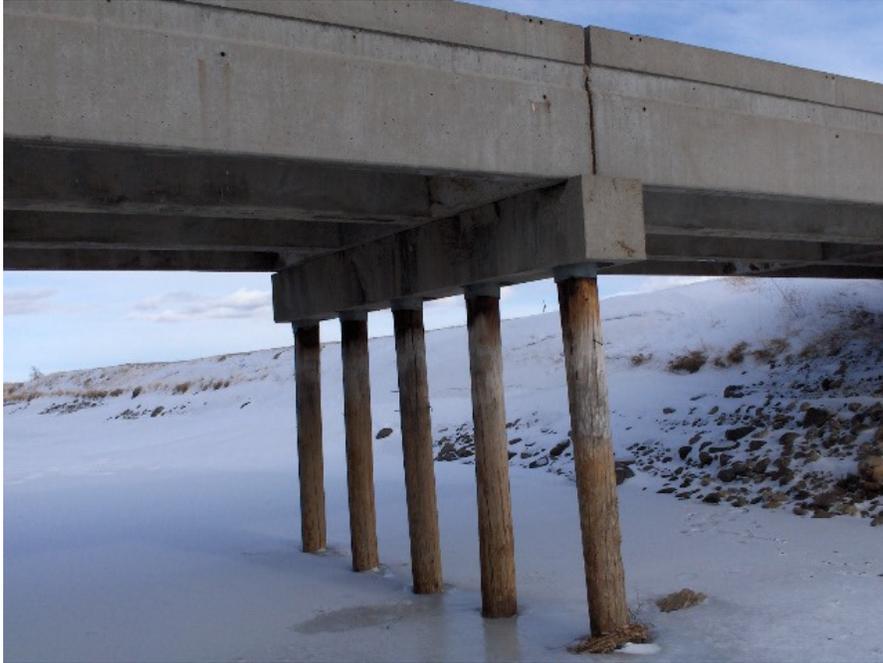
Photo 2.3– Midspan Pier w/ Timber Piles

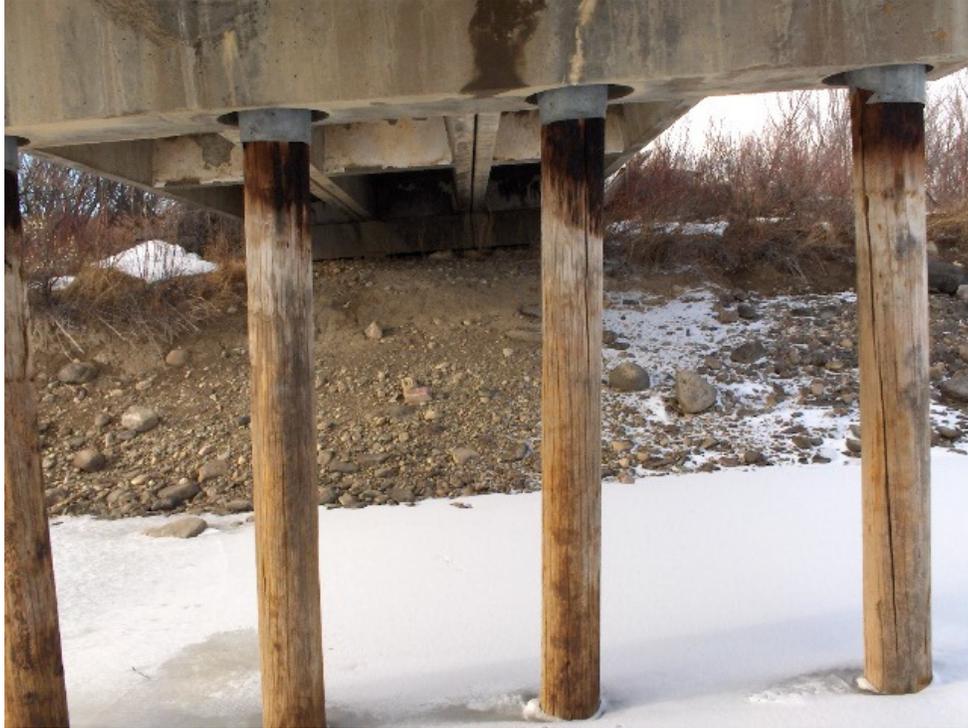
Photo 2.5 – Midspan Pier w/ Timber Piles

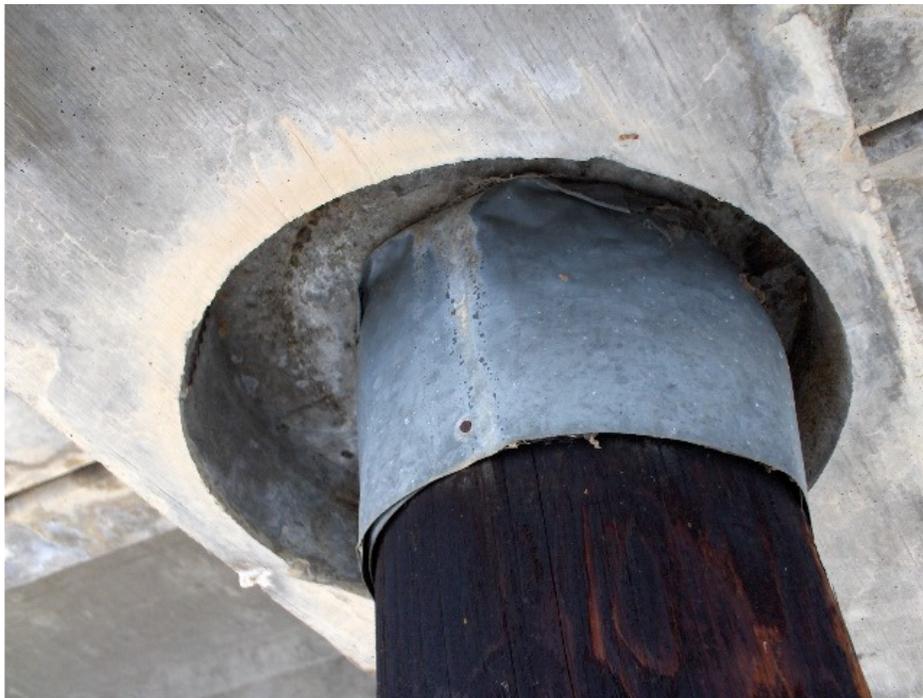
Photo 2.6 – Timber Piles at Concrete Pile Cap

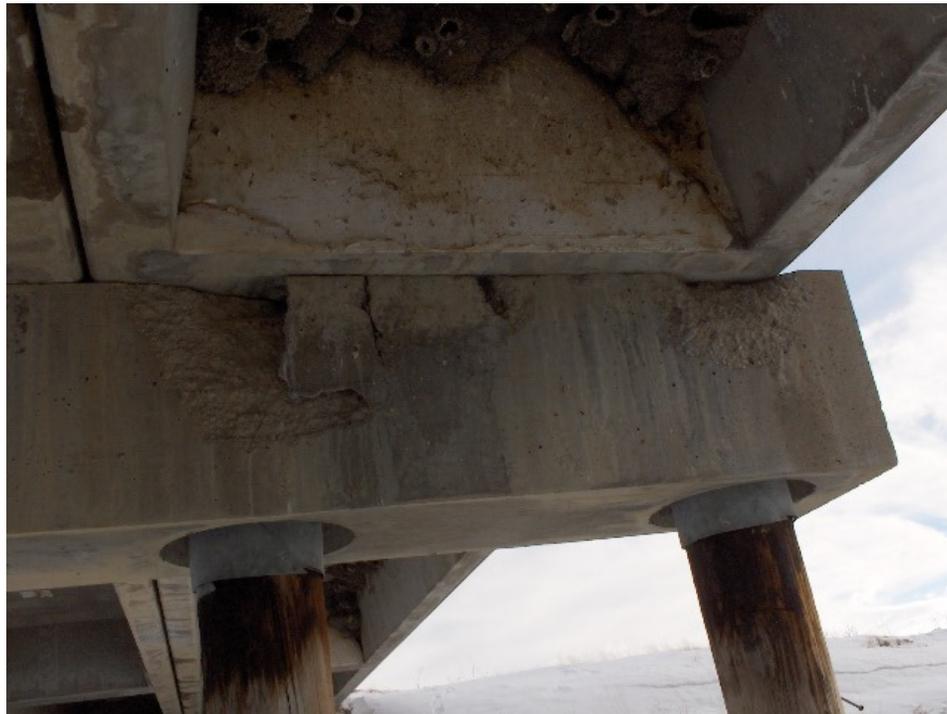
The midspan pier has five timber piles, all with a slight downstream lean. Two of the five timber piles are leaning significantly. The concrete pilecap is 18 inches wide by 19 inches depth. There are 3-1/2-inch deep gaps at the bottom of the pilecap at each of the five timber piles. Several areas of deteriorated and broken concrete exist adjacent to the interface of the timber piles and concrete pile cap. This is a concern since the size of the pile cap is insufficient to resist the shear loads from the pier reaction from bridge deck selfweight and heavy truck traffic.

Photo 2.8 – Spalling Concrete at Midspan Pile Cap

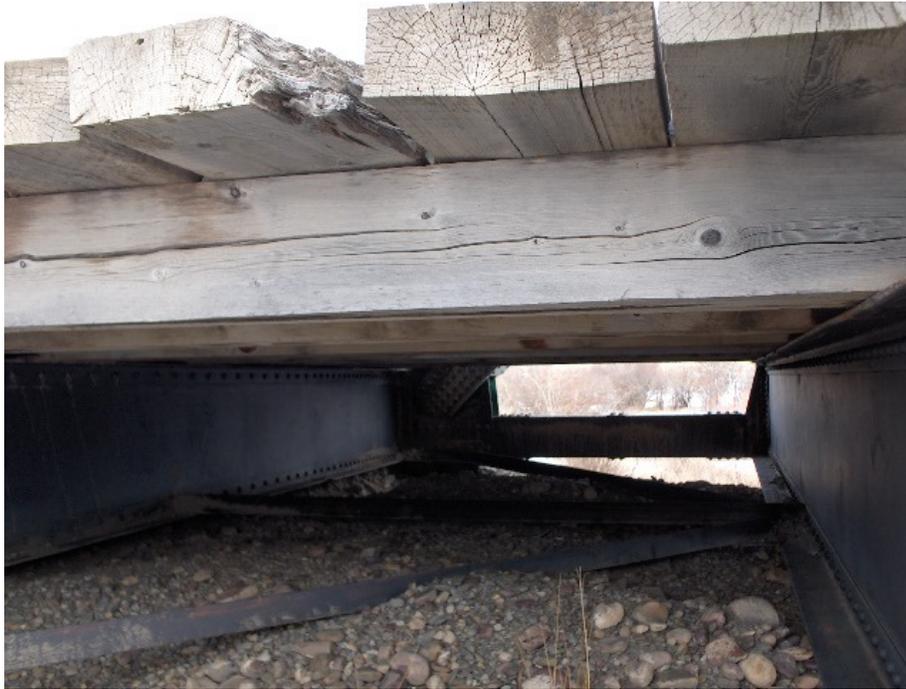
As stated, there are no true abutments or support points at either end of the truss bridge. At each end of the bridge, a short retaining wall with no wingwalls is found about 12 feet from the end of each truss. The short retaining walls hold the back gravel fill that extends to the elevation of the bottom of the steel girders. The truss is simply laid upon the gravel fill, without the existence of any rockers, truss pins, or bearing connections to a concrete foundation.

Photo 3.6 – Truss Bearing on Gravel

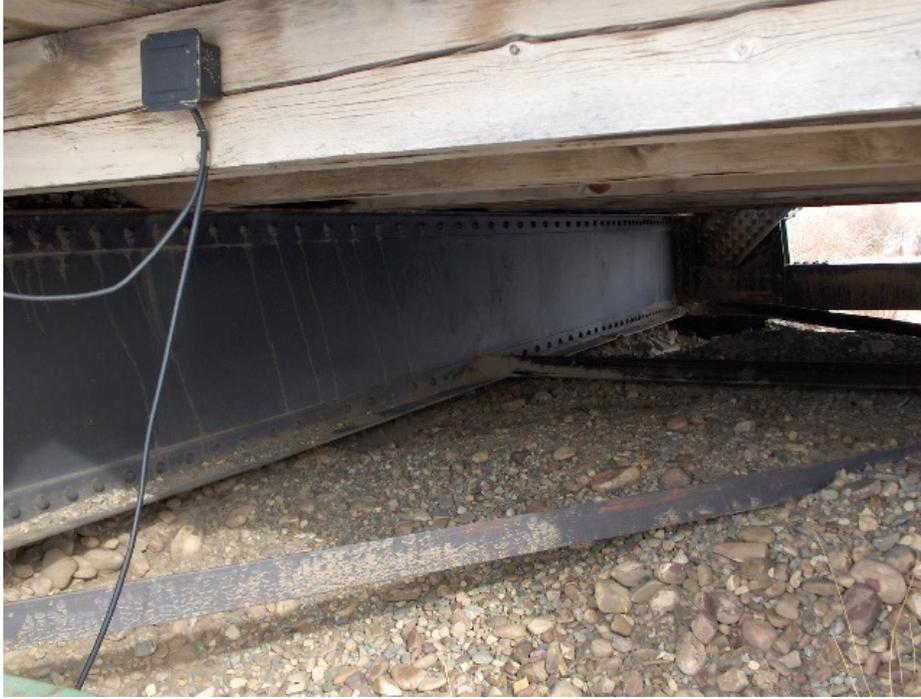
Photo 3.12 – Unidentified Electrical Wiring

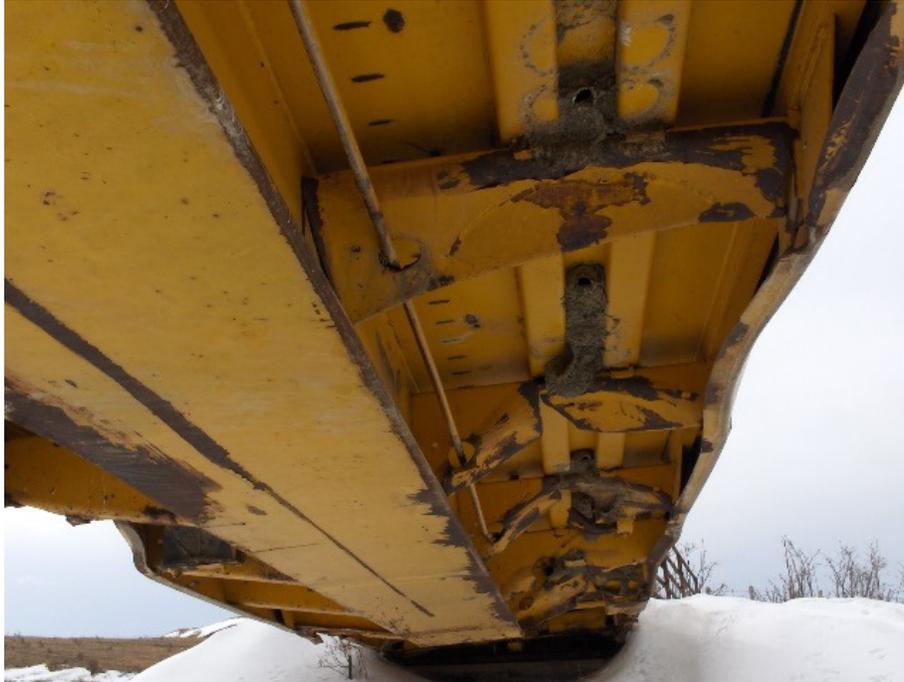
The structural make-up of the railroad car is of a main steel girder running along the centerline of the car, with two small tube steel beams on each side of the center girder also running the length of the railroad car. Stiffening brackets spaced at 36-inch centers are connected to the center girder and support the free edge of the deck and the tube steel beams. On the upstream side of the crossing, most of the brackets have been damaged and offer little or no support. The upstream edge of the deck is also severely damaged in this area.

Photo 4.2 – Damaged Steel Stiffeners on Underside

The crossing is extremely underdesigned for heavy truck traffic, considering both bridge sag and crossing width. Light duty trucks will cause extreme deflections, bounce, and sag during crossing, and the limited deck width is a definite safety issue. It is recommended that this crossing be replaced with an adequately designed single span, single lane structure.

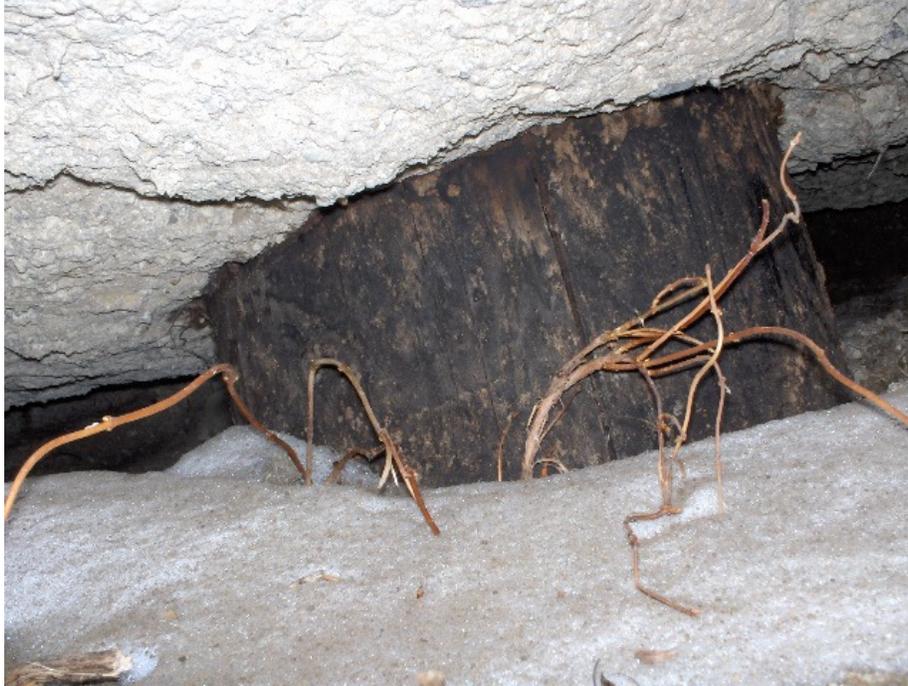
Photo 5.8 – Exposed Timber Pile at South Abutment

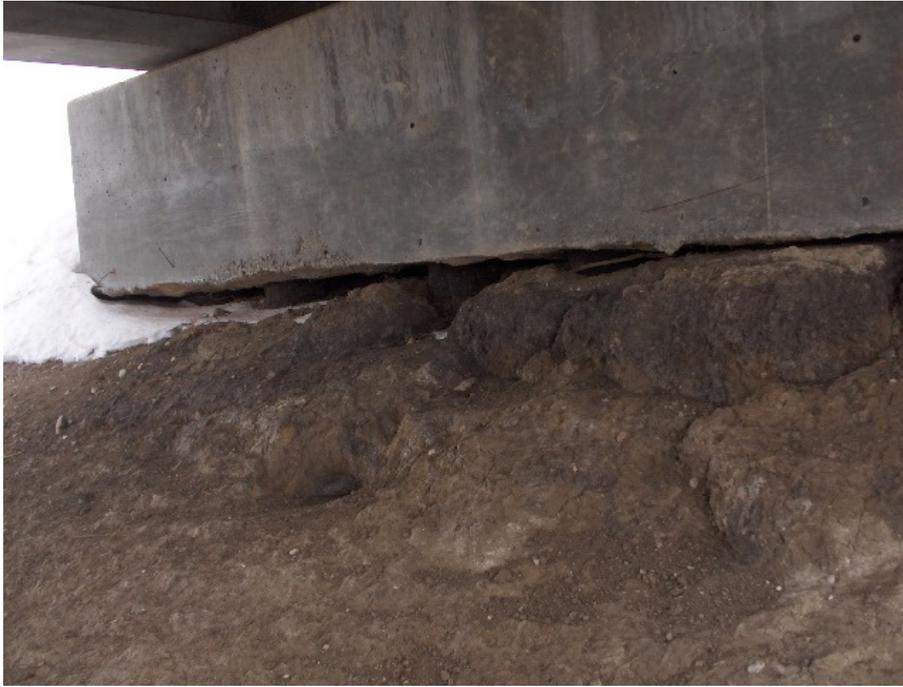
Photo 5.10 – South Abutment (Exposed Timber Piles)
