ST. MARY DIVERSION FACILITIES DATA REVIEW, PRELIMINARY COST ESTIMATE AND PROPOSED REHABILITATION PLAN

February 11, 2005

Montana DNRC
Conservation & Resource
Development Division

Thomas, Dean & Hoskins, Inc.

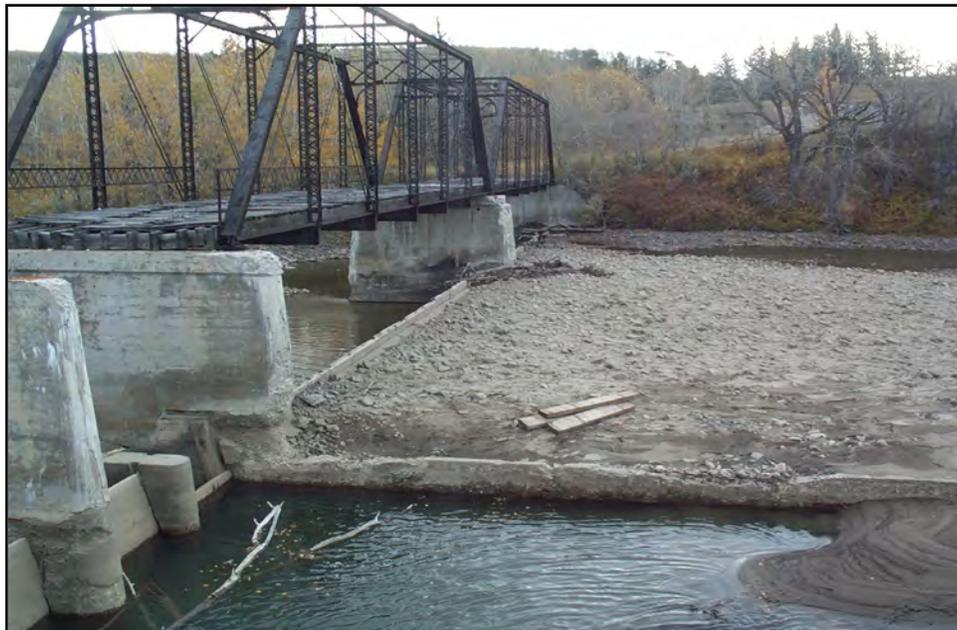
Figure 4.1.1 Looking east across St. Mary River at the two fixed weir segments below the remaining bridge spans. Note condition of concrete, magnitude of sediment deposition upstream of dam and timber plank added to fixed weirs (10/06/04).

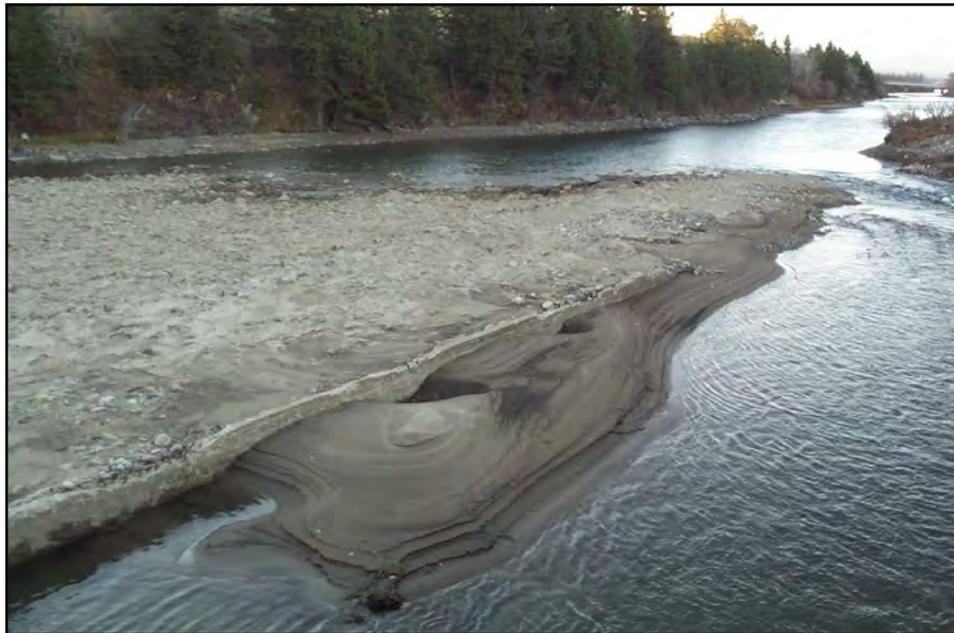
Figure 4.1.3 Looking upstream from sluiceway portion of diversion dam. Note condition of sluiceway training wall (10/13/04).

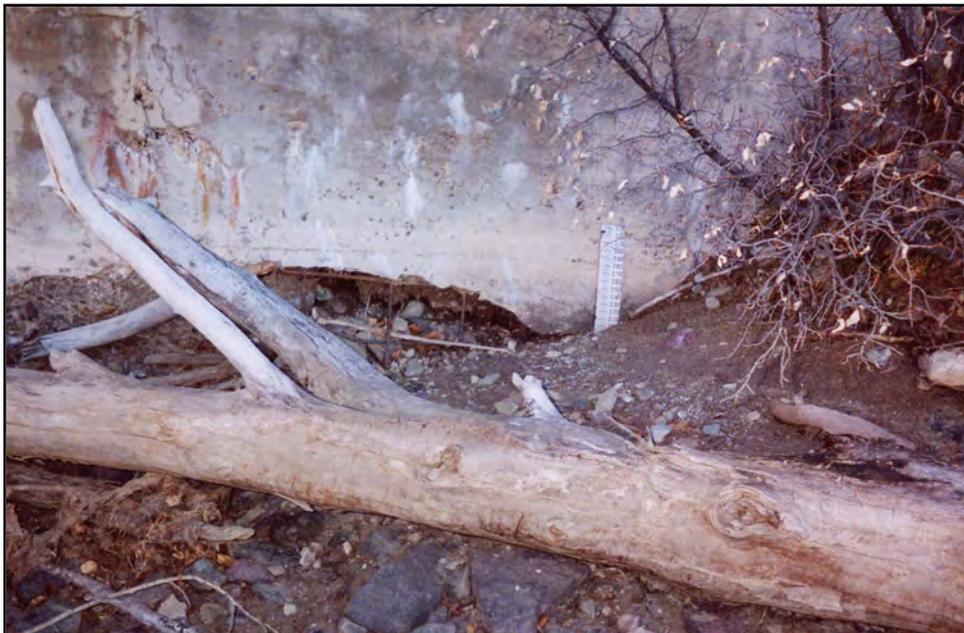
The east abutment of the dam is in very poor condition. Approximately one third of the downstream wingwall concrete is missing and the steel reinforcement (rebar) is exposed. The upstream wingwall also has a large piece of concrete missing with exposed rebar, but the hole was partially filled with sediment and its extent is unknown (Figure 4.1.4). The concrete in the center of the abutment that supports the bridge is in better, but marginal, condition. The wingwalls pose a risk of failure if the channel erodes around the abutment.

Figure 4.1.4 Looking at east abutment. Note condition of concrete and exposed reinforcement (11/11/04).

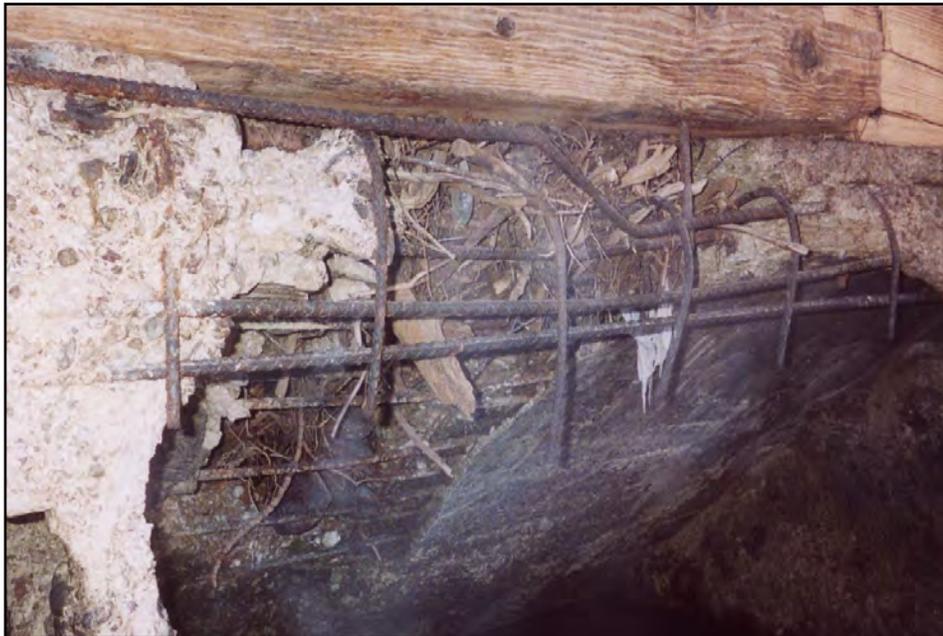
The sloped concrete wall is in very poor condition with large pieces of concrete missing and exposed rebar. In some areas, the rebar forms a net that directly supports cobbles and sediment deposited on the upstream side of the wall (Figure 4.1.5). If the sediment were to be eroded or removed, water would discharge through the holes and the effectiveness of the dam would be compromised.

Figure 4.1.5 View of concrete condition of the underside of fixed weir portion of diversion dam (11/11/04).

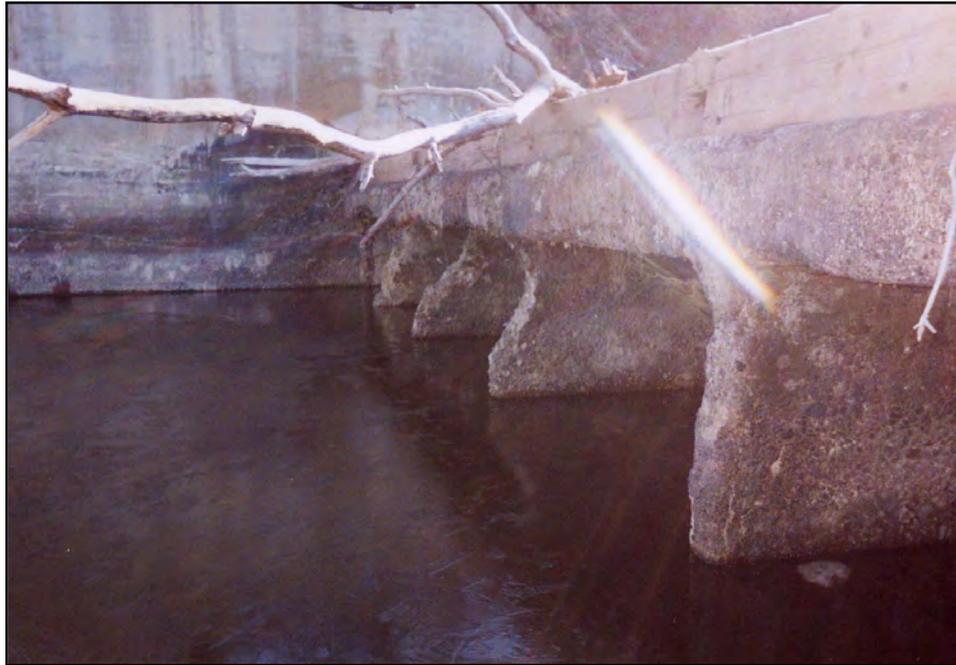
concrete in general seemed in better condition where it was visible. Previous BOR inspections indicated this concrete is in fairly good condition.

Figure 4.1.6 Looking at downstream side of weir. Typical condition of fixed weir support piers (11/11/04).

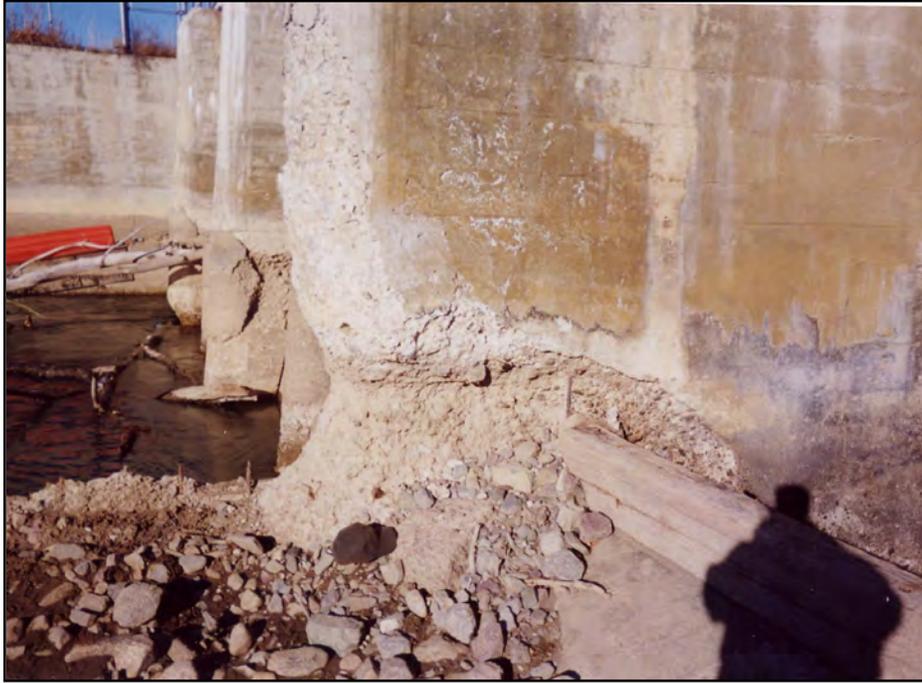
The concrete piers forming the walls of the three sluiceways are badly deteriorated near the waterline. The upstream face of these piers is missing more than a foot of concrete at some locations (Figure 4.1.7). Previous concrete repairs appear to be failing. The downstream portion of some of these piers is also in poor condition (Figure 4.1.8). Large holes extend deeply into or through the piers. The guide slots for the stop logs are deteriorating. Metal guide frames have been installed in the westerly sluiceway for use with the wooden gate panels.

Figure 4.1.7 Looking west at upstream edge of sluiceway piers. Note concrete condition and exposed reinforcement (11/11/04).

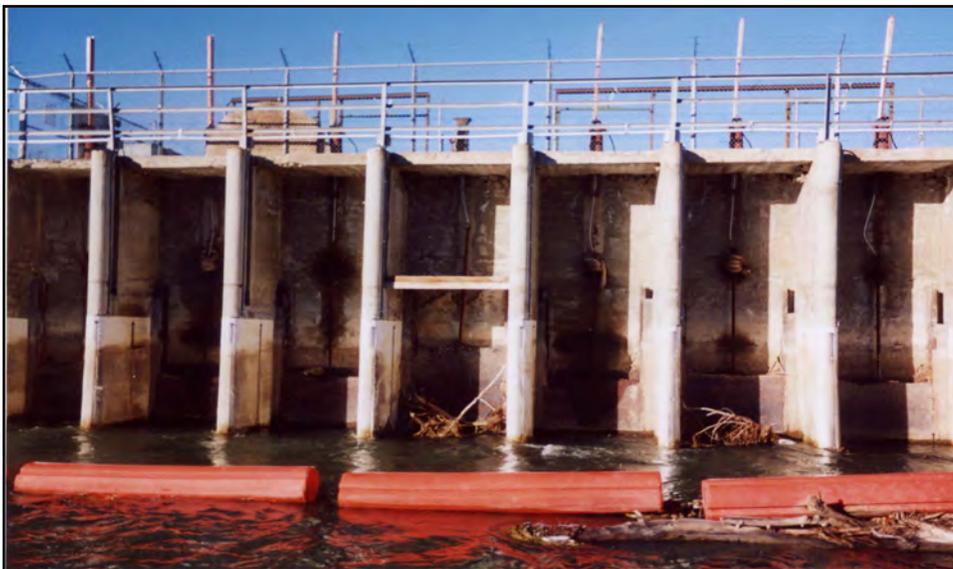
Some concrete repairs were made to the upstream side of the structure in 2003 when the experimental electric fish barrier was installed. Water flowing in the channel prevented a close inspection of the upstream side of the gates. The BOR 2003 review report indicated concrete on this side was in satisfactory condition at this time. That report indicated that several of the gate stems were bent and in need of replacement and one gate was missing a stem. The Gate 5 operator was in the process of being repaired during our inspection.

Figure 4.2.3 Upstream view of gate openings (11/11/04).

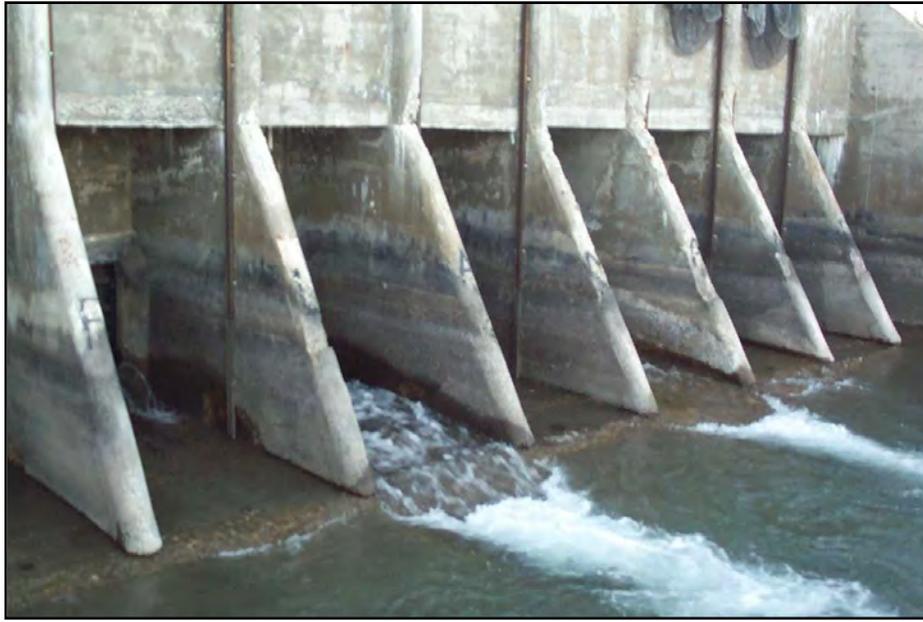
The bottom member of gates 1, 4, 6, & 7 were reported to be bent and cracked in the 2003 report. Debris is currently preventing total closure of gates 3 and 5 and these gates are leaking badly (Figures 4.2.3 and 4.2.4). The remaining gates had some leakage, but not as bad.

Figure 4.2.4 Downstream view of headgate structure. Note heavy leakage through Gates 3 and 5 (10/13/04).

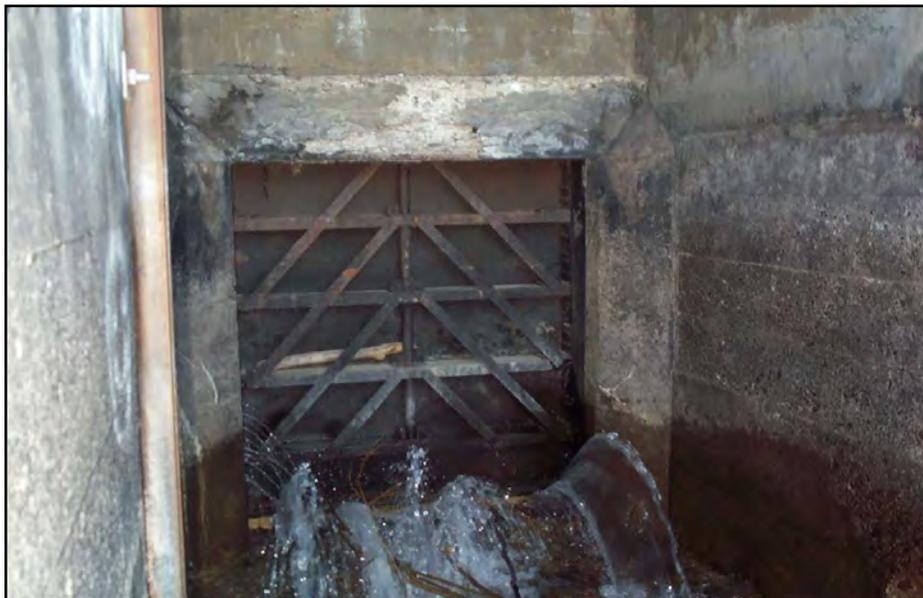
Figure 4.2.5 Close-up (downstream) of heavy leakage and debris on Gate 3 (10/13/04).

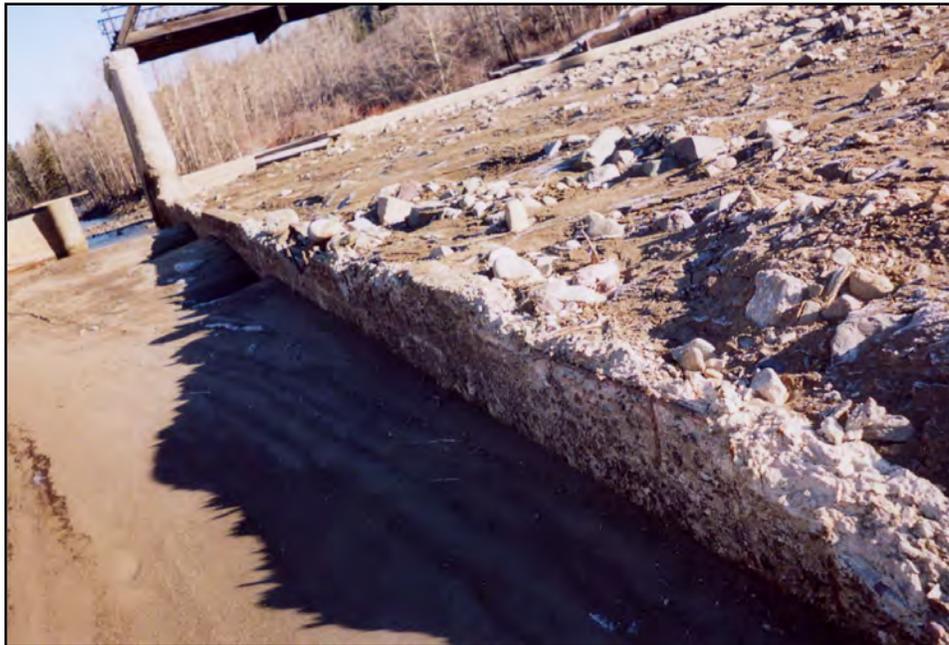
The concrete channel wall on the east side of the sluiceway (in front of the headgates) is in extremely poor condition where it is exposed (Figure 4.2.6). Most of the wall is hidden beneath sediment. The channel bottom was not observable.

Figure 4.2.6 Sluiceway training wall upstream of canal headgates (11/11/04).

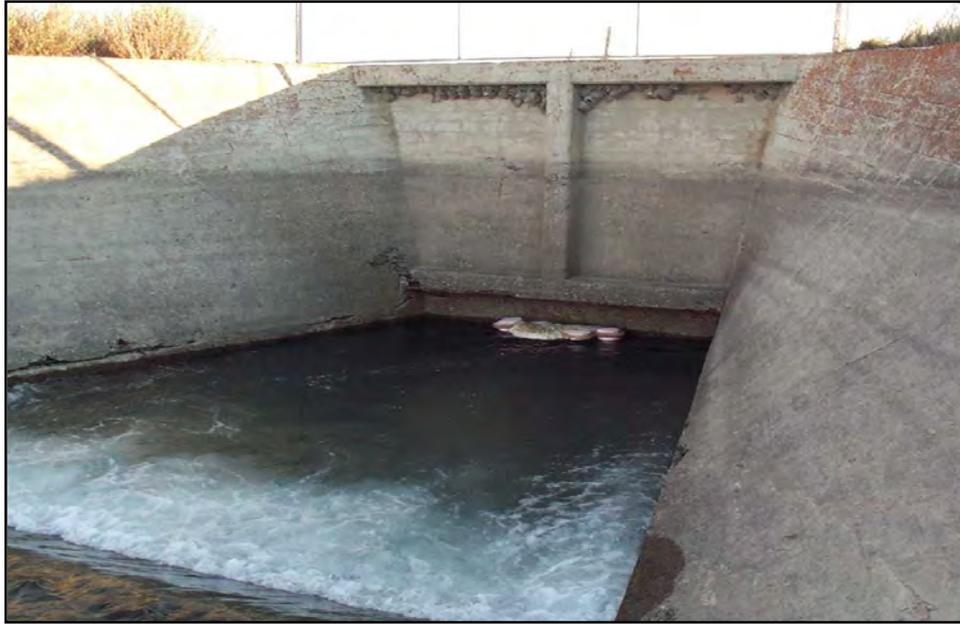
The inlet to the siphon appears to be in generally poor to marginal condition (Figure 4.3.1). There are areas of deteriorated concrete with pockets and holes near the winter low water line. Some reinforcing steel is exposed. The headwall is cracked in several places (Figure 4.3.2).

Figure 4.3.1 Inlet section (south side) of Kennedy Creek Siphon (10/13/04).

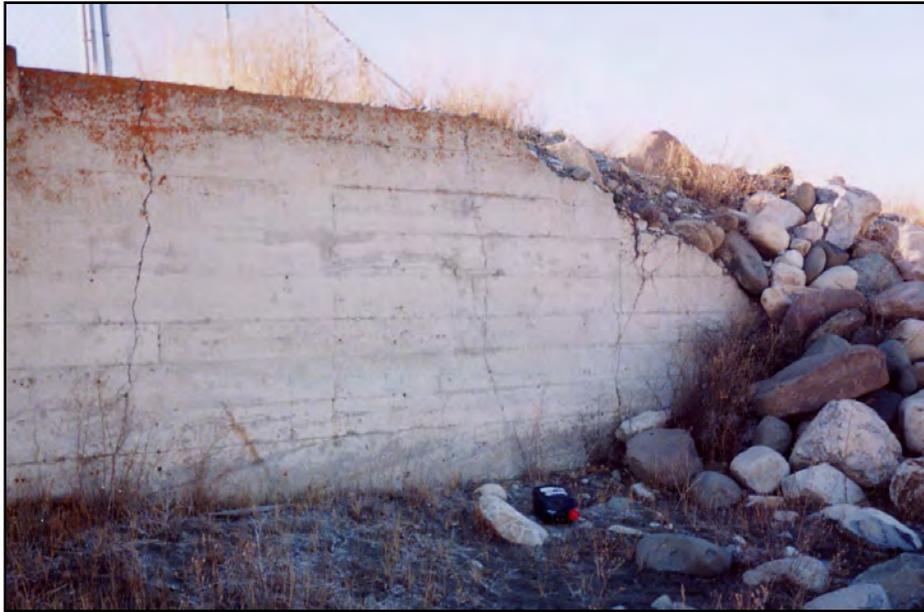
Figure 4.3.2 Kennedy Creek side of inlet structure (11/11/04).

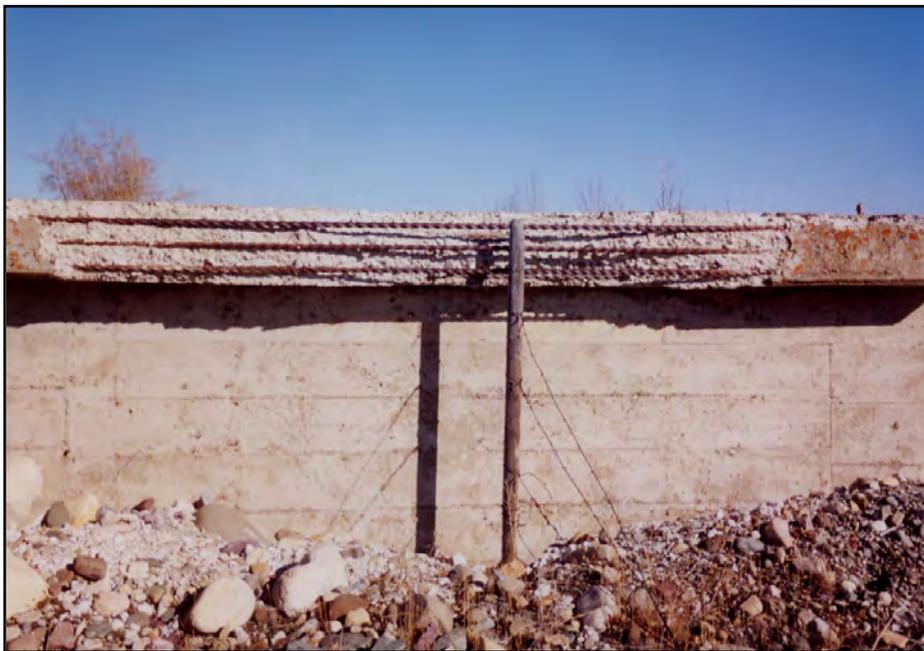
The outlet of the siphon is in similarly poor condition as the inlet. The beam at the top of the retaining wall at the siphon exit is in poor condition with a large amount of spalling and reinforcing steel exposed (Figure 4.3.3). The retaining walls appear to have been extended since the original construction based on the appearance of joints and types of exposed rebar.

Figure 4.3.3 Kennedy Creek side of outlet structure (11/11/04).

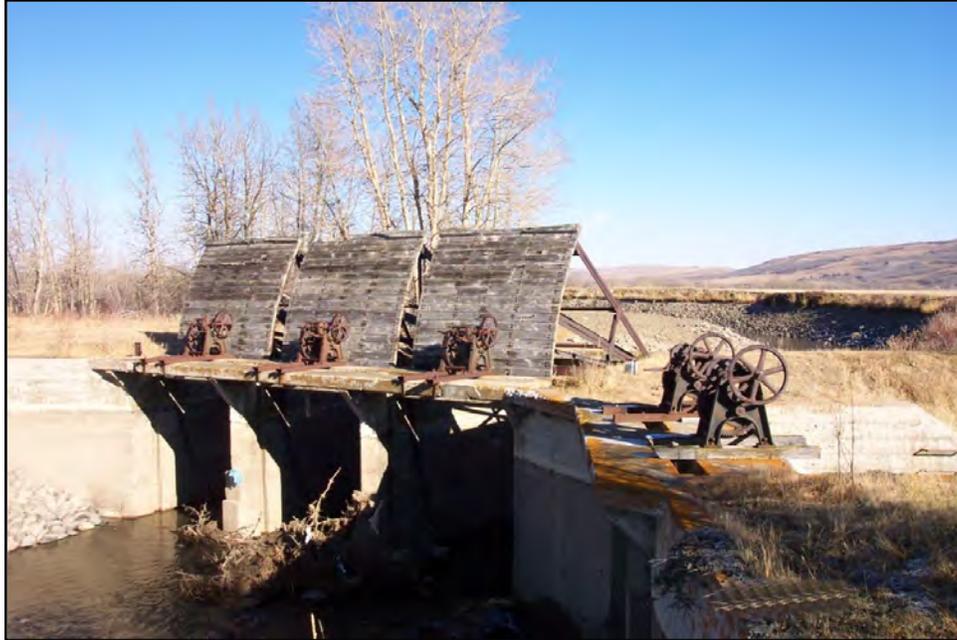
Figure 4.4.2 Upstream view of Kennedy Creek check structure (left) and wasteway (right). Note modifications to wasteway operator slab to maintain operation (11/11/04).

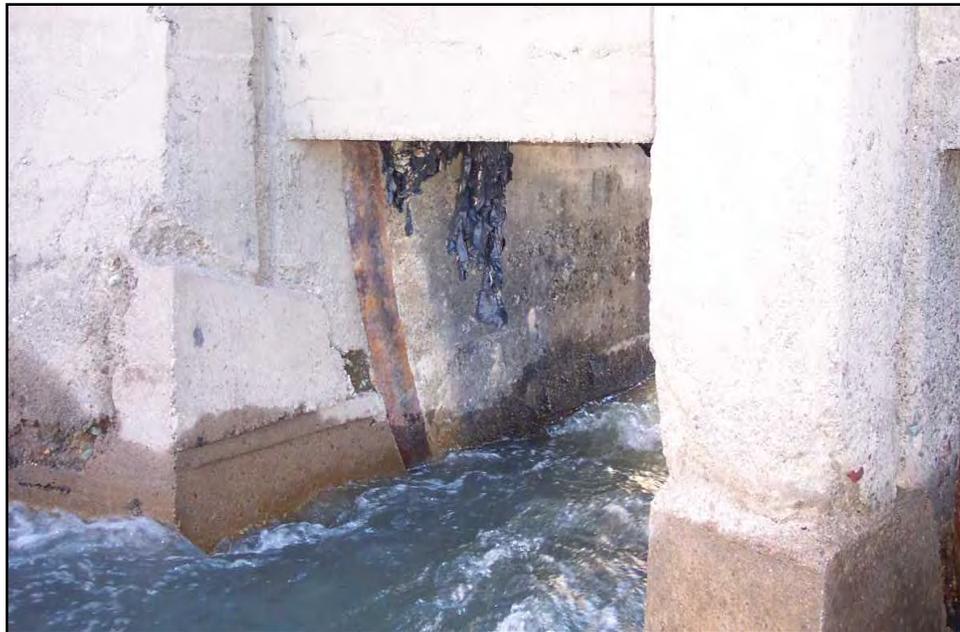
Figure 4.4.3 Upstream view of wasteway. Note condition of concrete. Wasteway is open during off-season to drain inflows and seepage (11/11/04).

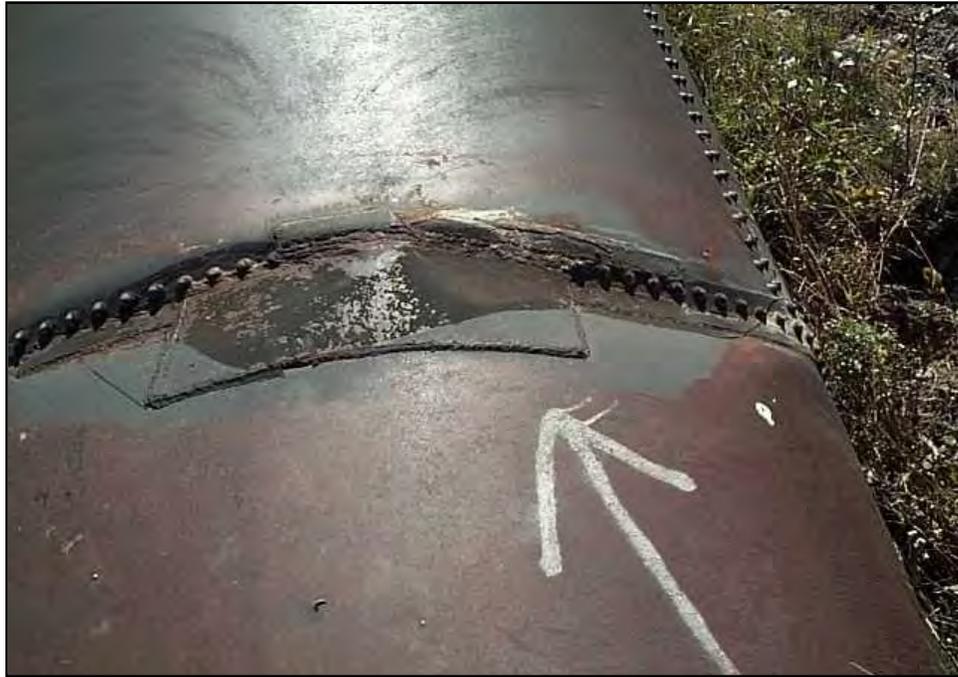
Figure 4.5.6 Typical siphon repair due to deflection and/or corrosion (10/13/04).

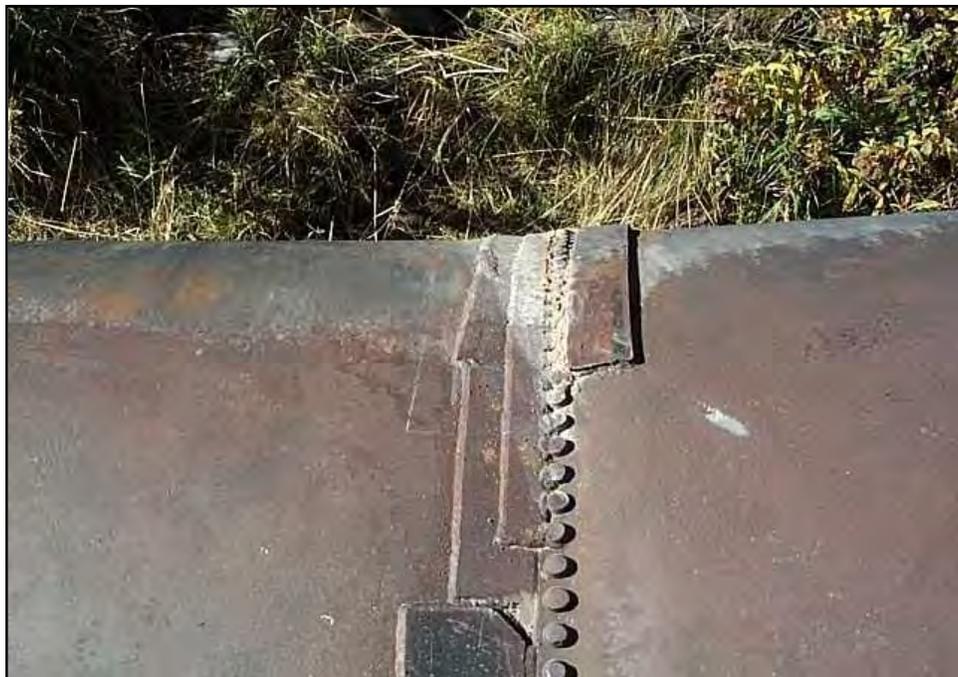
Figure 4.5.7 Typical siphon repair due to deflection and/or corrosion (10/13/04).

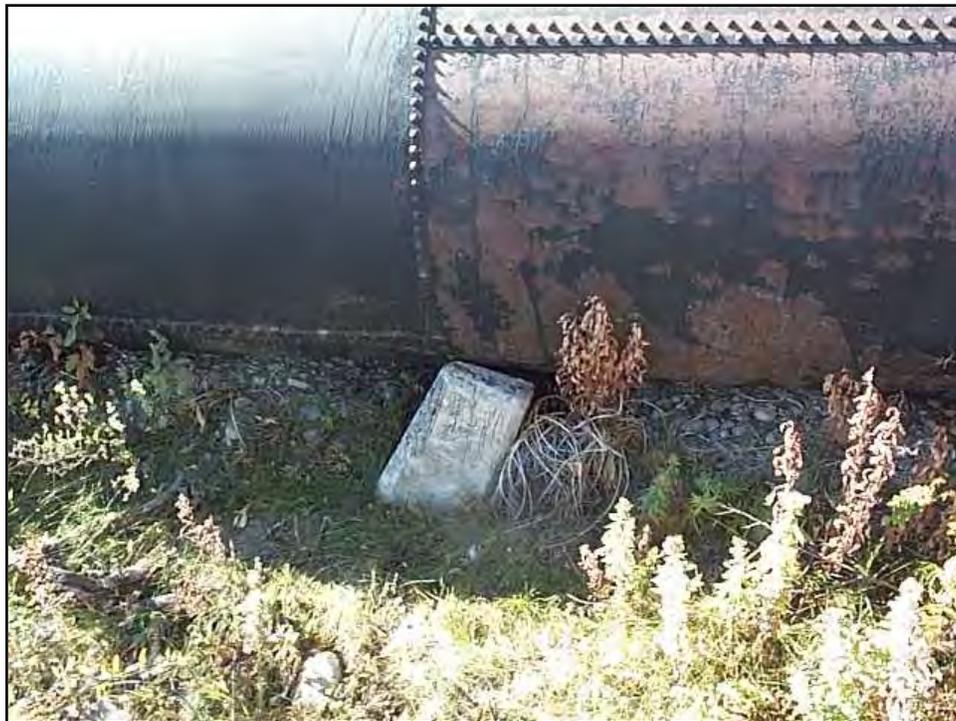
Figure 4.5.8 Photo shows ground movements right to left causing rotation of concrete support and point-loading of siphon which can lead to buckling (10/13/04).

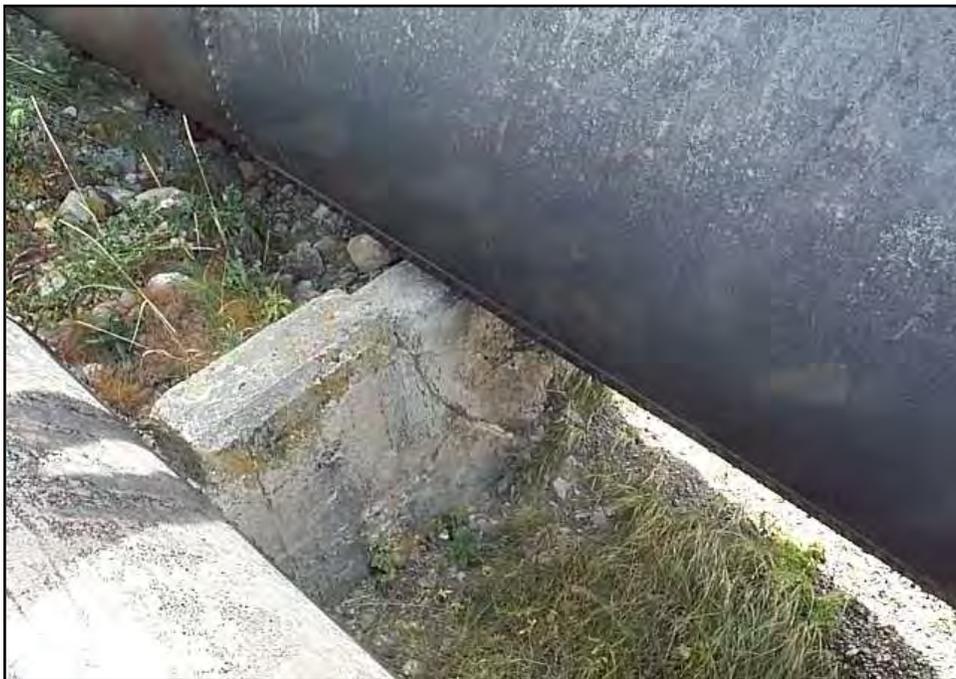
Figure 4.5.10 Photo shows concrete failure of a Halls Coulee Siphon support saddle (10/13/04).

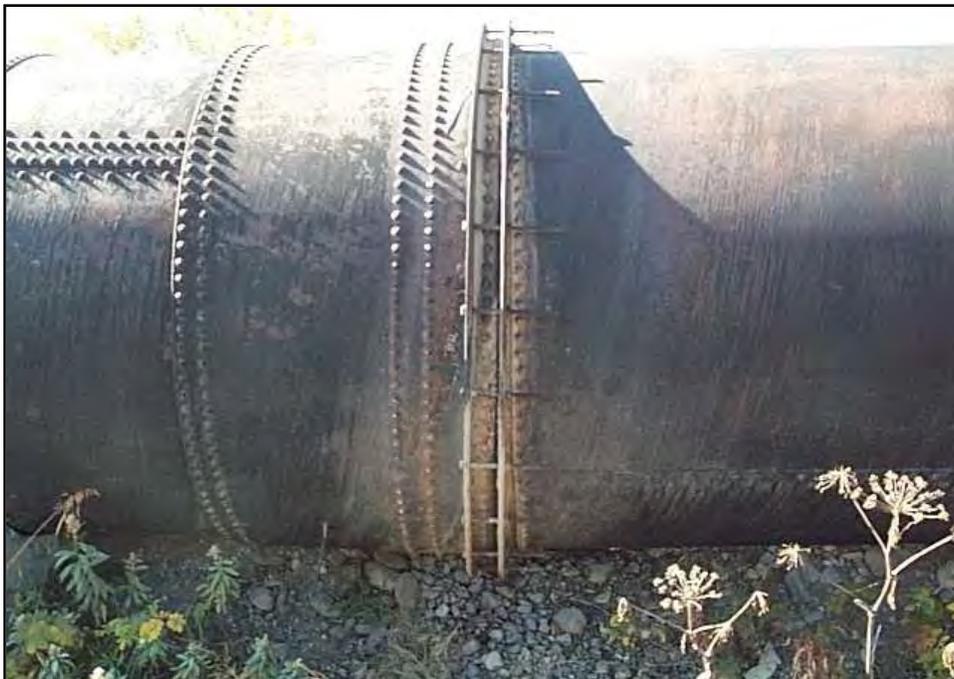
Figure 4.5.11 Leaking expansion/contraction joint on St. Mary River Siphon. Note erosion of supporting soil (10/13/04).

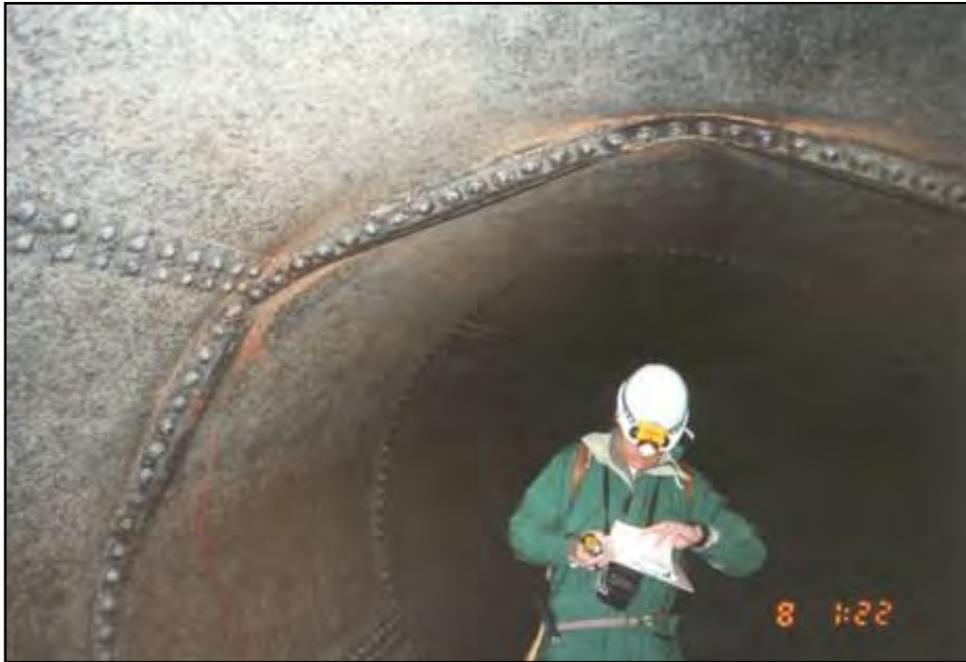
Figure 4.5.12 Typical Buckling at the Top of St. Mary River Siphon (10/26/04).

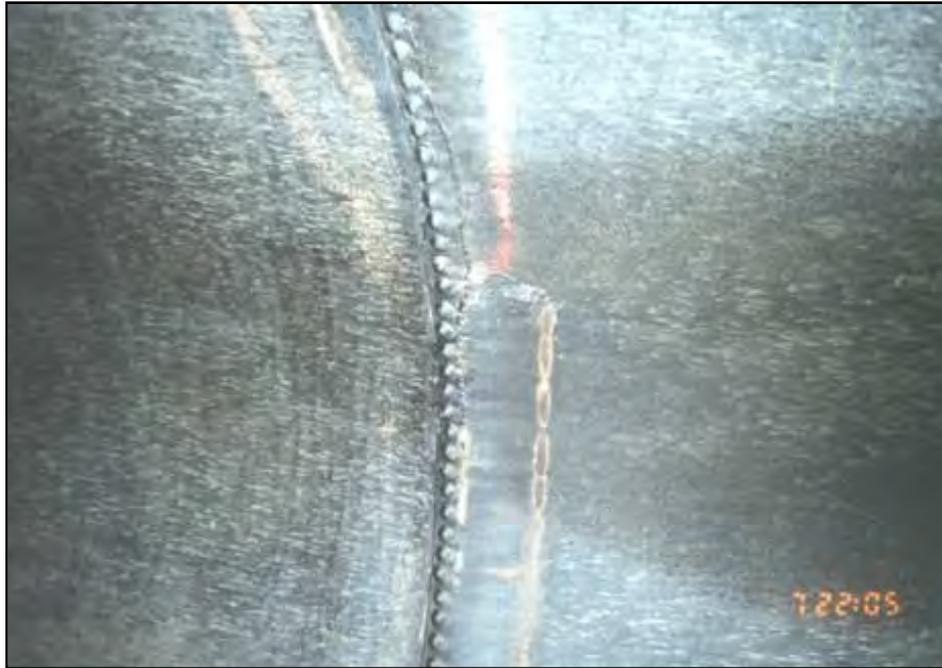
Figure 4.5.14 Cracks in the Steel Near the Downstream End of the Right St. Mary River Siphon (10/26/04).

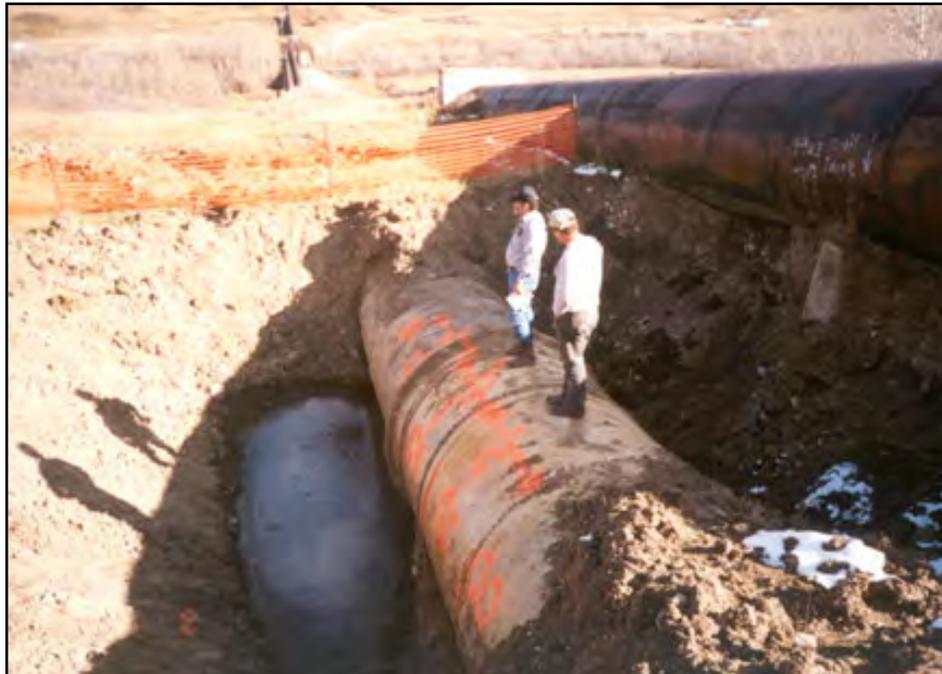
Figure 4.5.15 Exposed part of left siphon where expansion/contraction joint has closed. This joint was being replaced in the Fall 2004 (10/26/04).

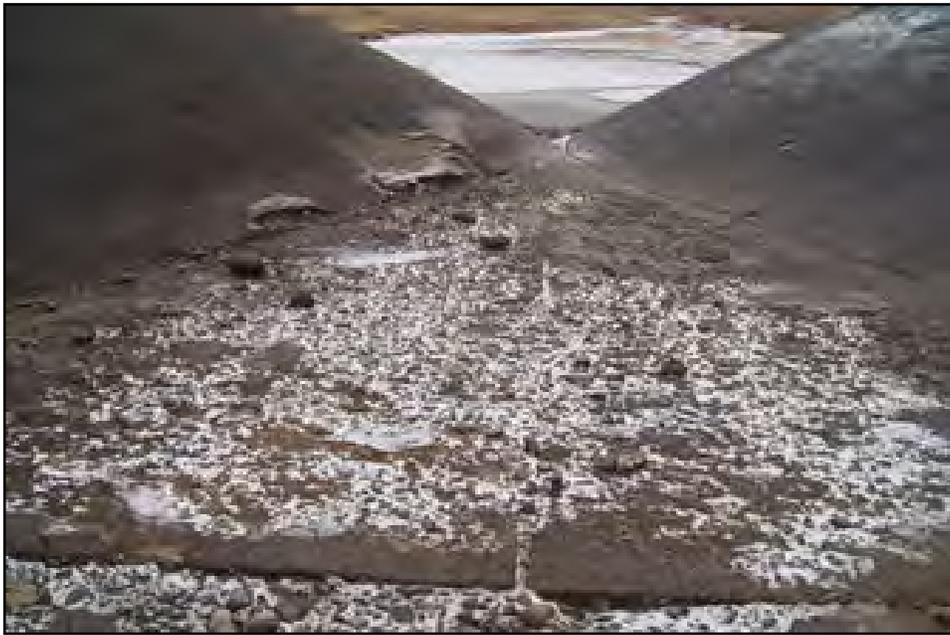
Figure 4.6.2 Looking at approach section of Drop No. 1. Note condition of concrete (11/10/04).

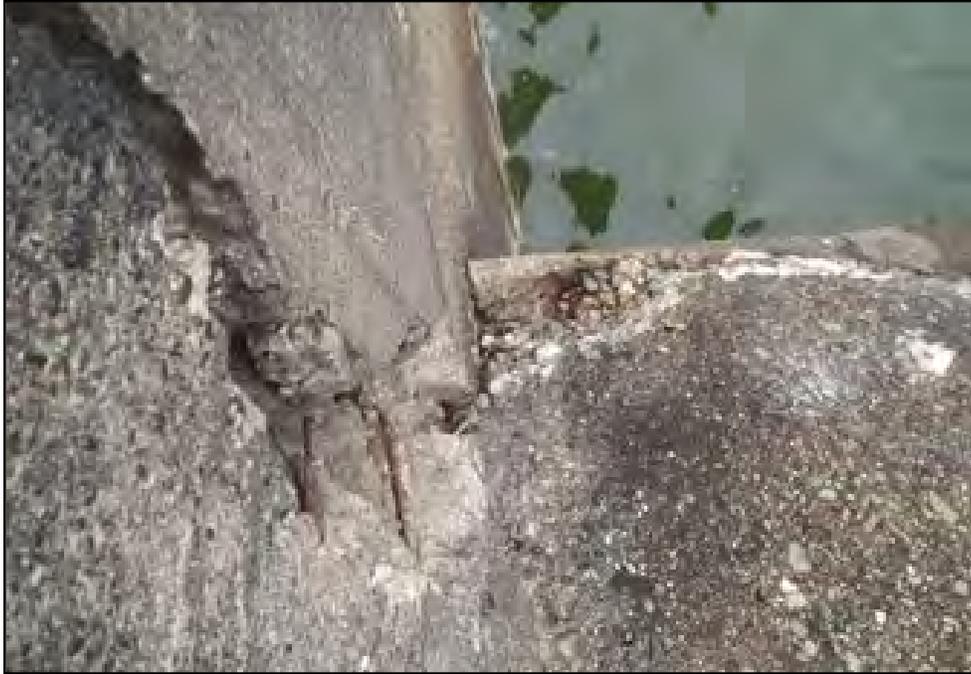
Figure 4.6.4 Looking at left (north) retaining wall at terminus of chute section (Drop No. 1). Note structural cracking (11/10/04).

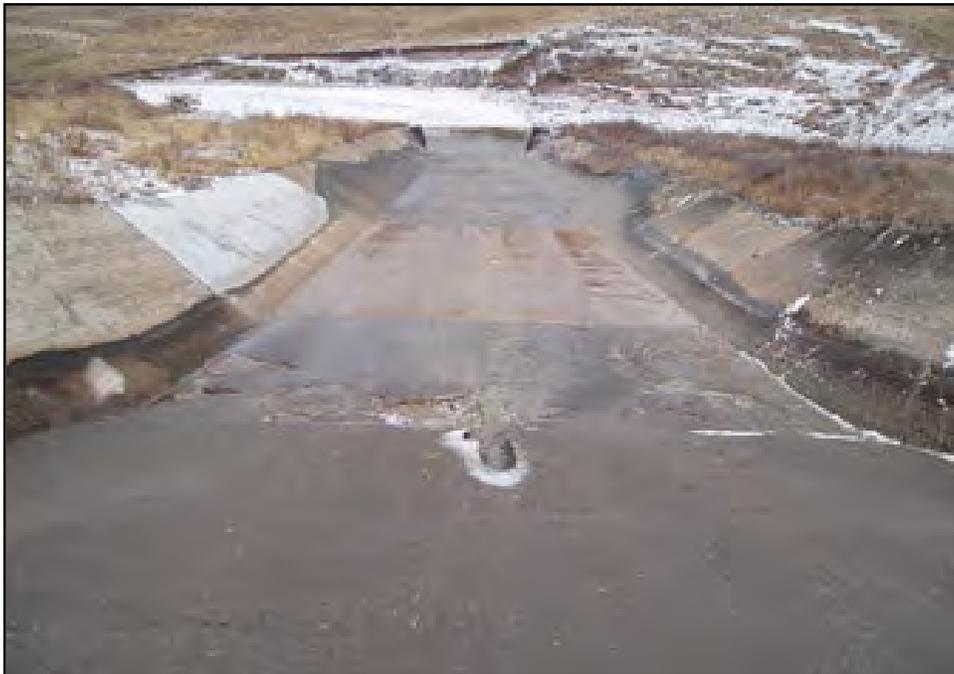
Figure 4.6.6 Downstream view of chute of Drop No. 2. Note new section replaced in 2002 and extent of landslide in background (11/10/04).

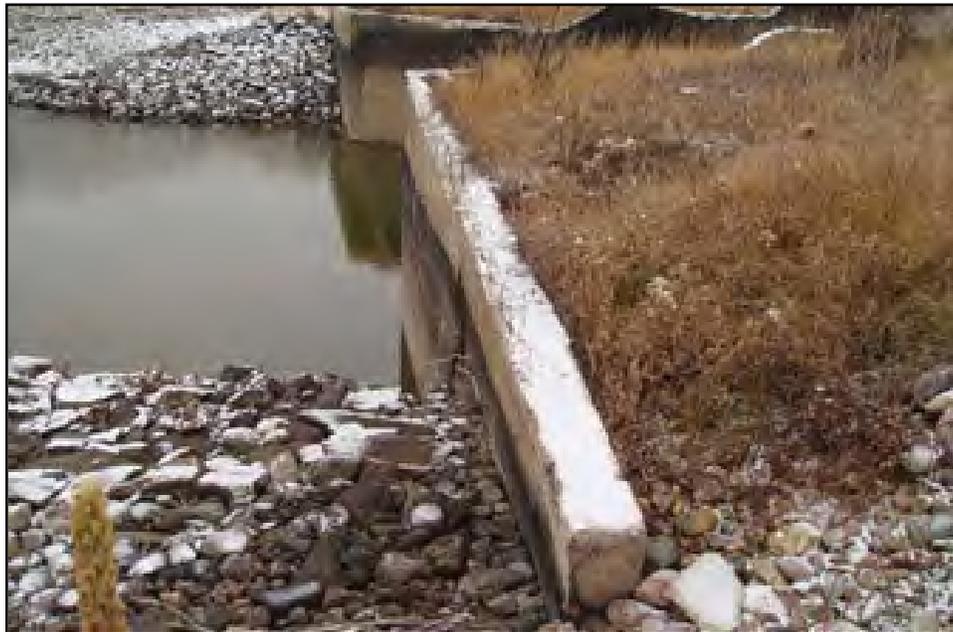
Figure 4.6.9 Left (north) wingwall of Drop No. 2 is failing (11/10/04). Also, see Figures 4.6.10 and 4.6.11.

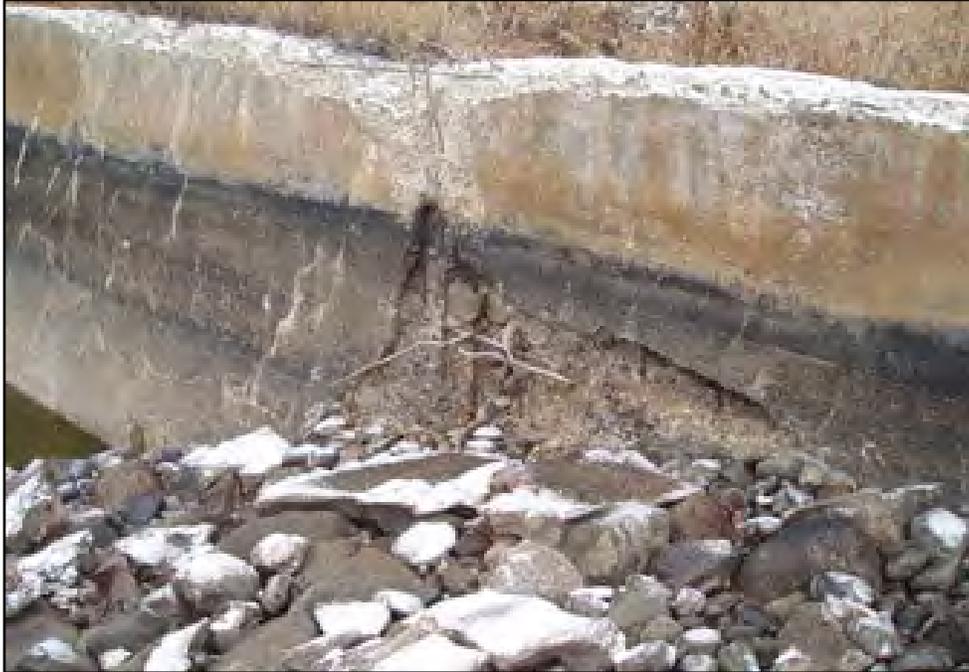
Figure 4.6.10 North wingwall of Drop No. 2. Note wall displacement, concrete loss and exposed reinforcement (11/10/04).

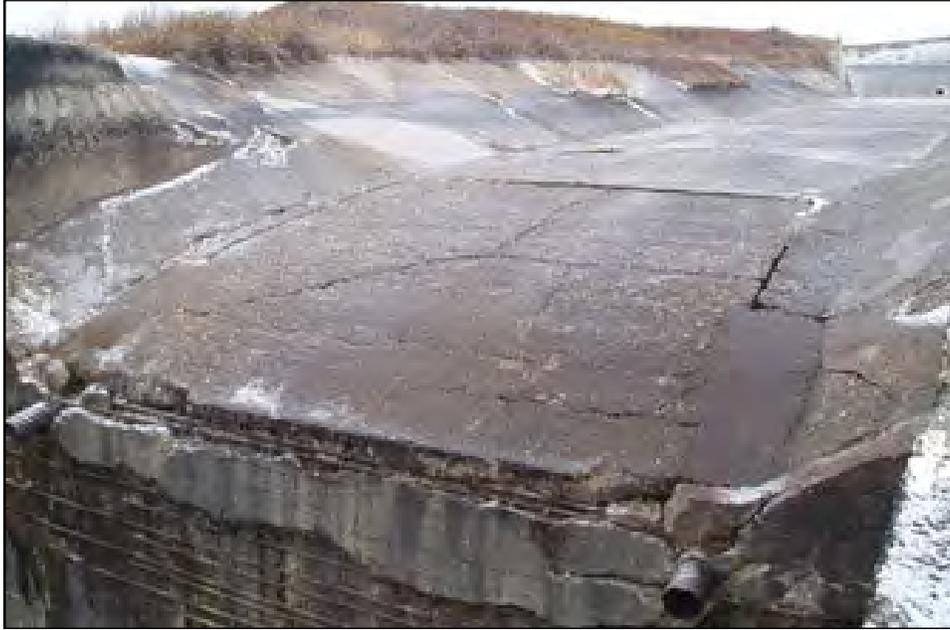
Figure 4.6.12 Looking at terminus of chute section for Drop No. 2. Note condition of plunge pool headwall and end of chute (11/10/04).

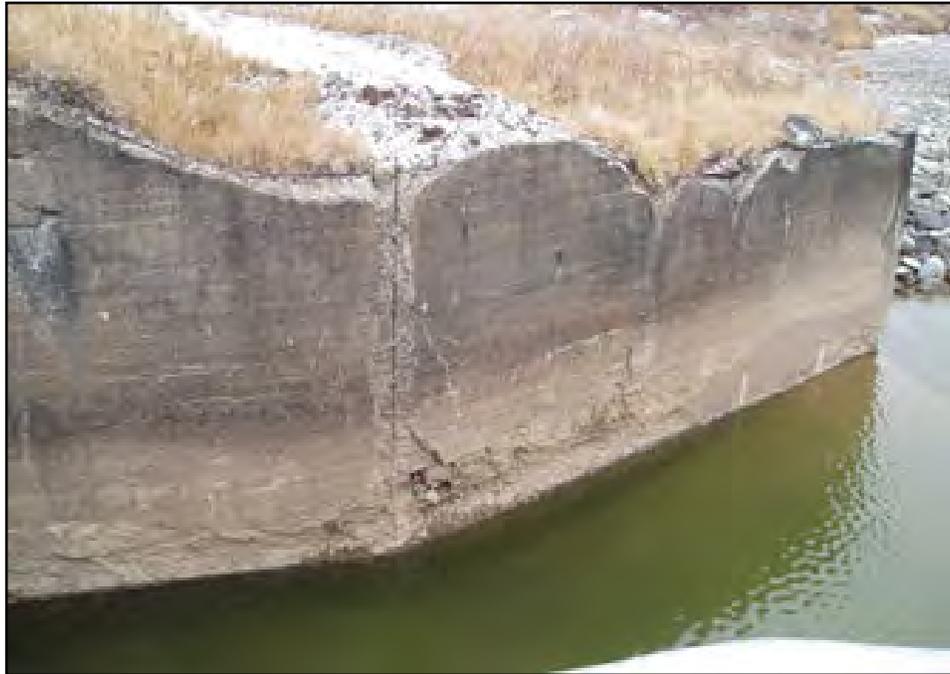
Figure 4.6.15 Looking at north (left) training wall in plunge pool of Drop No. 2. BOR crews filled large sink hole behind wall (11/10/04).

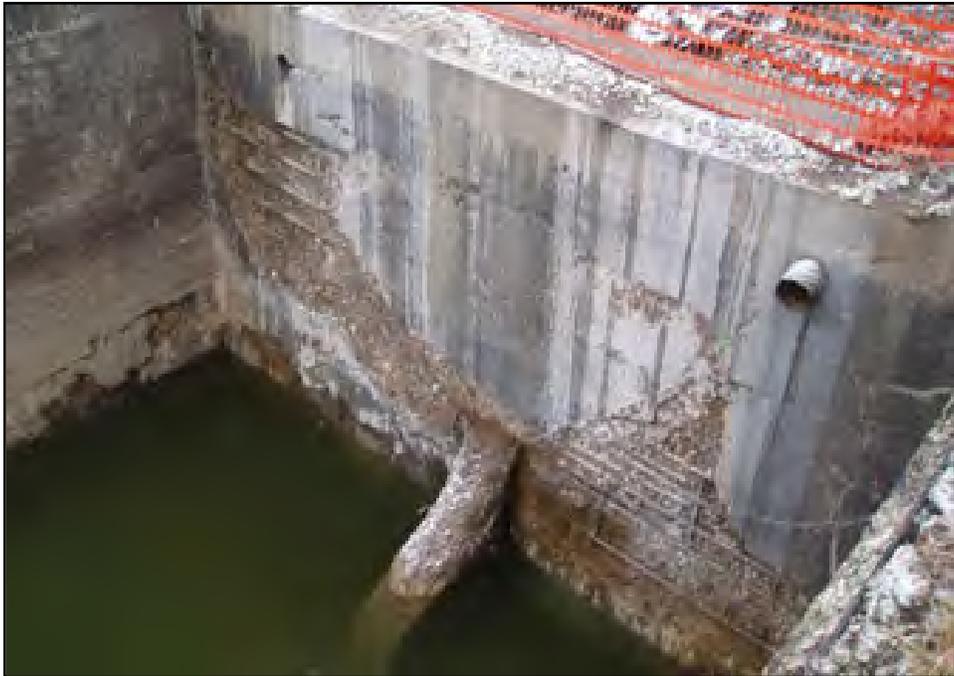
Figure 4.6.17 Condition of plunge pool headwall at drop No. 3 (11/10/04).

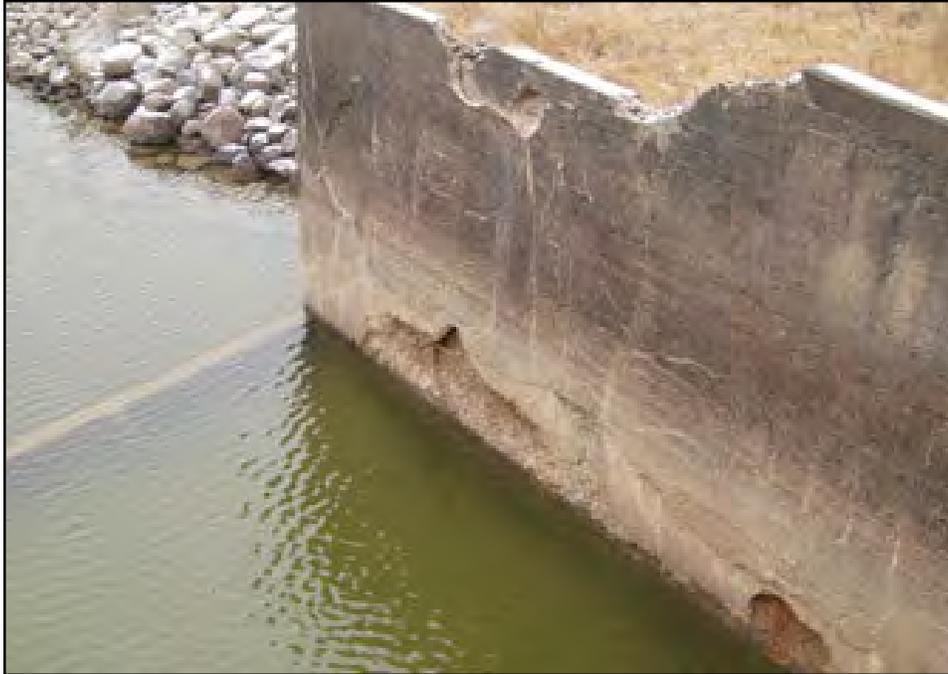
Figure 4.6.18 Typical condition of south (right) training wall at Drop No. 3 (11/10/04).

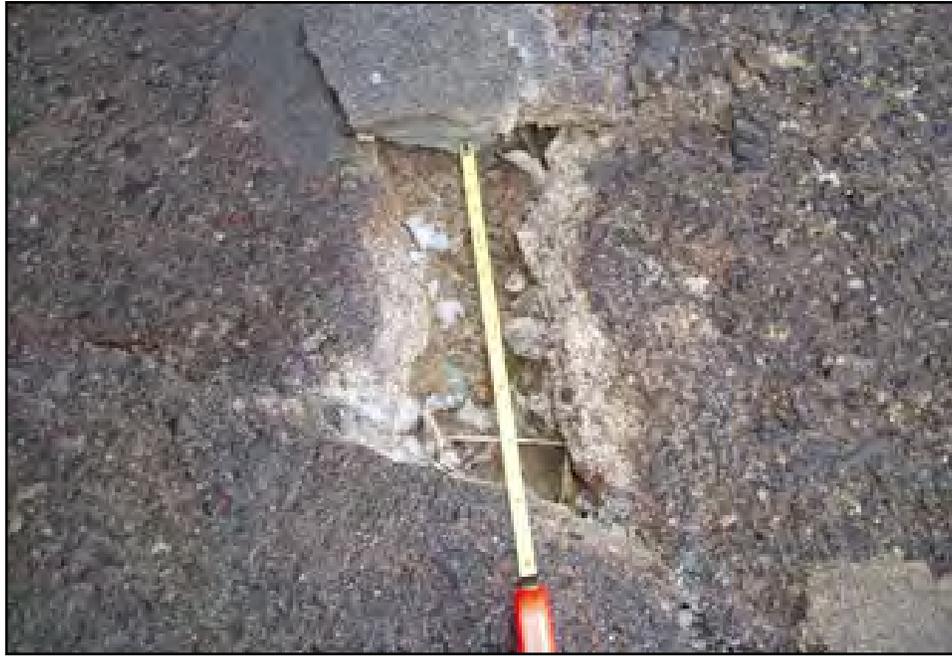
4.6.21 Close-up of concrete deterioration of Drop No. 4 chute floor (11/10/04).

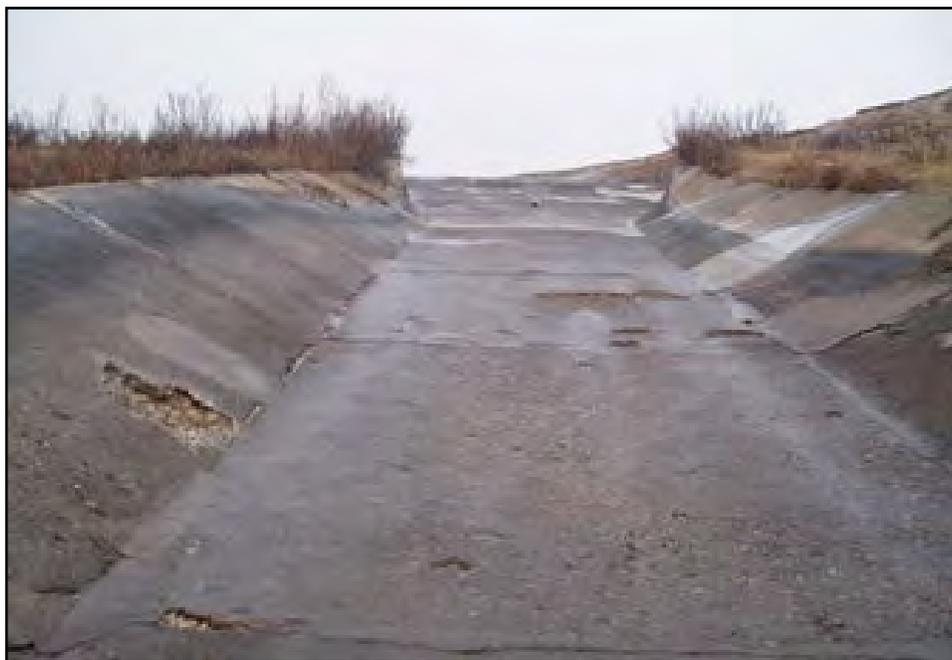
Figure 4.6.22 Looking upstream at Drop No. 4. Note concrete deterioration (11/10/04).
