ST. MARY DIVERSION FACILITIES DATA REVIEW, PRELIMINARY COST ESTIMATE AND PROPOSED REHABILITATION PLAN

February 11, 2005

Montana DNRC
Conservation & Resource
Development Division

Thomas, Dean & Hoskins, Inc.

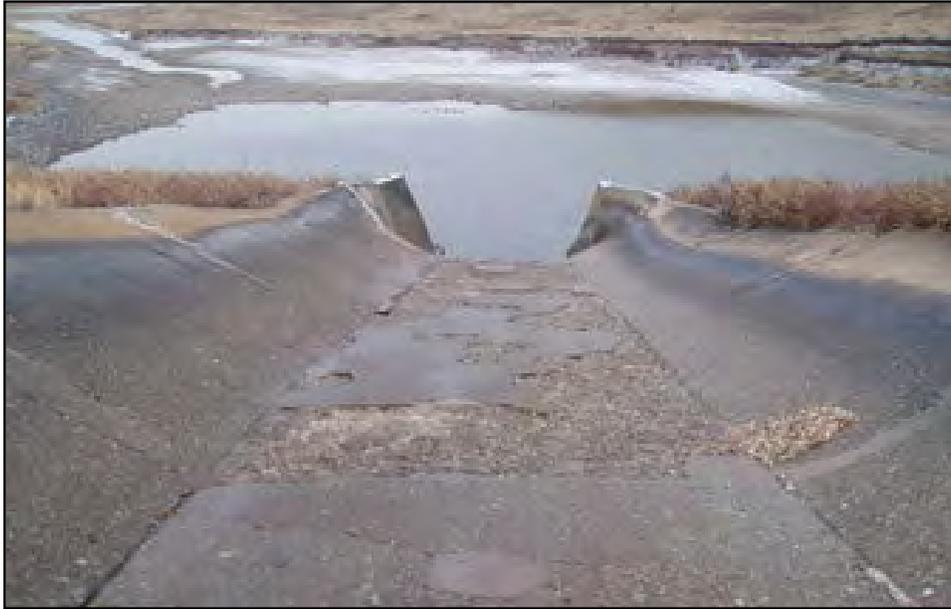
Figure 4.6.23 Looking at terminus of chute section (Drop No. 4). Note the degree of concrete spalling (11/10/04).

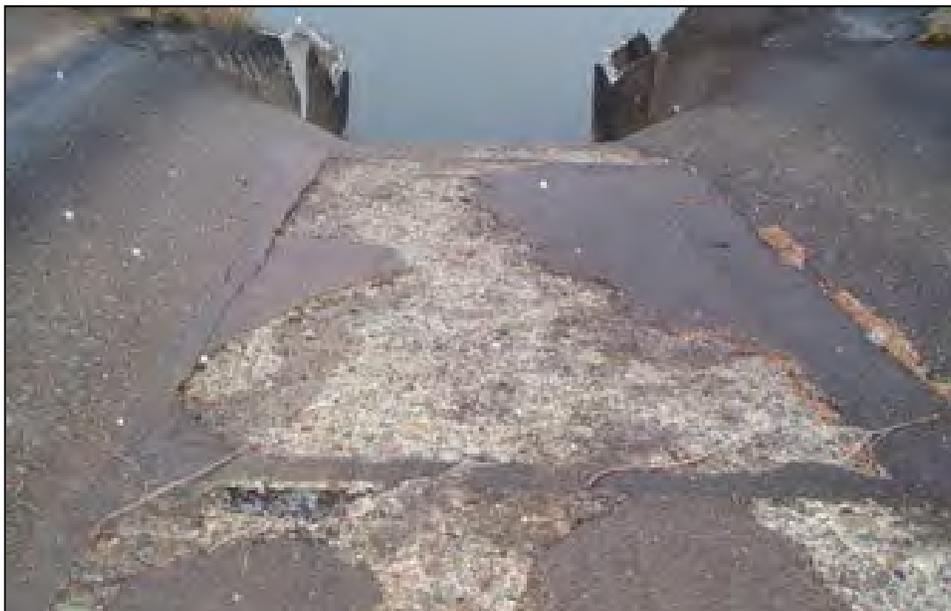
Figure 4.6.24 Heavy spalling of chute floor in Drop No. 5 (11/10/04).

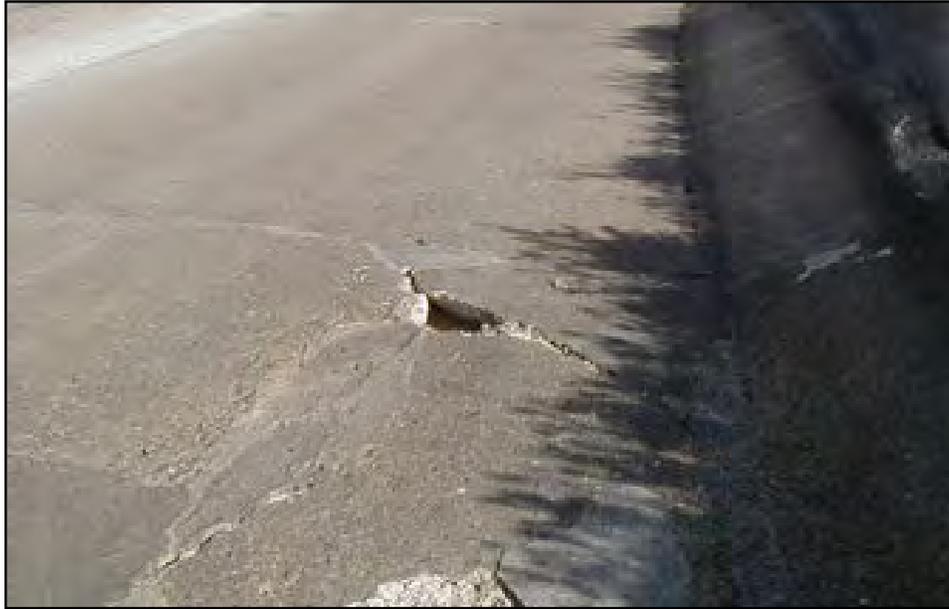
Figure 4.6.25 Hole in chute floor of Drop No. 5 (10/13/04).

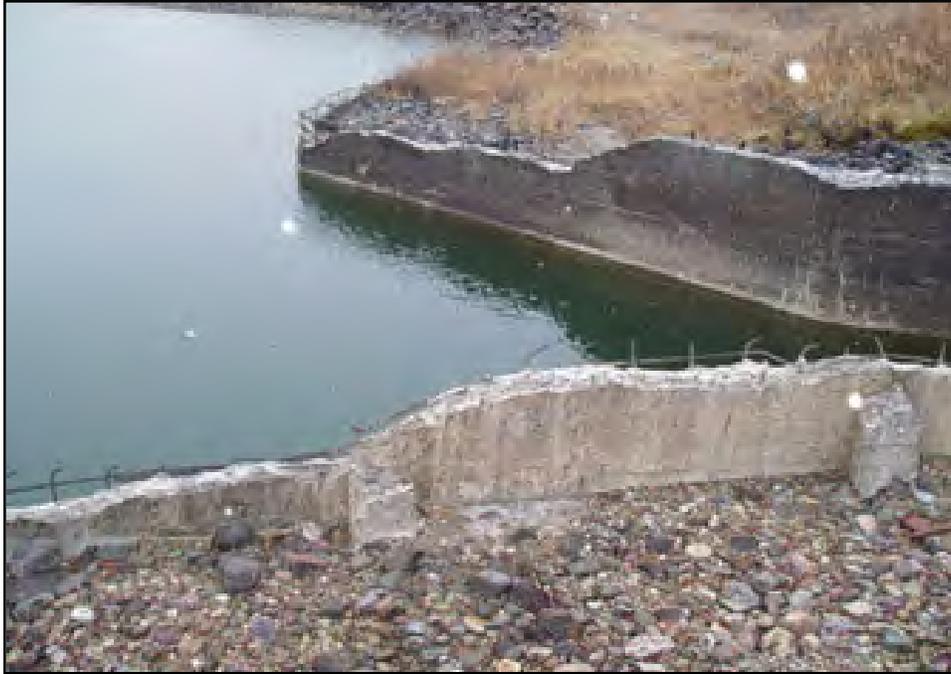
Figure 4.6.26 Heavily damaged/eroded wing and training walls on Drop No. 5 (11/10/04).

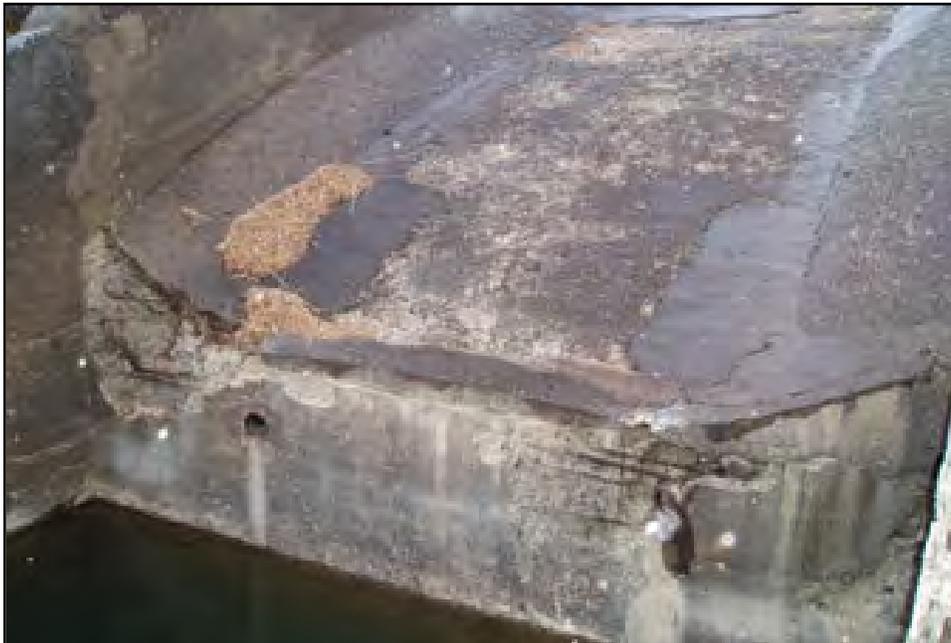
Figure 4.6.27 Terminus of chute section of Drop No. 5. Note condition of plunge pool headwall (11/10/04).

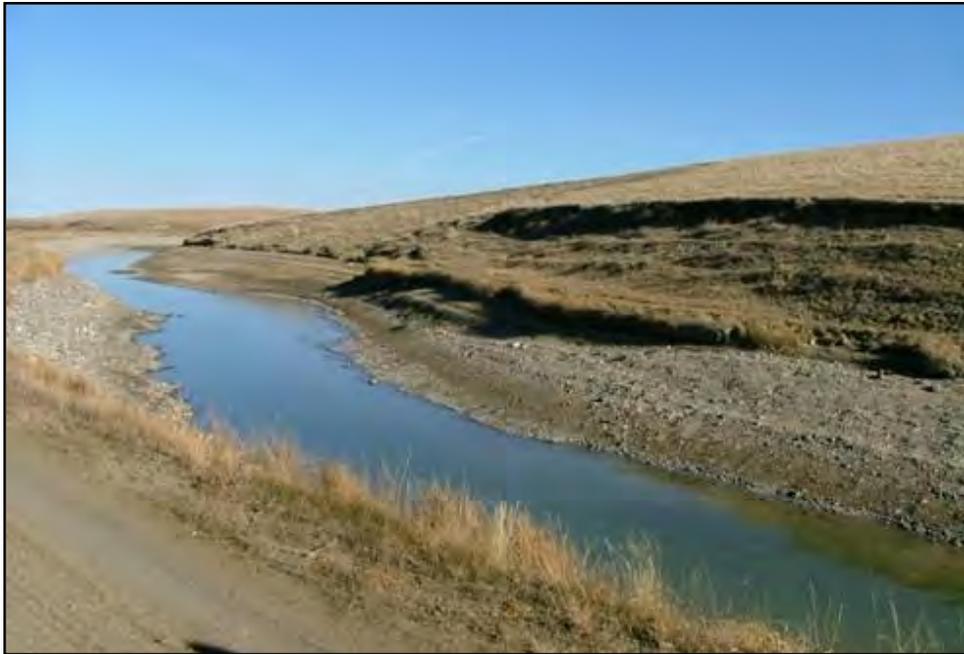
Figure 4.7.3 Typical earth slide encroaching into canal prism and reducing capacity (11/11/04).

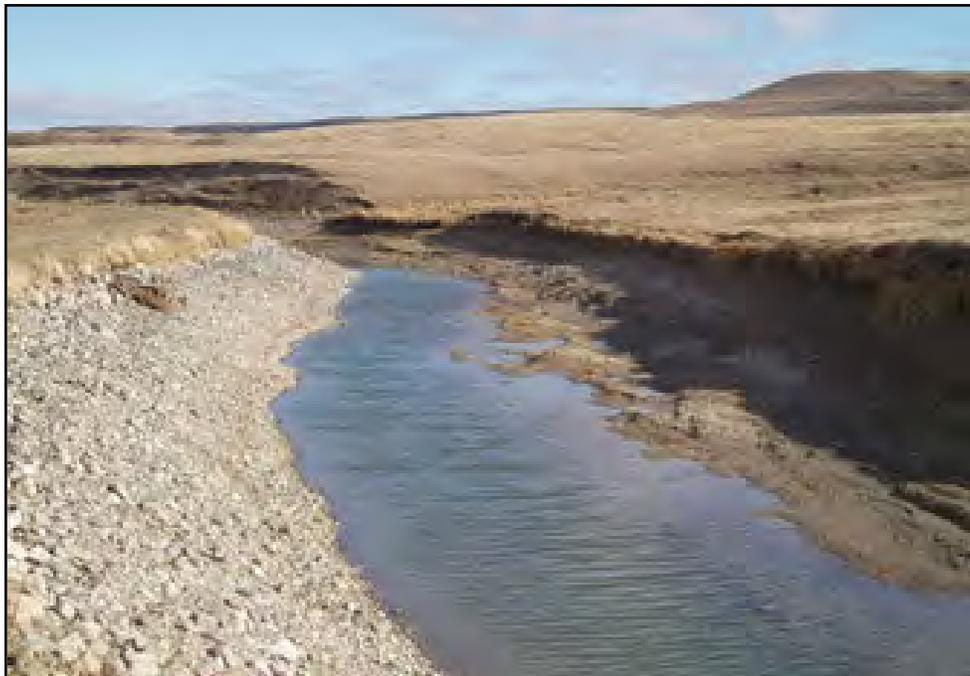
Figure 4.7.4 Looking downstream at typical canal prism. Note irregular cross-section, erosion of right bank, relatively recent armoring on left bank and slope failure in background (11/10/04).

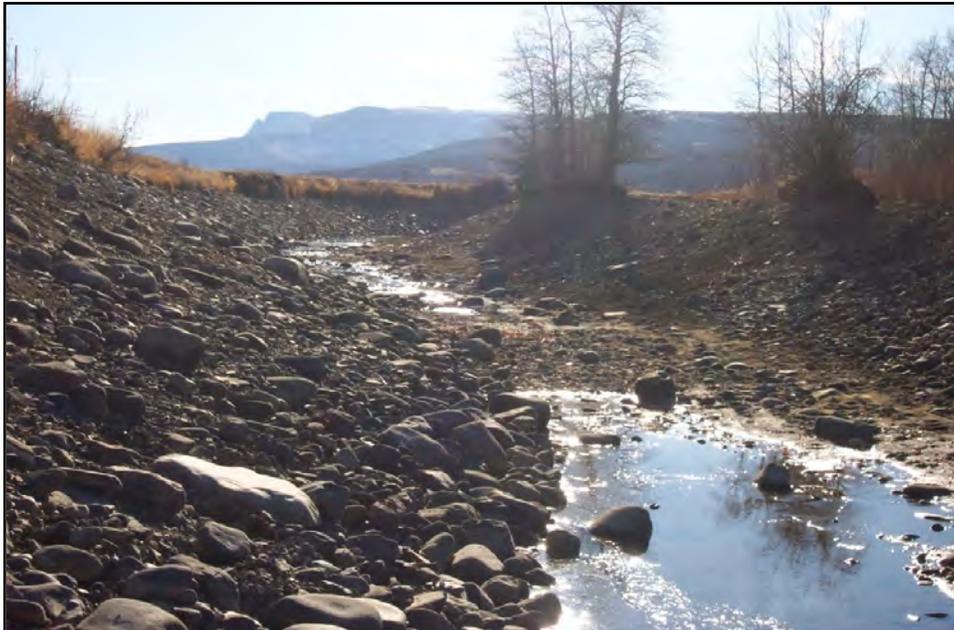
Figure 4.7.7 Rocky channel bottom decreases hydraulic capacity. This highly permeable material is typical of alluvial fan deposits associated with Swiftcurrent and Kennedy Creeks (11/11/04).

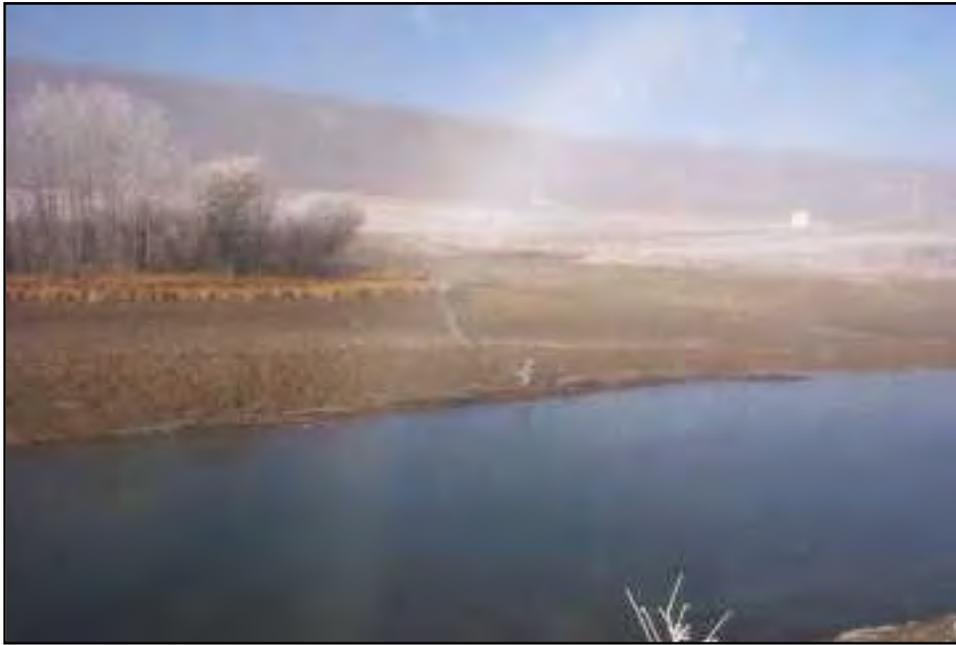
Figure 4.7.8 Example of irregular canal prism cross-section (11/11/04).

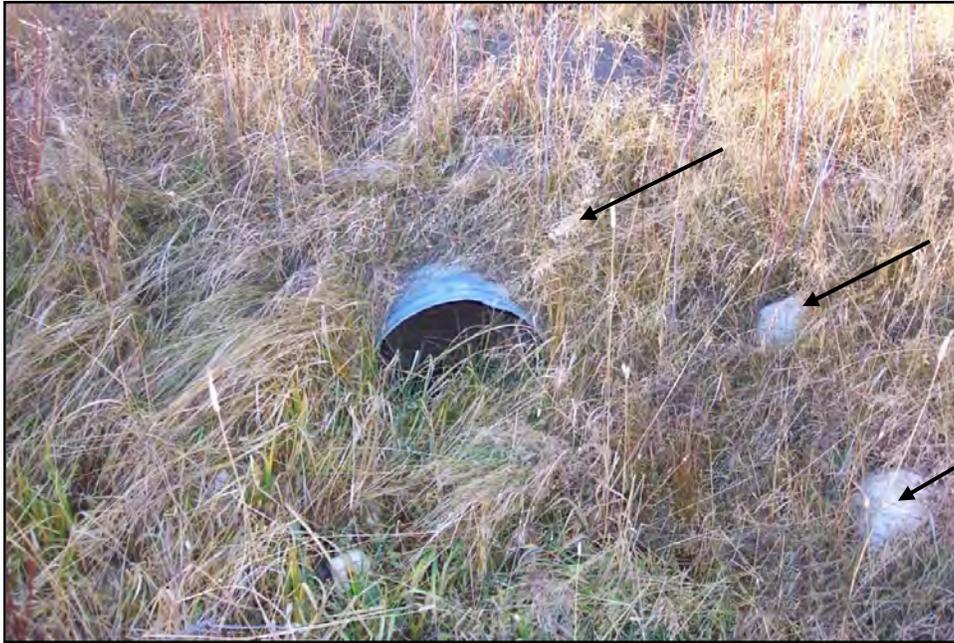
Figure 4.7.10 Piping on fill bank near existing drain turnout. Note areas of ongoing piping. (11/11/04).
