PAINTED ROCKS DAM  
2016 SPILLWAY CHUTE INVESTIGATION  
INFORMATION PACKET

# PAINTED ROCKS SPILLWAY

INVENTORY NO.: MT-19  
 HAZARD CATEGORY: HIGH  
 TYPE OF DAM: Zoned Earth Fill  
 YEAR BUILT: 1938  
 YEAR REHABILITATED: 2011-2015

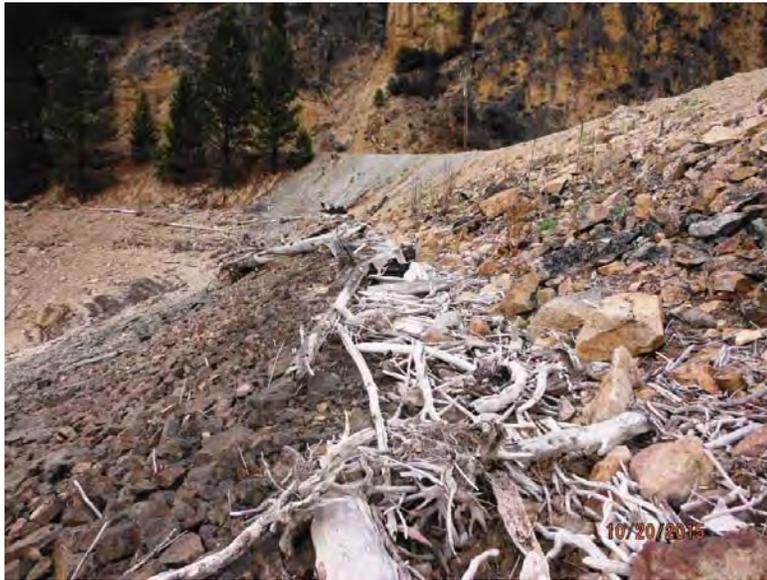
| 1. | EMBANKMENT | PHOTOS |
|---|--|---|
| 1.B.1 | There is a prominent erosion gully (three to four feet wide by 20 feet long) on the left upstream face near the left abutment in material that is occasionally replenished by the Ravalli County Road Department - the cause of the erosion is runoff from the road. Rills / gullies like this are not indicative of deficiency in the armoring of the upstream face of the dam. This is a maintenance issue that should be monitored and addressed as needed. | 16 |

**Photo 16 Erosion near left upstream end of dam. Erosion is in material that is regularly replaced.**

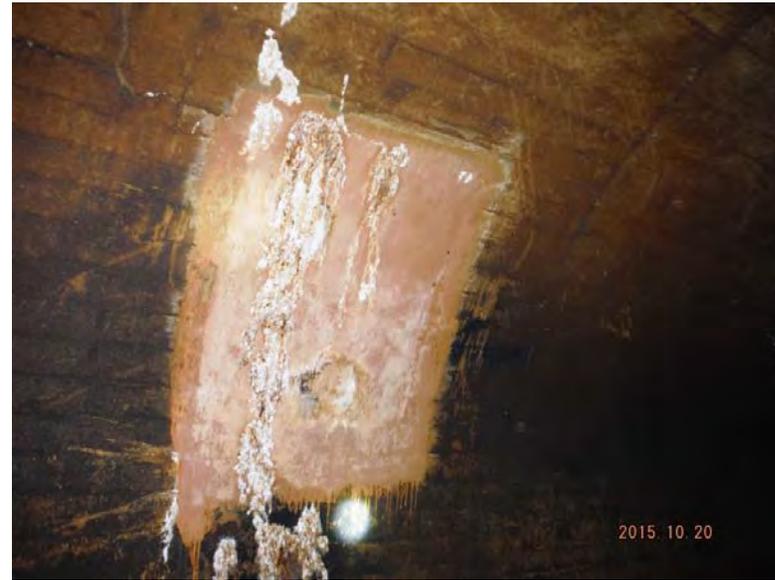
| 3. | OUTLET WORKS (Continued) | PHOTOS |
|---|---|---|
| 3.C.9 | There are calcium deposits at some of the joints, cracks, and repairs. | 33-37 |

**Photo 33 Diagonal crack in conduit**

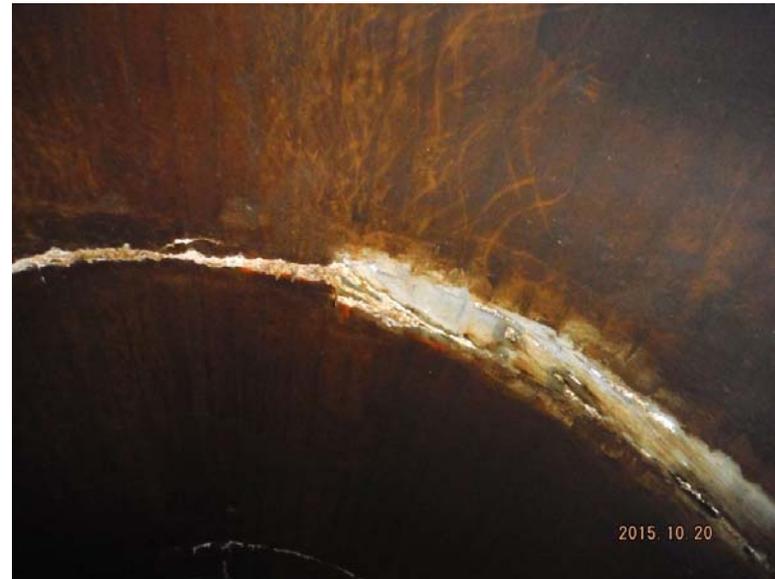
**Photo 35 Condition of old repair in conduit**

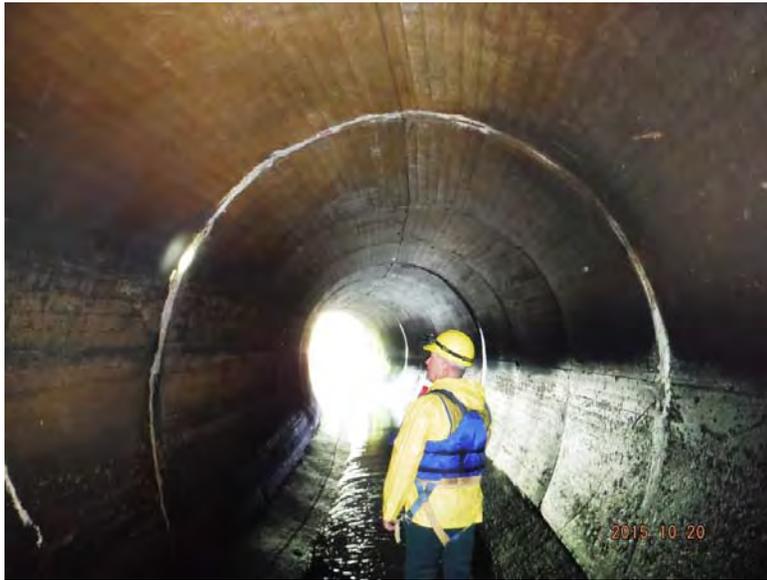
**Photo 36 Example old joint repair and calcification**

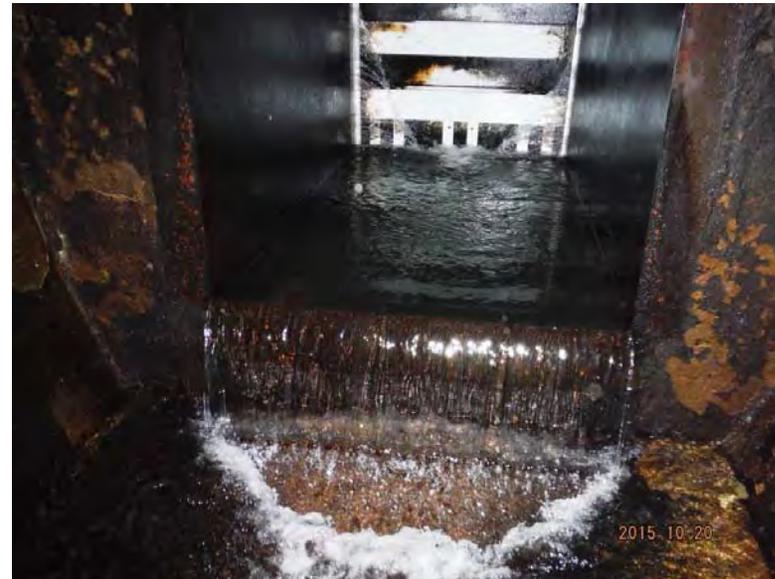
**Photo 43 Old spall / pop out just downstream of operating gate. According to the previous inspector, this condition has not changed (e.g. not erosion)**

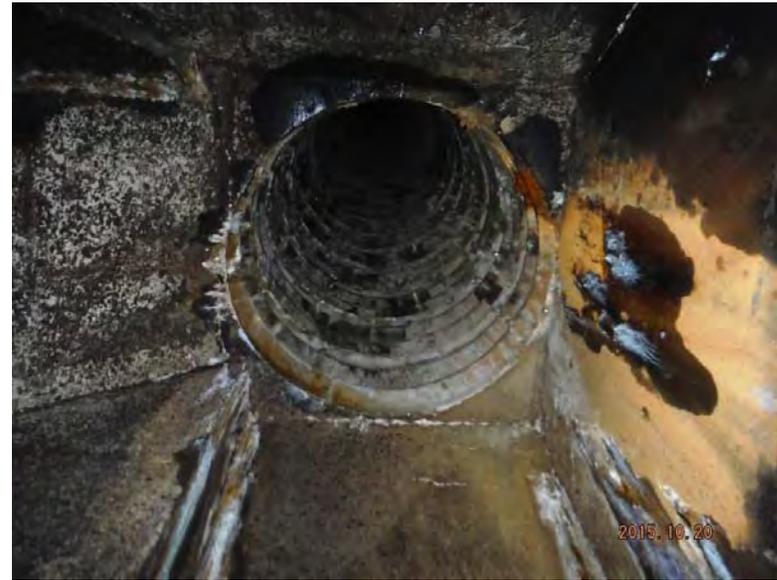
| 3. | OUTLET WORKS (Continued) | PHOTOS |
|---|---|---|
| 3.C.12 | There is ongoing cavitation that damages concrete immediately downstream from the gate chamber (repairs have been made several times in the past, in 2013 and 1978 for example). There is a 4 feet by 5 feet area of exposed aggregate and exposed reinforcement on the left expansion wall. The damage at this location does not appear to be progressing but needs to be monitored. The right side of the conduit downstream from the gate has similar cavitation damage, although the cavitation area is not as large and not as pronounced. During the 2015 inspection the main left side repair appeared to be in great shape - essentially fully intact with only minor edge loss. Other areas appeared the same as 2013. | 42, 45 |

**Photo 45 Exposed reinforcement left of left downstream thimble (stable condition)**

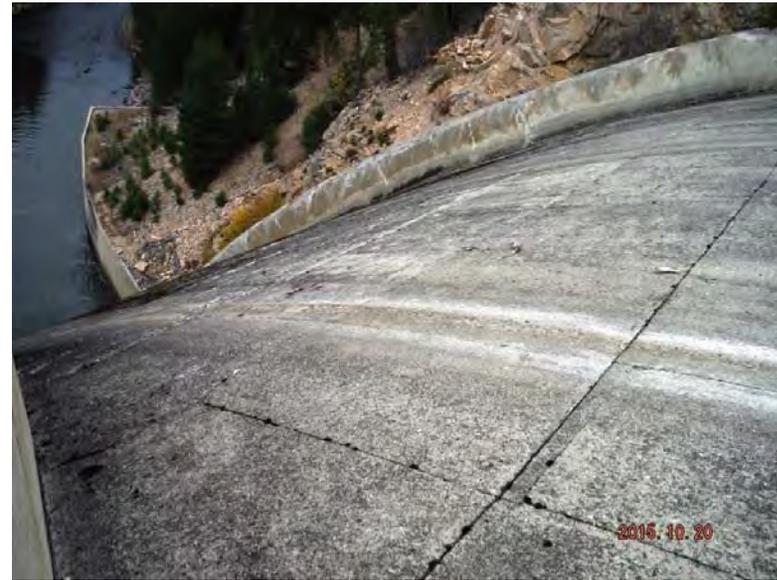
**Photo 57 Example of spalling damage on spillway weir**

| ID | DESCRIPTION | STATUS |
|---|--|---|
| PR-10-08 | Repair the spalls on the ogee weir and seal the cracks on the upper portion of the spillway floor slab and walls with an appropriate crack sealant product. The department will assist the association with this repair. | Incomplete / pending 2016 inspection |

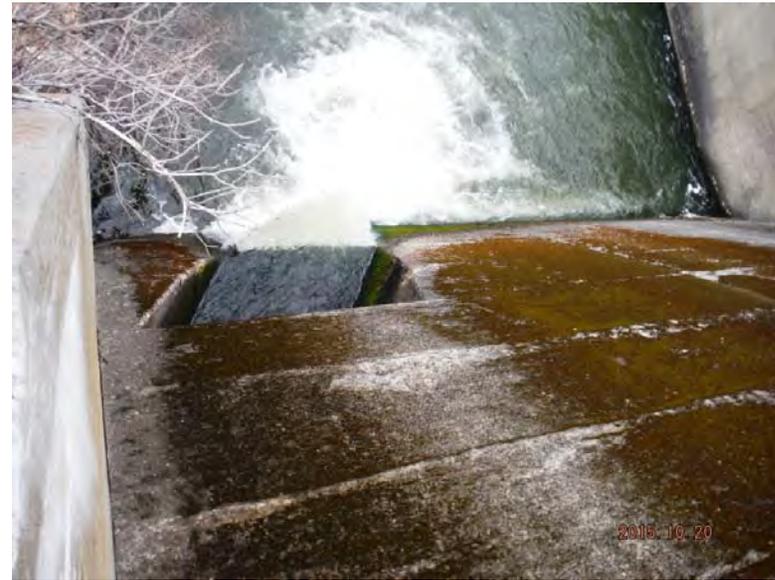
**Photo 61** View across steep portion of spillway - white areas void of moss may be concrete spalling / erosion, or wear moss is eroded from concrete

| ID | DESCRIPTION | STATUS |
|---|--|---|
| PR-13-01 | Inspect the entire spillway chute closely, assess if it is still functioning adequately and identify any areas in need of repair. The Department will be responsible for this recommendation. | Pending 2016 |

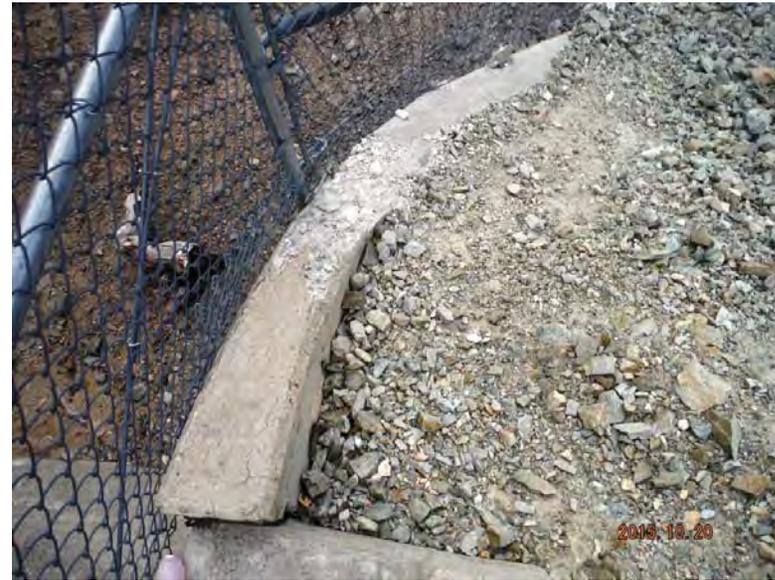
Photo 65 Transverse joint separation - spillway upper right

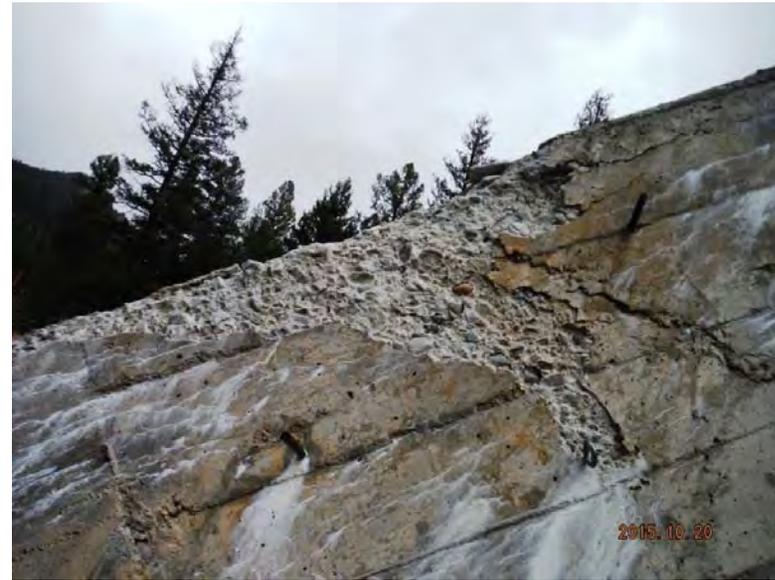
Photo 69 Concrete damage at top of left spillway wall

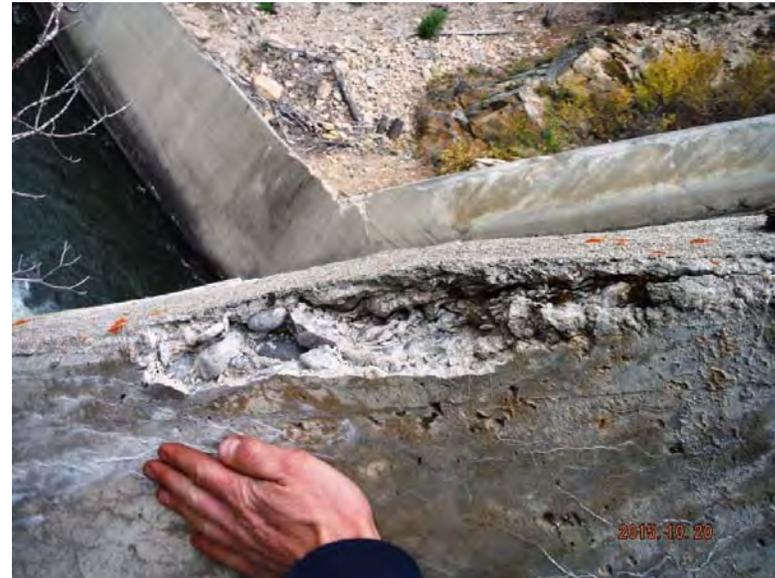
Photo 71 Concrete damage at top of left spillway wall

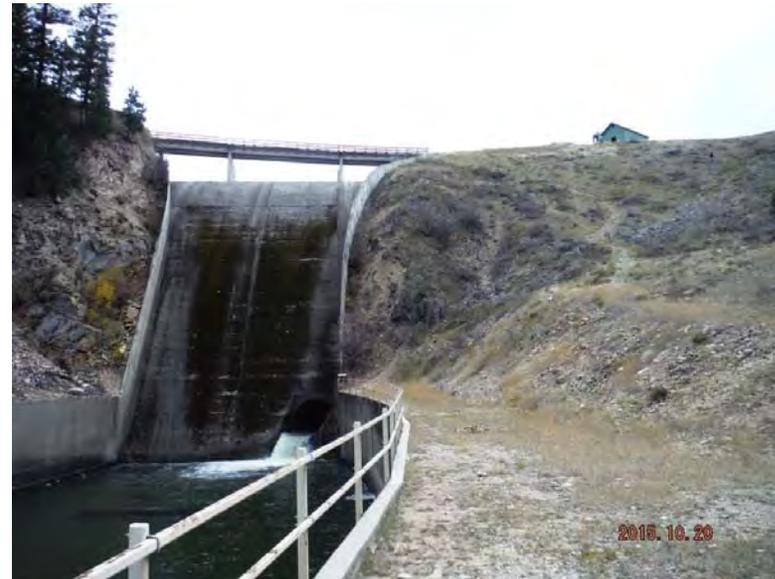
**Photo 75 Debris at / above right spillway wall, and concrete damage at top of wall**

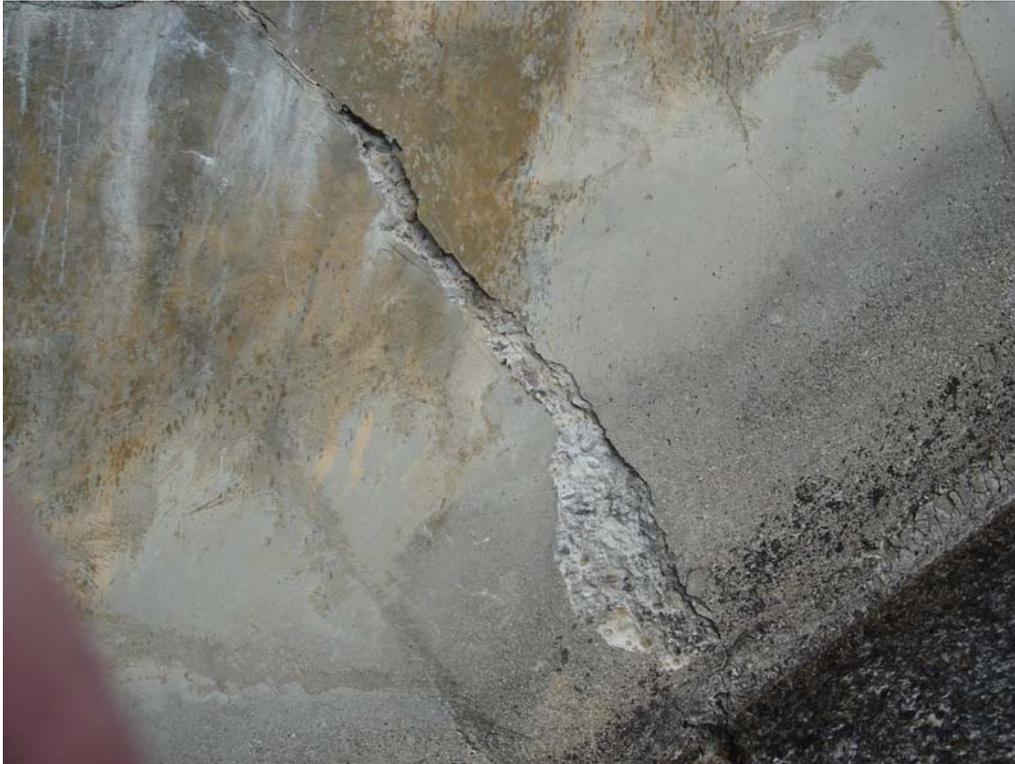
**Photograph 32 Efflorescence Deterioration on East Training Wall.**

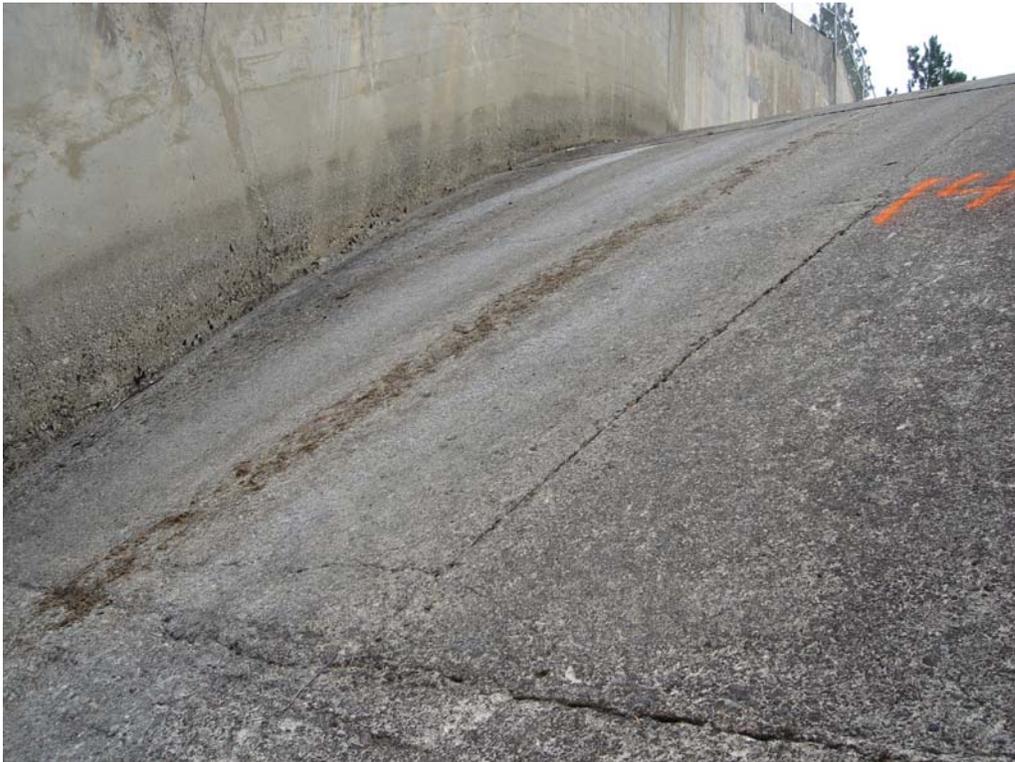
**Photograph 33 East Training Wall – Abrasion.**

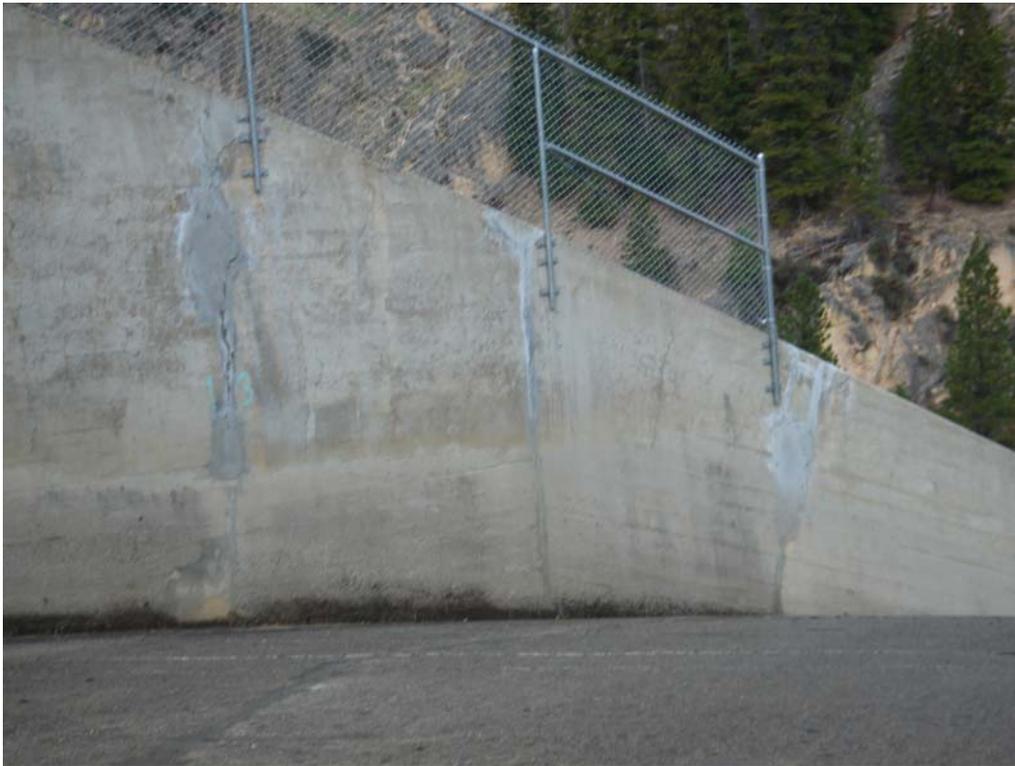
**Photograph 34 West Training Wall – Rehabilitation Patches & Cracking.**

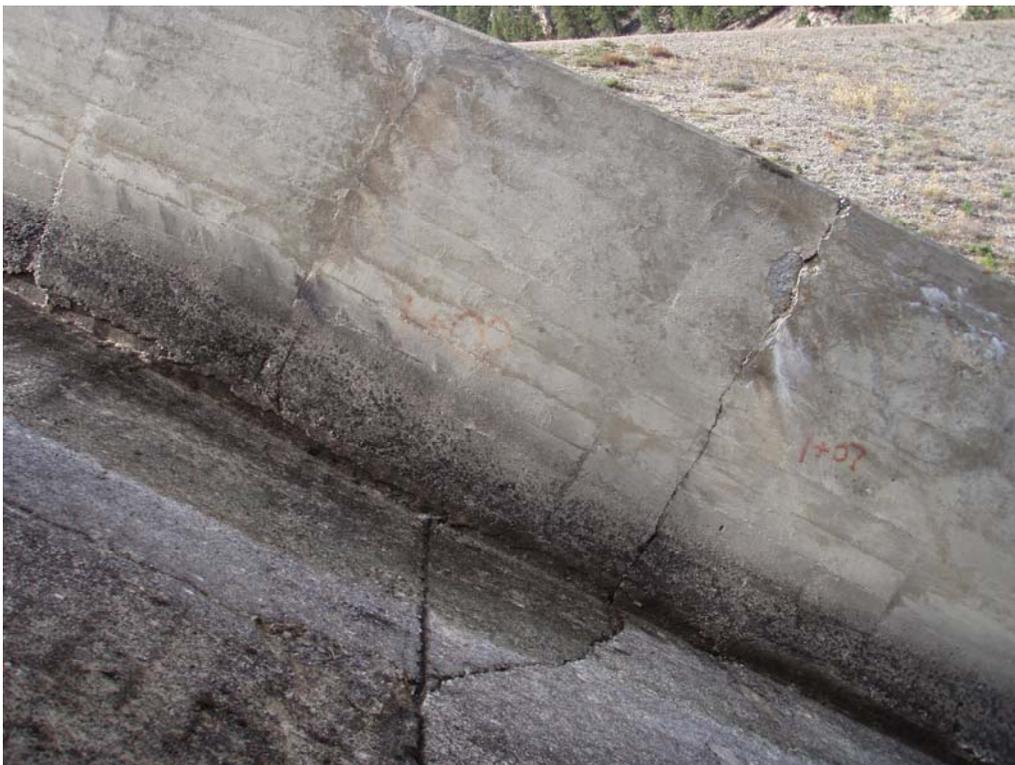
**Photograph 35 Cracking in West Training Wall.**

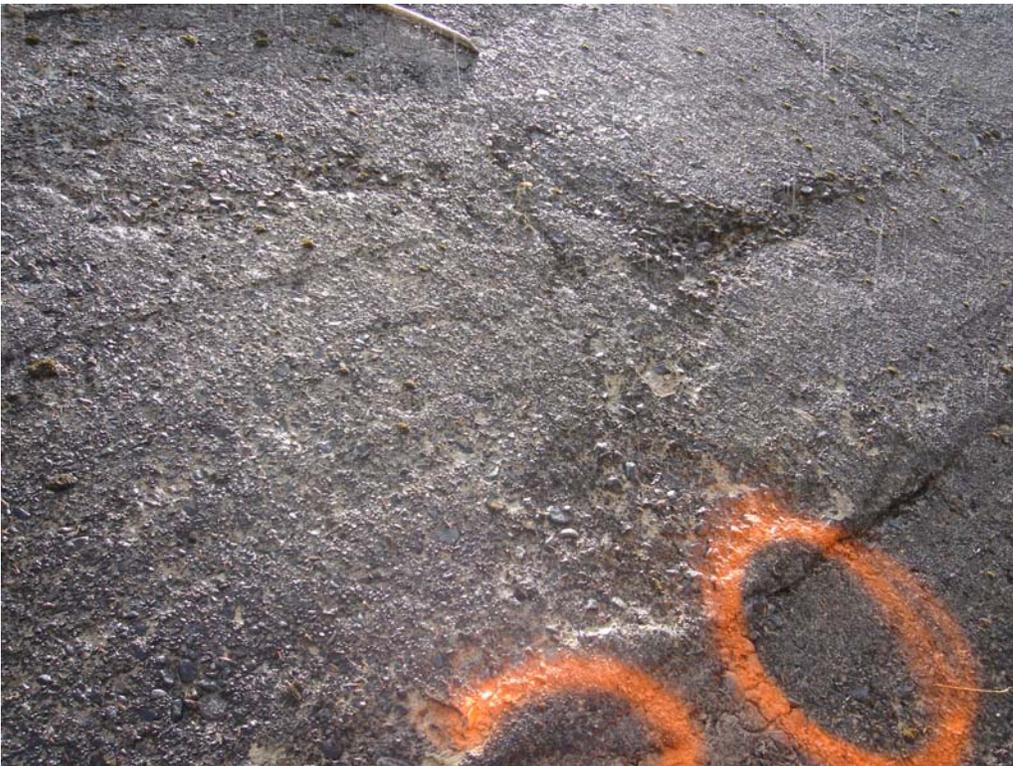
**Photograph 37 Spalling/Pitting on Spillway Floor.**

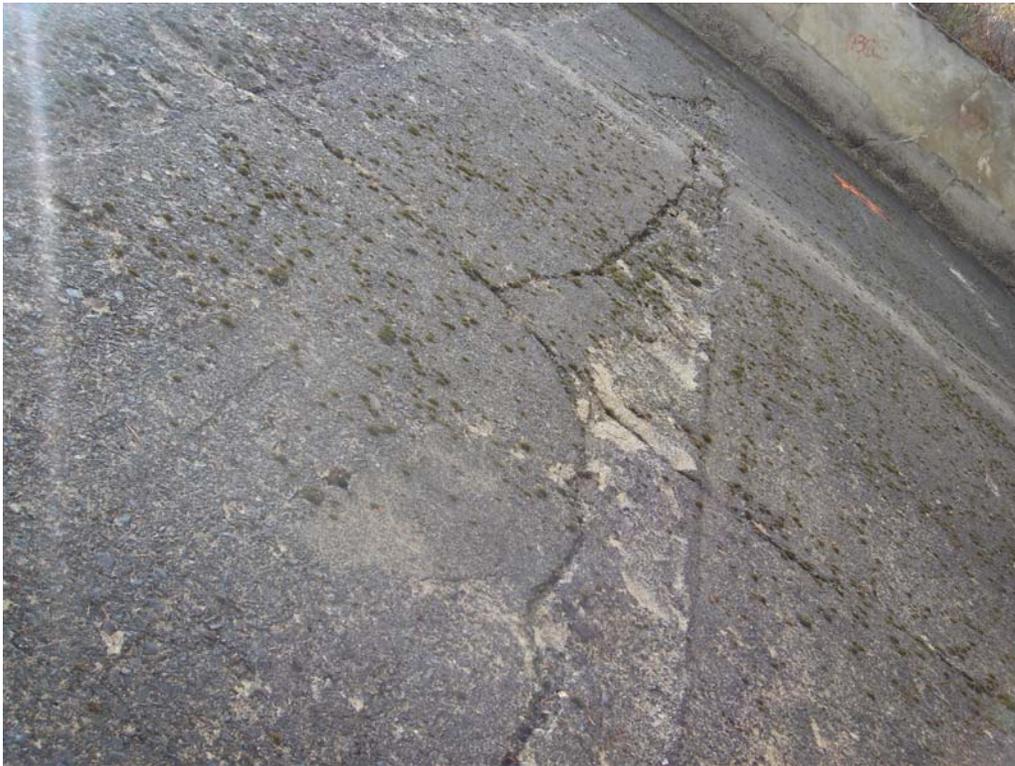
**Photograph 38 Horizontal Cracking on Spillway Floor.**

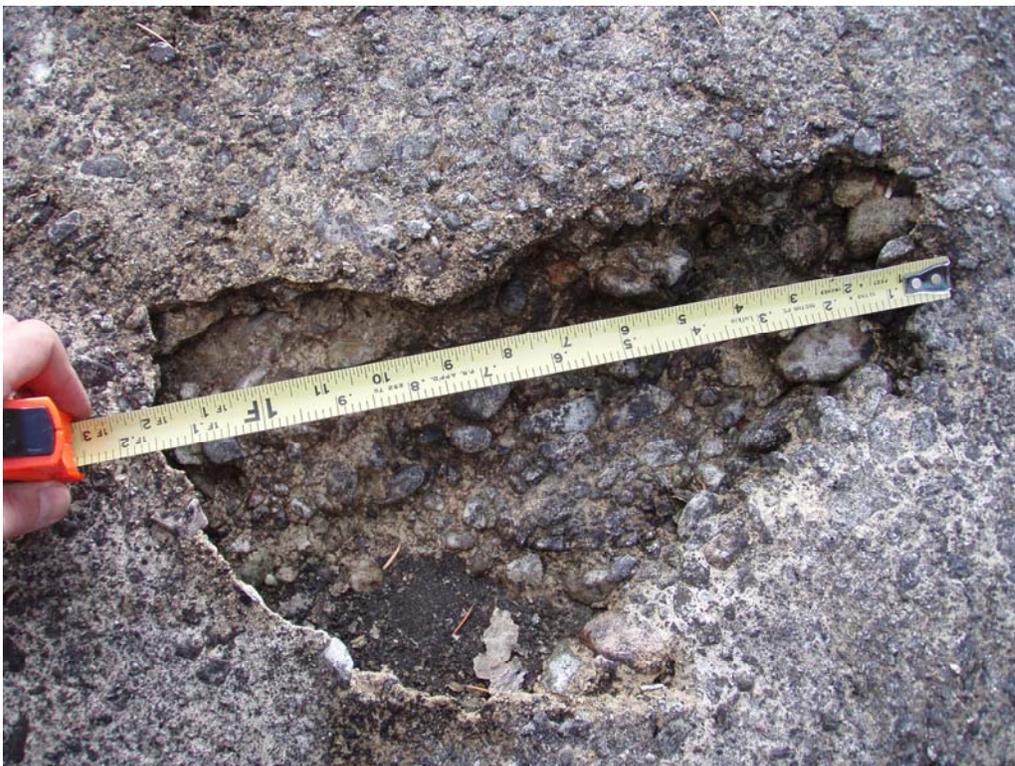
**Photograph 39 Pitting in Spillway Floor.**

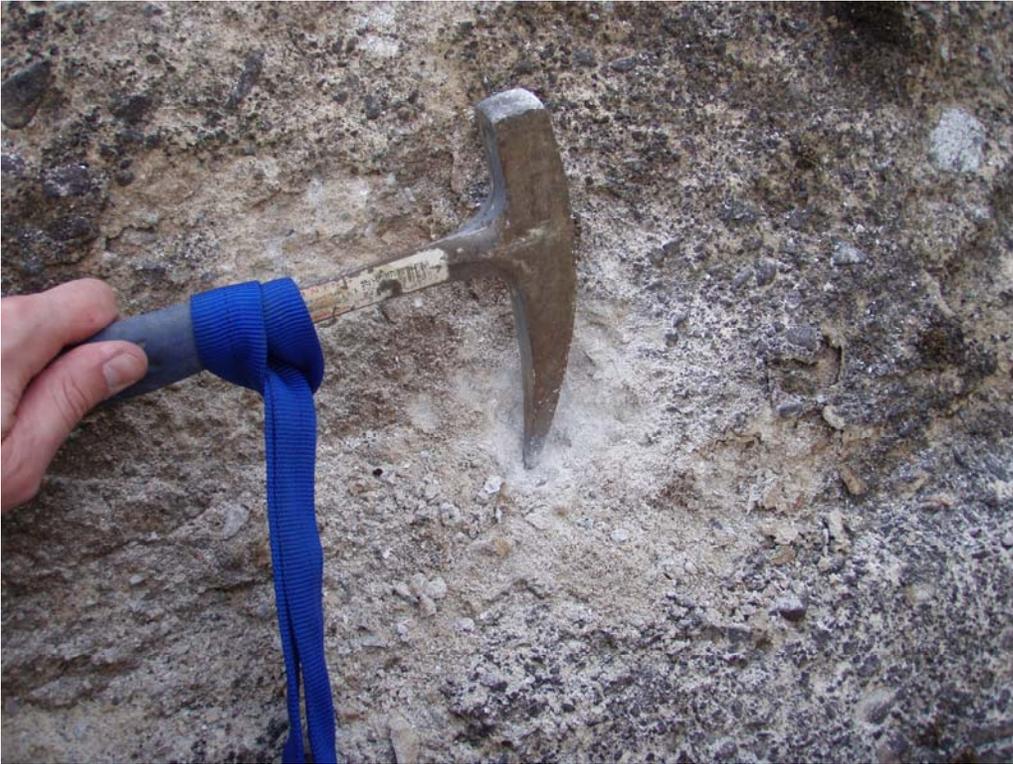
**Photograph 40 Deterioration of Spillway Floor Concrete.**

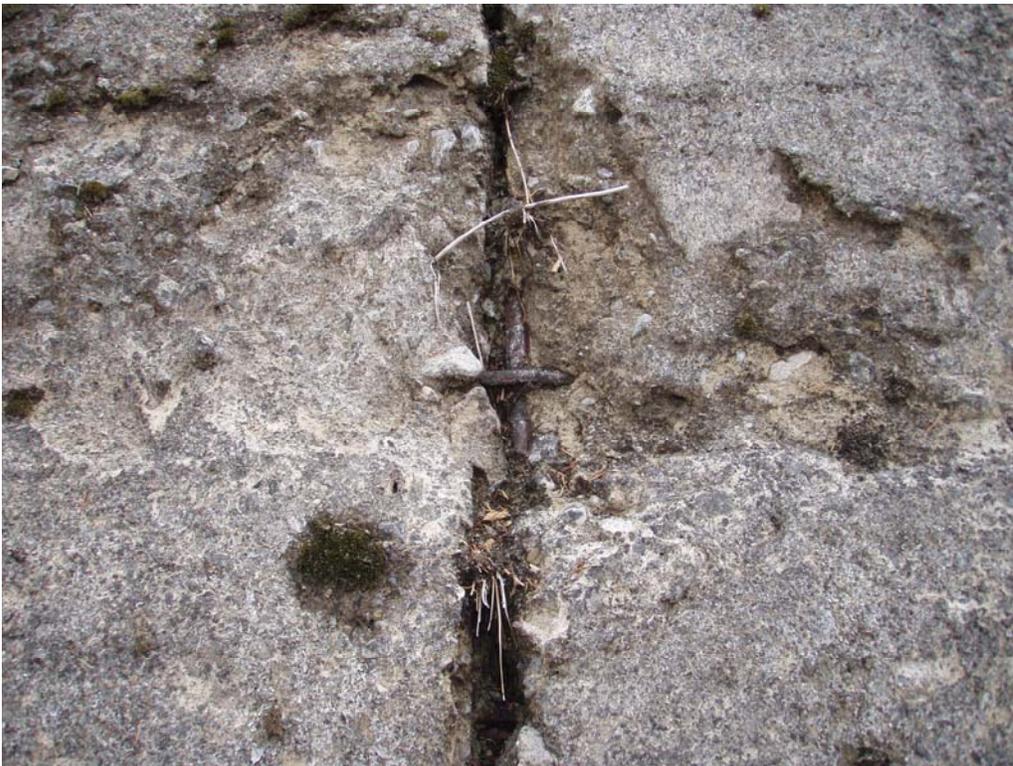
**Photograph 41 Exposed Reinforcing Bar in Spillway Floor Slab.**

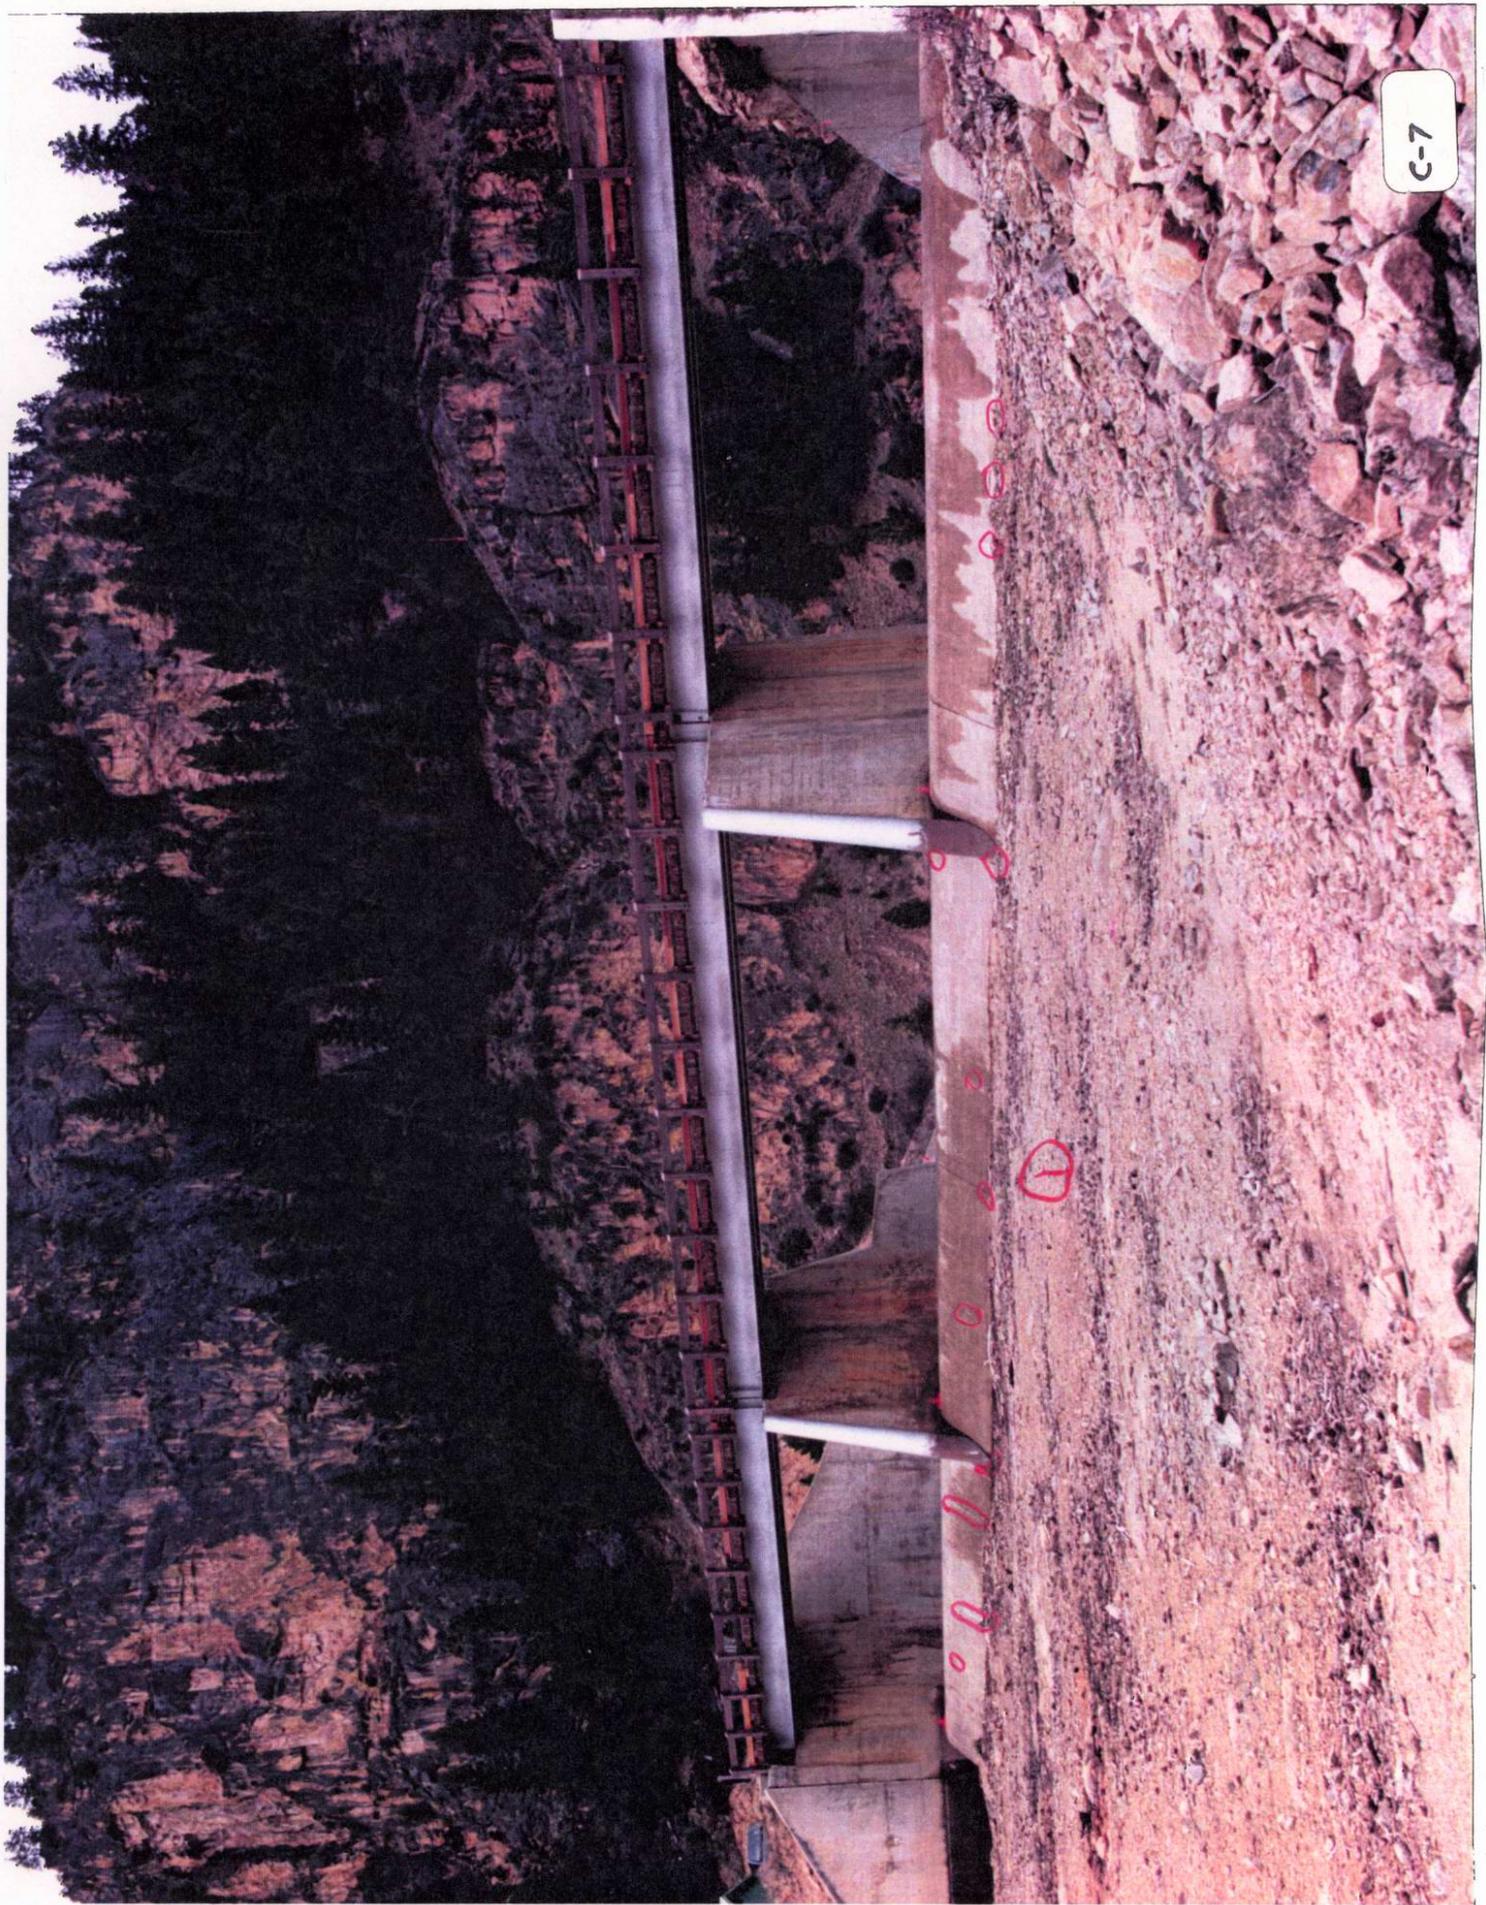
C-7

1. The small circular marks are from spalling along the crest area. They are all quite minor. Some of them have been patched previously and are spalling again over the old repair work.

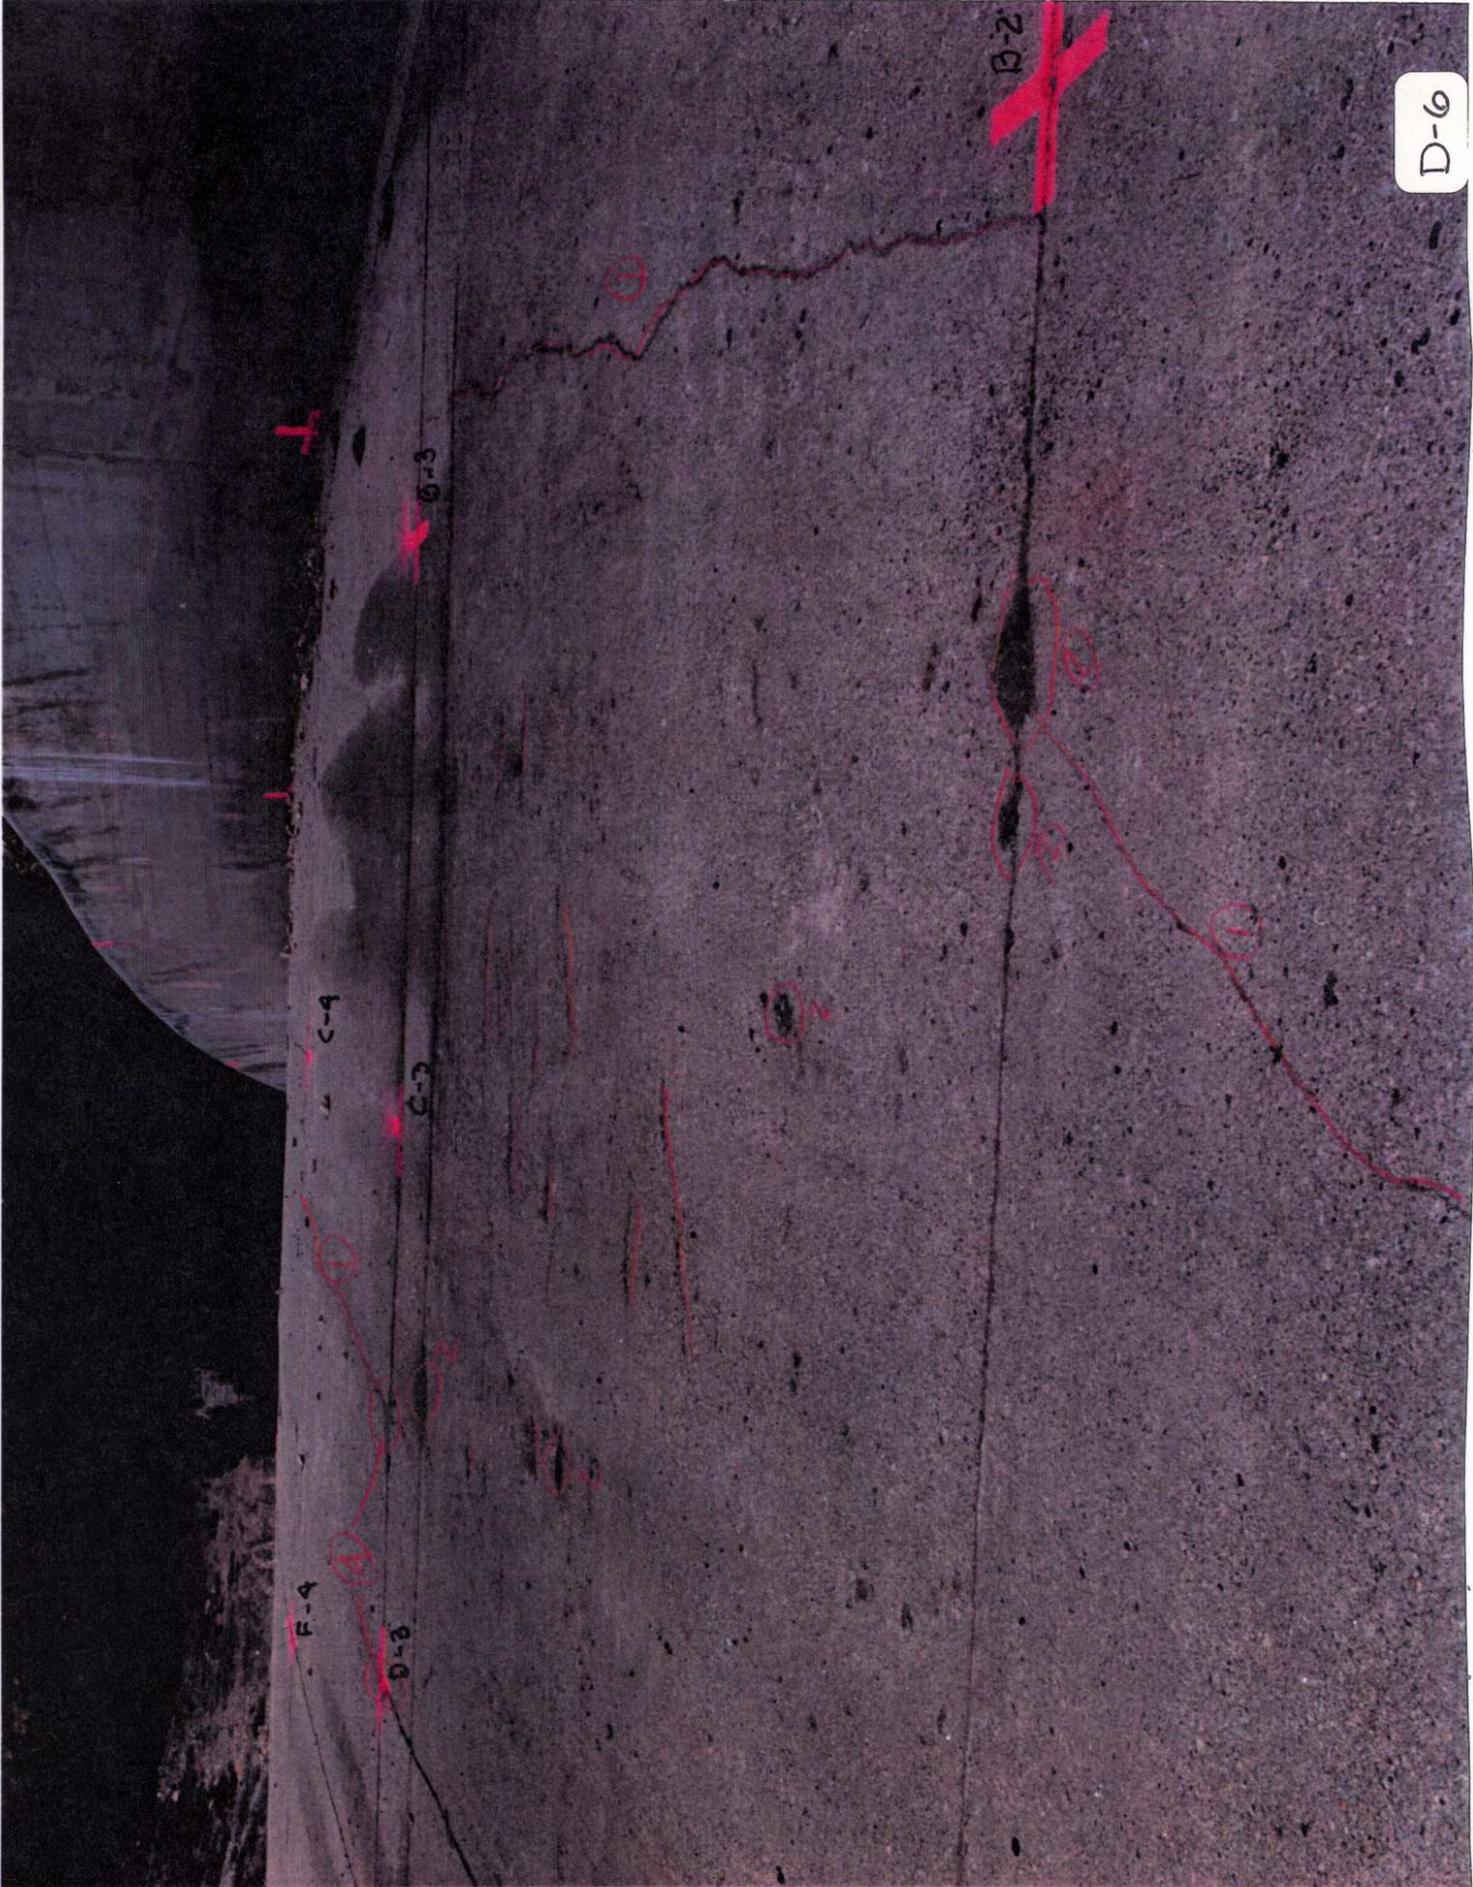
D-6

1. A longitudinal crack that begins a little above point B-2 and extends to the joint just above the B-3 line. Crack openings are spalling minor D-type cracking open to about 1/2 to 3/4 inch in width.
2. Are minor spall areas.
3. Will be used to show the short transverse cracking believed to be due to the wear of the materials coming over the crest of the spillway. These are short 2 feet to 1 foot in length and are more like a spalling crack than anything else. They're about an 1/8 inch to 1/4 inch in width.
4. Are small patches of spalling cracks. A big crack about 1/2 inch in width extends through those places showing further deterioration in these areas.

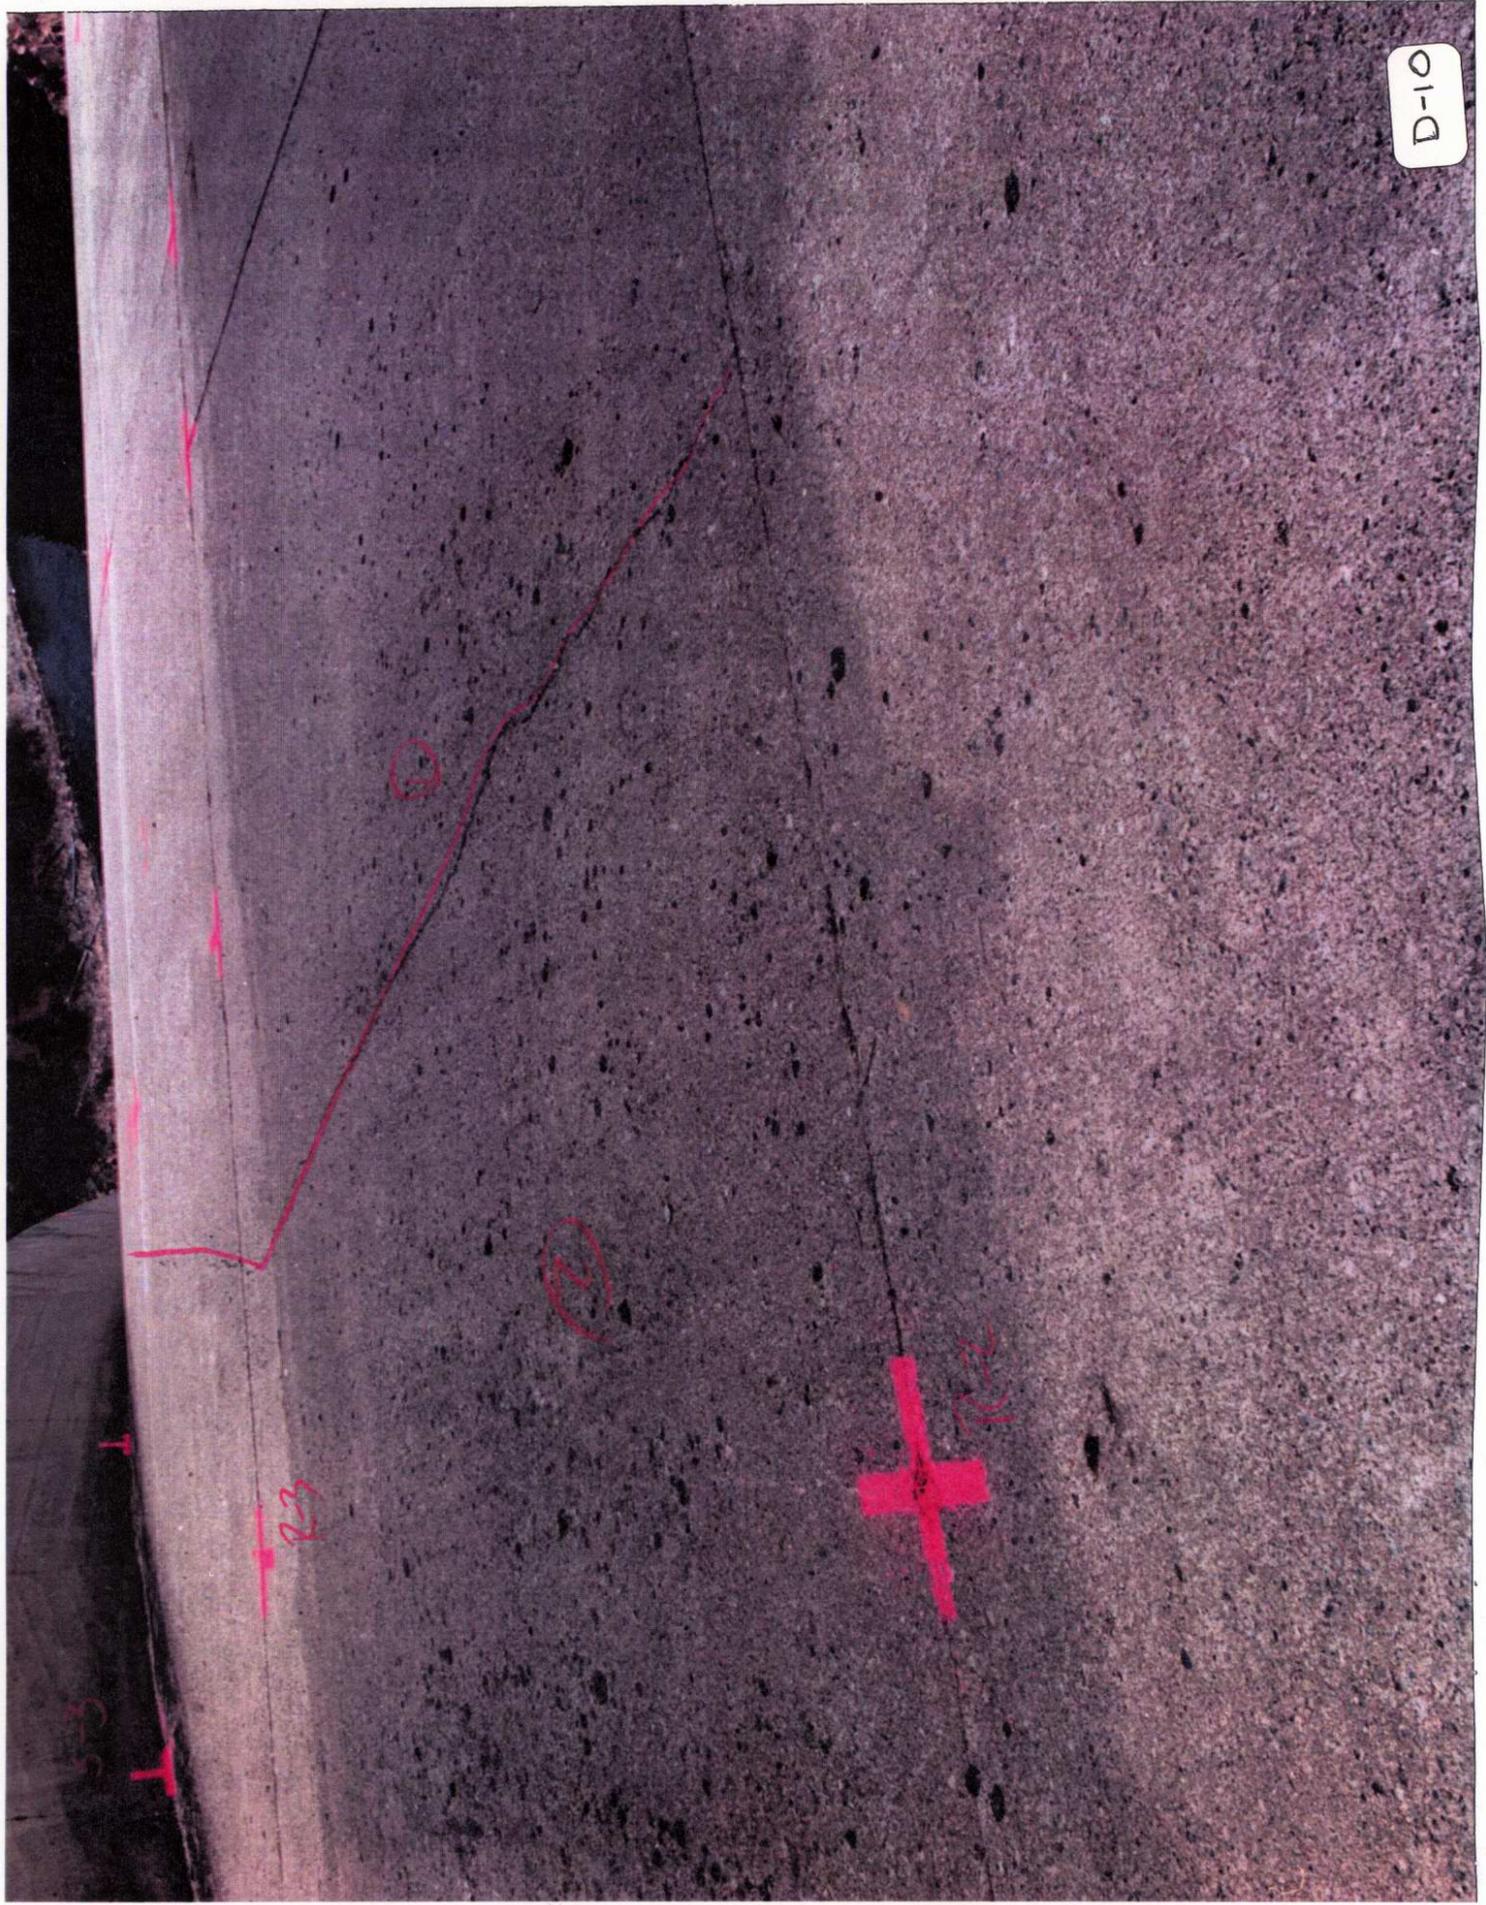
D-10

1. Longitudinal cracking.
2. Concrete spalling.
