PAINTED ROCKS DAM  
2016 SPILLWAY CHUTE INVESTIGATION  
INFORMATION PACKET

# PAINTED ROCKS SPILLWAY

INVENTORY NO.: MT-19  
 HAZARD CATEGORY: HIGH  
 TYPE OF DAM: Zoned Earth Fill  
 YEAR BUILT: 1938  
 YEAR REHABILITATED: 2011-2015

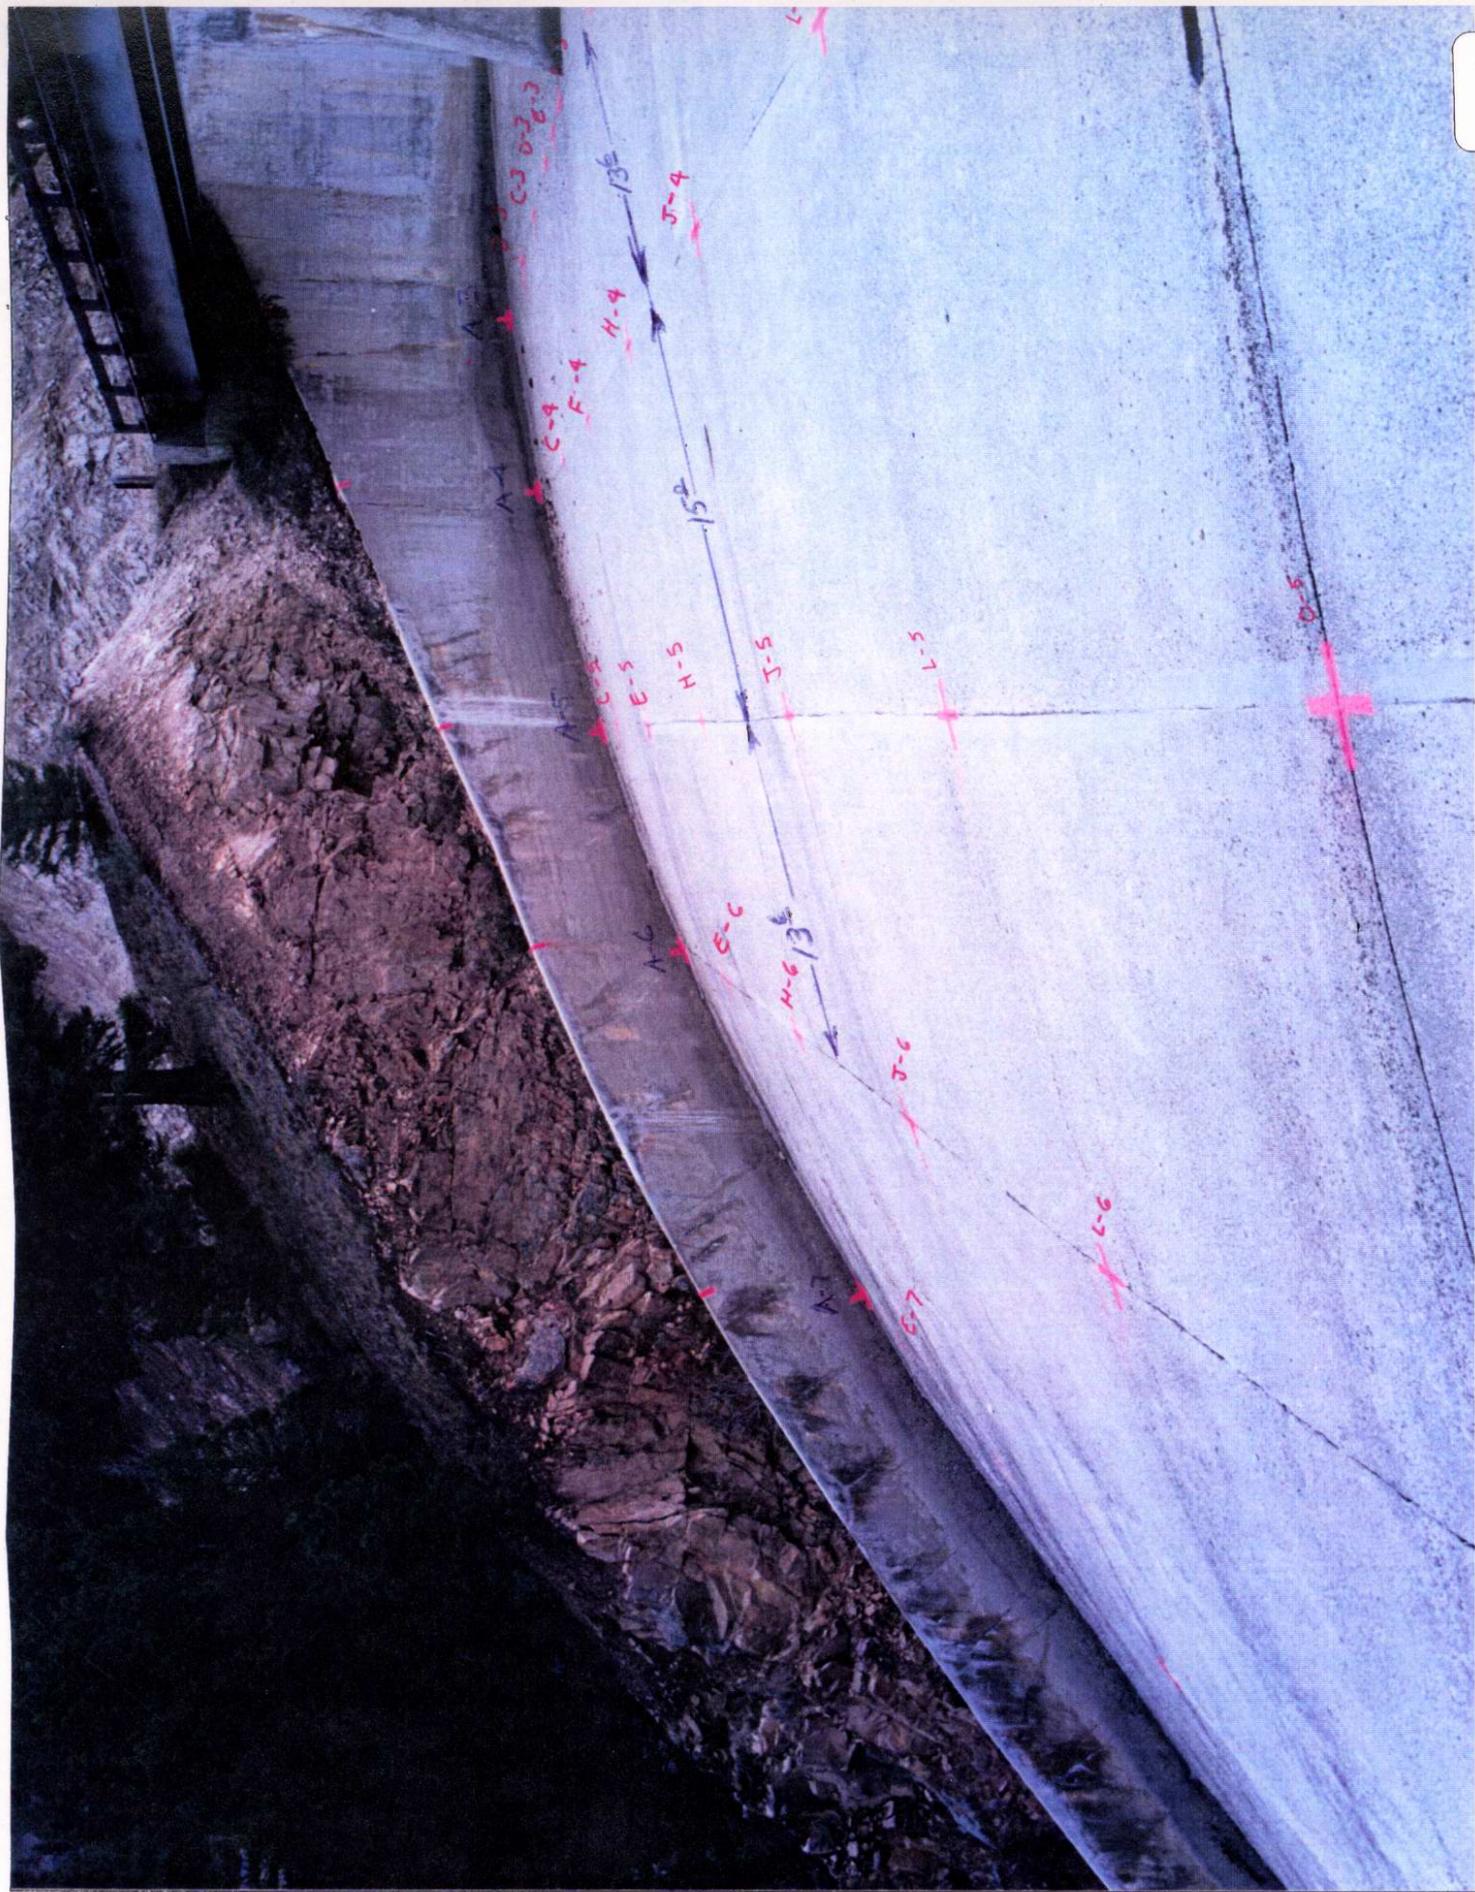
1. There's a crack running full panel parallel with the spillway from panel L-5 to L-6. Maximum crack size appears to be 1 inch tapering down to a hairline crack of less than 1/32 inch.

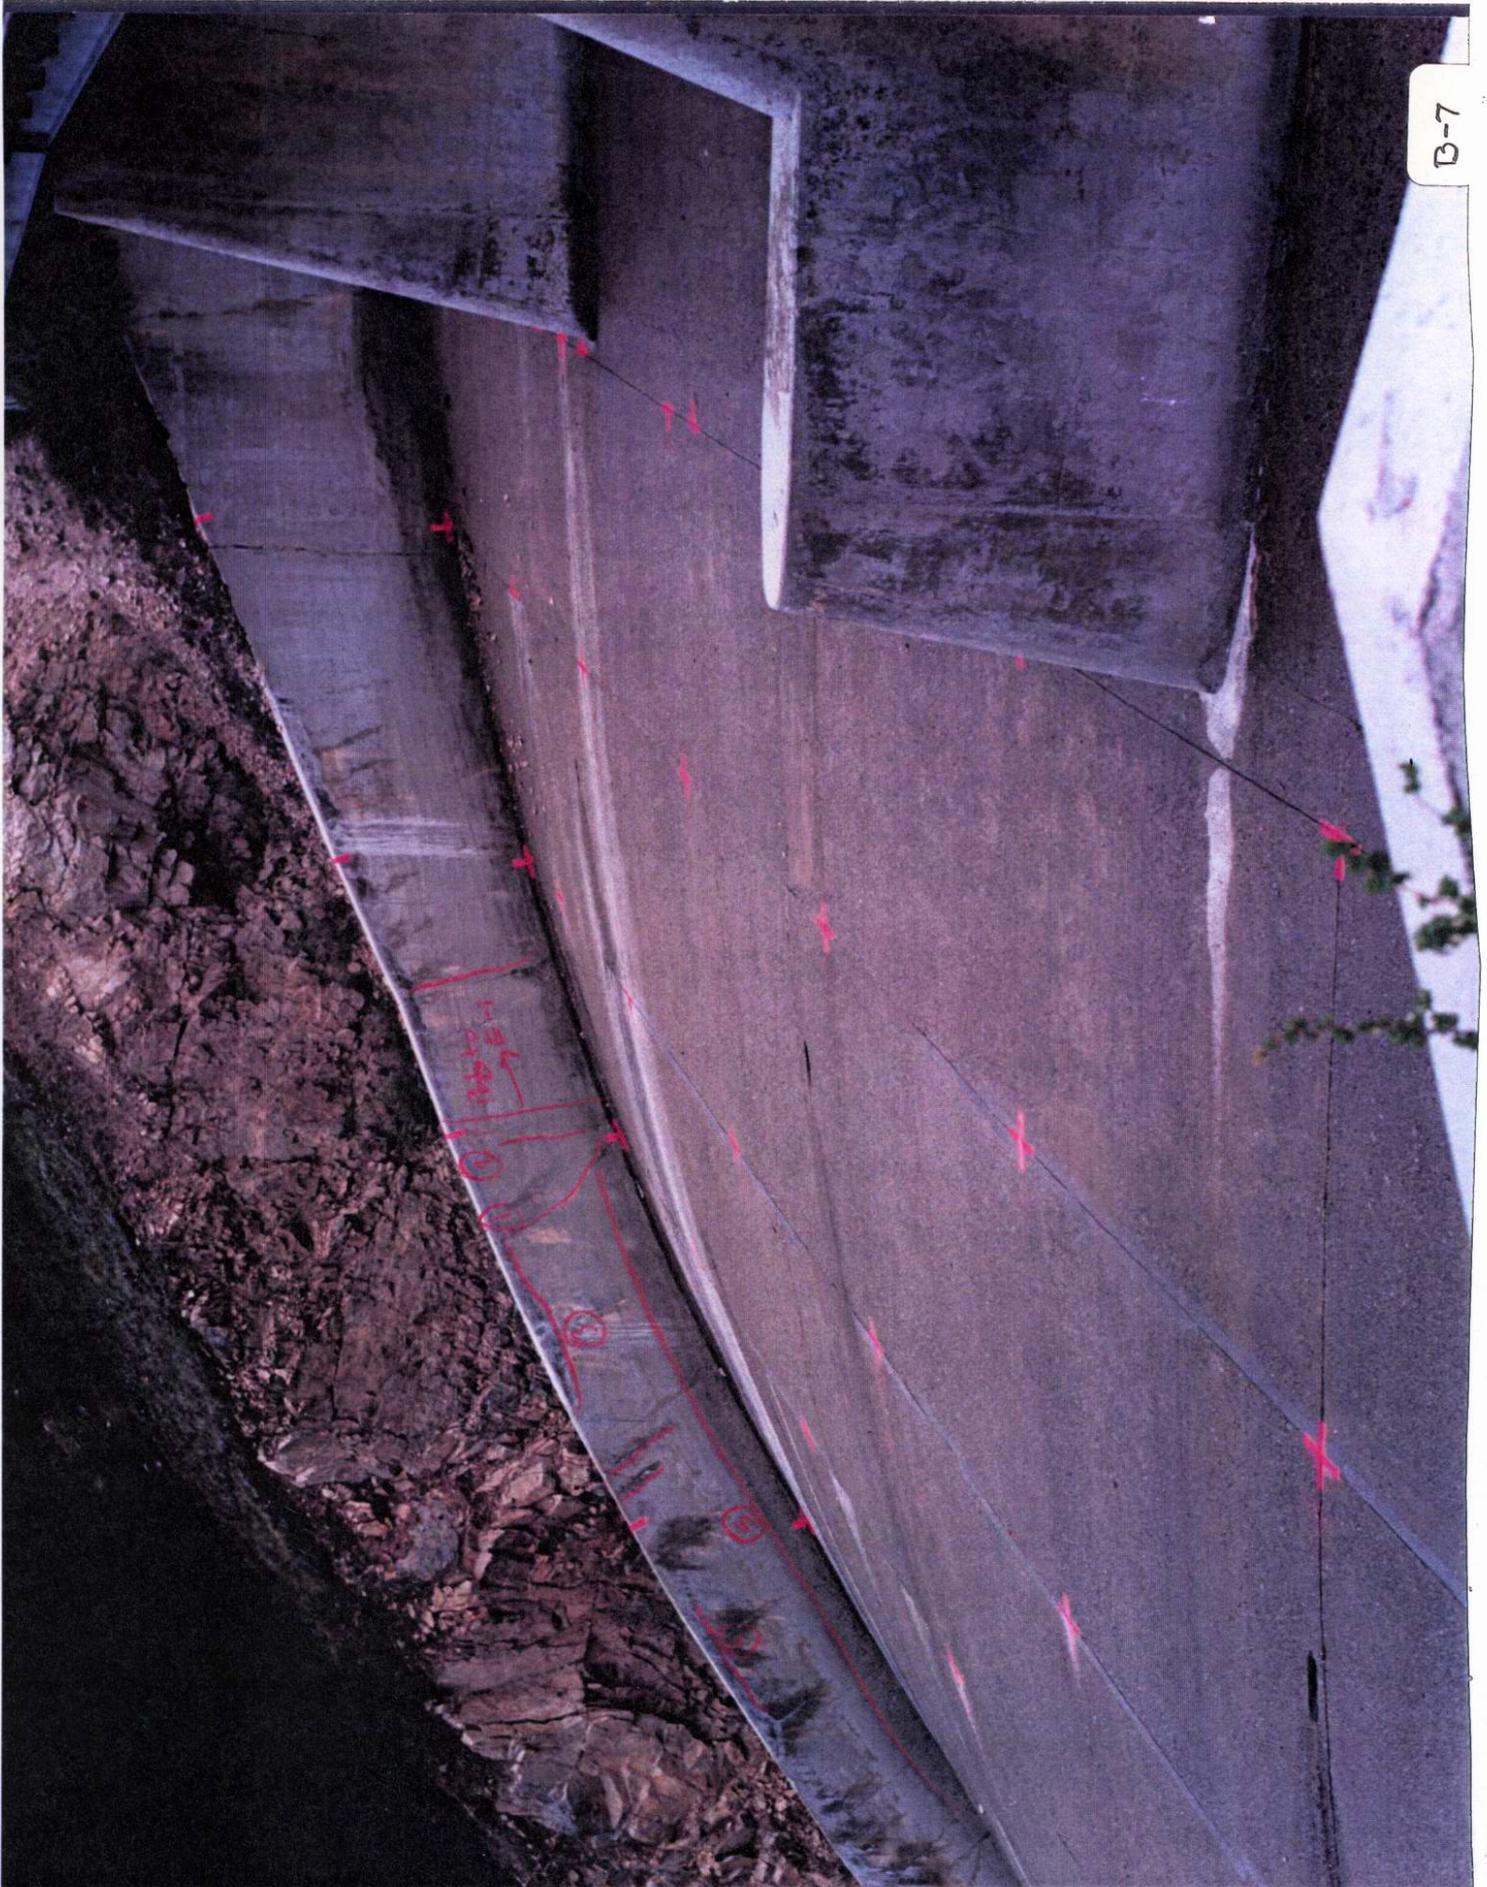
- B-7 View to northeast of upper spillway and right spillway wall
- 1 & 2 Diagonal cracks which verge on each other. Crack No.1 is open about 1/8 of an inch at the bottom. Crack No. 2 is open about 1/16 at the bottom and transitions into hairline type crack.
3. More of the cap repair done on the right upper chute wall. In the area of note No. 1 & 3 there is also quite a bit of calcium leaching through the cracks of the wall.
5. Shows the extensive erosion that the right chute wall has undergone due to hydraulic action. There is some aggregate exposed at the base of the wall where the concrete has been eroded off.

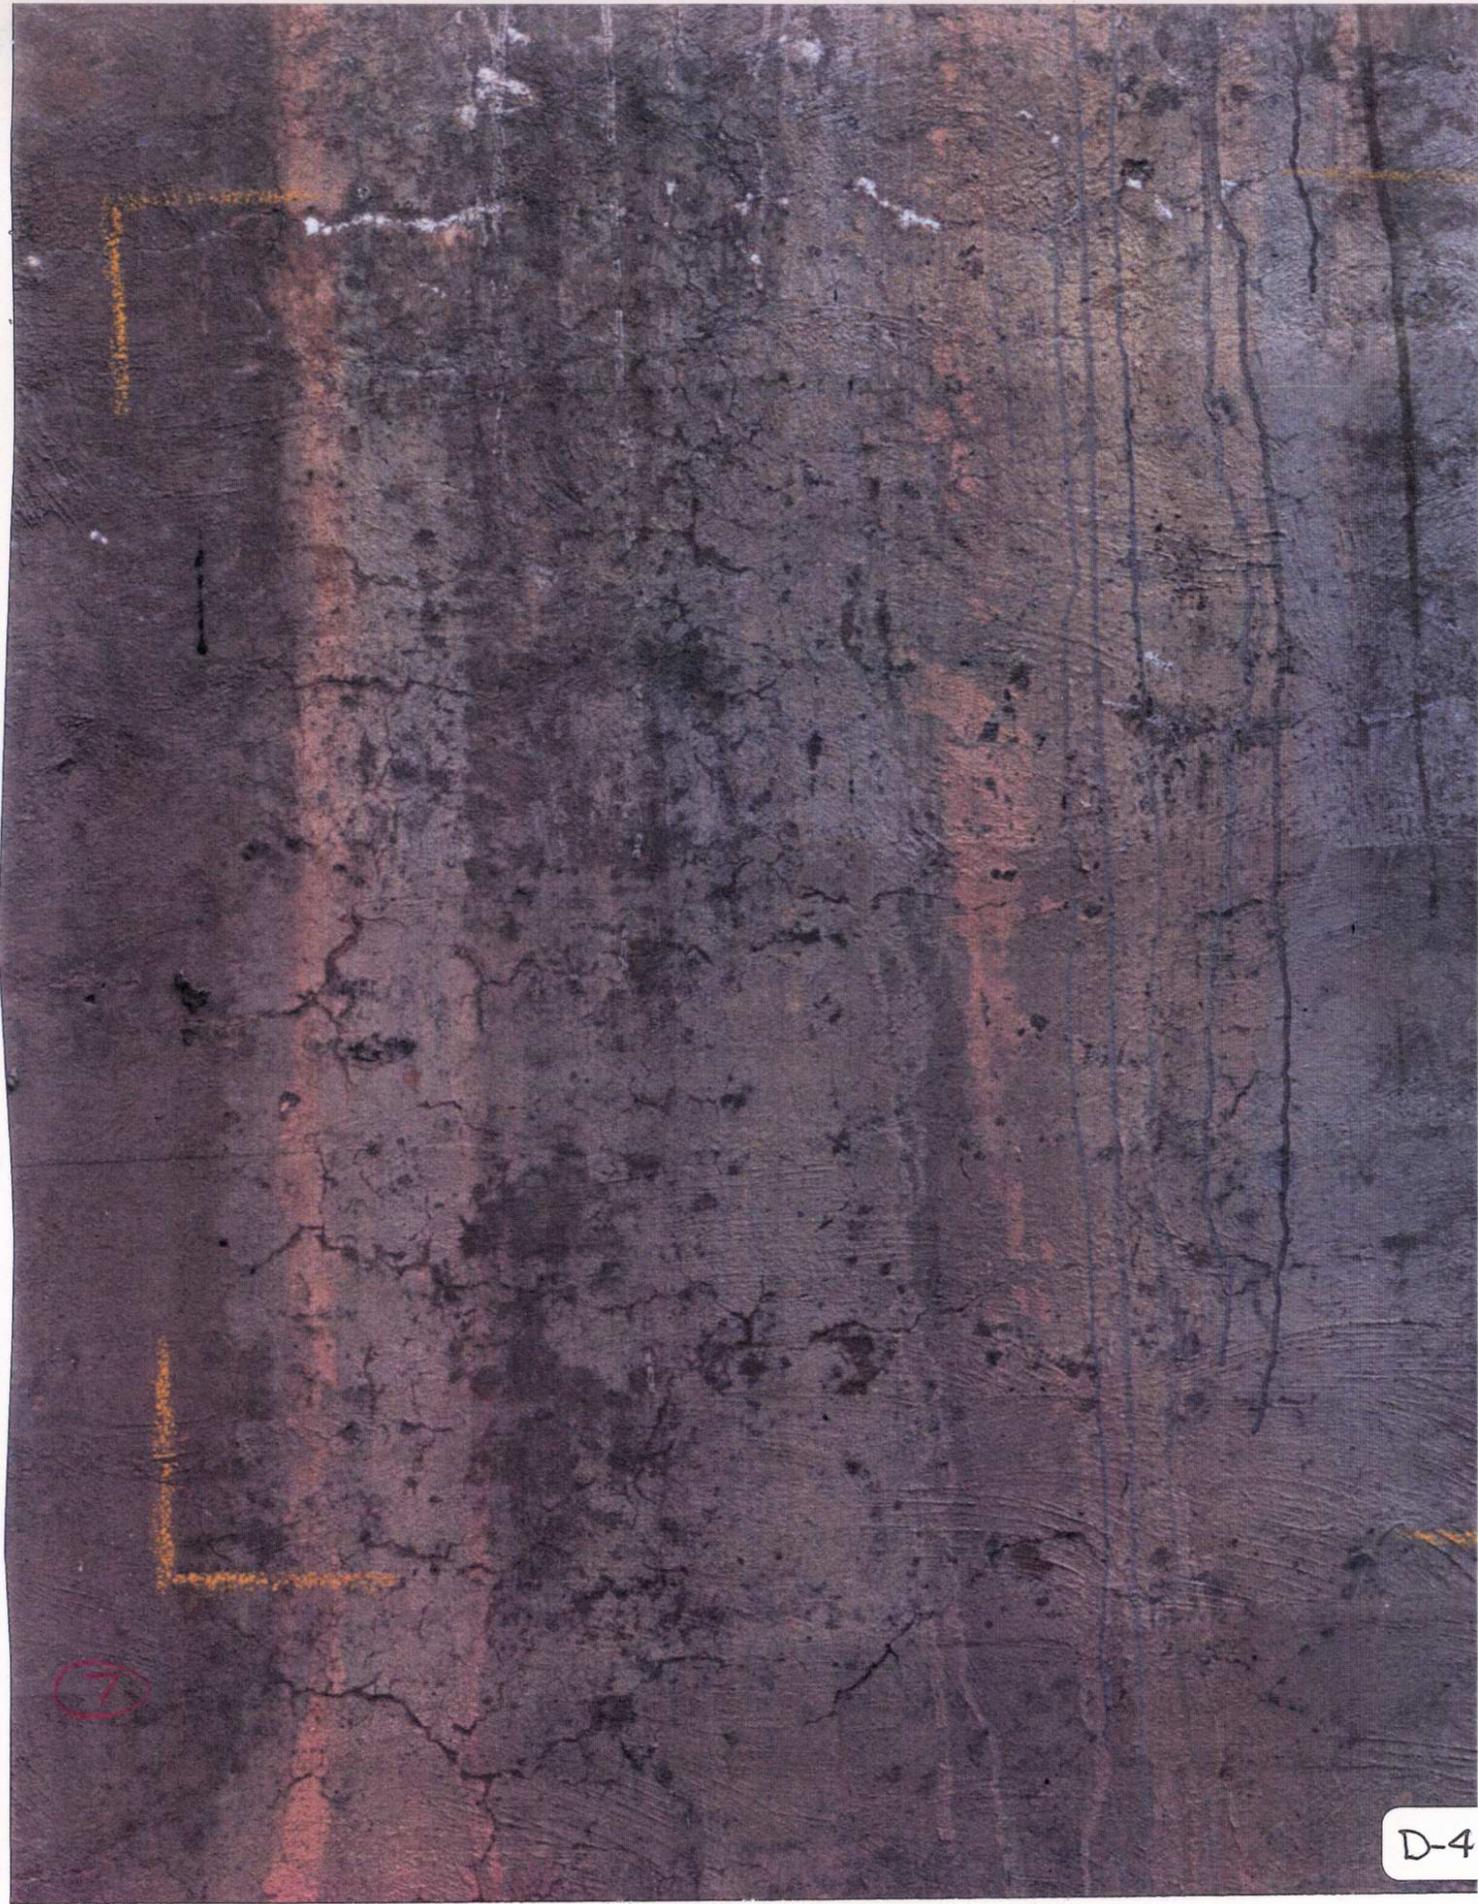
D-4 A close-up photo of area near comment No. 7 on Photo C-8 located on right spillway wall -  
- that illustrates the fine texture pattern of the crazing cracking that is typical throughout the spillway structures.

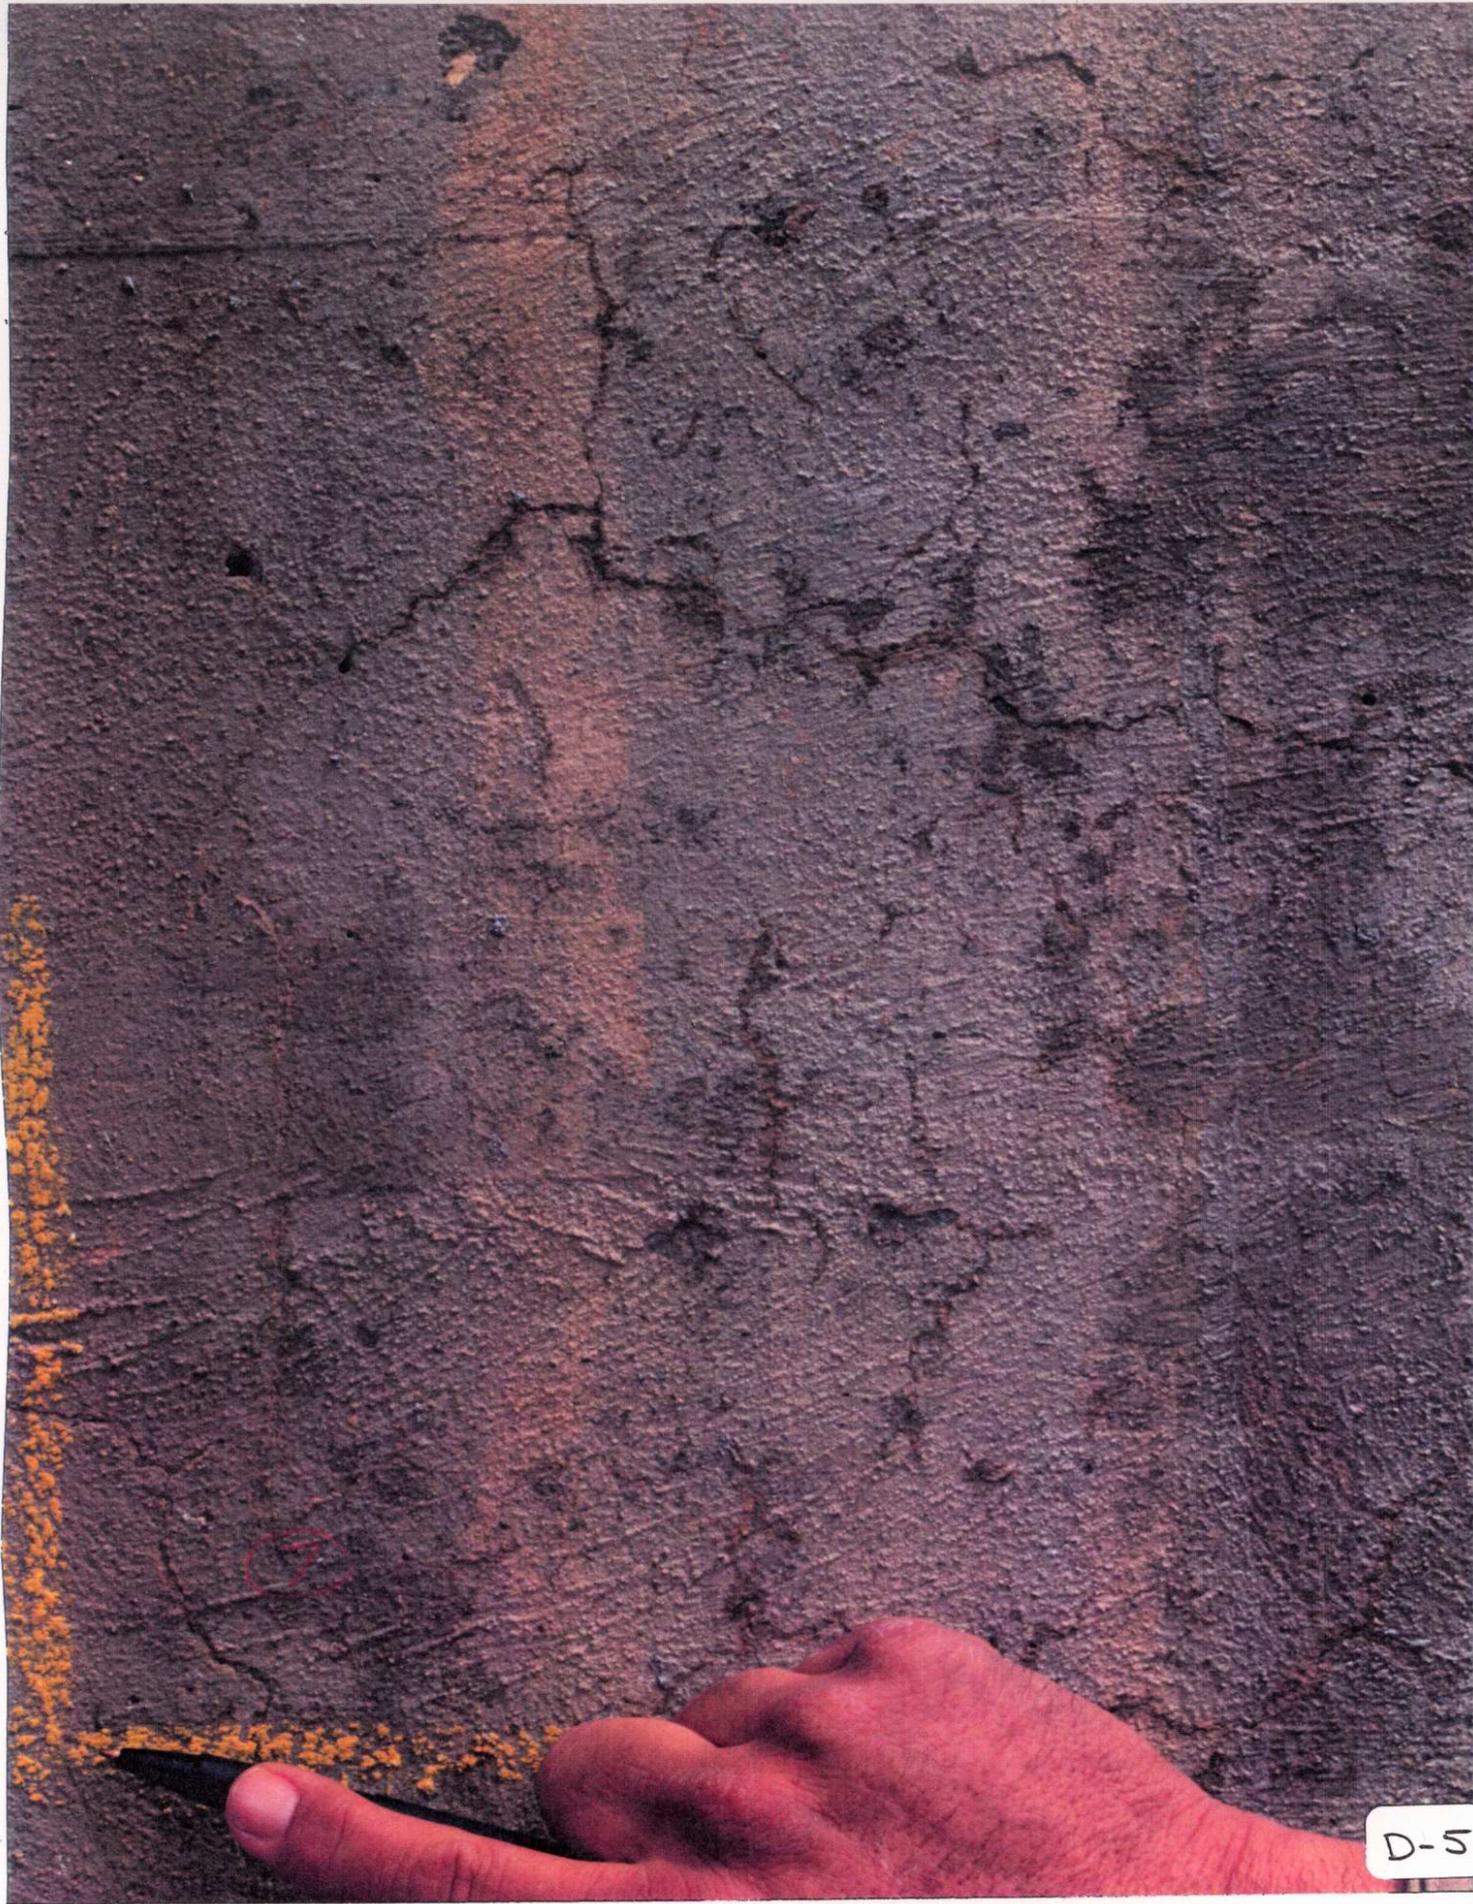
D-5 A more detailed photo of the lower left corner of the crazing crack pattern described on summary sheet D-4. This cracking pattern is referenced by comment No. 7 in Photo C-8.

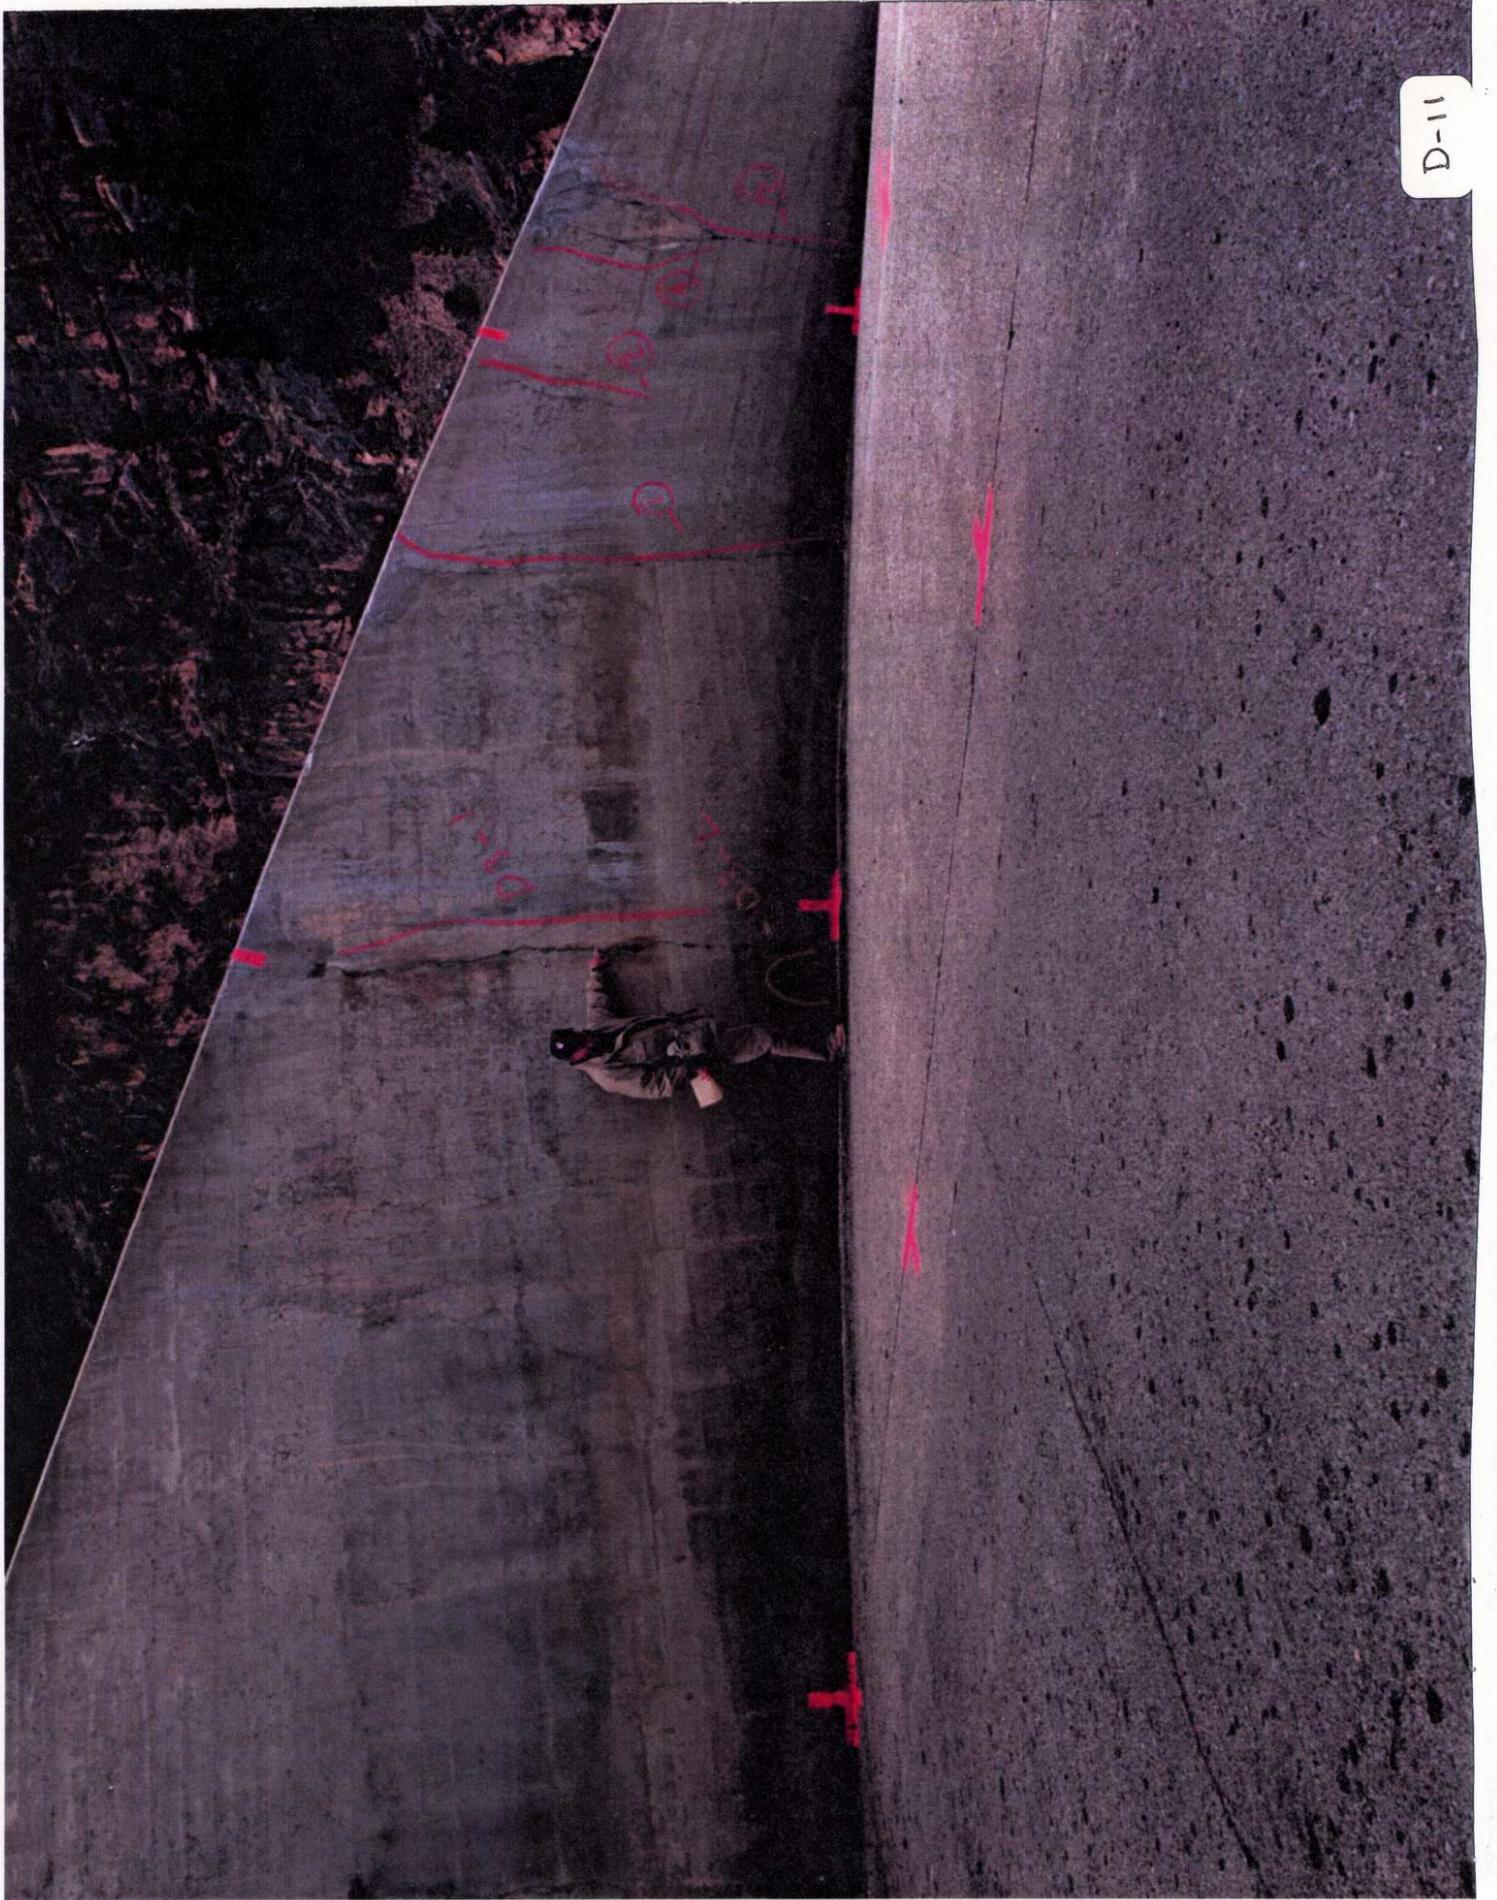
1. Vertical cracking in between panels 4 and 5. It starts out from a construction joint of the spillway floor and runs in widths from about  $1/32$  to about  $3/4$  inch at the widest spot where spalling is located.
2. A hairline crack running from a left side retaining wall cap down to mid wall height.
- 3 & 4 A vertical crack starting from the spillway floor that splits at out the mid point into 2 separate cracks. They range from about  $1/16$  to  $1/4$  inch in width and 1 inch in width at places where concrete is spalled out of the wall. There is some patching on the cap where the crackes fan out into crazing cracking.

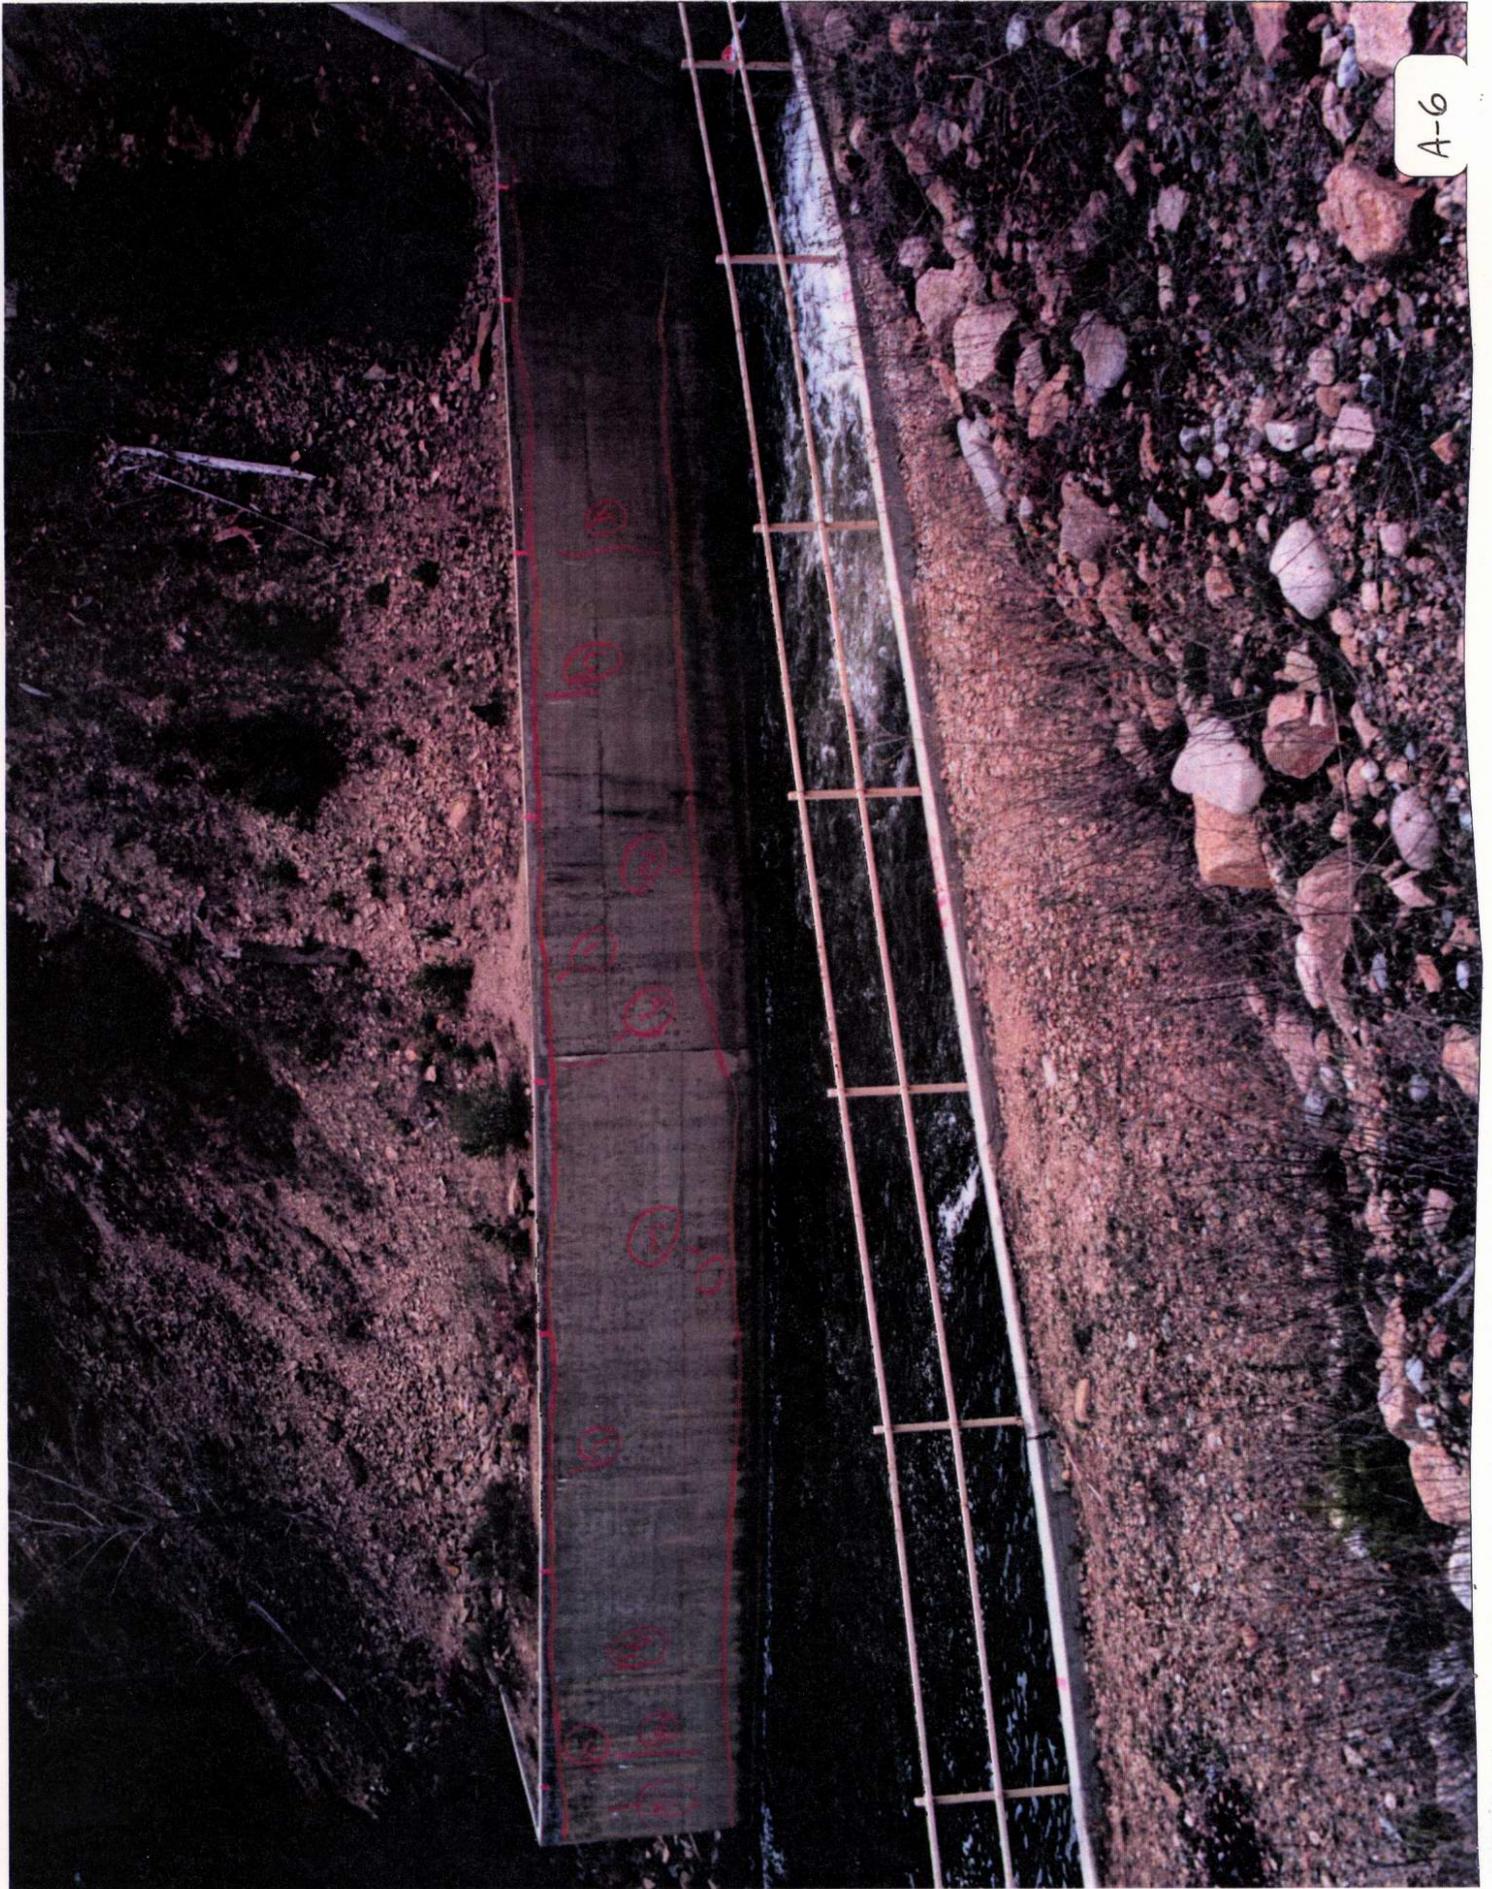
- A-6 Looking at the stilling basin wall, right side.
1. Dental type work on the cap of the stilling basin wall.
  2. Erosion due to hydraulic forces. A lot of aggregate is exposed for the entire length of the wall.
  3. A pocket of concrete that has spalled out or popped out.
  4. A vertical crack with calcite leaching out of it. It is pretty much a hairline crack.
  5. Another hairline crack running from the top of the wall about 4 feet in length.
  6. A vertical crack with some calcite leaching out. This could also be the construction joint.
  7. Horizontal cracks along the stilling basin basin wall. Quite a bit of calcite leaching out of the concrete.
  8. A vertical crack running from the top down to the top 2/3 of the wall.
- 9 to 11 Hairline cracking with calcite leaching out of it. Craze cracking not apparent.
