MONTANA

Forestry Best Management Practices 2022 Monitoring Report *Executive Summary*

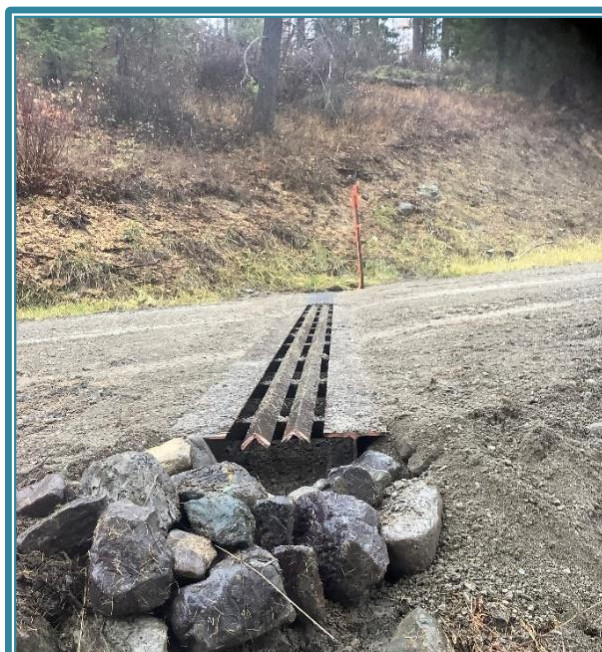
A water diverter installed on an open road. Road drainage should be installed at a frequency to minimize erosion, reducing maintenance costs and protecting water quality.
