FRED BURR DAM

Fact Sheet

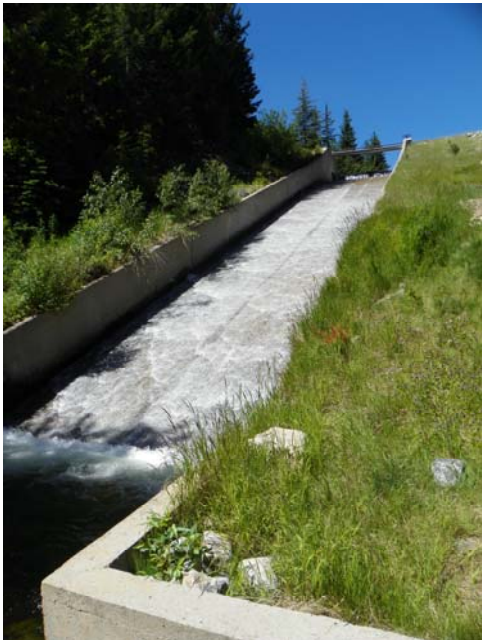
Spillway

- ◆ The spillway is deteriorating and near the end of its design life. It requires replacement.
- ◆ The concrete outlet is deteriorating and needs repair. Lining or replacing the outlet is anticipated to be the primary options to correct the deficiencies.
- ◆ The 2012 Feasibility Study provided alternatives for rehabilitating the dam but recommended additional monitoring before a final evaluation can occur. Monitoring of the dam is ongoing and will assist in deciding the best alternative for addressing deficiencies at Fred Burr Dam.
