PAINTED ROCKS DAM

Fact Sheet

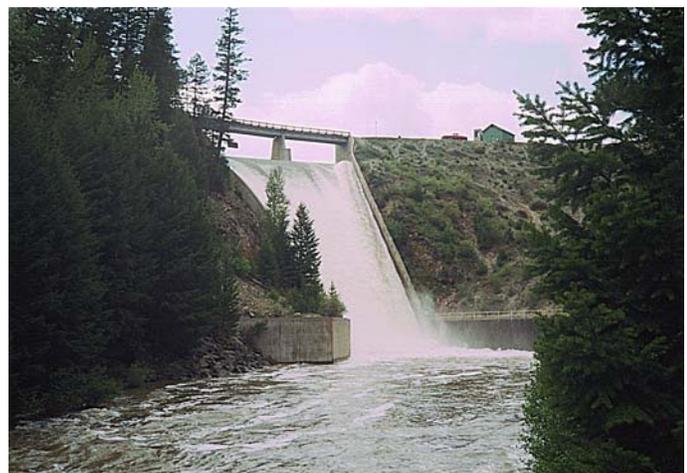
Spillway and Outlet

- ◆ Spillway stilling basin floor is severely eroded. Periodic dive inspections are required. Repairs will be necessary in the future.
- ◆ Spillway chute concrete is deteriorated. Increased monitoring and periodic repairs are on-going in the short term. Replacement will likely be necessary in the future. In addition, the spillway has undesirable flow characteristics that reduce its safe capacity.

- ◆ The outlet conduit discharges in the spillway chute, making it difficult to conduct outlet repairs without impacting downstream flows. Future modifications may be required.
