FRED BURR DAM

Fact Sheet

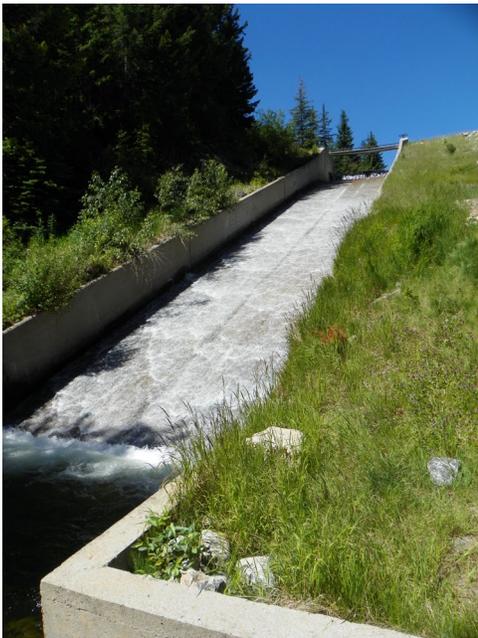
Spillway

- ◆ The spillway is deteriorating and near the end of its design life. It requires replacement.
- ◆ The concrete outlet is deteriorating and needs recurring repair. Lining or replacing the outlet is anticipated to be the primary options to correct the deficiencies.
- ◆ The 2012 Feasibility Study provided alternatives for rehabilitating the dam but recommended additional monitoring before a final evaluation can occur. Monitoring of the dam is ongoing and will assist in deciding the best alternative for addressing deficiencies at Fred Burr Dam.
