# Dam Safety- Fact Sheet

Montana Watercourse and Montana Department of Natural Resources and Conservation  
Water Resources Division

## Problems with Metal Materials

Fact Sheet: 13

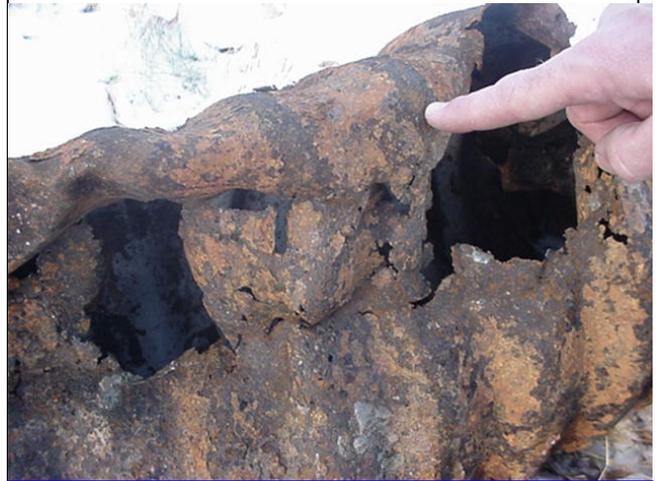
Severely damaged corrugated metal pipe, due to corrosion.

In areas with aggressive water such as, acid runoff from a strip-mined area, rapid corrosion of metal conduits can occur. In these areas, conduits made of less corrodible materials such as concrete or plastic should be used. Due to these destructive effects on corrugated metal conduits, they typically need to be repaired or replaced early in the dam's design life, which can be very expensive.

If corrosion is allowed to continue, metal conduits will rust out. The spillway must be repaired before water flows through the rusted out portion of the conduit and erodes the fill material of the embankment. Continued erosion can lead to failure of the dam. Sliplining can be an economical and effective method of permanently restoring

deteriorated spillways. During sliplining, a smaller diameter pipe is inserted into the old spillway conduit and then grout is used to fill in the void between the two pipes. If sliplining the spillway is not feasible, the reservoir may need to be drained and a new spillway must be installed. A registered professional engineer must be retained to develop and submit plans and specifications for any major modifications such as spillway sliplining or replacement.

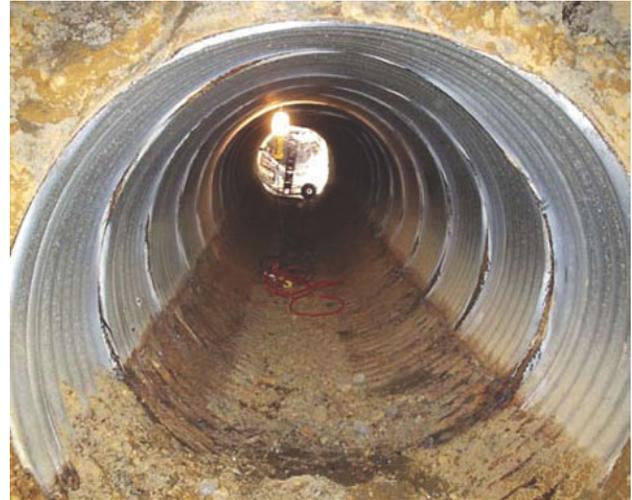
Aging metal culvert, with bulging seams and some corrosion on the bottom of the pipe.

Regular inspection and monitoring is essential to detect any problems with metal materials. Coatings on metal pipes should be inspected for scratched and worn areas. The inspector should also look for corrosion inside the spillway conduit. Proper ventilation and confined space precautions must be considered when entering the spillway conduit system. If using cathodic protection, regular inspections are required to verify that the system is working properly. It is important to keep written records of the amount of surface rust, pitting, and corrosion on any metal surface. Areas of thin metal should be monitored more frequently and repaired or replaced if they rust out. Photographs provide invaluable records of changing conditions. A rapidly changing condition may indicate a very serious
