DNRC Floodplain Engineering 101 Workshop

Lessons Learned from the Legal Side of
Permitting

Jeremiah Theys | Great West Engineering

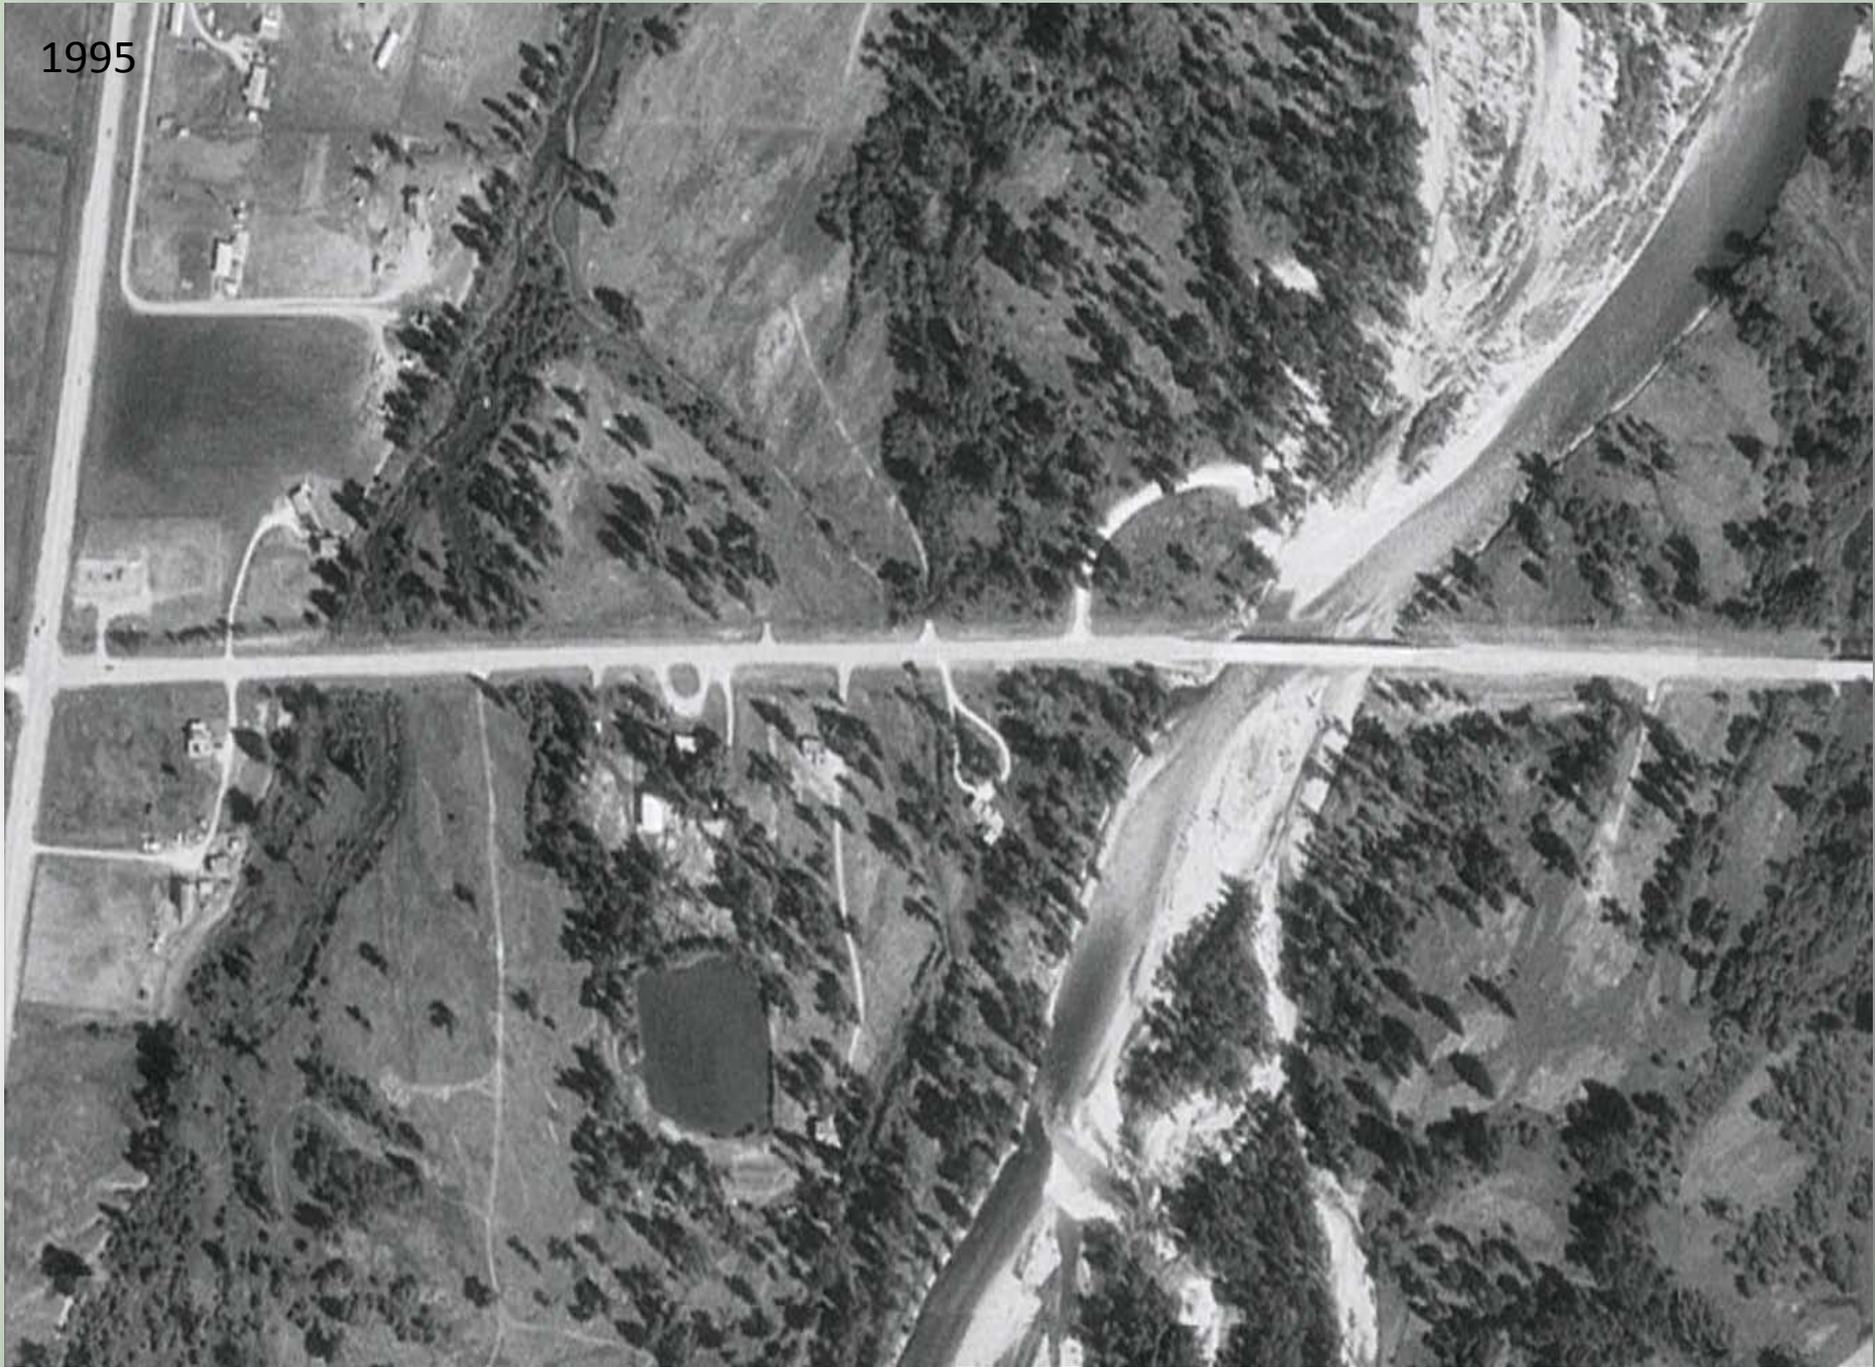
1995

- ▶ Loss of bank issues potentially due to MDT scour mitigation project
 - ▶ Significant channel migration over the life of the bridge
 - ▶ Up to 1800 ft of channel shift in areas
 - ▶ Significant braiding
 - ▶ High sedimentation
 - ▶ 1996 & 1997 floods significantly altered channel
 - ▶ Bridge developed significant scour at intermediate piers
 - ▶ River migration changed attack angle
 - ▶ Erosion along abutment and river bank

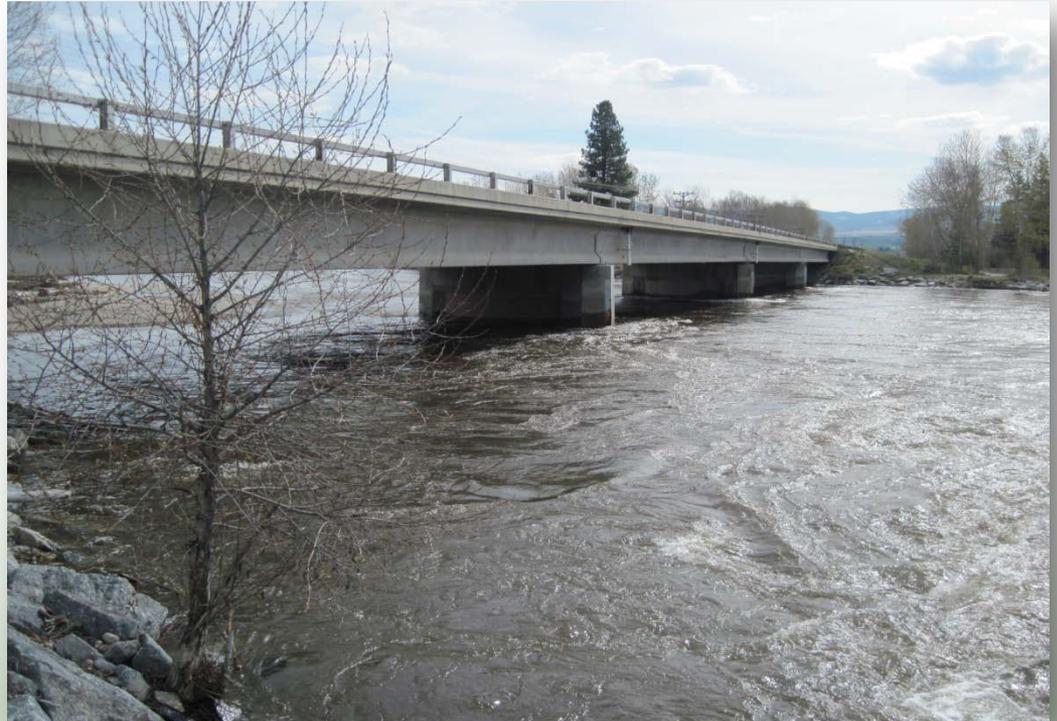
- ▶ MDT completed scour mitigation project on bridge
 - ▶ Detailed design
 - ▶ Cable-tied blocks around piers
 - ▶ Riprap trench along roadway
 - ▶ Constructed in 2004

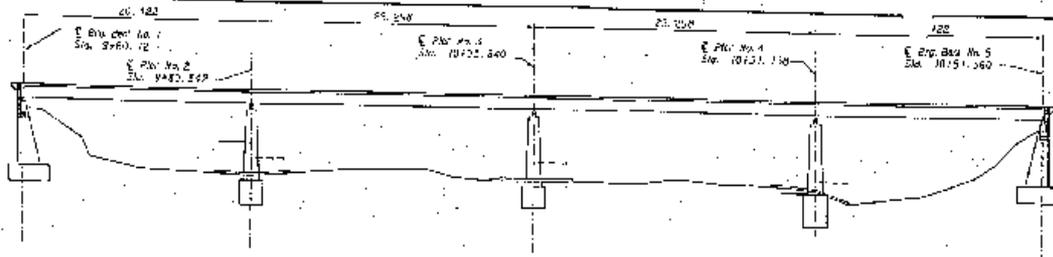
PROFILE ELEVATION

NOTE: The maximum chord slope shown represents the grade shown on Stationing 11+00. The current grade may vary.

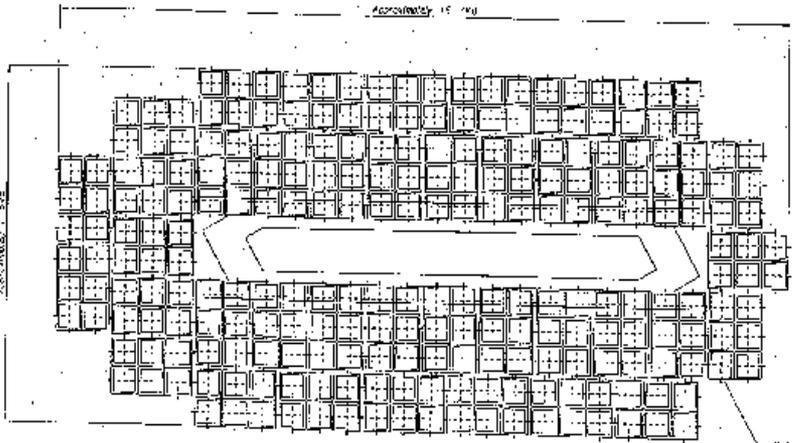
MAT LAYOUT FOR PIER NO. 2, NO. 3 AND NO. 4

NOTE: See Eng. No. 10543 for details concerning steel layout and steel detail.

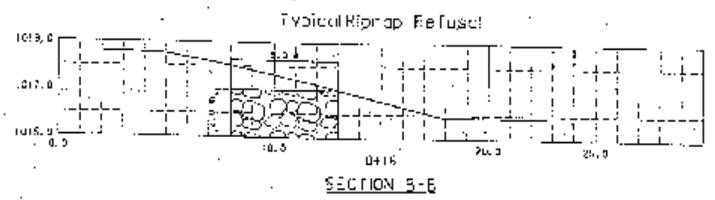
SECTION B-B

Typical Riprap Refusal

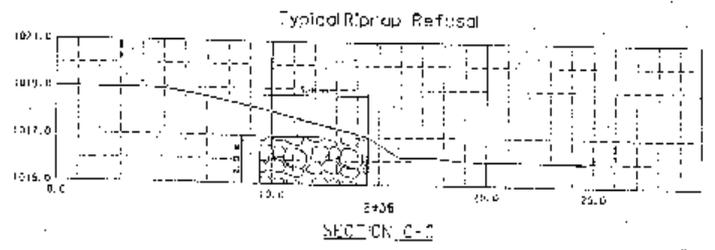
SECTION C-C

Typical Riprap Refusal

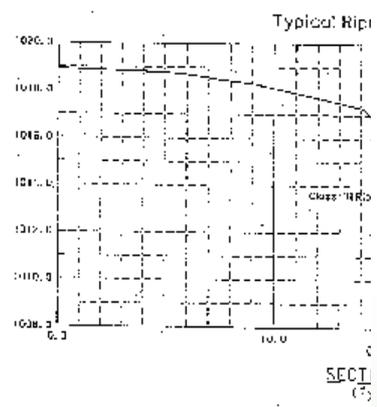
SECTION D-D

Typical Riprap

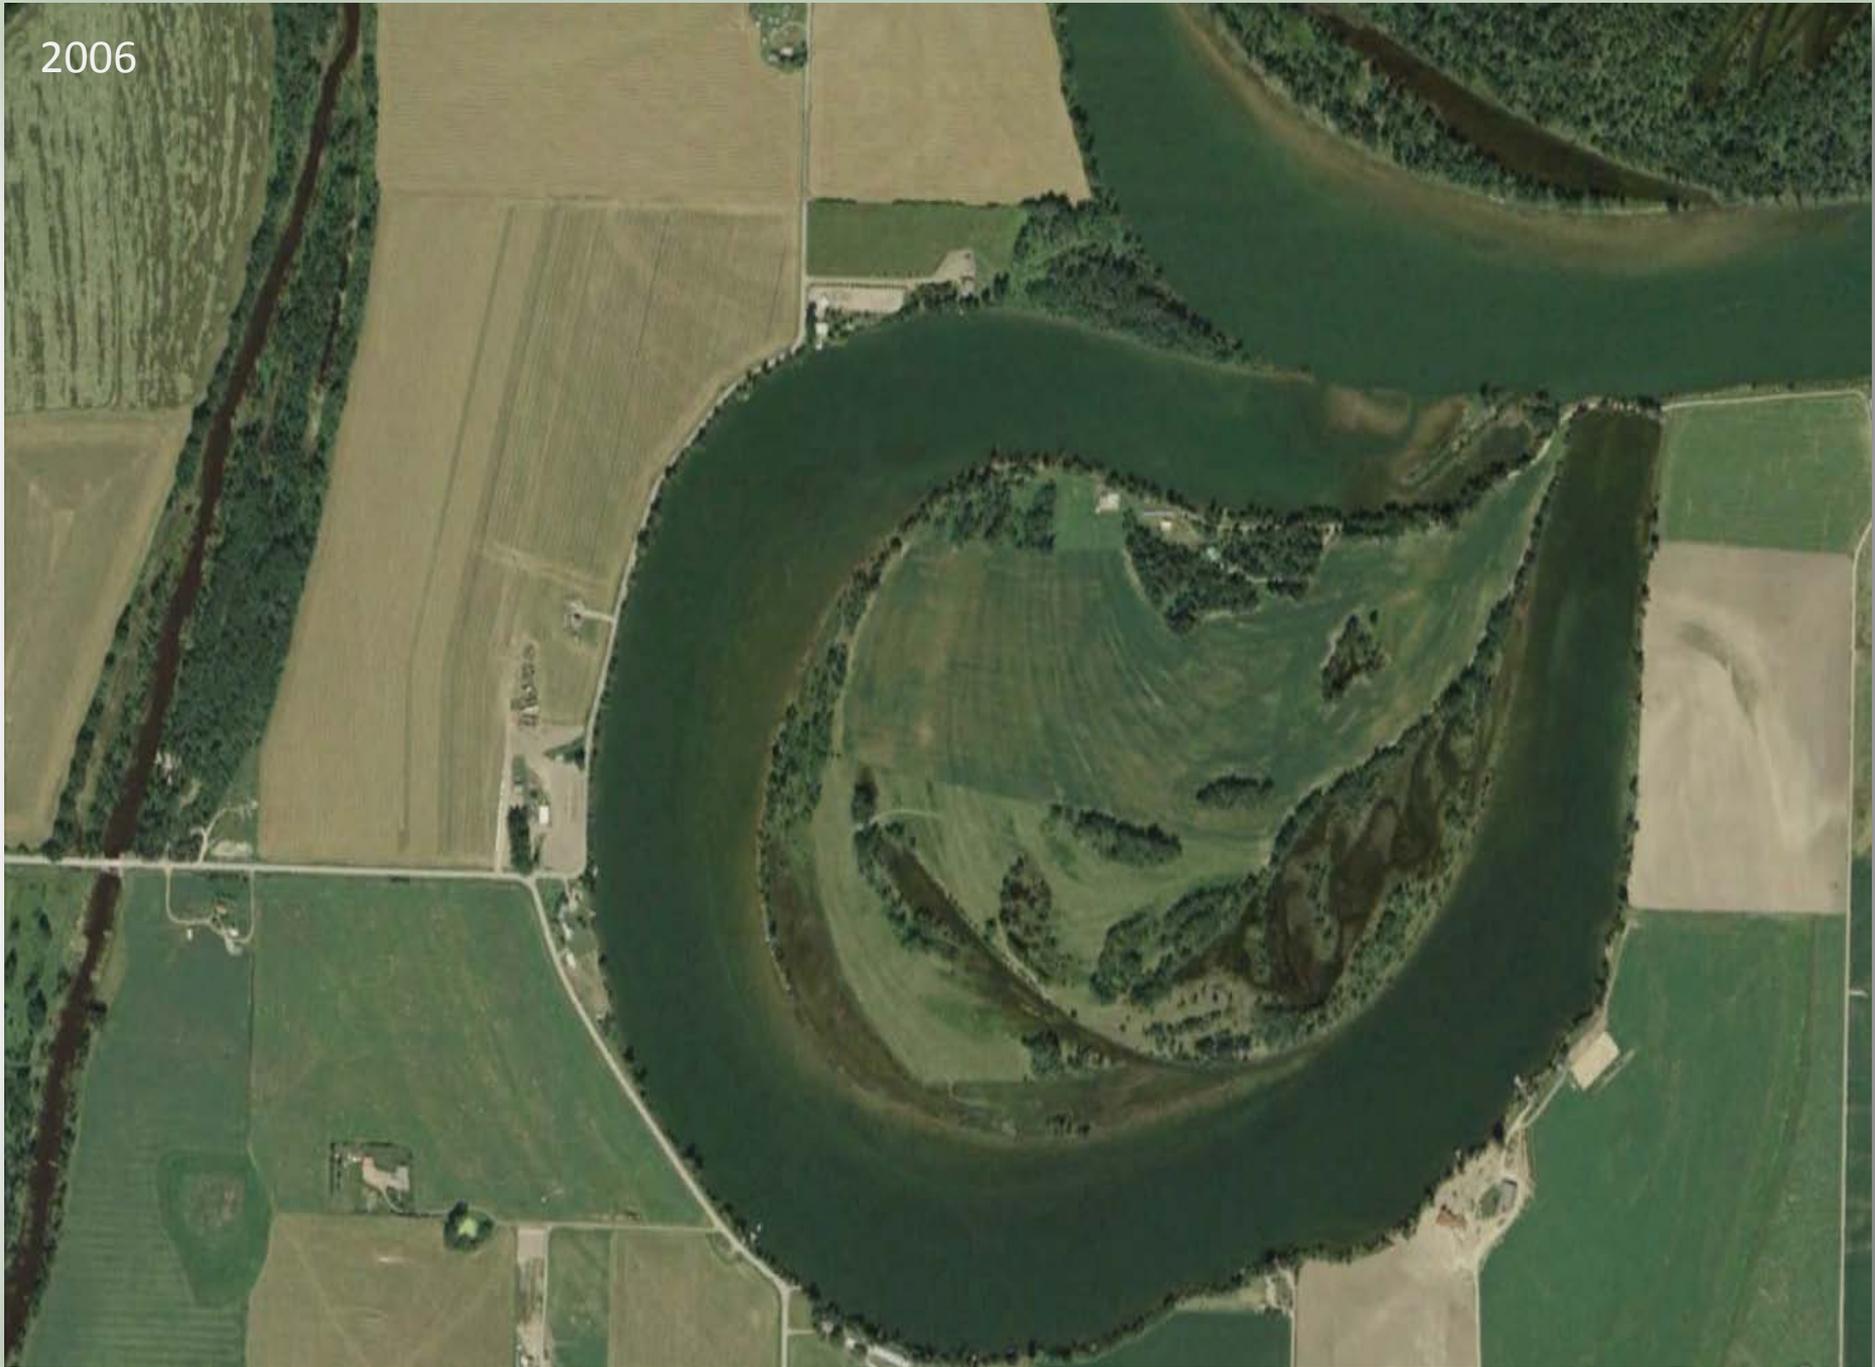
2006

- ▶ County constructed fishing access and concrete boat ramp accessing Church Slough (River Vista Park Boat Ramp)
 - ▶ Project completed as part of a land swap with adjacent property owner
 - ▶ Landowner wanted to develop property
 - ▶ Wanted to move County road
 - ▶ Allow parcels developed adjacent to slough
 - ▶ Provide a dedicated fishing access and boat ramp
 - ▶ Backwater slough from the main channel of the Flathead River
 - ▶ Detailed floodplain in project area
 - ▶ County obtained all necessary permits
 - ▶ 124, 404 and Floodplain
 - ▶ 318 authorization and Navigable Water not required

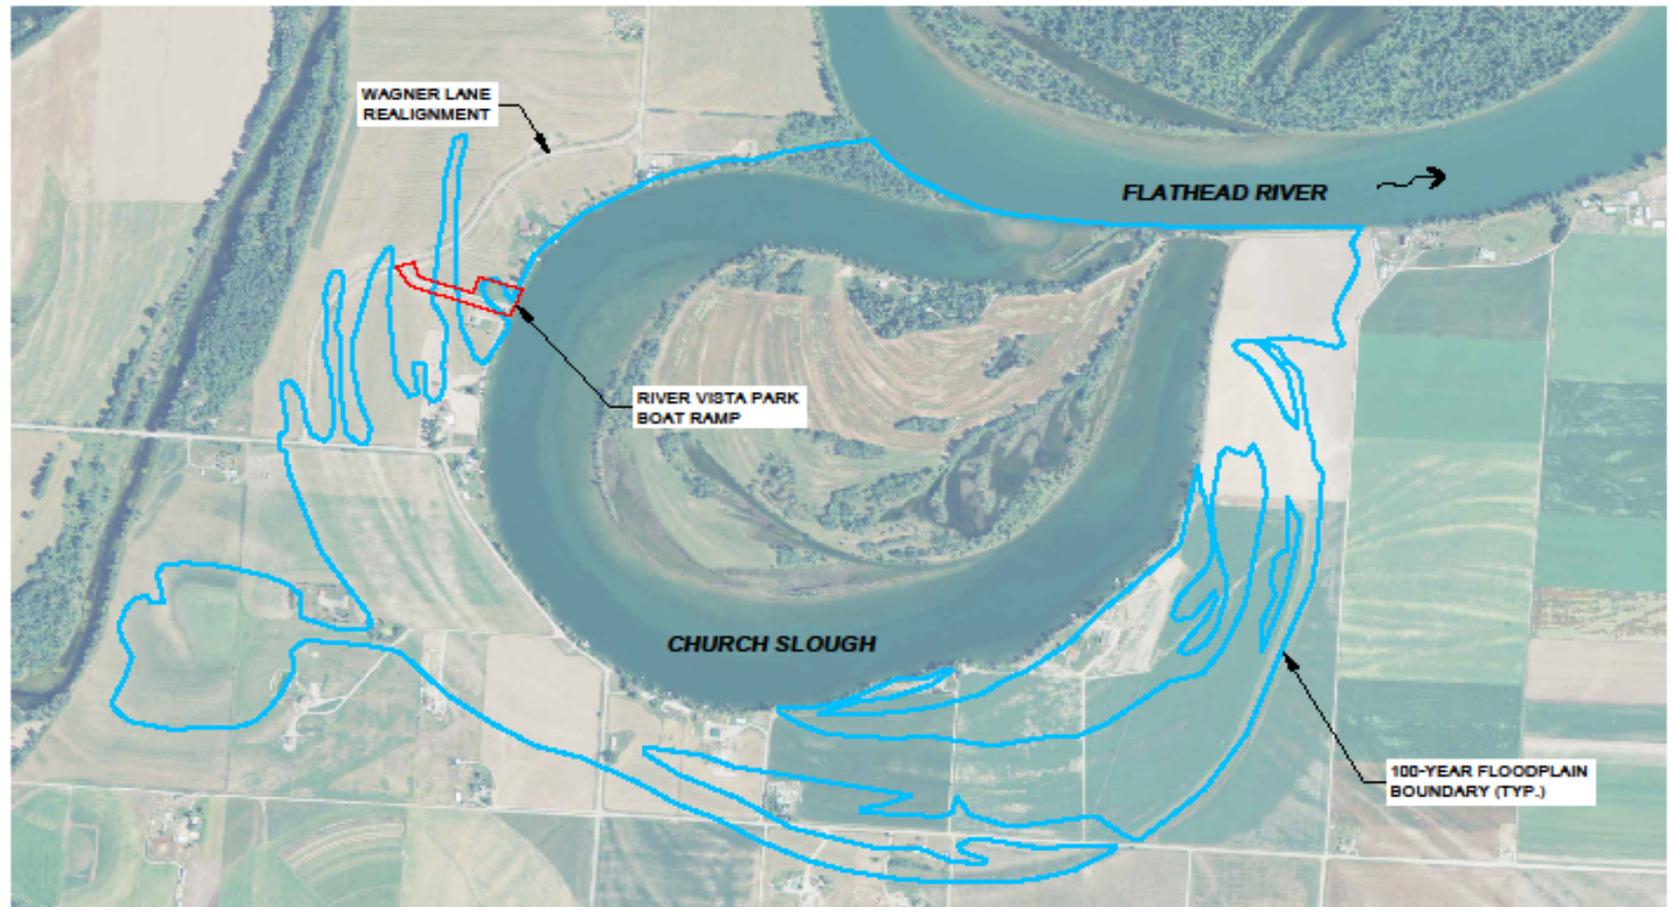
EXHIBIT B AERIAL PHOTO SITE PLAN

AREA OF CHURCH SLOUGH 100-YEAR
FLOODPLAIN = 28,143,157 SQ. FT.

RIVER VISTA PARK BOAT RAMP
FLATHEAD COUNTY, MONTANA

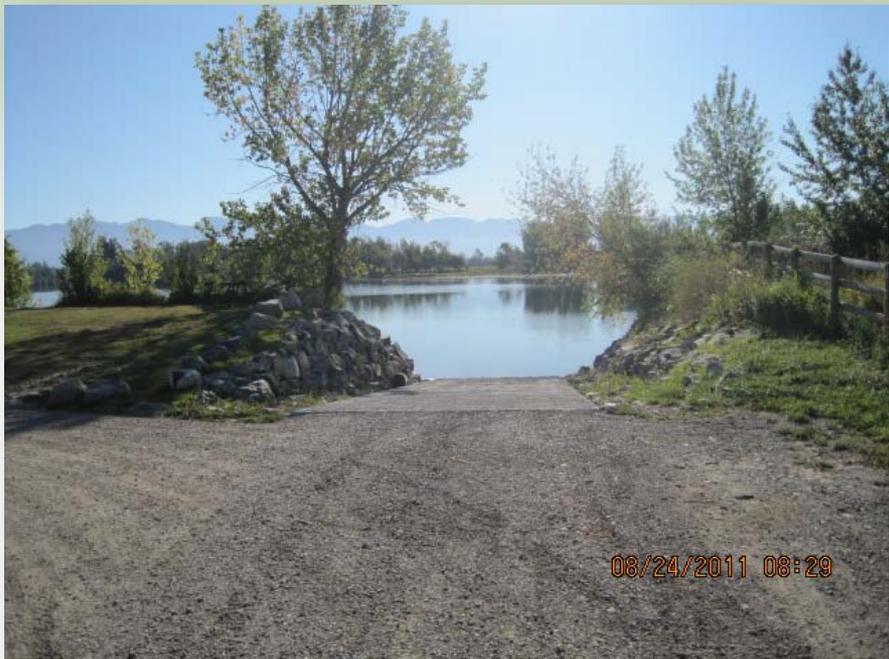
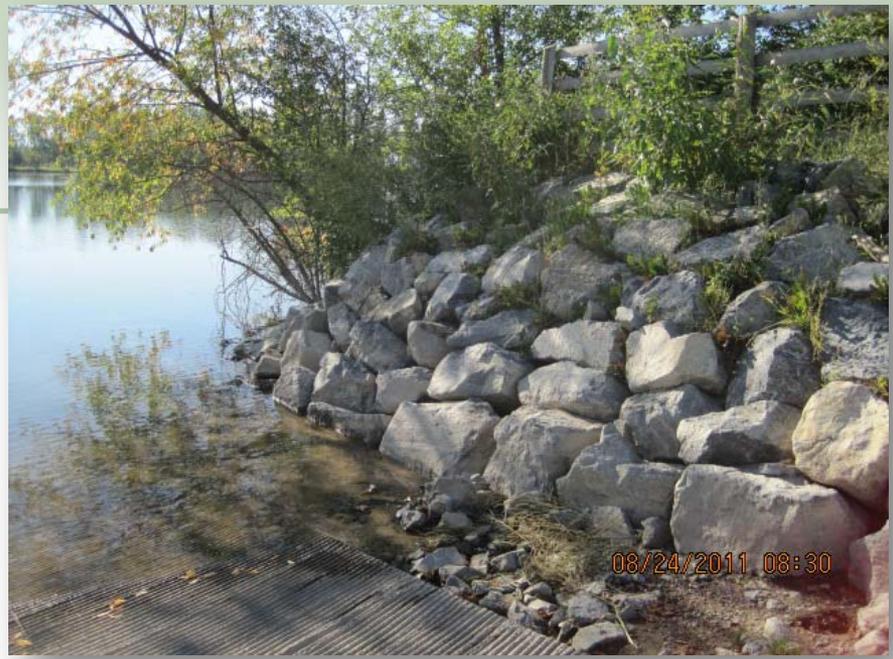
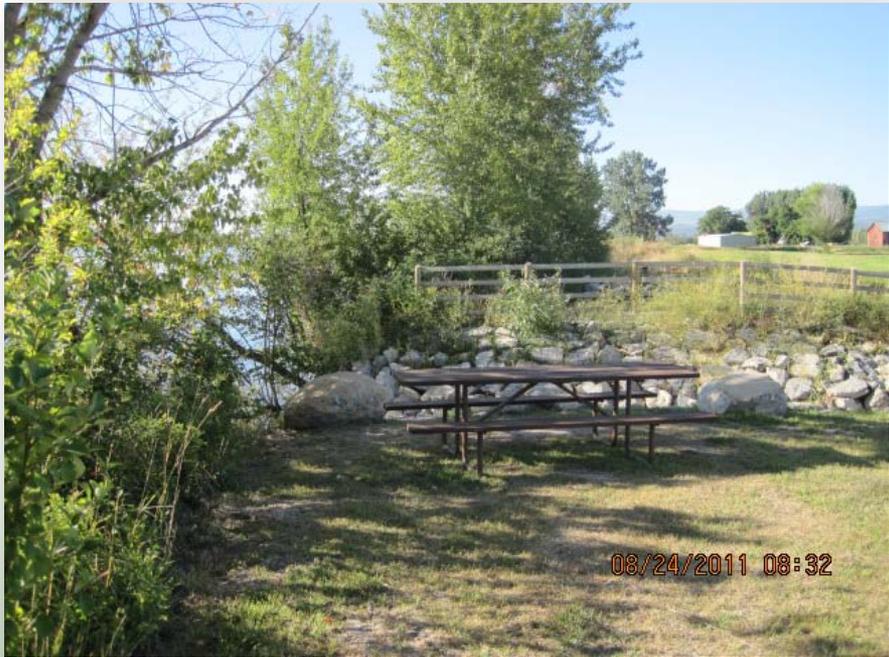
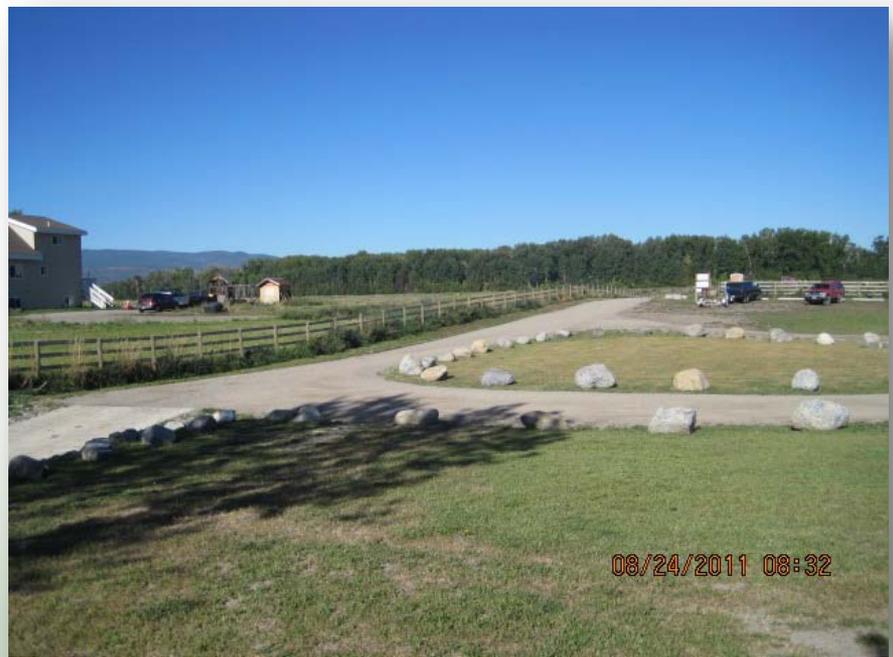
- ▶ Expert Report completed on project
 - ▶ Findings
 - ▶ Floodplain permit was deficient due to lack of supporting data
 - ▶ Unauthorized fill placed in floodplain (44 CY)
 - ▶ Flood flows entering floodplain quicker
 - ▶ Stability of channel banks and impacts from additional boat traffic
 - ▶ Deficient permit process

- ▶ Church Slough is hydraulically linked to the Flathead River
- ▶ Impacts to floodplain in Church Slough effect the entire system
- ▶ River banks are stable and well protected with riparian vegetation – no noticeable erosion
- ▶ No permanent features placed in the floodplain
- ▶ Project (Boat ramp construction and fill placement for roadway) impacted the BFE 0.000507 inches
- ▶ Break in bank doesn't affect limits of floodplain
