Painted Rocks Dam Toe Access Road Maintenance Project

Final Environmental Assessment

AECOM

June 22, 2020

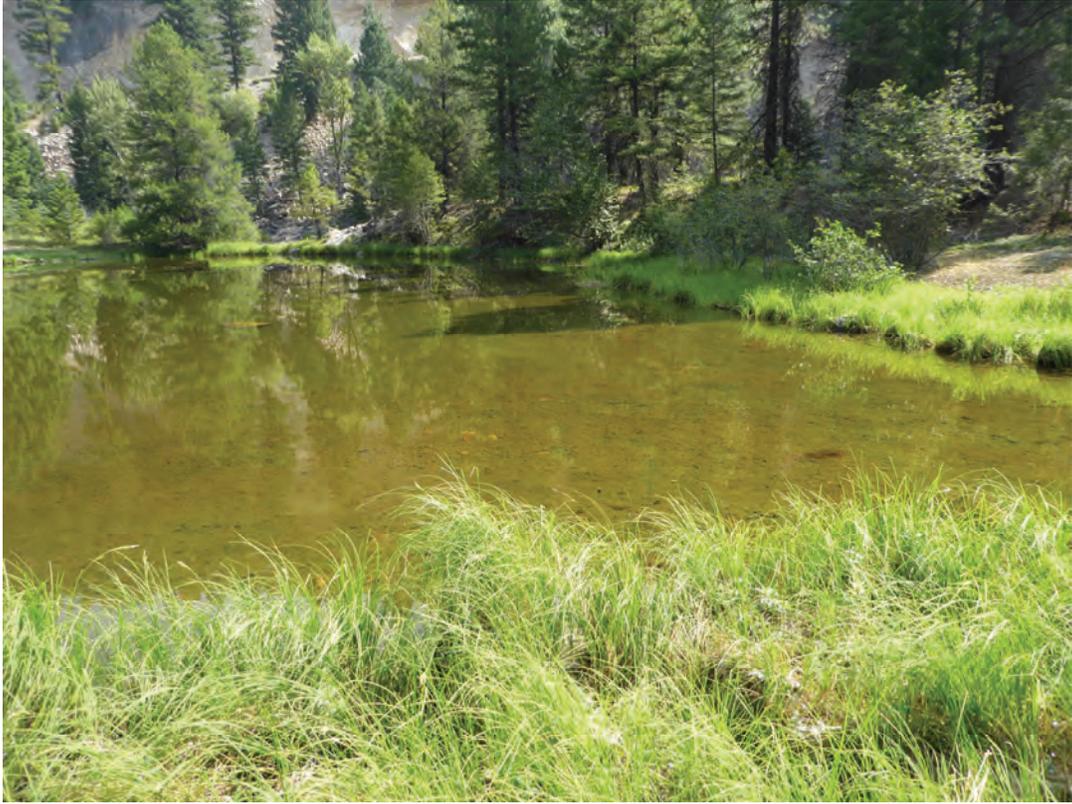
1. Access Road Area – Wetland 1 and Pond 1

A site visit was conducted on August 15-17, 2018, to assess the existing jurisdictional wetlands and waters of the U.S. Five wetlands were delineated, including four on the west side of the river and one on the east side (see maps in Appendix B). All of the wetlands observed were dominated by palustrine emergent vegetation, although some shrubs were also present (see photos and data sheets in Appendix B). All of the wetlands on the west side of the river are hydrologically connected to the river. Wetland 1 is the largest and occurs around the perimeter of a pond on the west side of the river. Wetlands 2, 3, and 5 are located in depressions on the floodplain on the west side of the river. Wetland 4 is on a terrace on the east side of the river and appears to be supported by groundwater discharge. Wetland 1 covers 0.18 acre, and the other four wetlands combined occupy 0.14 acre. Other aquatic features in the project area include the West Fork Bitterroot River and a pond on the floodplain on the north side of the river. All wetlands and other aquatic features are assumed to be jurisdictional under the Clean Water Act because they are connected to perennial waters. The wetlands are classified as Category III wetlands under the Montana Wetland Assessment Method (Berglund and McEldowney 2008). The most important wetland functions shared by all of the wetlands are sensitive species habitat, general wildlife habitat, sediment/shoreline stabilization. Wetland 4 also consists of a groundwater discharge function.

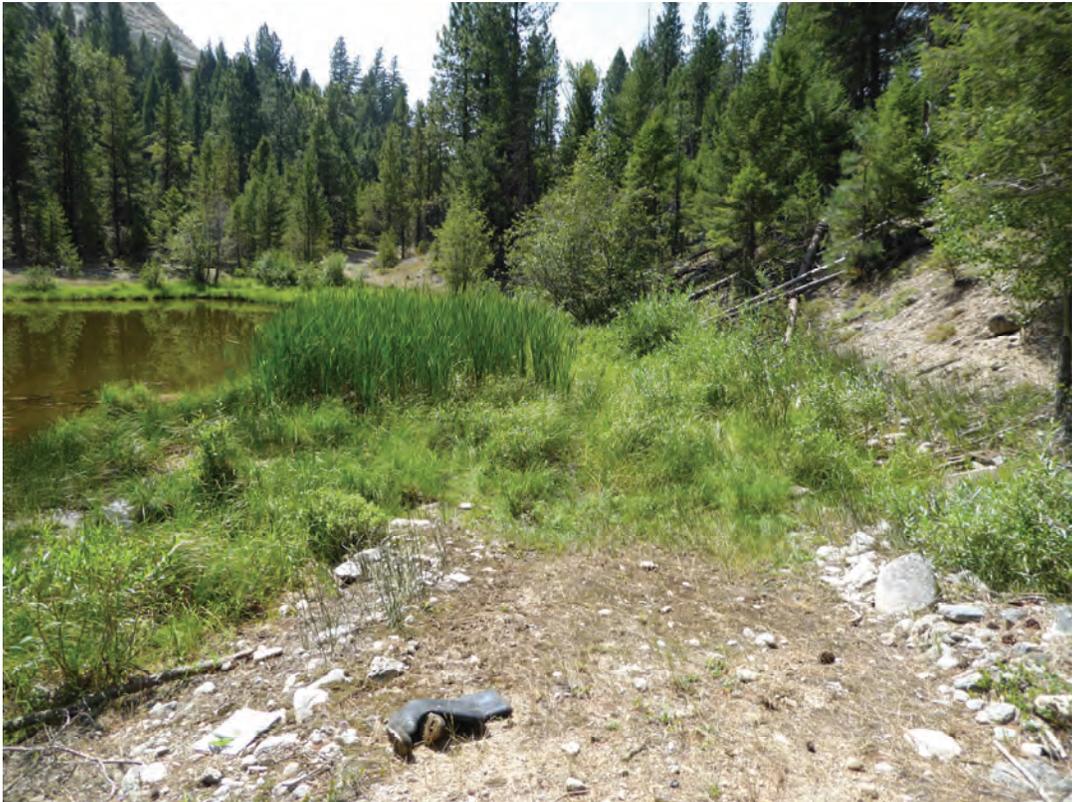
2. Access Road Area – Crossing Location in Wetland 1

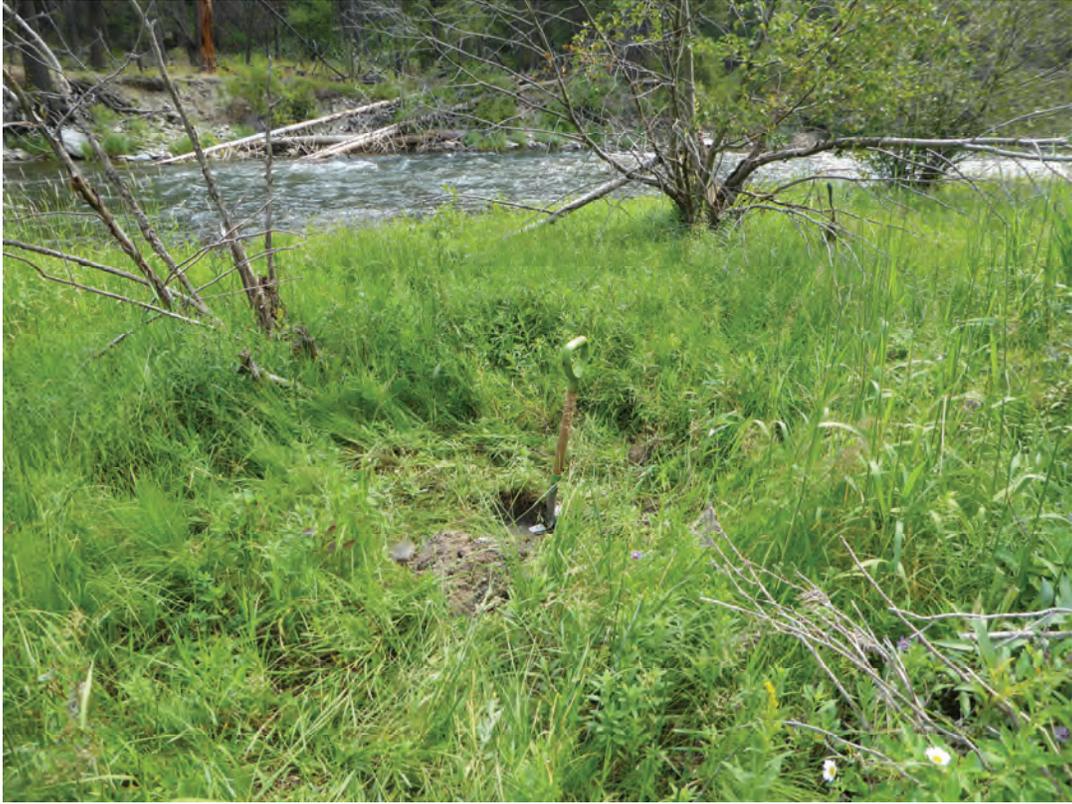
3. Access Road Area – Wetland 3

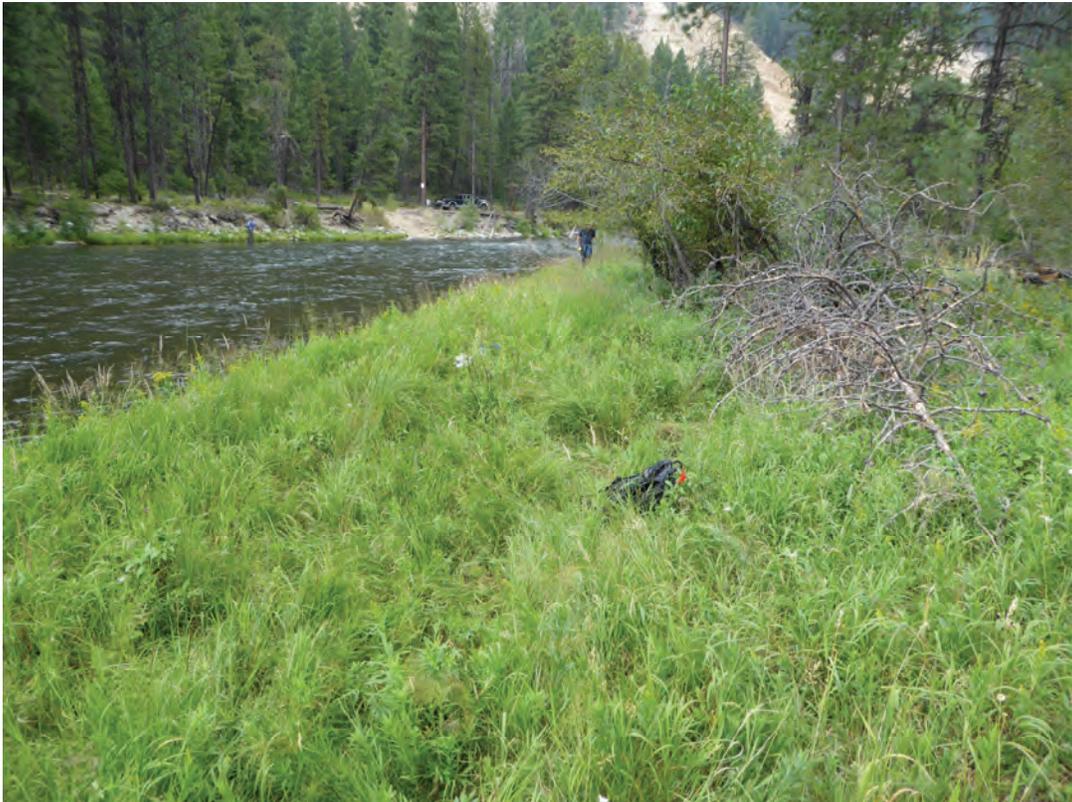
4. Access Road Area – Wetland 5

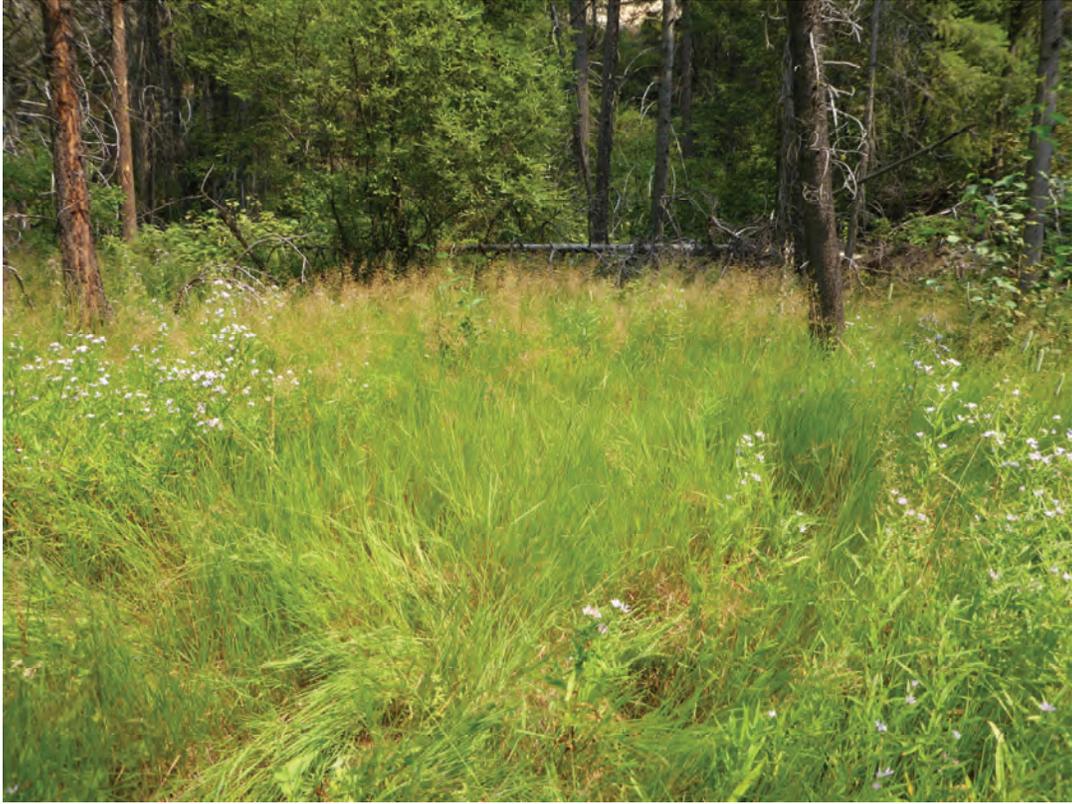
5. Access Road Area – Wetland 4 (east of river)

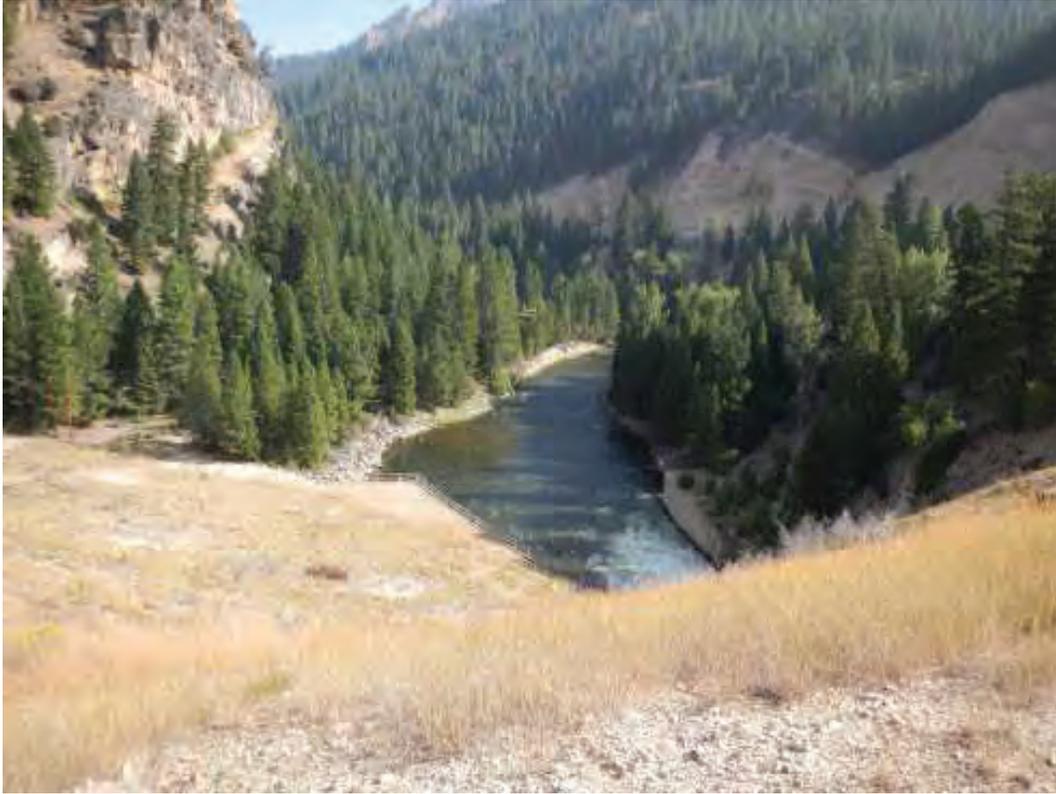
7. West Fork Bitterroot River downstream from Painted Rocks Dam, view from dam crest

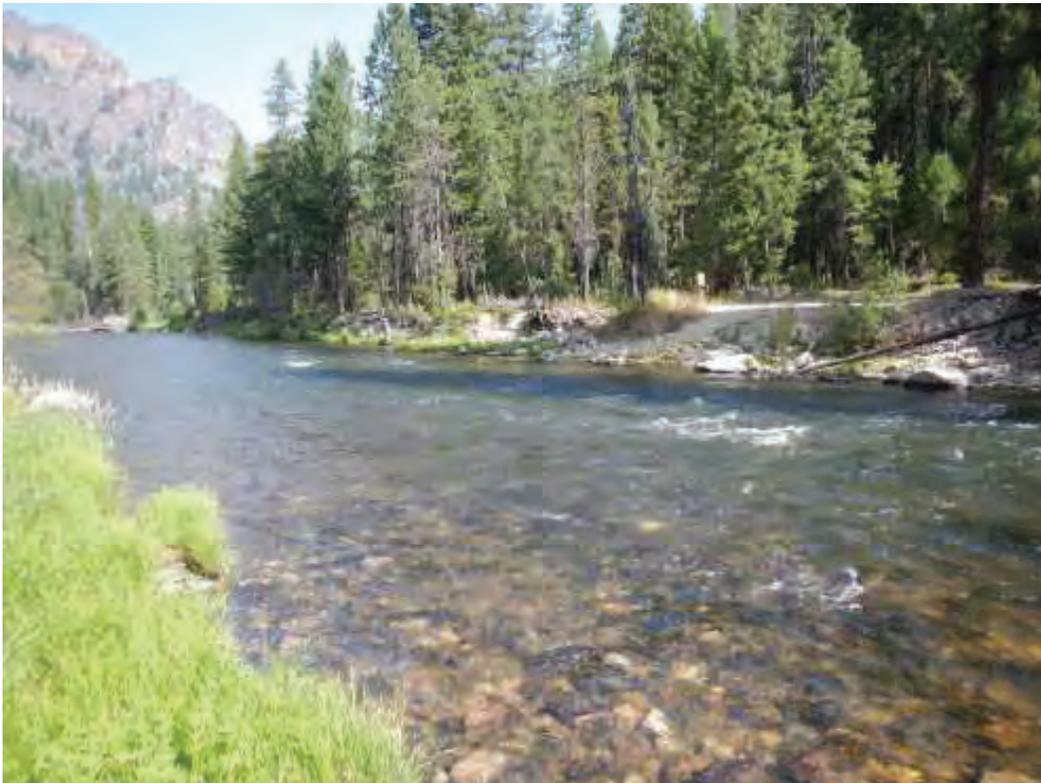
8. West Fork Bitterroot River at approximate location of proposed bridge crossing

Construction of the improved access road and bridge is anticipated to occur in Fall 2021. The bridge would likely consist of a pre-manufactured bridge (i.e. pre-stressed concrete, steel truss, etc.) and would span the width of the river. The surface of the bridge may be asphalt or concrete. The bridge is anticipated to provide a minimum of two foot of freeboard between the water surface for the 100-year recurrence interval flood event and the low cord of the bridge. The bridge abutments will be founded using either a spread footings or piles.
