Painted Rocks Dam Toe Access Road Maintenance Project

Montana Department of Natural Resources and Conservation
Ravalli County, Montana

Environmental Assessment

PAINTED ROCKS DAM TOE ACCESS ROAD DRAFT ENVIRONMENTAL ASSESSMENT

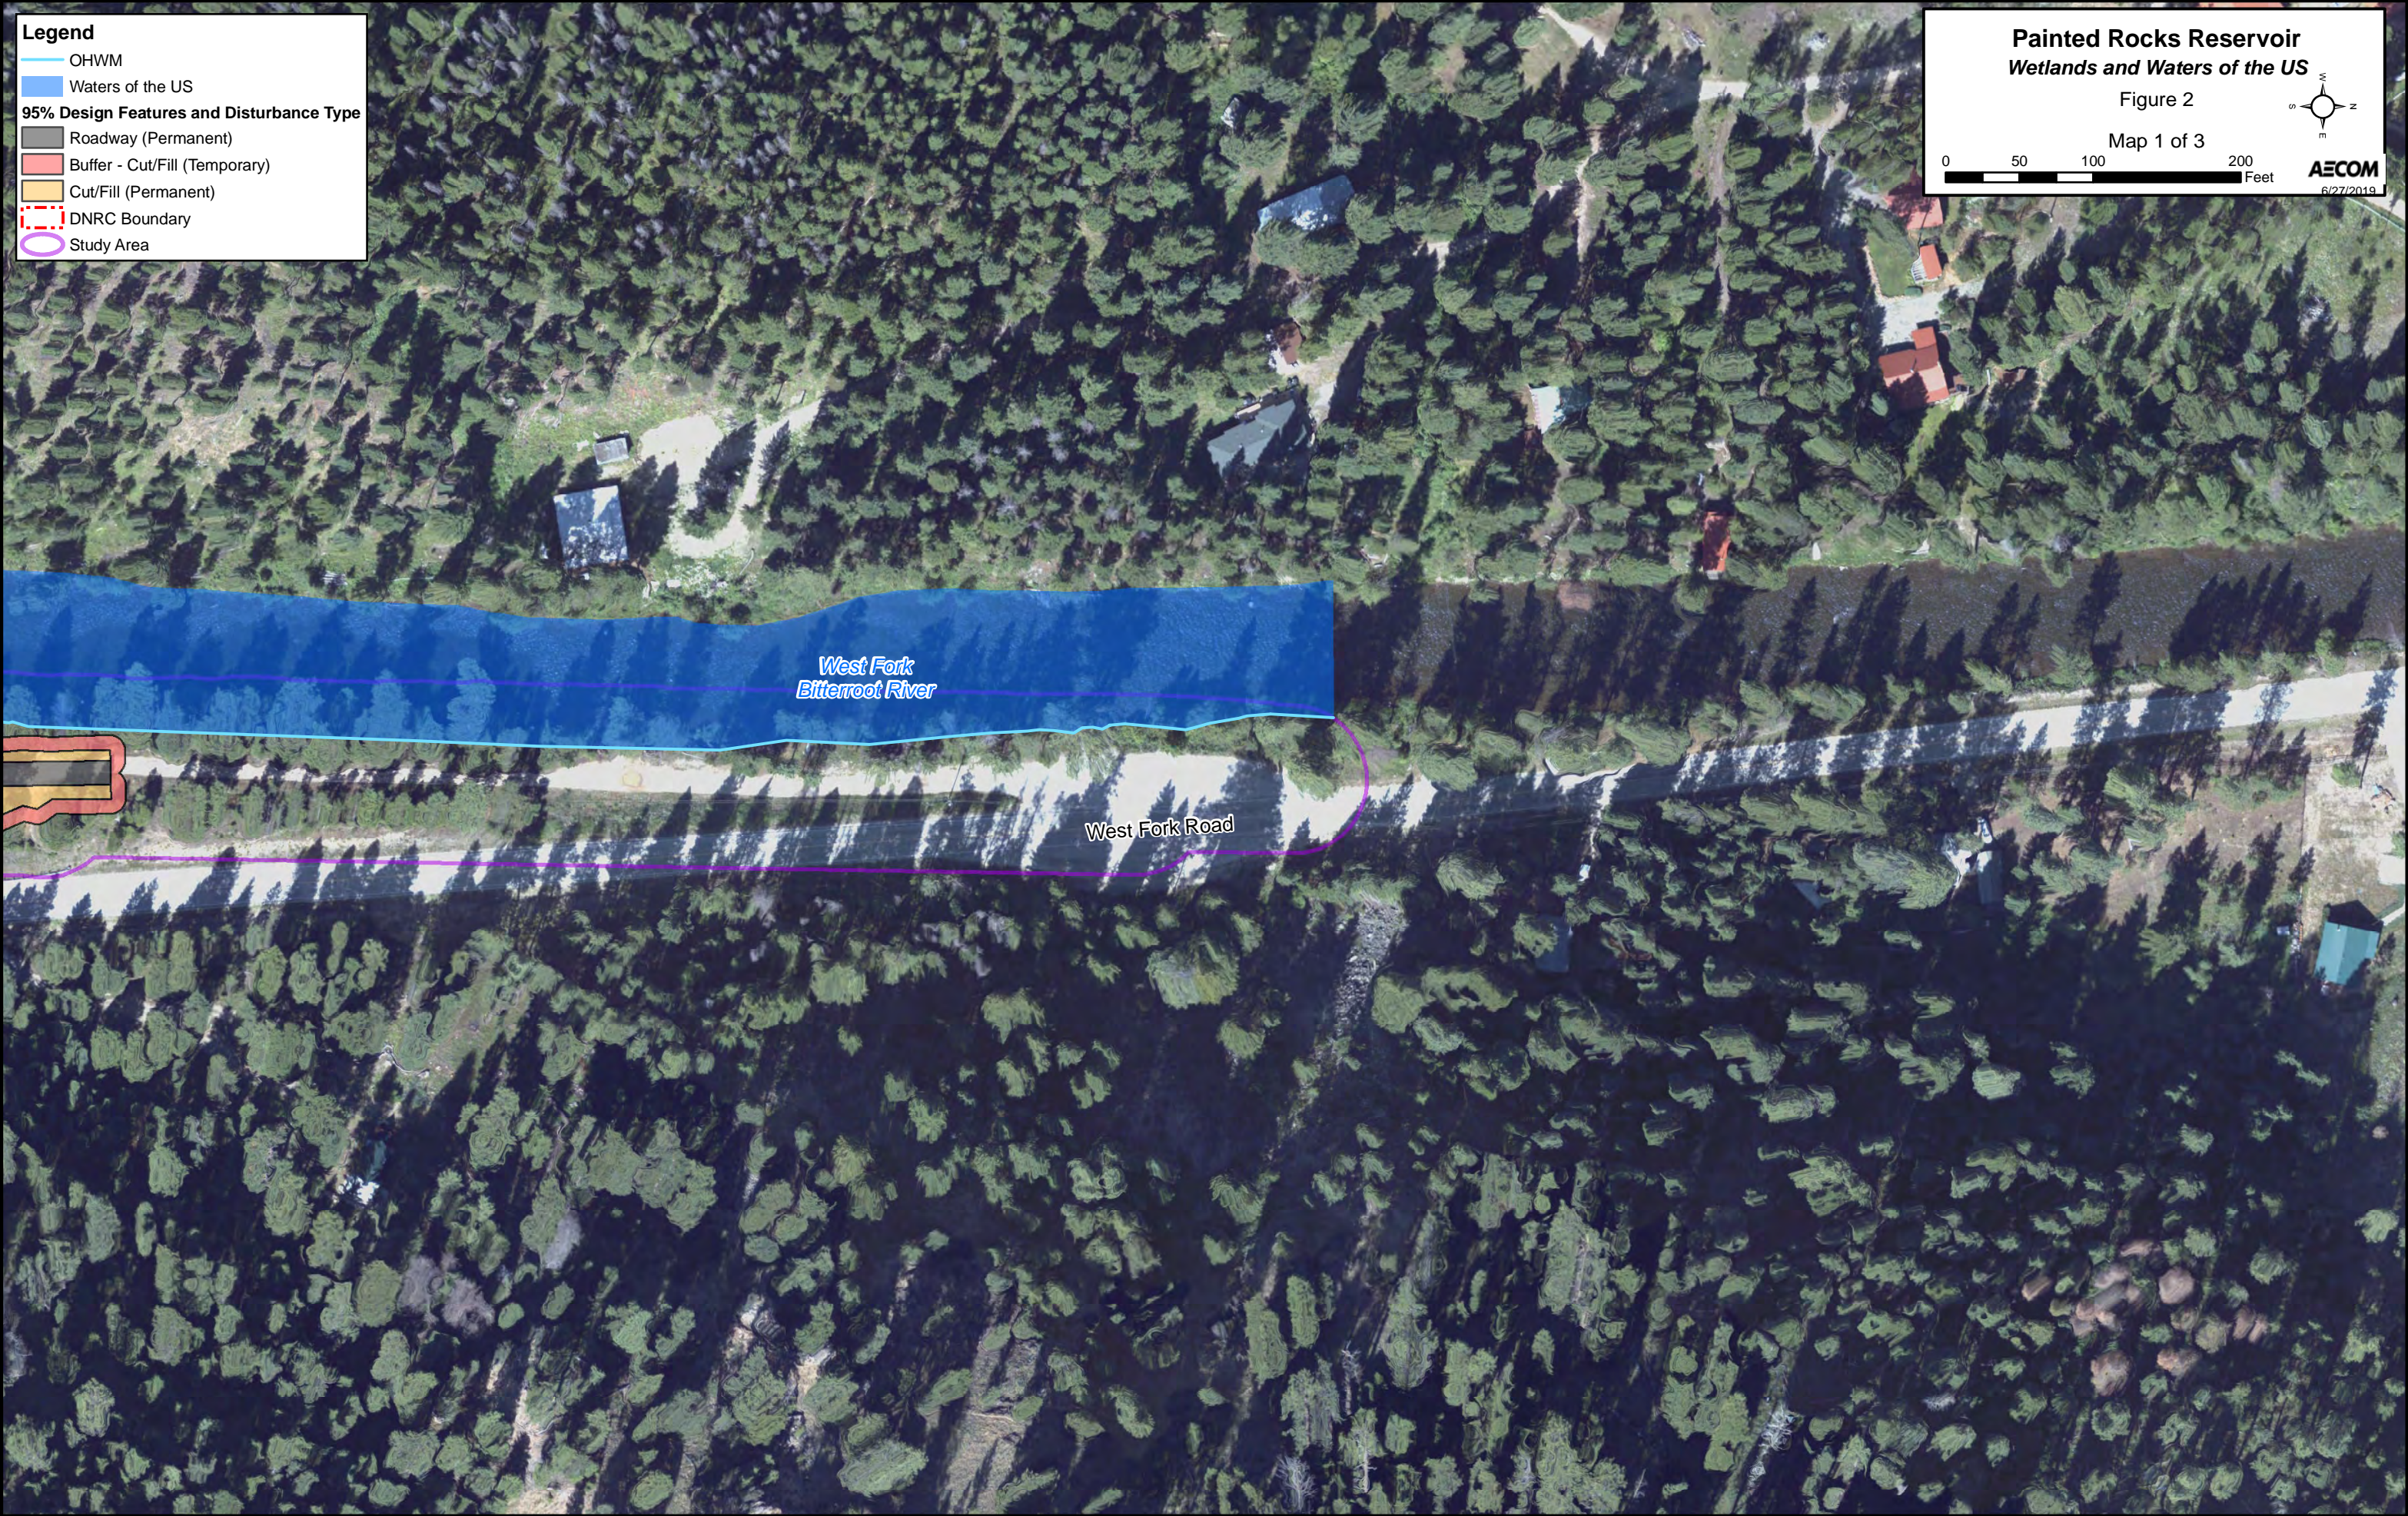
Appendix B Wetlands and Waters of the U.S.

Wetlands/Waters of US Disturbance Impacts

A site visit was conducted on August 15-17, 2018, to assess the existing jurisdictional wetlands and waters of the U.S. Five wetlands were delineated, including four on the west side of the river and one on the east side (see maps in Appendix B). All of the wetlands observed were dominated by palustrine emergent vegetation, although some shrubs were also present (see photos and data sheets in Appendix B). All of the wetlands on the west side of the river are hydrologically connected to the river. Wetland 1 is the largest and occurs around the perimeter of a pond on the west side of the river. Wetlands 2, 3, and 5 are located in depressions on the floodplain on the west side of the river. Wetland 4 is on a terrace on the east side of the river and appears to be supported by groundwater discharge. Wetland 1 covers 0.18 acre, and the other four wetlands combined occupy 0.14 acre. Other aquatic features in the project area include the West Fork Bitterroot River and a pond on the floodplain on the north side of the river. All wetlands and other aquatic features are assumed to be jurisdictional under the Clean Water Act because they are connected to perennial waters. The wetlands are classified as Category III wetlands under the Montana Wetland Assessment Method (Berglund and McEldowney 2008). The most important wetland functions shared by all of the wetlands are sensitive species habitat, general wildlife habitat, sediment/shoreline stabilization. Wetland 4 also consists of a groundwater discharge function.

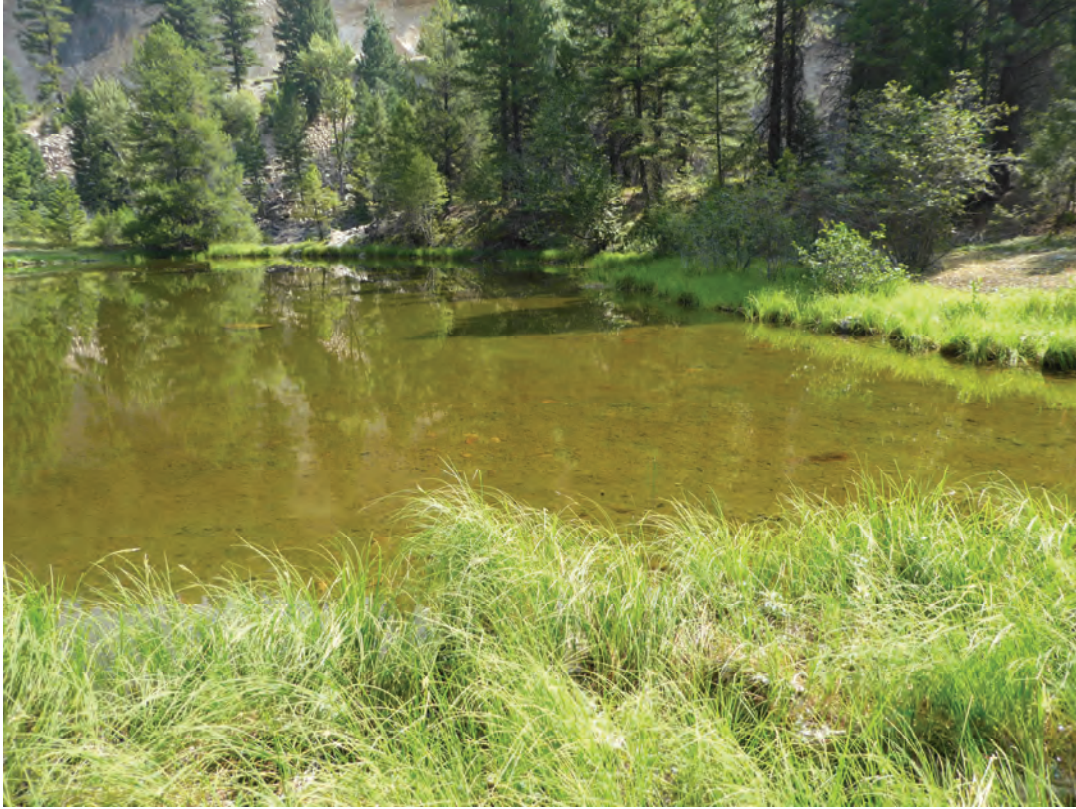
1. Access Road Area – Wetland 1 and Pond 1

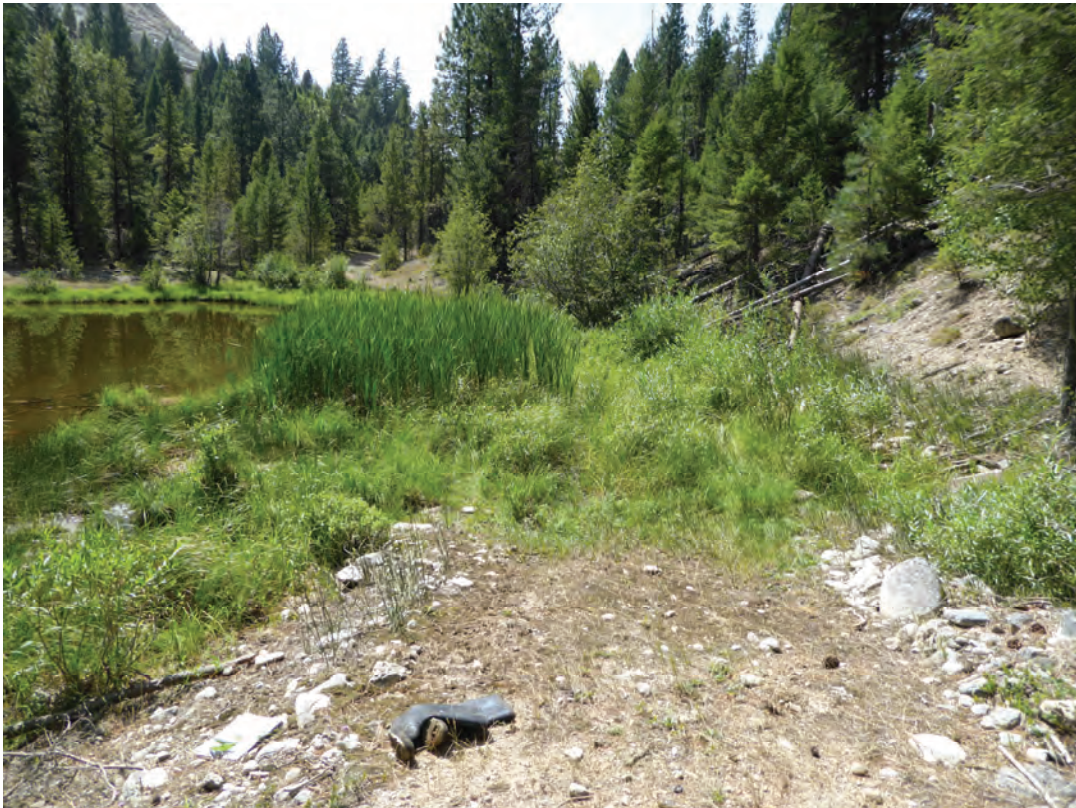
2. Access Road Area –Crossing Location in Wetland 1

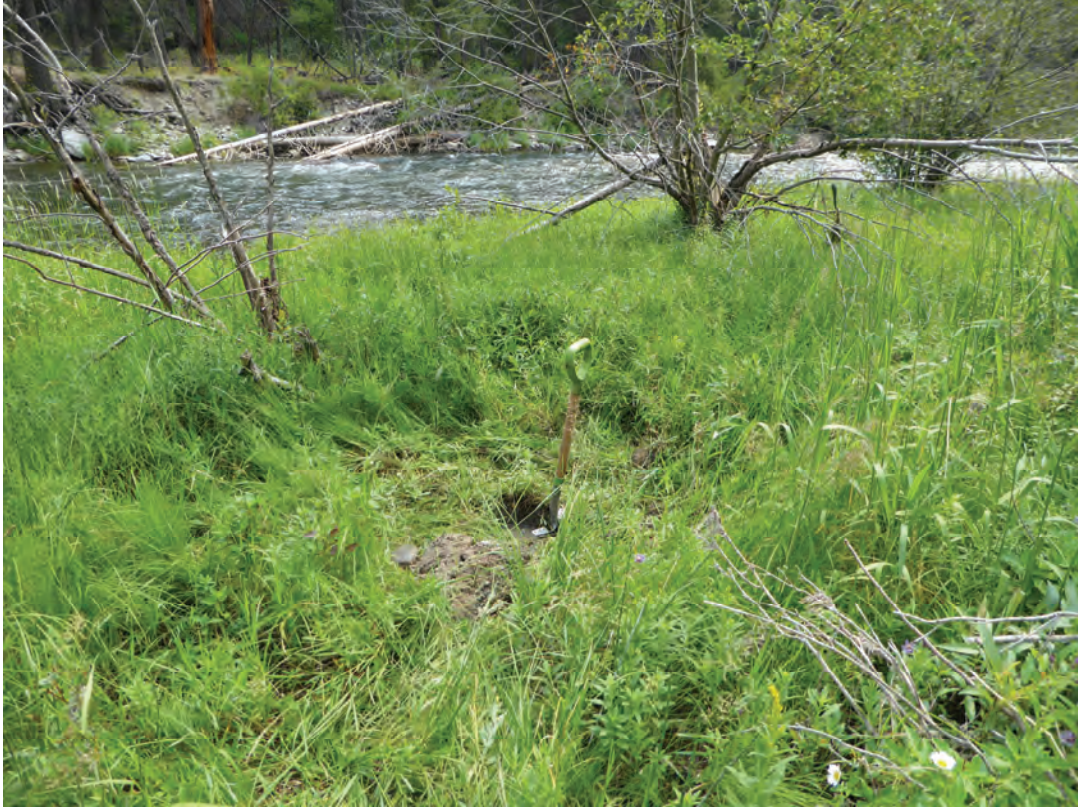
3. Access Road Area – Wetland 3

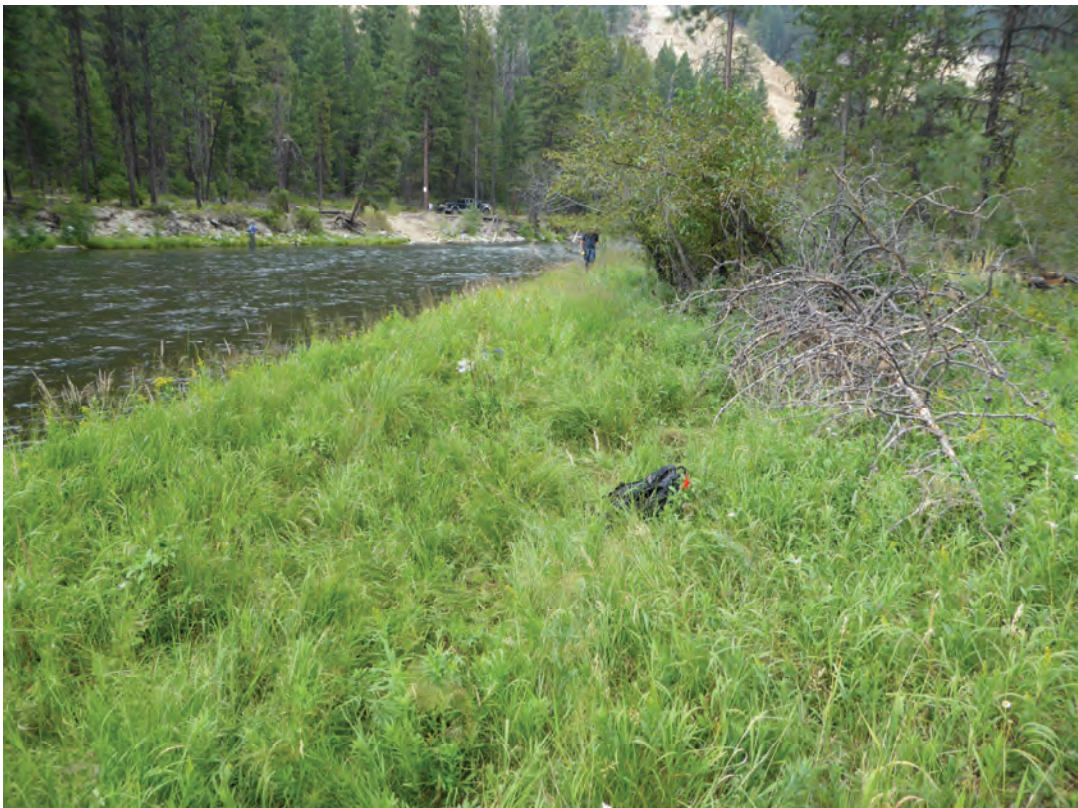
4. Access Road Area – Wetland 5

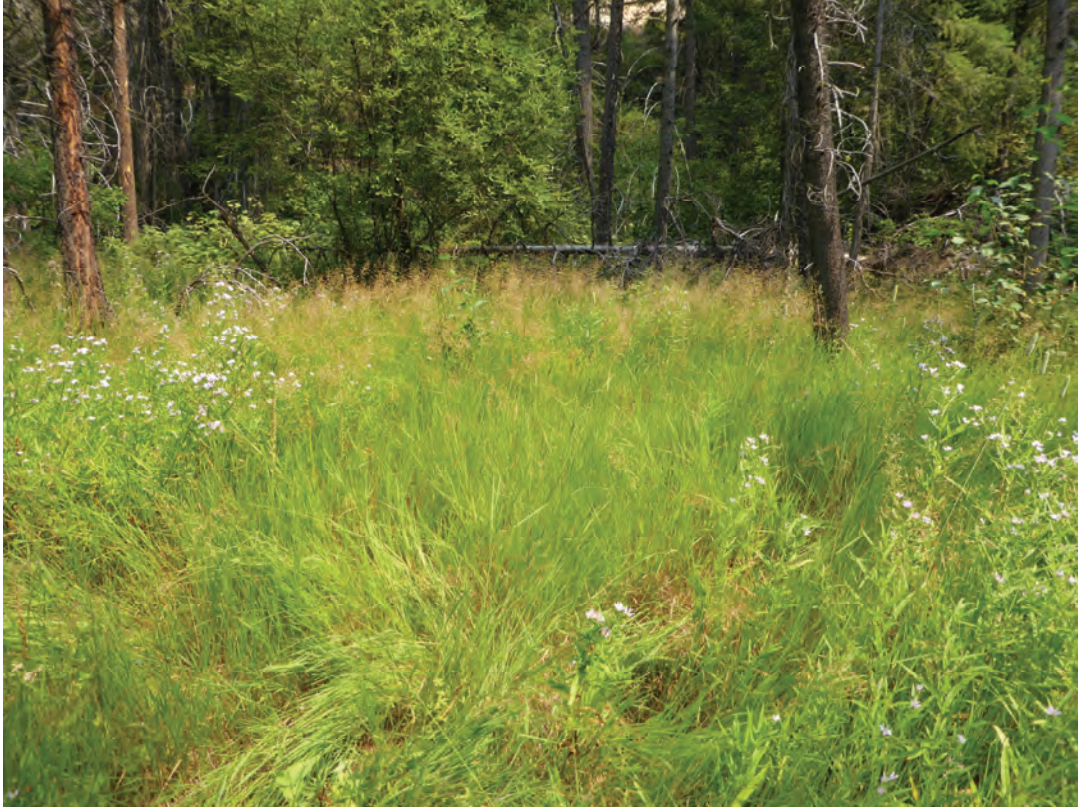
5. Access Road Area – Wetland 4 (east of river)

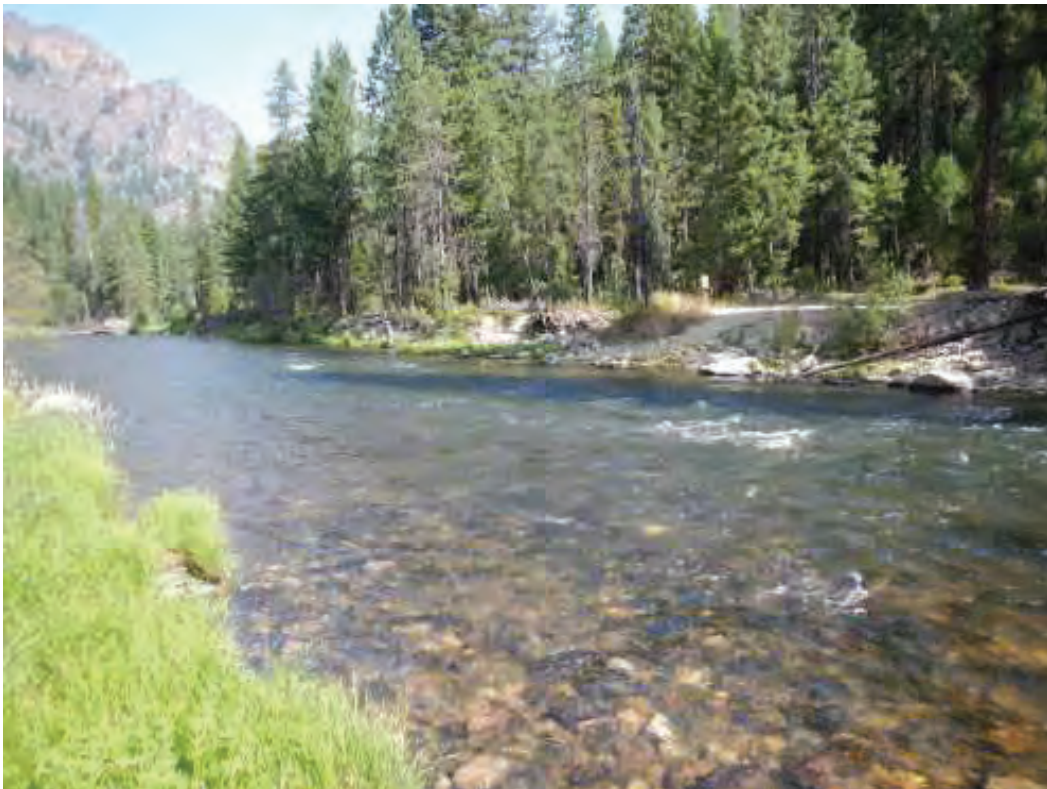
8. West Fork Bitterroot River at approximate location of proposed bridge crossing

Construction of the improved access road and bridge is anticipated to occur in Fall 2021. The bridge would likely consist of a pre-manufactured bridge (i.e. pre-stressed concrete, steel truss, etc.) and would span the width of the river. The surface of the bridge may be asphalt or concrete. The bridge is anticipated to provide a minimum of two foot of freeboard between the water surface for the 100-year recurrence interval flood event and the low cord of the bridge. The bridge abutments will be founded using either a spread footings or piles.
