Montana
Department of
Natural Resources
and Conservation
Forested State
Trust Lands
Habitat
Conservation Plan
5-Year Monitoring
Report

**Reporting
Period**

January 1,
2017-
December 31,
2021

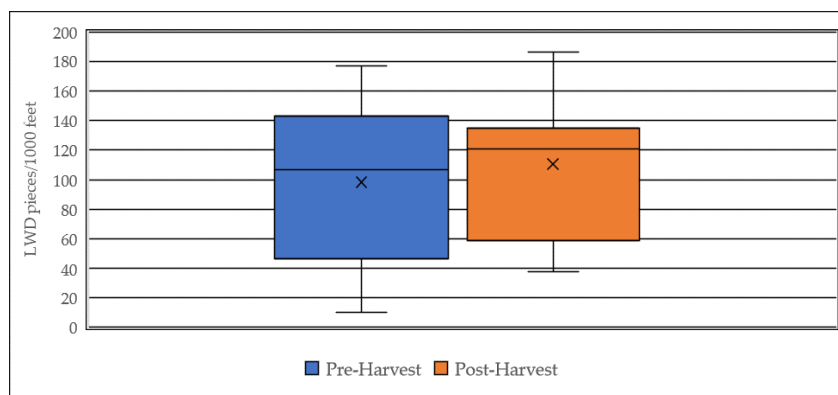
Figure 2. Results of pre-harvest and post-harvest large woody debris counts conducted as a part of riparian management zone timber harvest monitoring sites.

Observed LWD loading rates during the first 10-years of RMZ monitoring indicate that target levels identified in the HCP are generally being met during both pre- and post-harvest time periods. LWD loading increased during the post-harvest period in 10 of 14 monitoring sites, with an average increase of 24.6 pieces per 1,000 feet. In monitoring sites where LWD decreased between pre- and post-harvest time periods, the average decrease was 18.5 pieces per 1,000 feet of stream. Based on the results of the modeling of pre-harvest riparian timber stand condition, there would be an expected increase in LWD at most sites, with an initial increase during the first 10-year period, where the FVS model projects stand mortality rates and removal based on the proposed timber harvest. Subsequent 10-year time steps in the model project a relatively constant mortality rate, and based on the estimated recruitment rate, in combination with estimated rates of decay and loss indicate slow accumulation of LWD over time. In an effort to validate the LWD model, loading rates for completed RMZ monitoring sites will be repeated on a 10-year interval. Results of these repeated LWD measurements will be reported in future HCP monitoring reports.

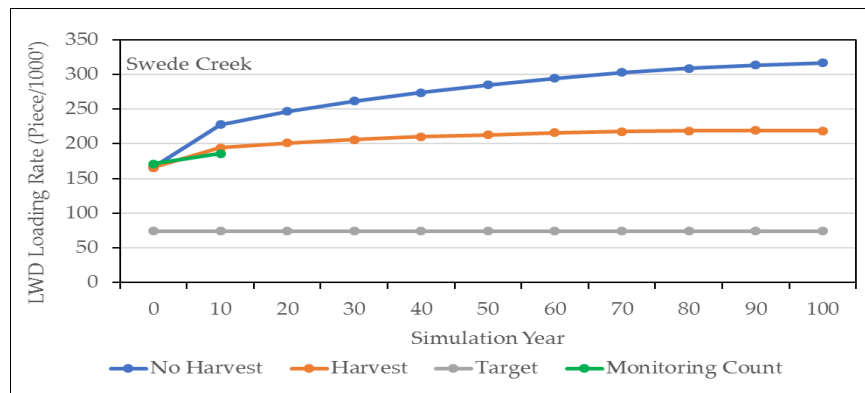
Pre-harvest LWD surveys conducted in 2008 found initial loading rates of 171 pieces per 1000' in the monitoring reach. Post-harvest LWD monitoring was conducted in 2016 and found an increase in LWD to 186 pieces per 1000'. These findings were similar to simulation results which indicated an increase under the harvest scenario to 194 pieces per 100' at year 10 of the simulation. LWD loading rates in Swede Creek were considerably higher than the target established in the HCP for this forest and stream channel type which was 85 pieces per 1000' (Figure 5).

Figure 5. LWD simulation, target loading rates for the forest and stream channel type, and monitoring results from Swede Creek.

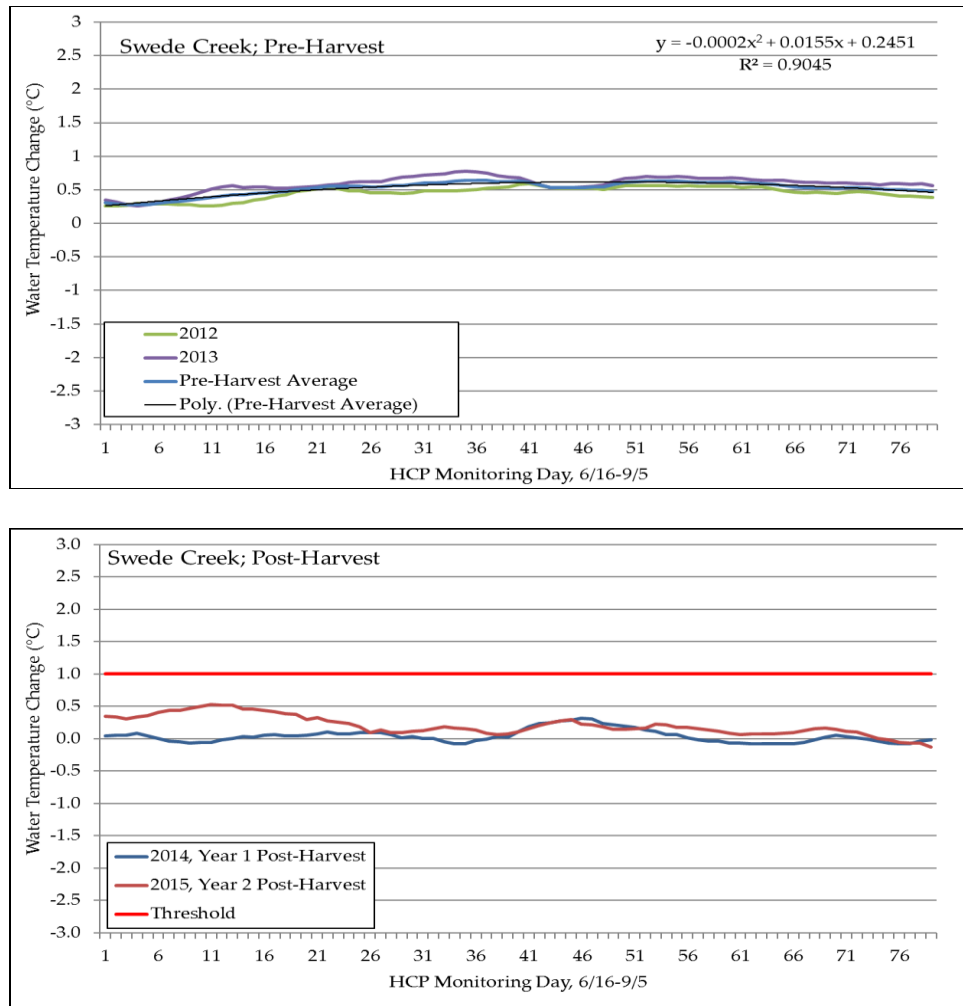
Pre-harvest stream temperature monitoring in Swede Creek occurred in 2012 and 2013, with peak pre-harvest mean weekly maximum temperature of 6.7°C. Average rate of change in the monitoring reach was 0.5°C with a maximum change of 0.6°C (Figure 7). Based on pre-harvest data, a post-harvest threshold of 1.0°C increase over the existing stream temperature was established. Post-harvest monitoring began in 2014 and was completed in 2015. No threshold exceedances were noted in the monitoring site during post-harvest monitoring (Table 2). The maximum temperature change observed during the two-year post-harvest monitoring period was 0.5°C, well below the threshold of 1.0°C (Figure 7).

Figure 7. Pre- and Post-harvest water temperature change collected from the upper RMZ monitoring site on Swede Creek in 2014 and 2015. Red line indicates the chronic temperature threshold established from pre-harvest temperature data.

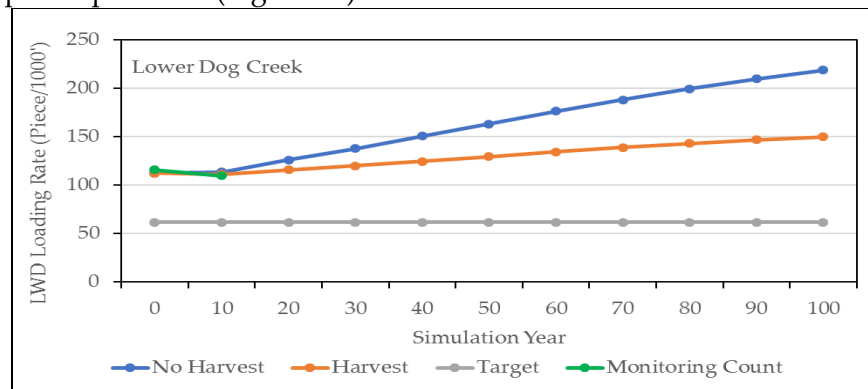
Pre-harvest LWD surveys in Lower Dog Creek conducted in 2013 found initial LWD loading rates of 116 pieces per 1000' in the monitoring reach. Post-harvest LWD monitoring was conducted in 2016 and found a slight decrease in LWD to 110 pieces per 1000'. These findings were similar to simulation results which indicated LWD loading under the harvest scenario of 111 pieces per 1000' at year 10 of the simulation. Projected LWD loading during the 100-year simulation peaked in year-100 at 150 pieces per 1000'. Comparing the unharvested stand simulation with the harvested stand simulation indicate a decrease in LWD loading by 69 pieces per 1000' at the end of the simulation as a result of new stand establishment and decreased tree mortality. Both harvest simulation results and monitoring data collected from Lower Dog Creek were considerably higher than the target established in the HCP for this forest and stream channel type which was 61 pieces per 1000' (Figure 10).

Figure 10. LWD simulation, target loading rates for the forest and stream channel type, and monitoring results from Lower Dog Creek, Stillwater State Forest.

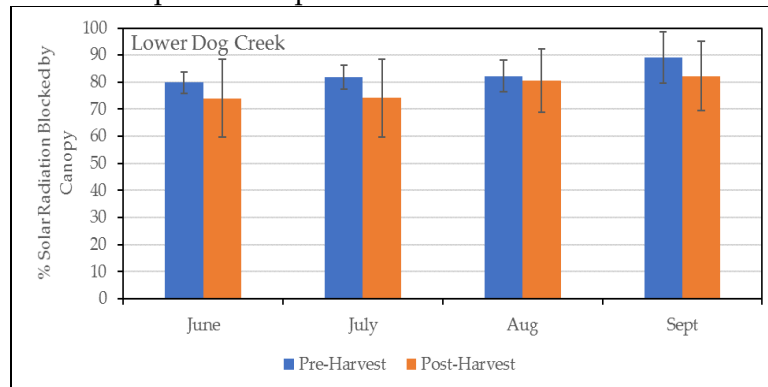
Pre-harvest stream shade measurements were collected from six sites on both upper and lower Dog Creek in 2013. Between June and September, pre-harvest stream shading was 89.1 percent \pm 2.2 and 83.2 percent \pm 3.4 for the upper and lower sites respectively. Post-harvest monitoring stream shading decreased significantly to 82.2 percent \pm 2.2 in the upper site ($P = 0.008$) and decreased to 77.7 percent \pm 6.8 in the lower site, which was not a significant reduction ($P = 0.12$). The reduction in stream shade observed in the upper site was likely a result of reductions observed during June and July, as later season shade measurements were similar. Assessment of monthly differences pre- and post-harvest in the lower site indicate that a reduction in stream

shading occurred during all four months, as well as an increase in variability during post-harvest monitoring (Figures 11 and 12).

Figure 11. Stream shade measurements collected during riparian monitoring zone monitoring under AQ-RM1. Error bars represent 95 percent C.I.

Figure 12. Stream shade measurements collected during riparian monitoring zone monitoring under AQ-RM1. Error bars represent 95 percent C.I.

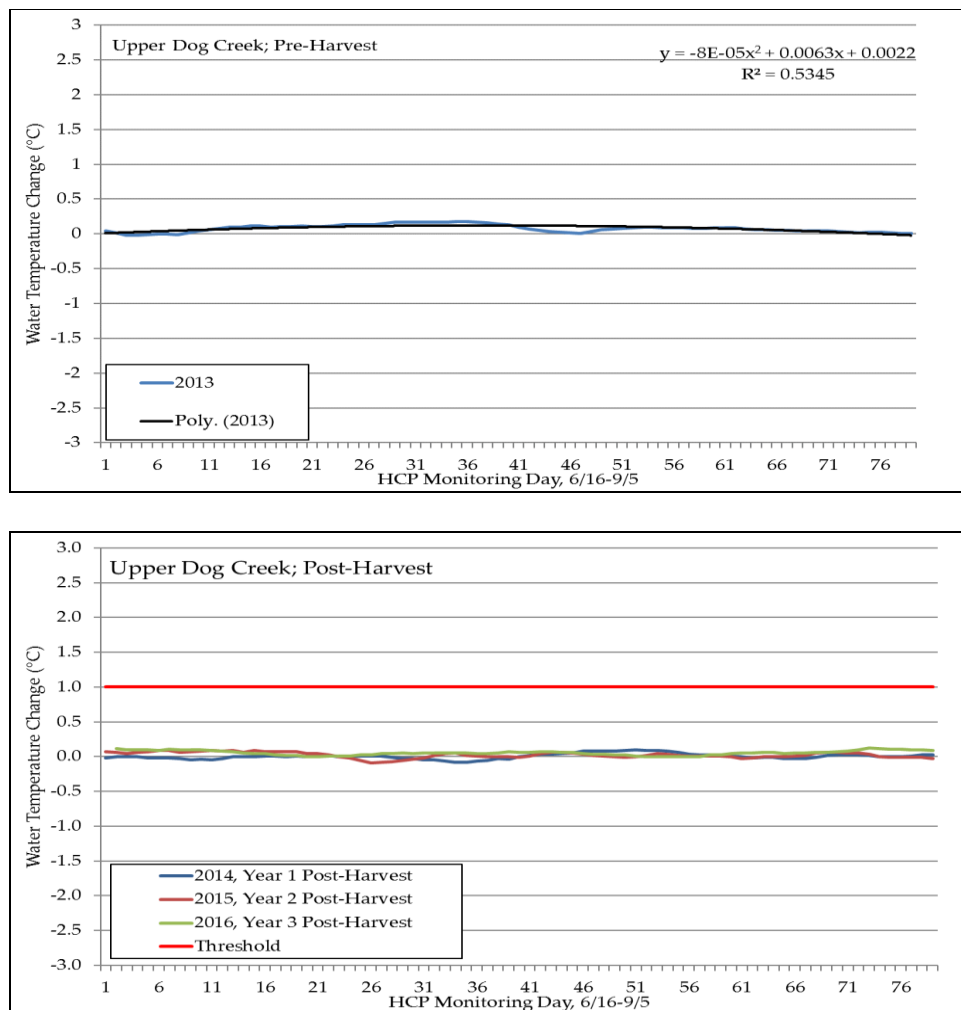
Pre-harvest monitoring was limited to one year of temperature data at both the upper and lower sites. Pre-harvest data established a threshold of 1.0°C increase over the existing 0.2°C maximum temperature change in the upper site (Figure 13). In the lower site, the threshold was also established at a 1.0°C increase over the 0.19°C maximum temperature change observed in 2013 (Figure 14). Pre-harvest temperature change in the upper study site averaged 0.08°C, the maximum observed temperature change was 0.2°C. Pre-harvest average temperature change in the lower monitoring site was also 0.08°C, with a maximum temperature change of 0.2°C. Post-harvest monitoring began in 2014 and were completed in 2016. No threshold exceedances were noted in either the upper or lower site during post-harvest monitoring (Table 2). The average post-harvest temperature change was 0.1°C in the study reach, a 0.04°C increase over pre-harvest conditions. The maximum temperature change observed during the three-year post-harvest monitoring period was 0.2°C, well below the threshold of 1.2°C (Figure 13). No chronic or acute threshold exceedances were noted in the lower monitoring site during post-harvest monitoring (Table 2). The average post-harvest temperature change was 0.06°C, a slight decrease over pre-harvest conditions. The maximum temperature change observed during the three-year post-harvest monitoring period was 0.2°C which was also well below the established threshold of 1.0°C (Figure 14).

Figure 13. Pre- and Post-harvest water temperature change collected from the upper RMZ monitoring site on Dog Creek from 2014–2016. Red line indicates the temperature change threshold established from pre-harvest temperature data.

suggest that timber harvest levels on both upper and lower Dog Creek did not impact fisheries habitat through increased stream temperature. While significant reductions in stream shade were noted at the upper site on Dog Creek, no coincidental increases in stream temperature were observed. The observed thermal regime indicated a stable stream system largely dominated by cold groundwater input. Water temperature in both the upper and lower sites rarely exceeded 15.0°C (<1.0 percent total observations). No future shade or stream temperature monitoring is anticipated associated with this RMZ harvest site.

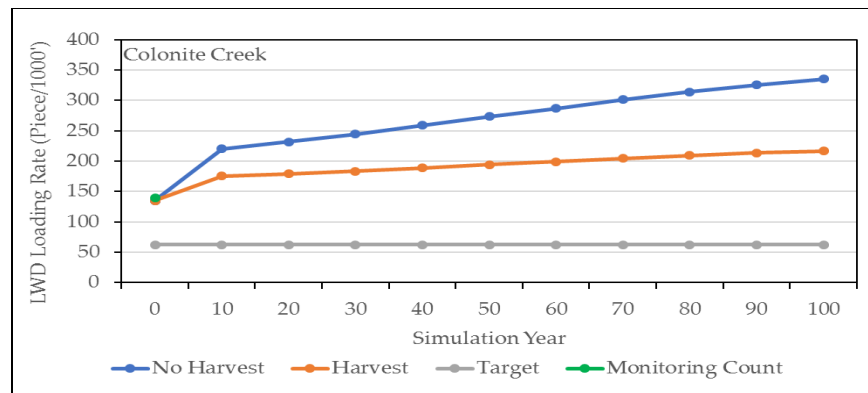
Figure 21. LWD simulation, target loading rates for the forest and stream channel type, and monitoring results from Colonite Creek, Northwest Land Office.

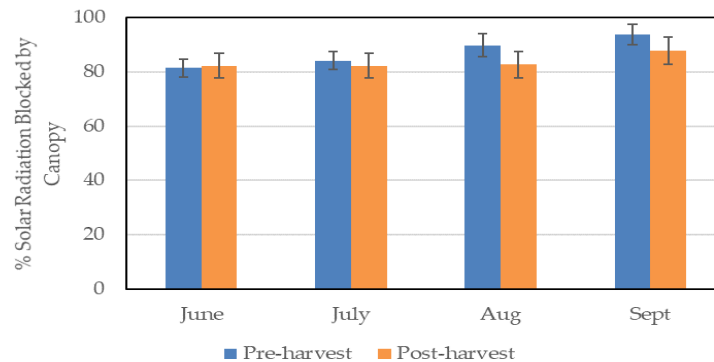
Figure 22. Stream shade measurements collected pre- and post-harvest in Colonite Creek, Libby Unit, Northwest Land Office.

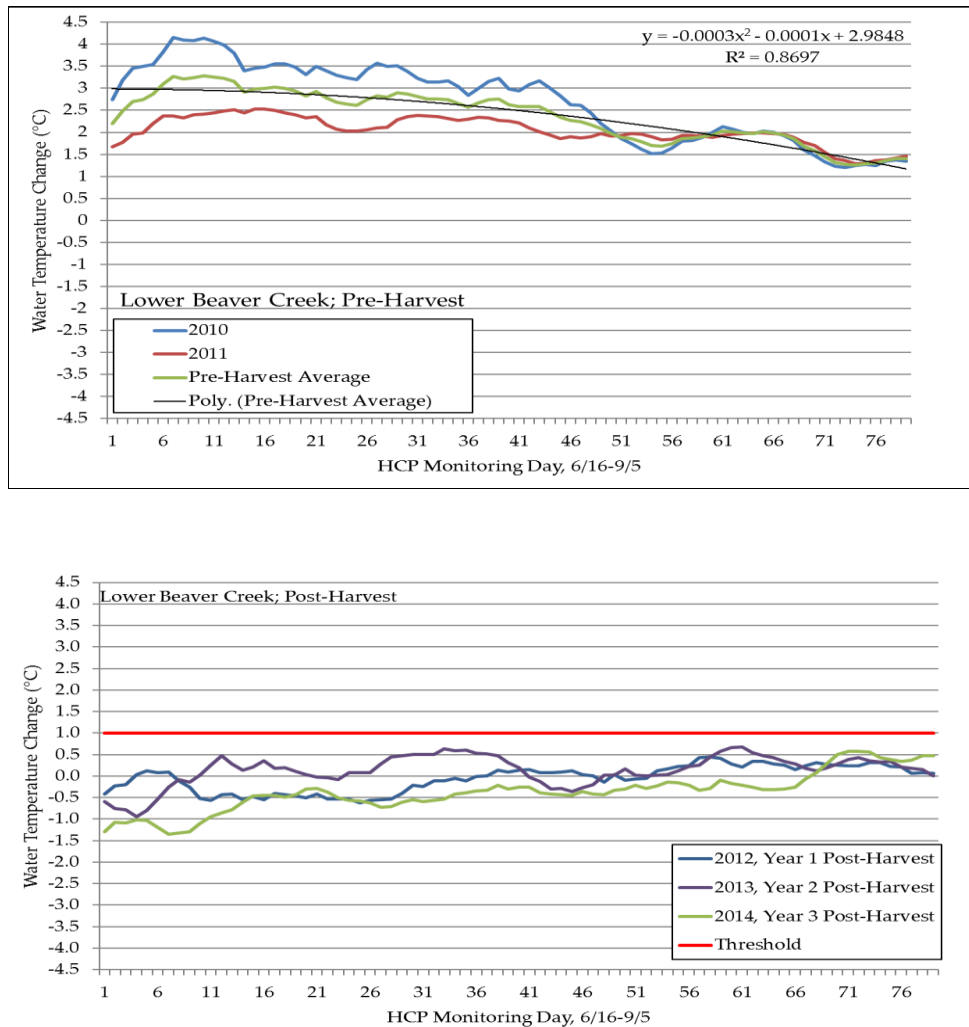
Figure 35. Pre- and Post-harvest water temperature change collected from the RMZ monitoring site on lower Beaver Creek from 2009–2012 Red line indicates the temperature change threshold established from pre-harvest temperature data.
