ST. MARY DIVERSION and CONVEYANCE FACILITIES

Failure and O&M Reference Guide

January 2010 (Final)

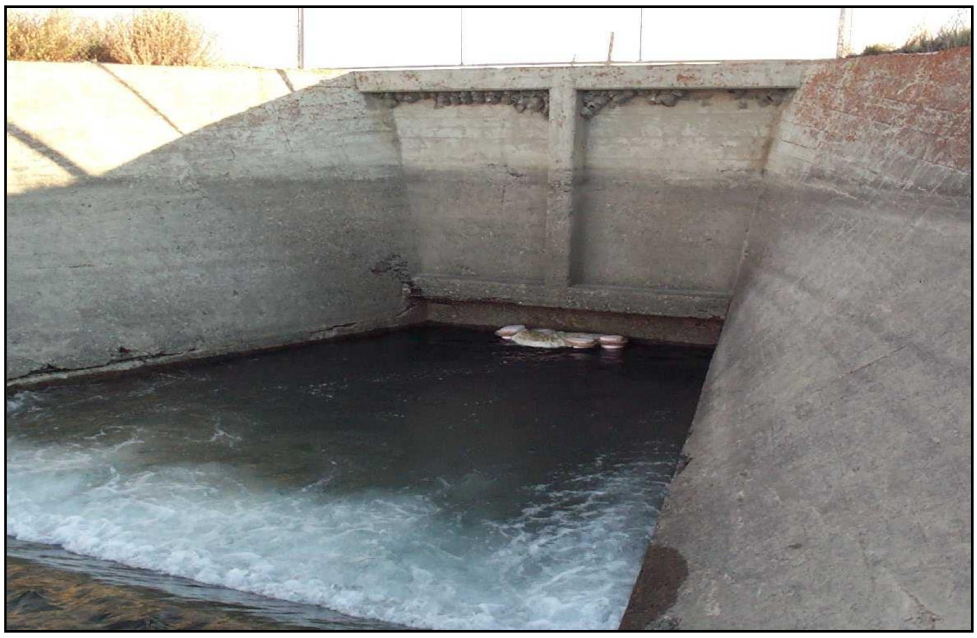
Photo 10. Inlet section (south side) of Kennedy Creek siphon during off-season (10/13/04).

The top of the siphon barrel is exposed in the channel of Kennedy Creek, which has caused minor scouring in the stream channel on its downstream side.

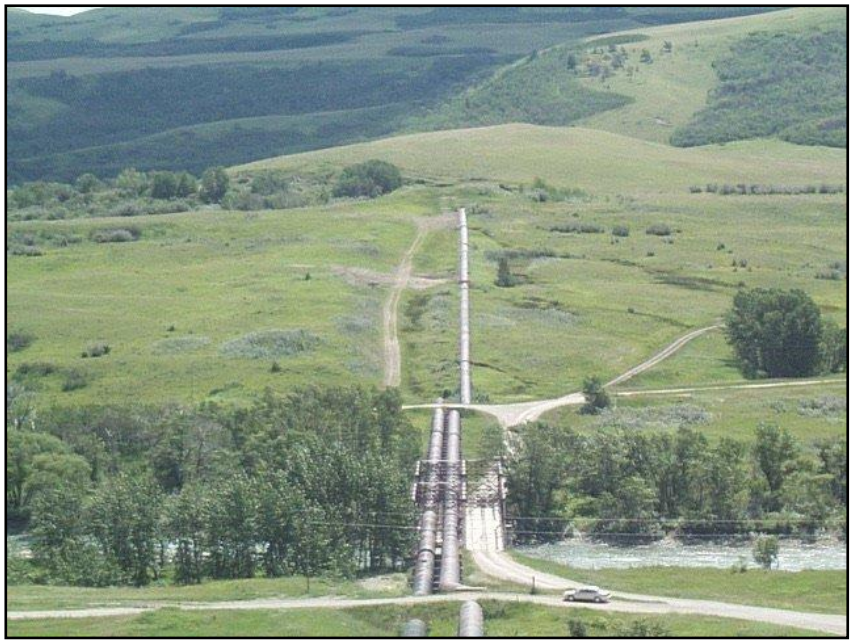
Photo 17. Looking downstream (southeast) along the St. Mary River Siphon crossing (07/04/05).

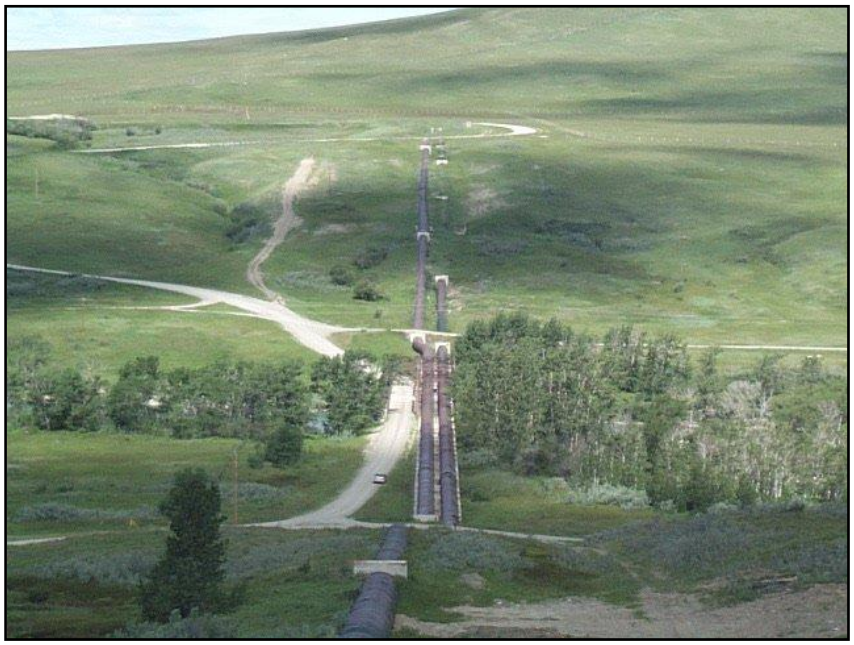
Photo 18. Looking upstream (northeast) along the St. Mary River Siphon crossing (07/04/05).

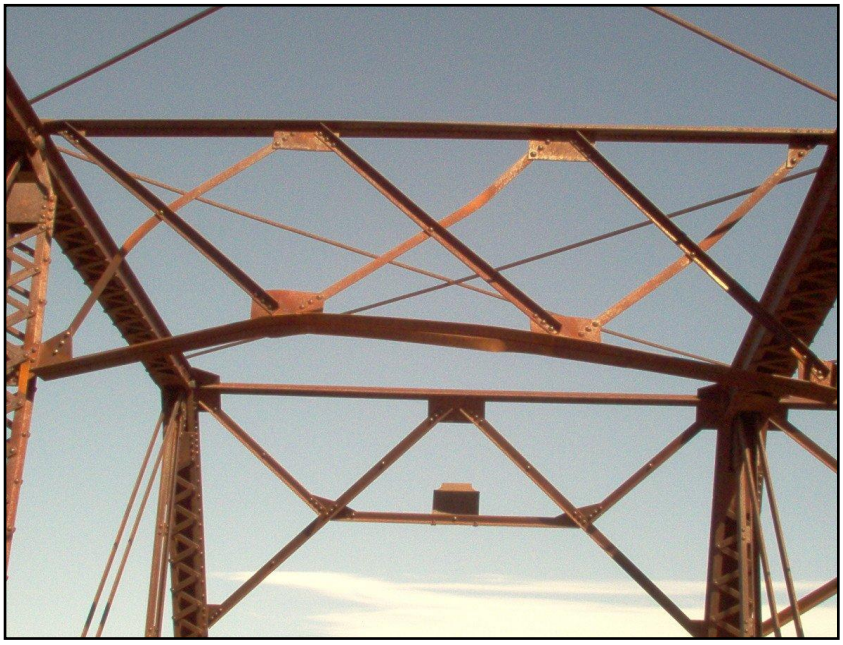
The bridge has experienced recent damage to the vertical trusses and top cords of the steel portal bracing from oversized equipment crossing the bridge (Photos 28 and 29). The posted 10-ton load limit was exceeded regularly, even when the siphon was full. The bridge is constructed of low tensile and yield strength, mild steel. The truss superstructure has a fractured critical member. The substructure exhibits deteriorating and spalling concrete, especially at the fixed bearing points. Expansion rollers are reportedly frozen and nonfunctional.

Photo 28. Damage to top chord (5/10/07).
