ST. MARY DIVERSION FACILITIES GEOTECHNICAL STUDIES FOR THE ST. MARY RIVER SIPHON CROSSING

JUNE 2012

Montana DNRC
Water Resources Division

**GEOTECHNICAL REPORT
ST. MARY RIVER SIPHON CROSSING
ST. MARY DIVERSION AND CONVEYANCE FACILITIES**

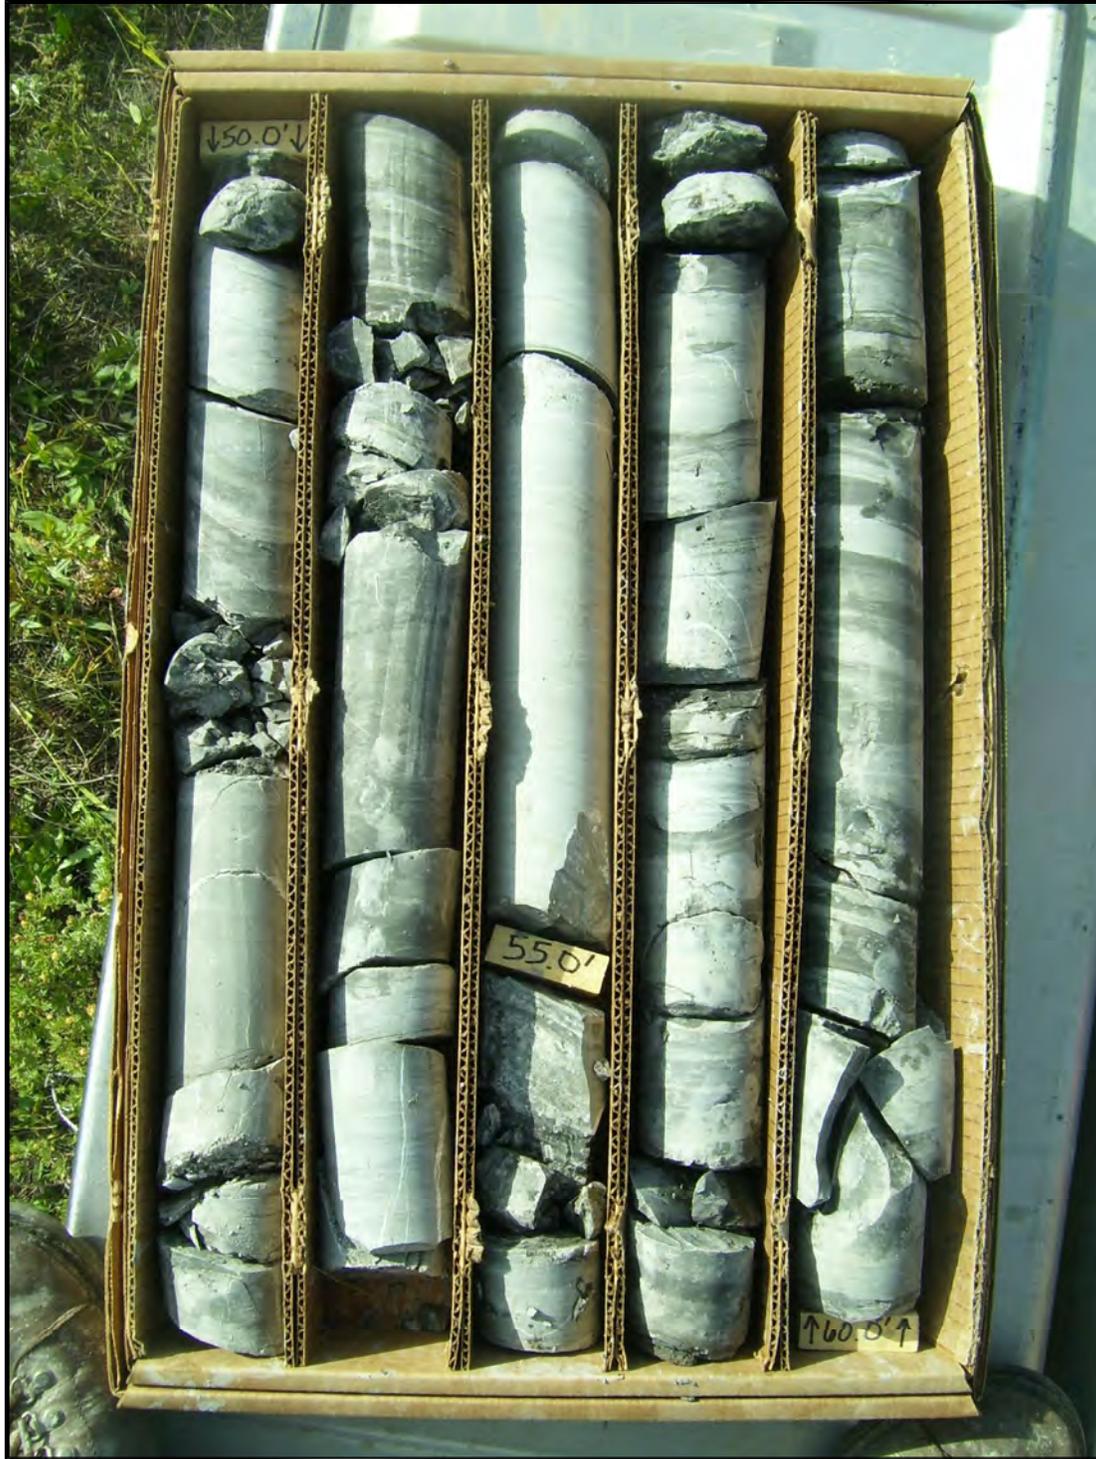
FIGURE B10

BORING 09PA-9, ELEVATION 4396.5 FT, ROCK CORE RUNS 2 & 3
 CORE RUN 2: DEPTH=50.0' TO 55.0', RQD=0.55, RECOVERY=100%
 CORE RUN 3: DEPTH=55.0' TO 60.0', RQD=0.37, RECOVERY=94%

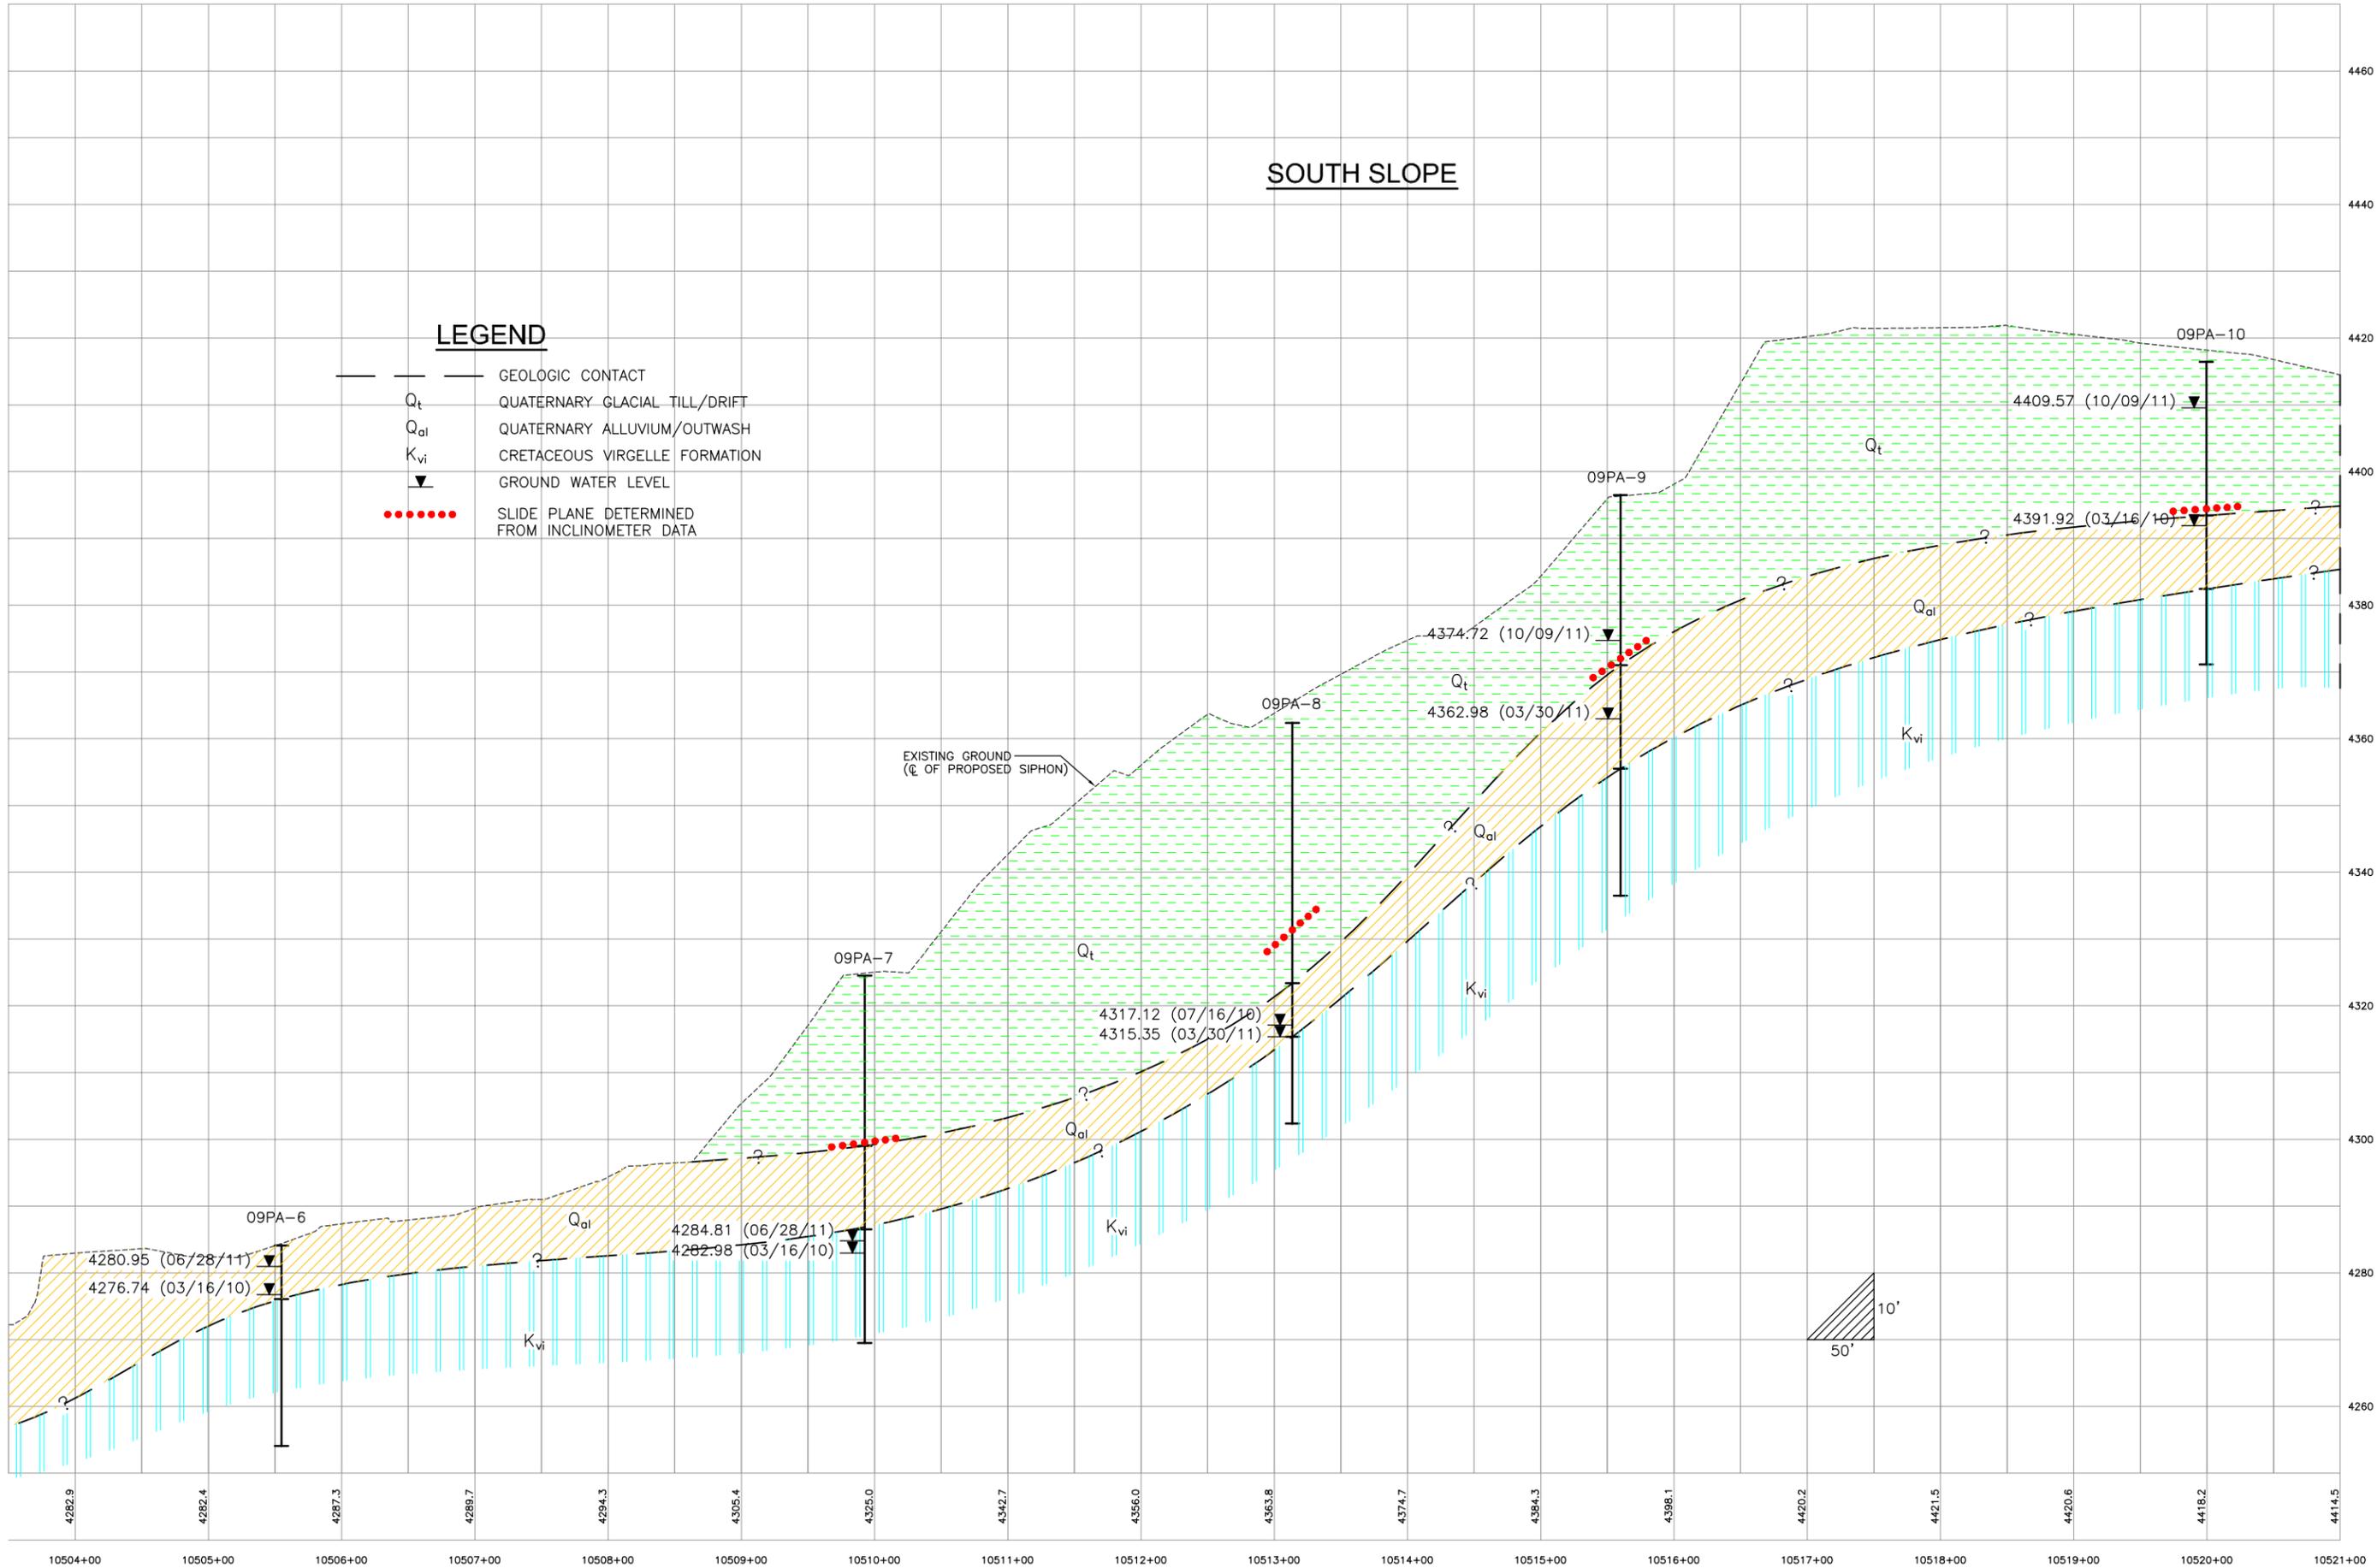
FIGURE B33

DNRC - CARDD
ST. MARY CANAL REHABILITATION
ST. MARY DIVERSION FACILITIES GEOTECHNICAL STUDIES
FOR THE ST. MARY RIVER PROPOSED SIPHON CROSSING
GEOLOGIC CROSS SECTION - SOUTH SLOPE

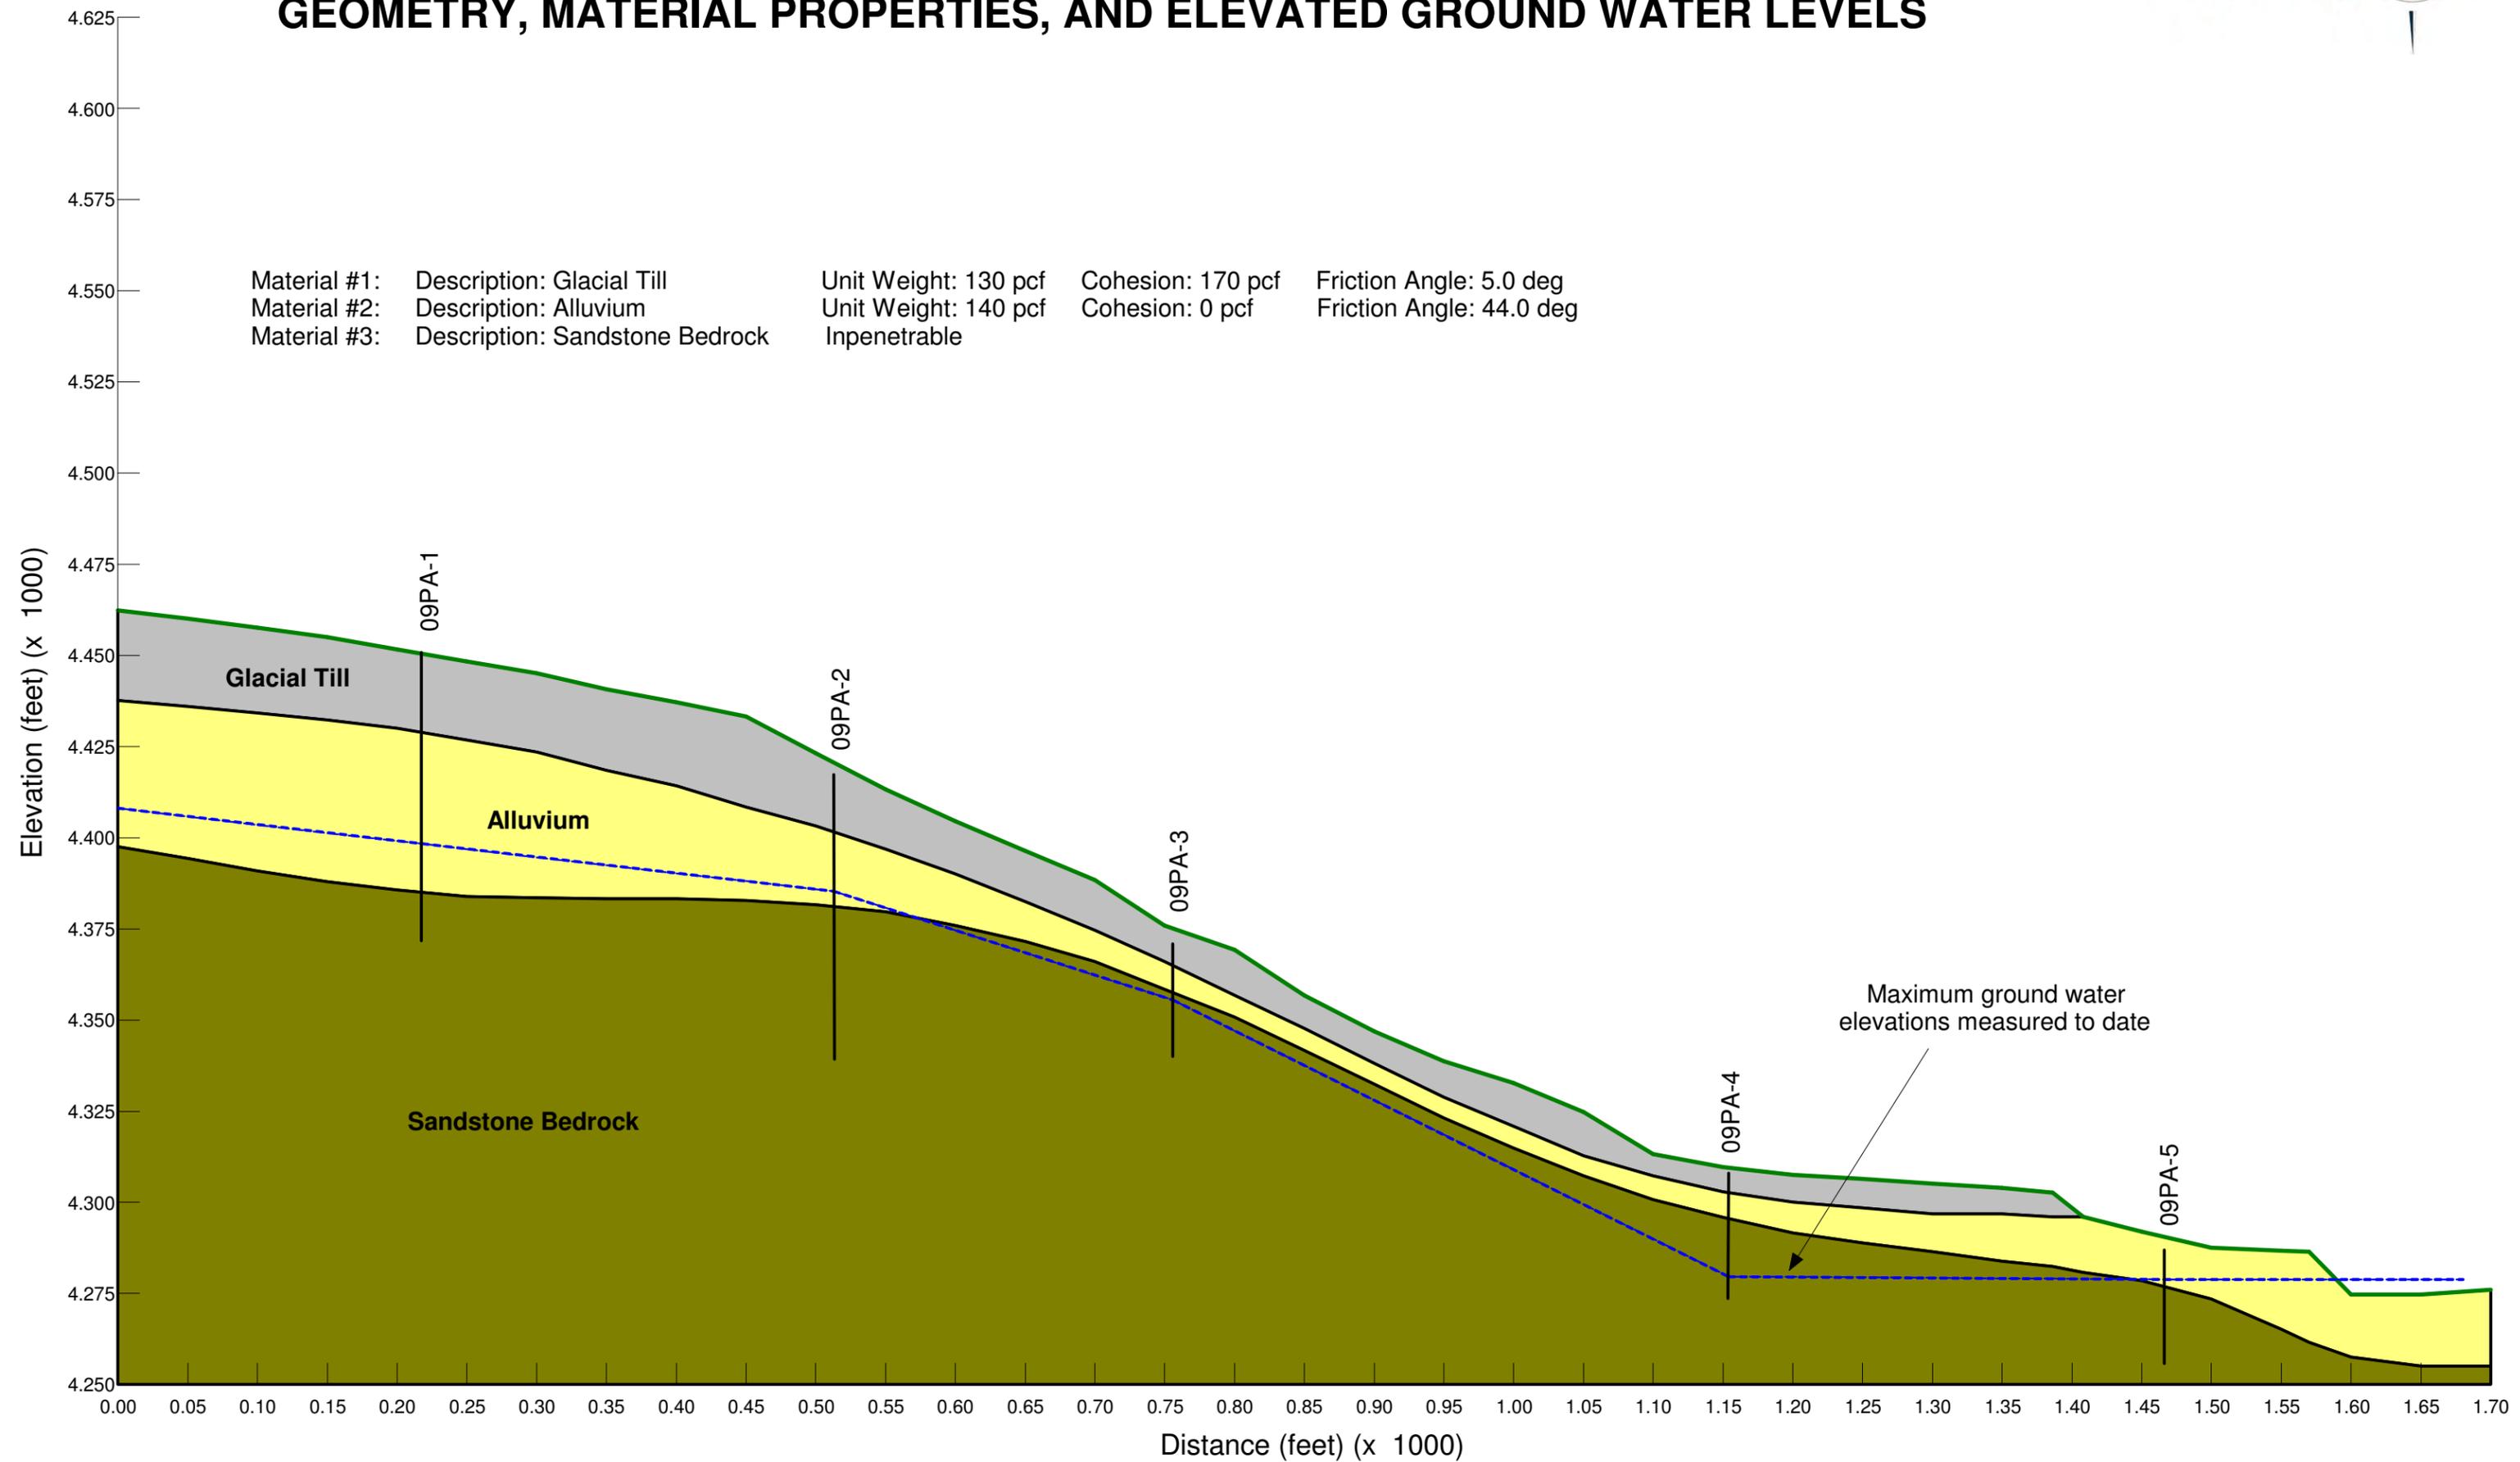
FIGURE B39 PROPOSED ST. MARY RIVER SIPHON CROSSING - NORTH SLOPE GEOMETRY, MATERIAL PROPERTIES, AND ELEVATED GROUND WATER LEVELS

Material #1:	Description: Glacial Till	Unit Weight: 130 pcf	Cohesion: 170 pcf	Friction Angle: 5.0 deg
Material #2:	Description: Alluvium	Unit Weight: 140 pcf	Cohesion: 0 pcf	Friction Angle: 44.0 deg
Material #3:	Description: Sandstone Bedrock	Inpenetrable

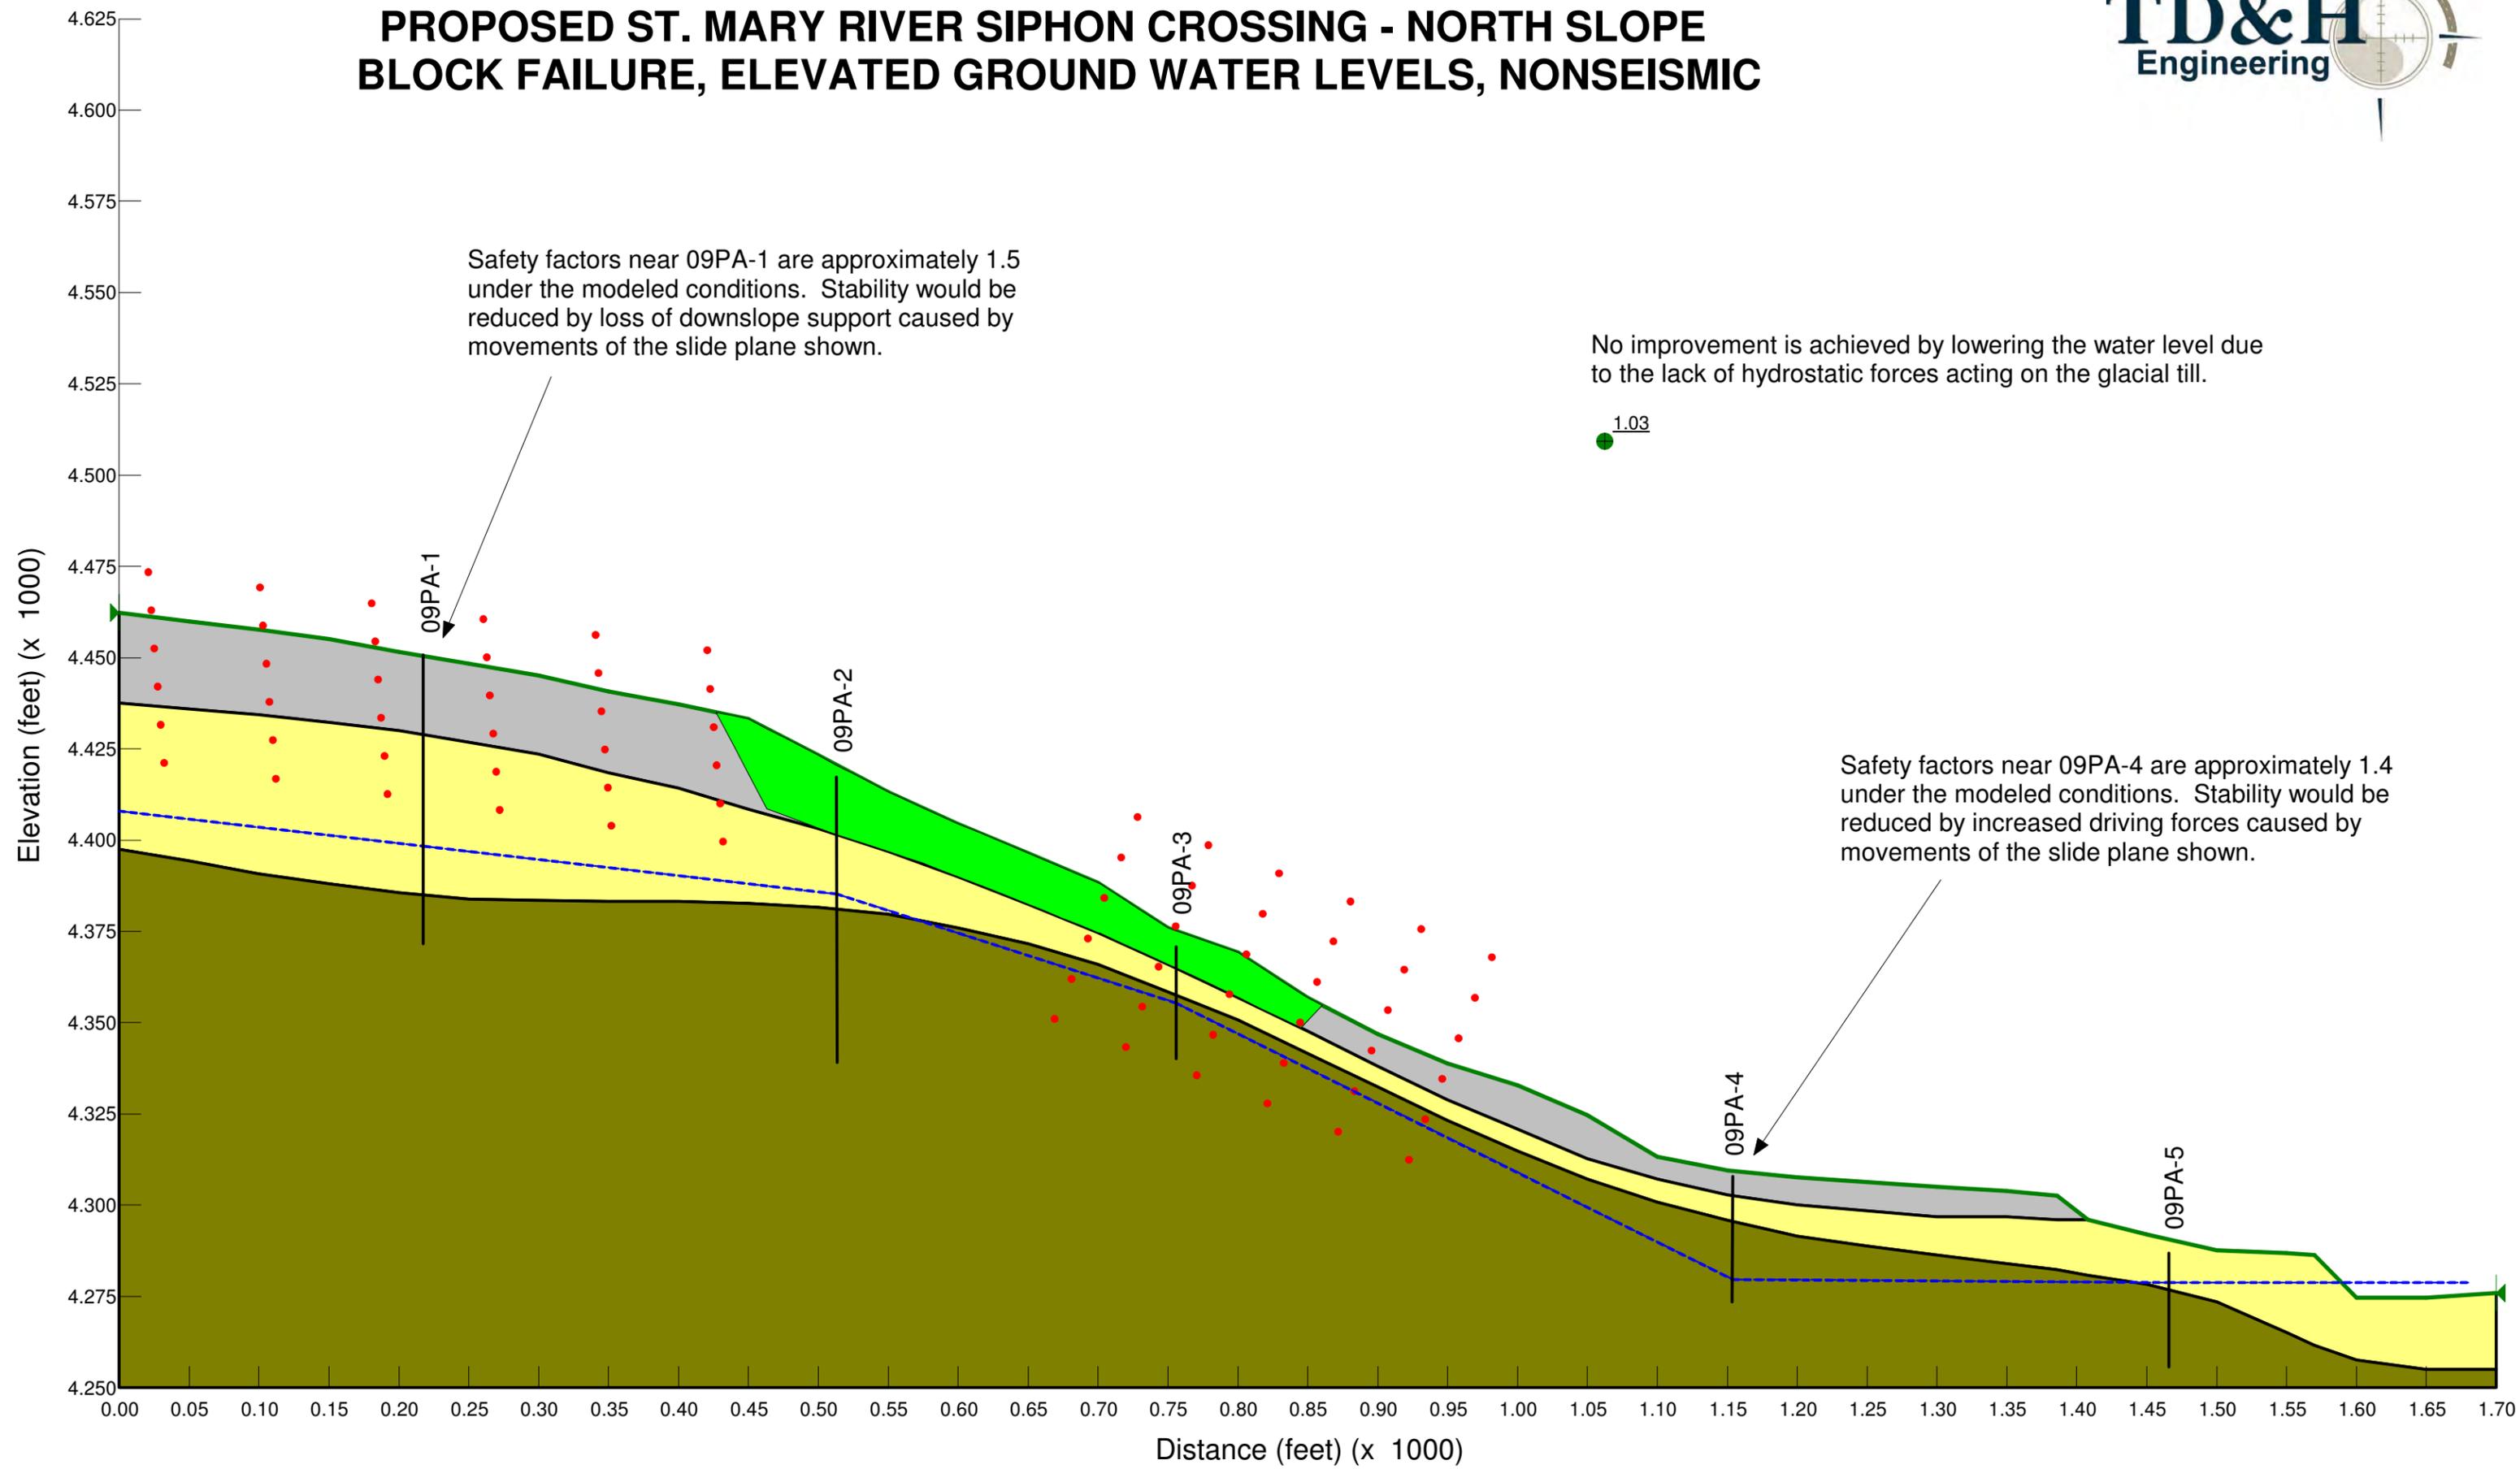
FIGURE B40 PROPOSED ST. MARY RIVER SIPHON CROSSING - NORTH SLOPE BLOCK FAILURE, ELEVATED GROUND WATER LEVELS, NONSEISMIC

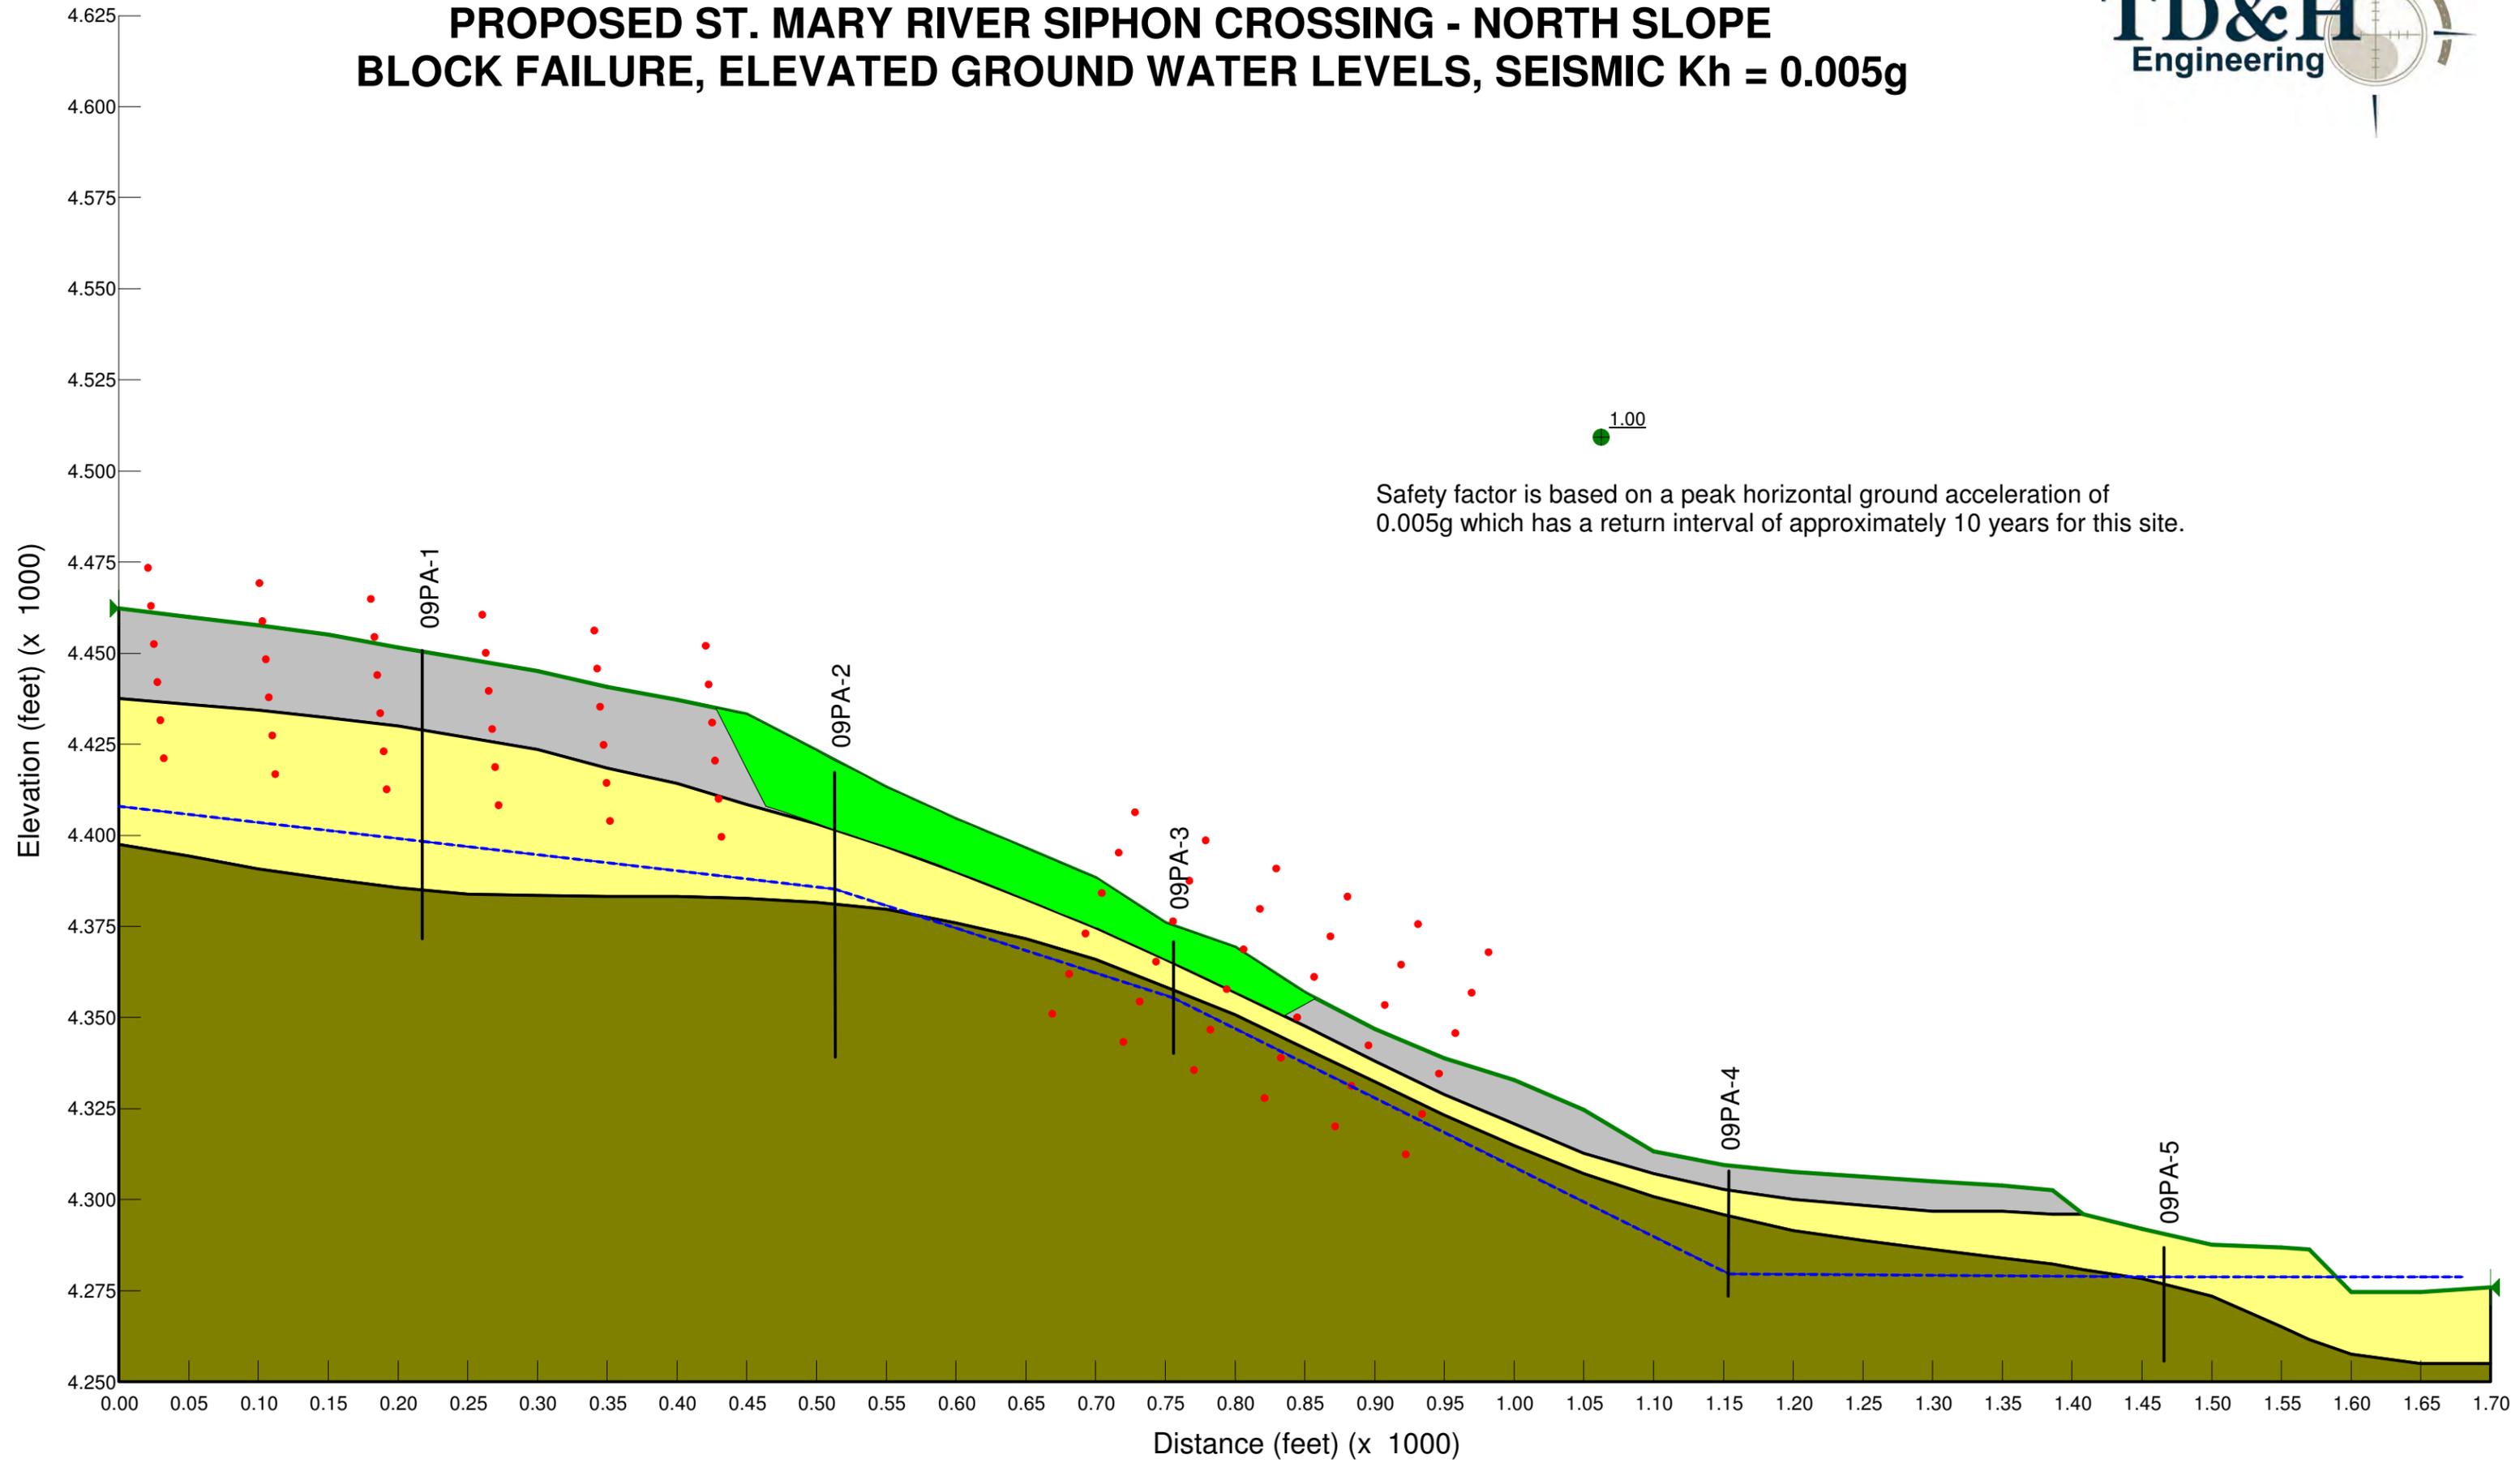
FIGURE B41

PROPOSED ST. MARY RIVER SIPHON CROSSING - NORTH SLOPE

BLOCK FAILURE, ELEVATED GROUND WATER LEVELS, SEISMIC Kh = 0.005g

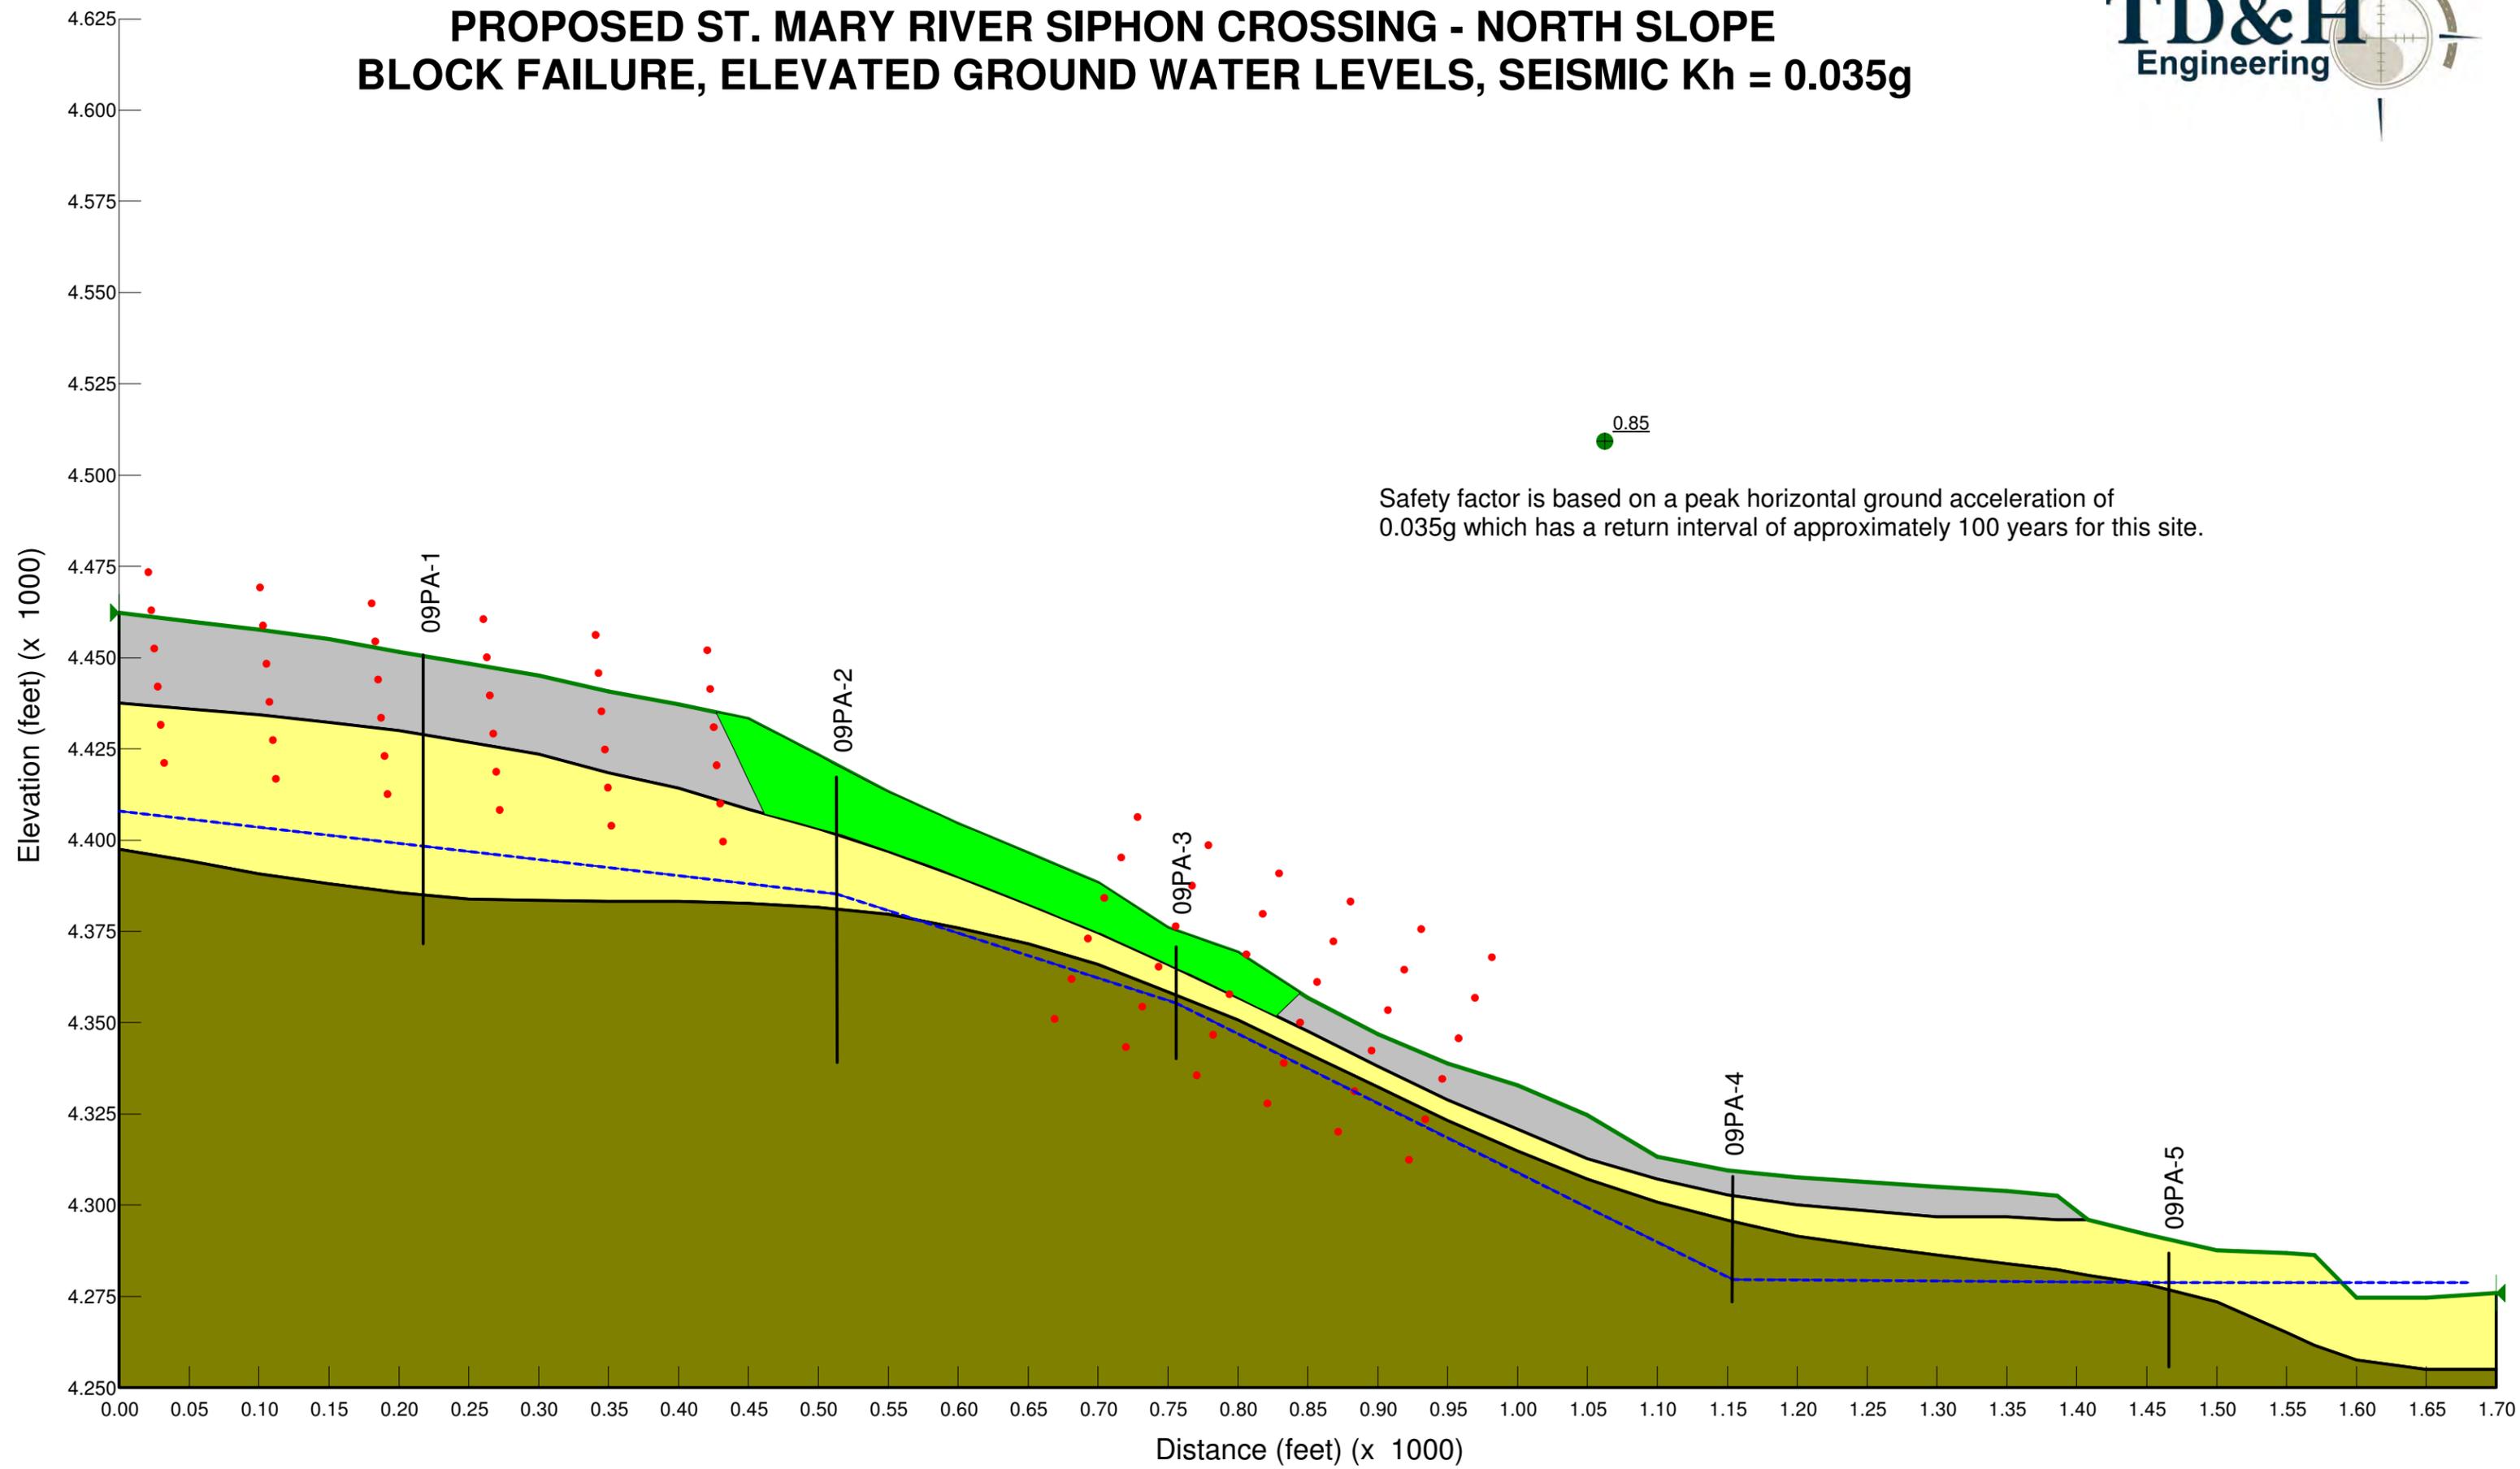
FIGURE B42

PROPOSED ST. MARY RIVER SIPHON CROSSING - NORTH SLOPE

BLOCK FAILURE, ELEVATED GROUND WATER LEVELS, SEISMIC Kh = 0.035g
