ST. MARY DIVERSION FACILITIES DATA REVIEW, PRELIMINARY COST ESTIMATE AND PROPOSED REHABILITATION PLAN

February 11, 2005

Montana DNRC
Conservation & Resource
Development Division

Thomas, Dean & Hoskins, Inc.

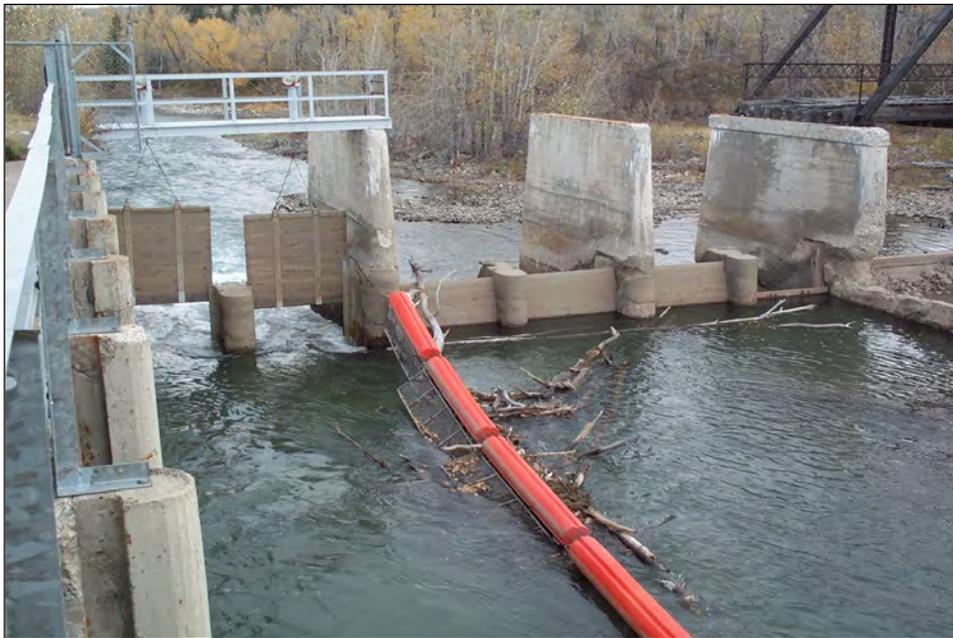
Figure 4.1.2 Looking downstream (north) at three sluiceways on the west side of diversion dam. Canal headgates are left of photo. Note two manually operated lift gates used to regulate flow and permit passage of off-season flow (10/06/04).

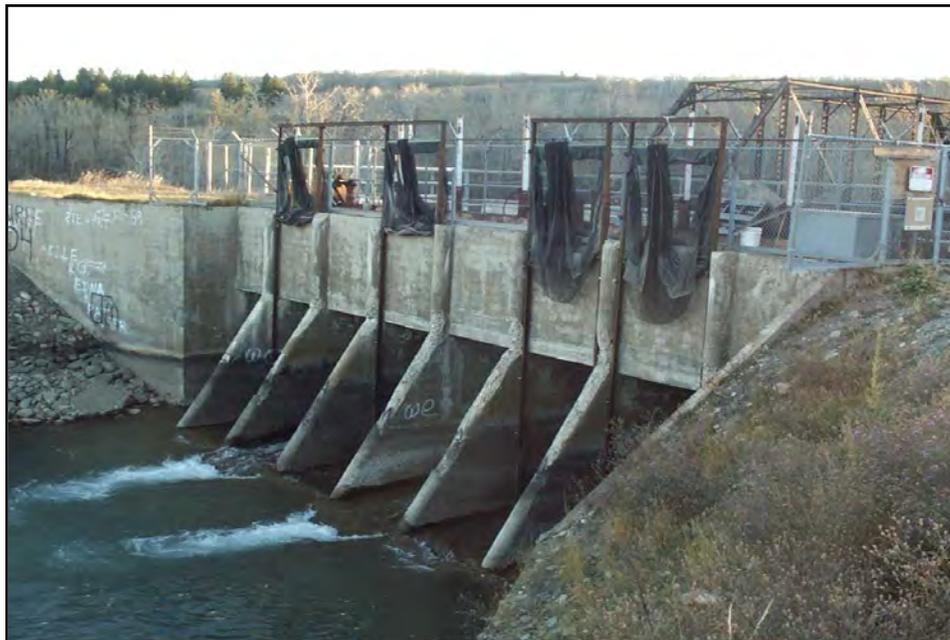
Figure 4.2.1 Looking at downstream end (canal side) of headgate structure. Diversion dam is located behind headgates (10/13/04).

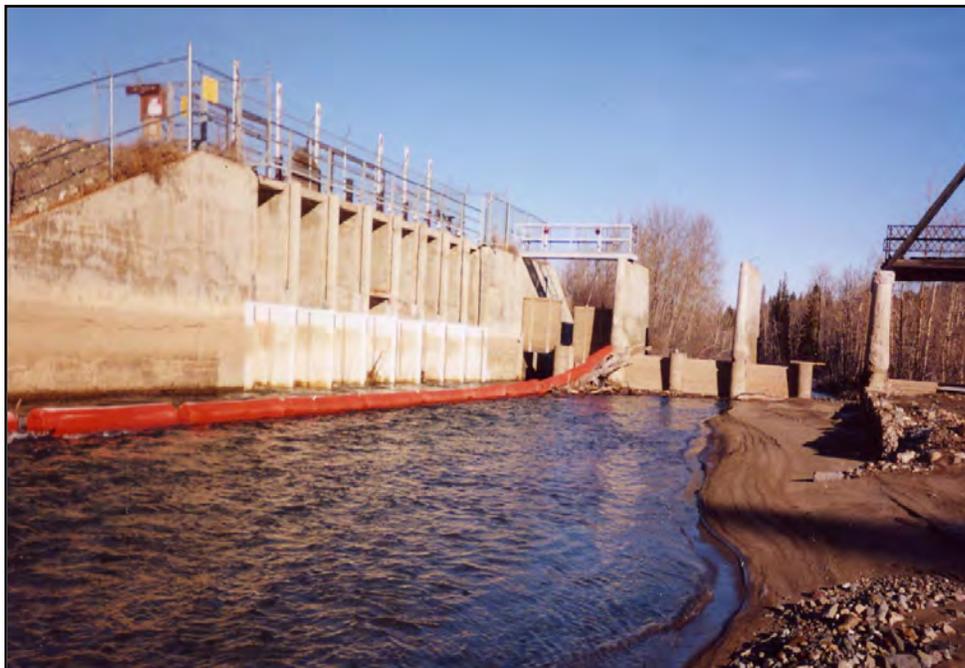
Figure 4.2.2 Upstream view of headgates showing trash boom, electric fish barrier, and dam sluiceways (11/11/04).

Debris is a problem for gate operation and for the electric fish barrier. A floating boom was installed upstream of the electric fish barrier and gates to divert debris; however, debris still impacts gate operations (Figure 4.2.3).

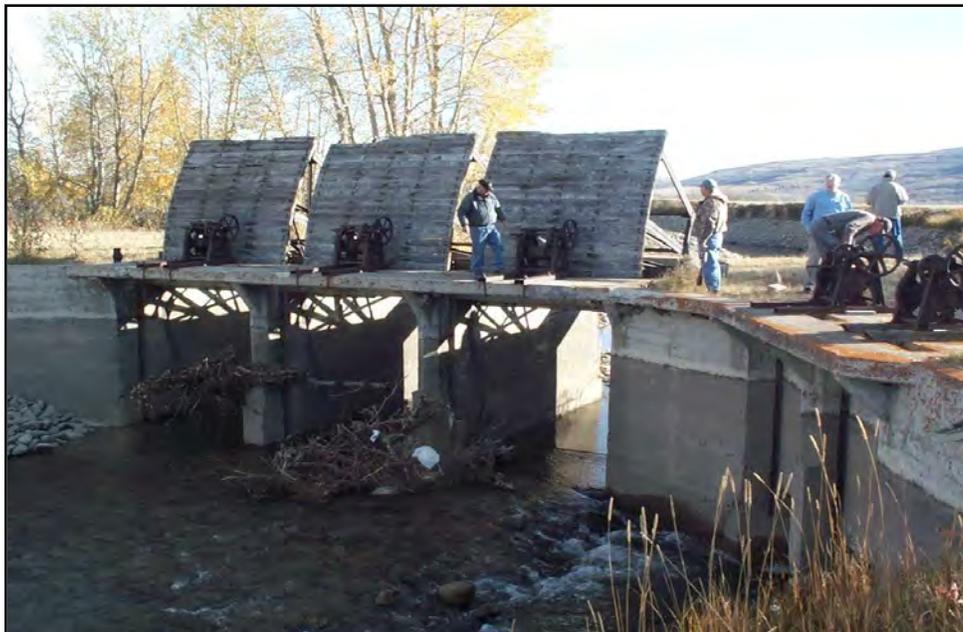
Figure 4.4.1 Upstream view of Kennedy Creek check structure. Wasteway is located at right side of photo (10/13/04).

The check portion of the structure is approximately 29 feet wide and 11.5 feet high with three radial gates. Each of the gates is 9 feet wide and 10 feet high. The gates are wood-faced and do not appear to have been operated in a long time. The gates are secured in the open position with chains to lock them open. This may be a safety measure to prevent unauthorized operation or accidental closure if the operating cables failed. The check structure slab is about 20 feet long and has hand laid rip rap extending upstream and downstream from the structure.

The BOR recommends replacing these structures with a new system slightly upstream of its present location. The recommendation is for a new check with three radial gates 10 ft. x 10 ft.

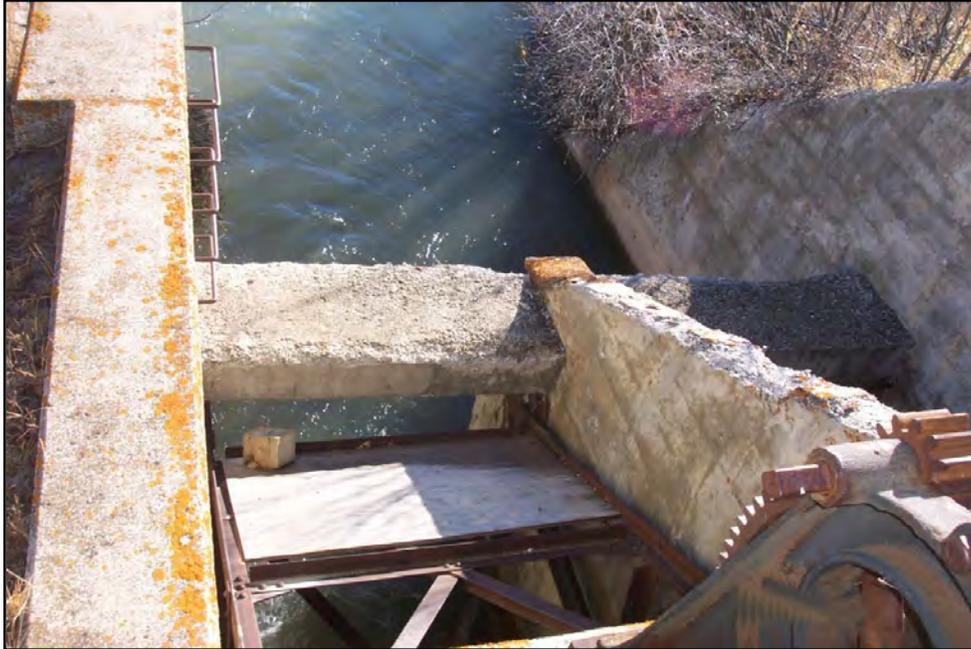
The concrete on the wasteway portion of the structure is in a much more deteriorated condition. There is significant spalling and reinforcing steel exposed in each of the raceways above the low water line. The downstream walls and center wall are also in poor condition. The top slab is extremely deteriorated and can no longer support the reaction thrust produced by the gate operators. Steel beams have been placed beneath the operator for the only operable gate to support the gate reaction load (Figure 4.4.2).

Figure 4.4.4 Downstream view of wasteway (11/11/04).

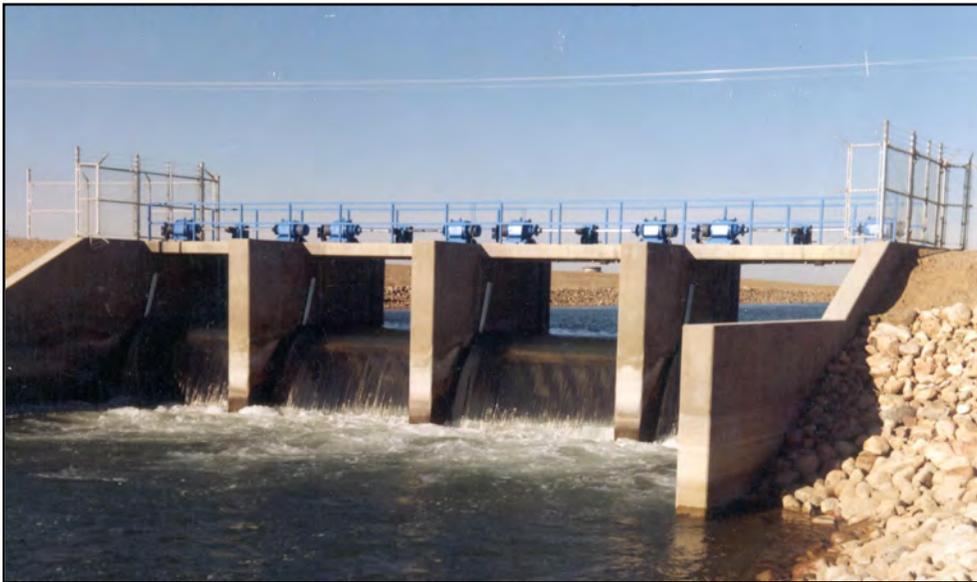
Figure 4.4.5 Typical check structure equipped with overshoot style gates.

each and a wasteway with two sluice gates 6 ft. x 6 ft. each. In our opinion, use of overshoot gates in the check and wasteway structures warrants further consideration. This type of gate system has been used successfully in Canada on similar canals. An example of an overshoot gate check structure is shown in Figure 4.4.5. The main disadvantage of a radial gate, especially in a check structure, is that they fail in a closed position. The BOR does not include automation in their alternatives or cost estimates but do indicate that the new structures should be designed to allow for automation in the future.

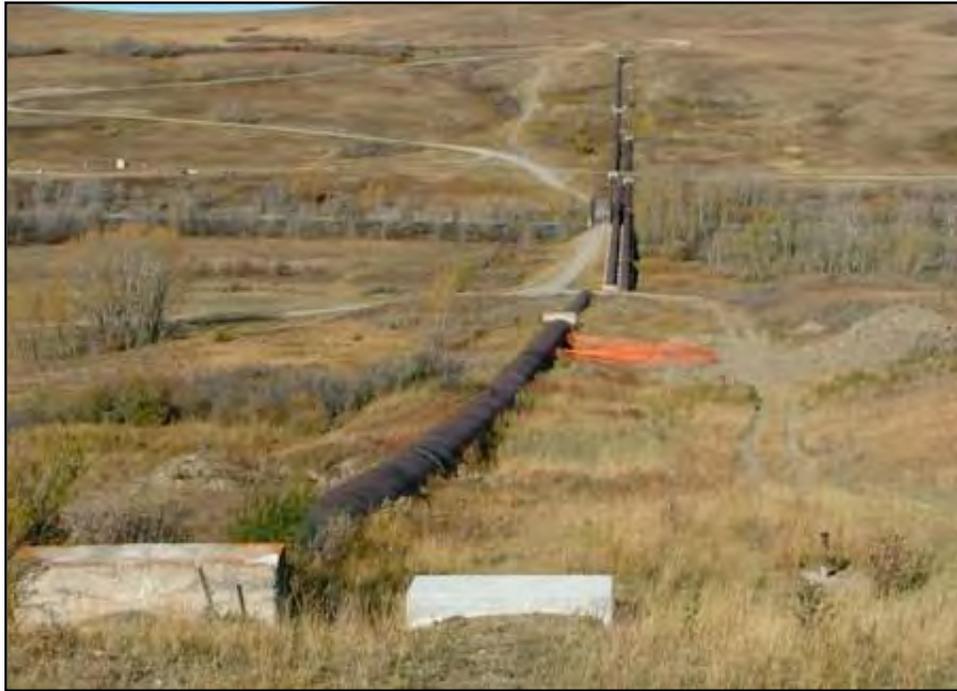
Figure 4.5.1 St. Mary River Siphon, looking upstream (northwest) across St. Mary River (10/13/04).

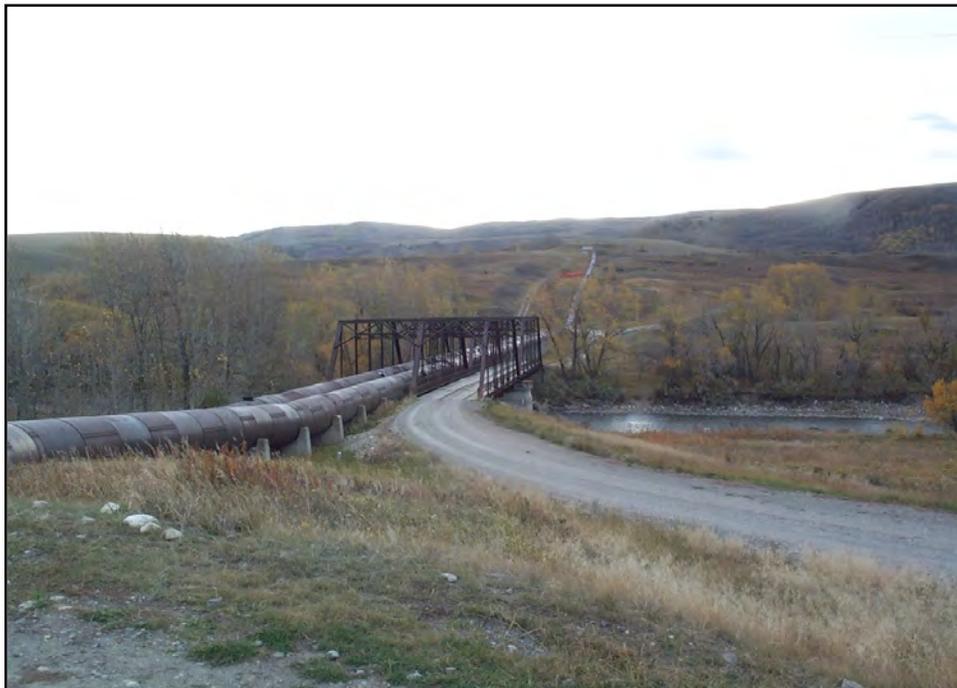
Figure 4.5.2 View of the St. Mary River Bridge carrying the siphon (06/04/04).

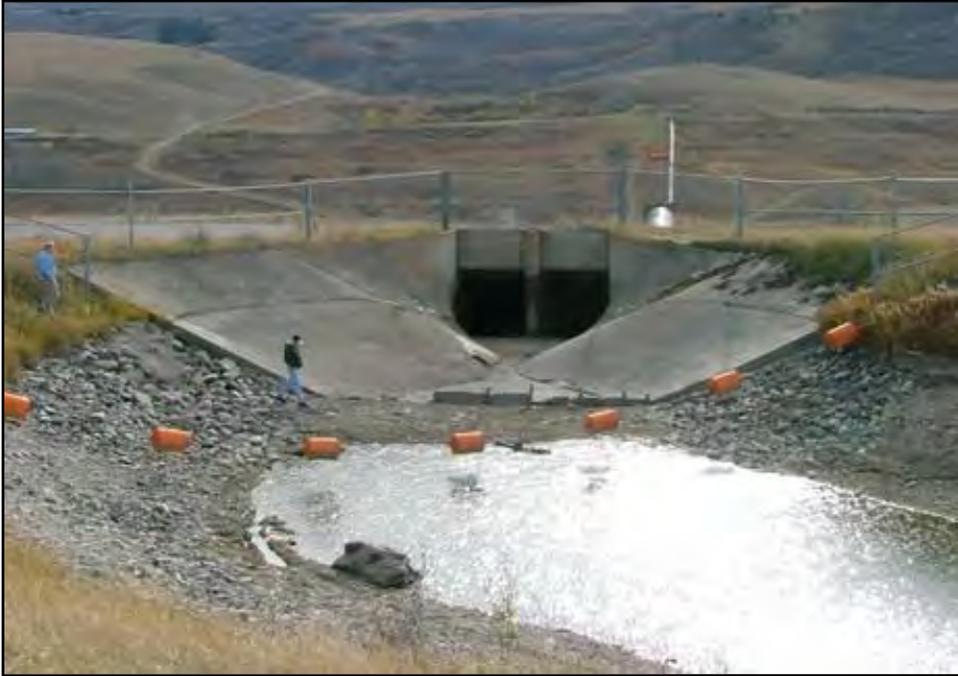
Figure 4.5.3 St. Mary River Siphon Inlet Structure (10/13/04).

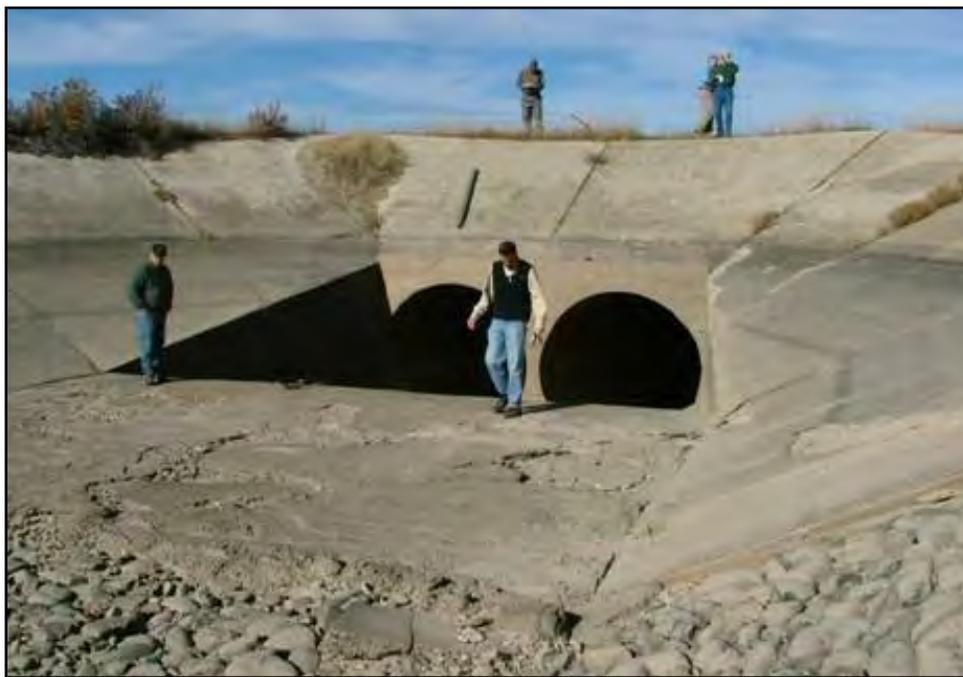
Figure 4.5.4 St. Mary River Siphon Outlet Structure (10/13/04).

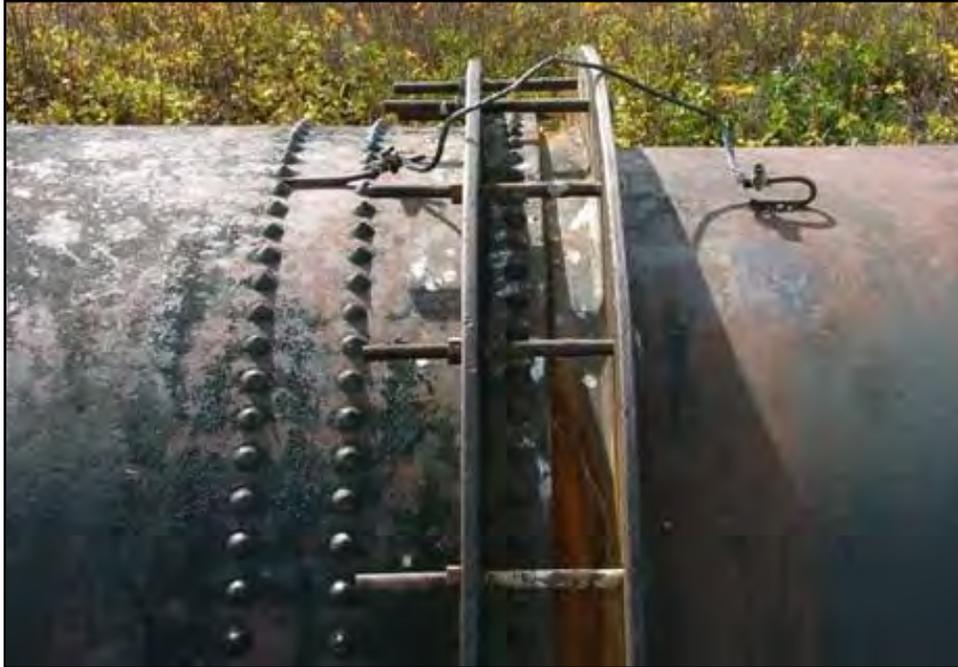
Figure 4.5.5 St. Mary River Siphon - Typical Expansion/Contraction Joint, Including Cathodic Protection Continuity Cable (10/26/04).

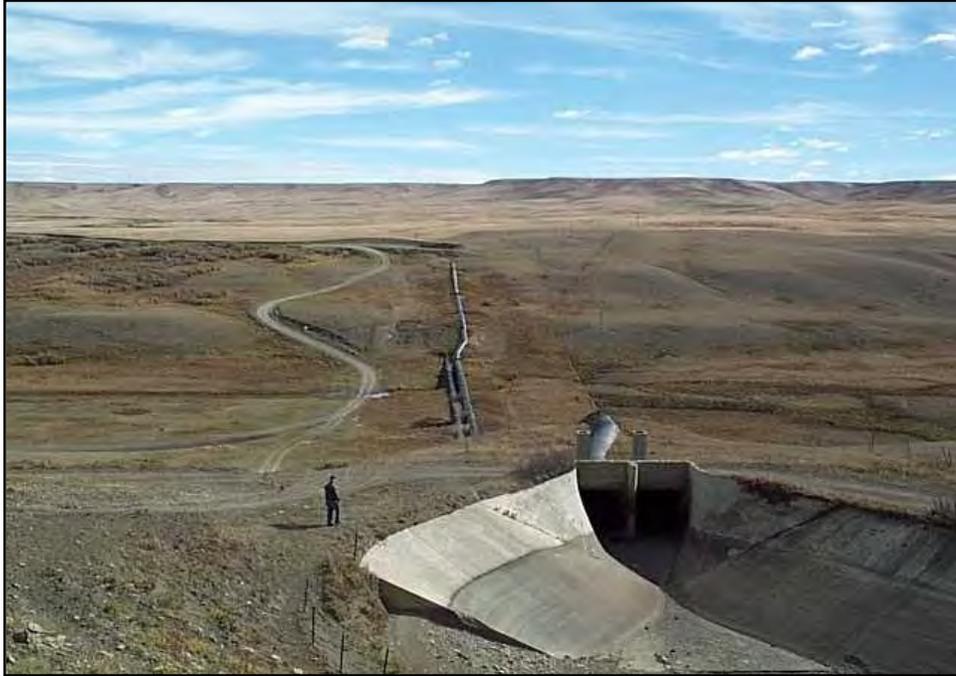
Similar to that of the St. Mary River Siphon, Halls Coulee Siphon (Figure 4.5.9) was constructed in two phases: 1912 to 1915 and 1925 to 1926. These siphons, approximately 1405 feet each, are also rivet steel conduits, have a 78-inch diameter and a combined design capacity of 850 cfs. The original wall thickness of the pipes was 1/4-inch. The first pipe was buried except along the bottom of the coulee. Due to problems associated with the St. Mary River Siphon, the second pipe at Halls Coulee was constructed above ground and supported on similar concrete saddles (Figure 4.5.10). The siphons at Halls Coulee are relatively stable compared to the St. Mary River Siphon but have experienced some minor problems with sliding, leakage and closure of expansion/contraction joints.

Figure 4.5.9 Looking downstream (southeast) along Halls Coulee Siphon (10/13/04).

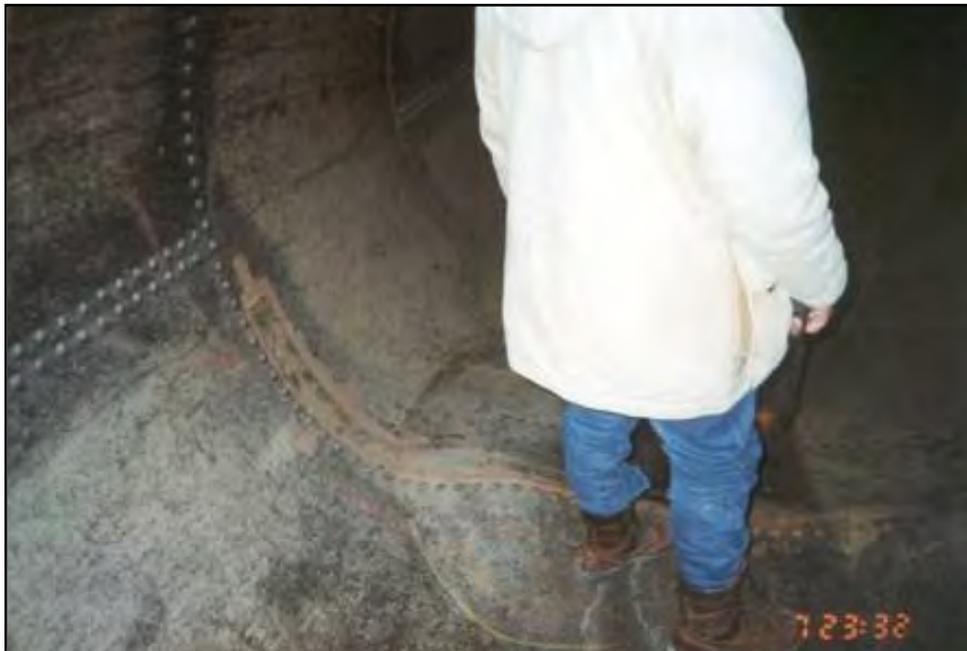
Figure 4.5.13 Typical Buckling at the Bottom of St. Mary River Siphon (10/26/04).

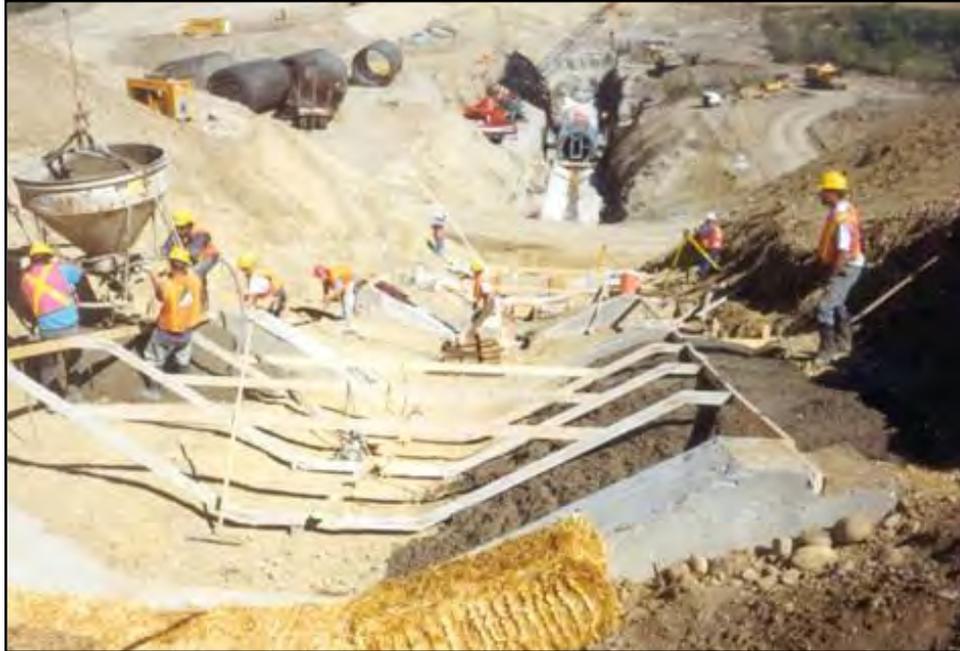
Figure 4.5.16 Preparation of reinforced concrete footings and foundation concrete. Note conduit construction in background (July 1999).

Another alternative, which should be considered during the Feasibility Study, is to utilize a buried cast-in-place (CIP) concrete conduit. Cast-in-place concrete allows a single pipe option. At a velocity of 13 fps, a single pipe 9.0 to 10.0 feet in diameter would be required for 850 to 1000 cfs respectively. This type of siphon construction used was for replacement of the East Arrowwood Siphon in southern Alberta in 1999. For that project, the single siphon pipe diameter is 13.1 feet with a discharge capacity of 1800 cfs. A steel slip form was used to construct the CIP concrete siphon (Figures 4.5.16 through 4.5.18). The advantages of a single pipe siphon include a potential construction cost savings and essentially half the future maintenance.

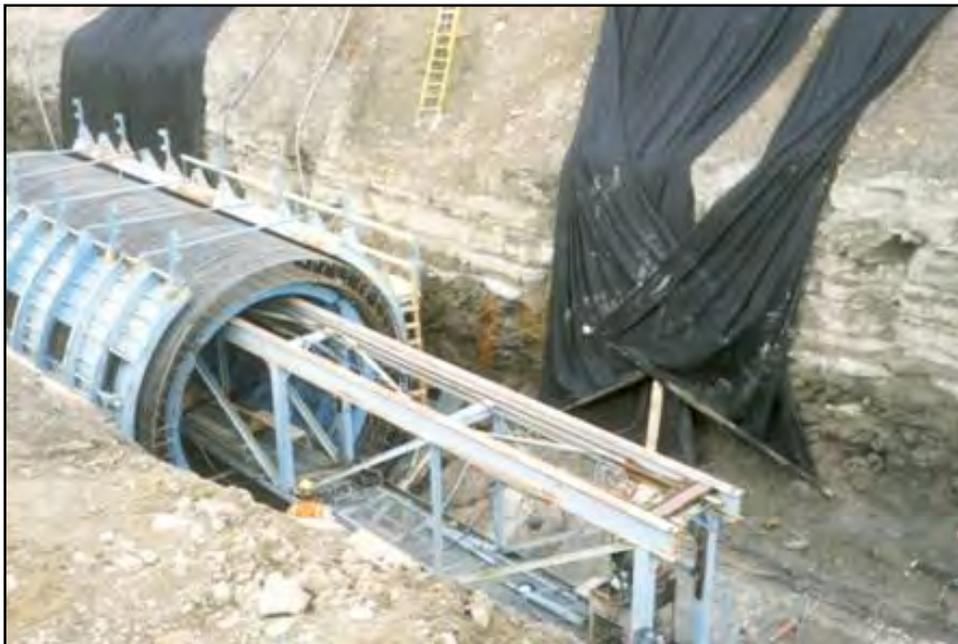
Figure 4.5.17 Close up of steel slip form partly in place in preparation of placing a 30 foot length of siphon (July 1999).

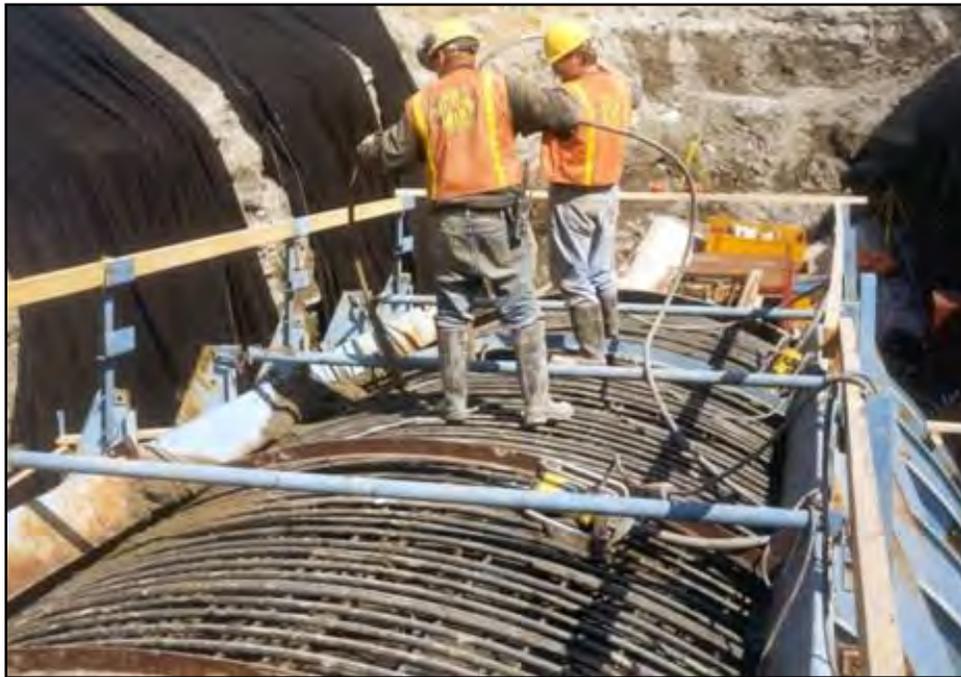
Figure 4.5.18 Filling form with concrete (July 1999).

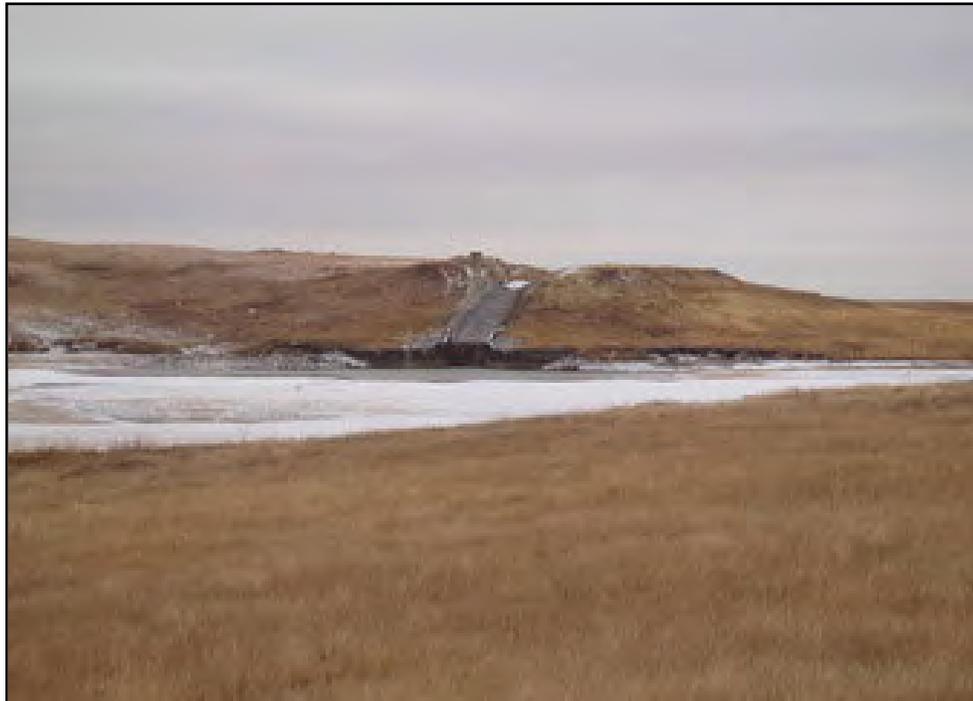
Drop No. 1 has a total length of approximately 215 feet and a vertical drop of approximately 36.5 feet. An overall view of the structure is shown in Figure 4.6.1. This structure appears to be in the best condition of all five drops. The spillway chute downstream of the V-notch has experienced moderate concrete spalling. However, the approach slab has experienced moderate to severe spalling as shown in Figure 4.6.2.

Figure 4.6.1 Looking west towards Drop No. 1 (11/10/04).

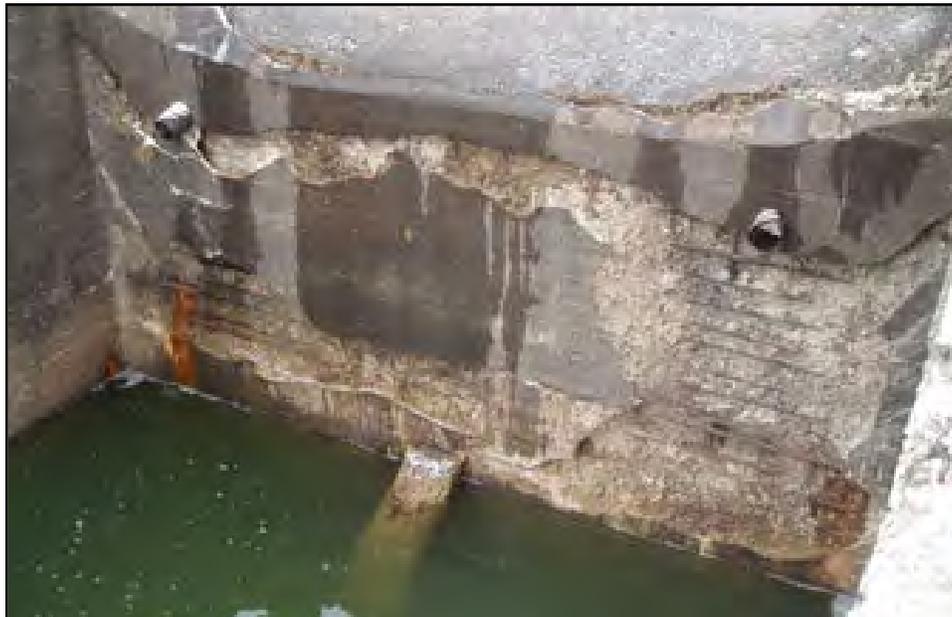
Water in the plunge pool prevented a complete inspection of the condition of the lower walls or slab. Rebar is exposed on the visible portion of the vertical face just downstream of the chute as shown in Figure 4.6.3. There is also a large crack, with exposed rebar, at the left wall to chute slab interface just upstream of the vertical drop as shown in Figure 4.6.4.

Figure 4.6.3 Looking at vertical face downstream of chute section of Drop No. 1 (11/10/04).

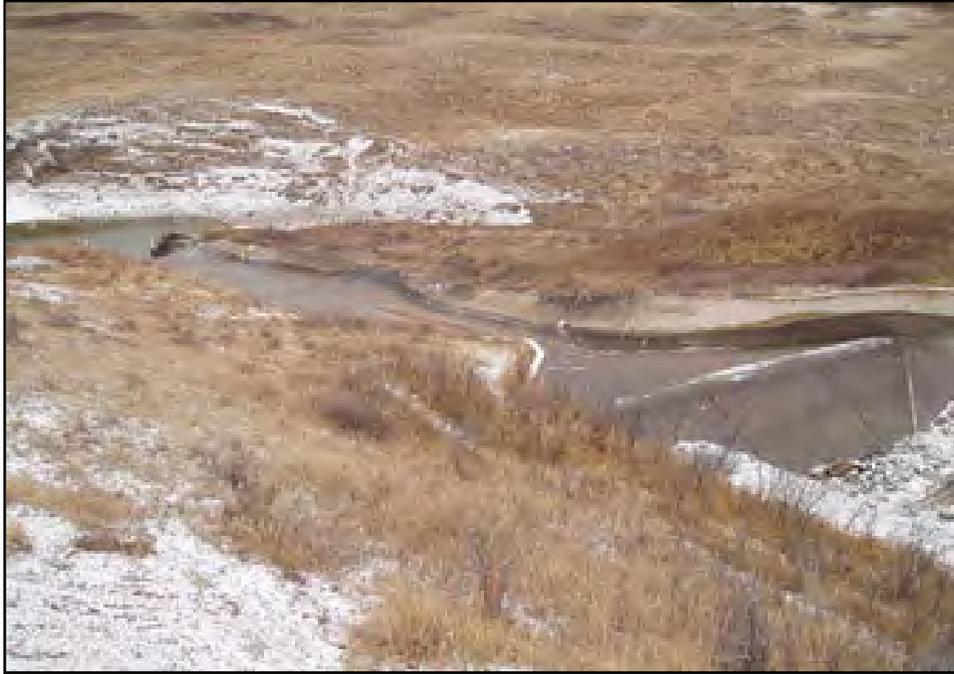
Drop No. 2 has a total length of approximately 205 feet and a vertical drop of approximately 29.5 feet. An overall view of the structure is shown in Figure 4.6.5. A section of this structure (slab and sloping side walls) was replaced after a partial failure that occurred in 2002 as shown in Figure 4.6.6.

Figure 4.6.5 Downstream view of Drop No. 2. Note stilling basin landslide in background (11/10/04).

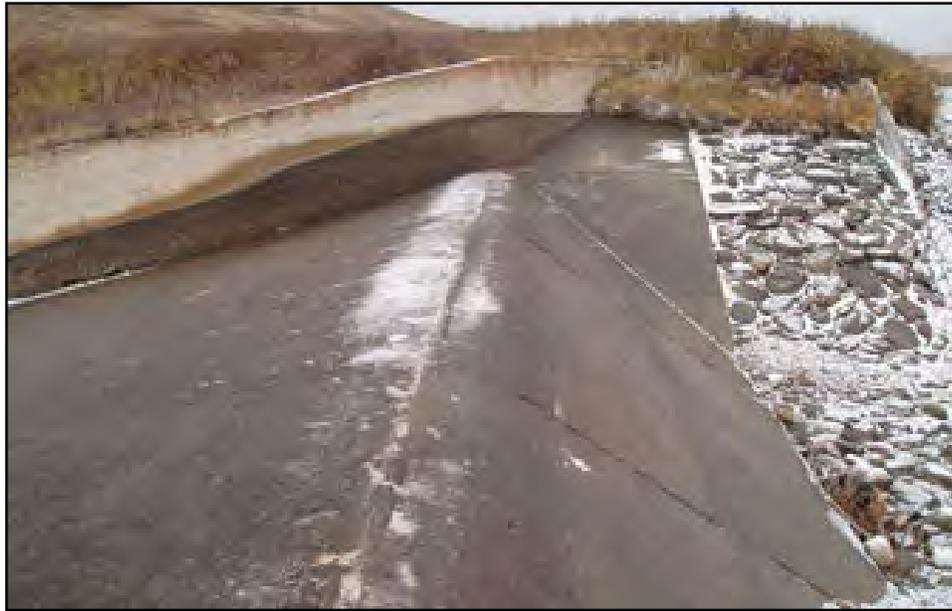
The ogee crest appears to be in good condition as shown in Figure 4.6.7. The slab upstream and downstream of the replaced section shows widespread spalling. The chute slab is shown in Figure 4.6.8, upstream and downstream of the replaced section, respectively. The condition of the foundation under the entire structure is unknown.

Figure 4.6.7 View of ogee crest of Drop No. 2 (11/10/04).

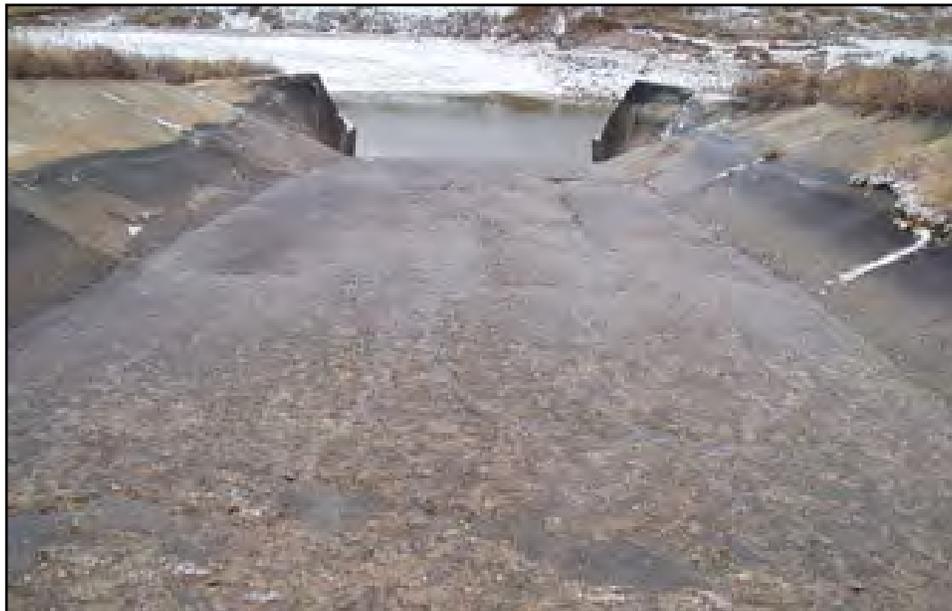
Figure 4.6.8 Downstream view of chute section of Drop No. 2 (11/10/04).

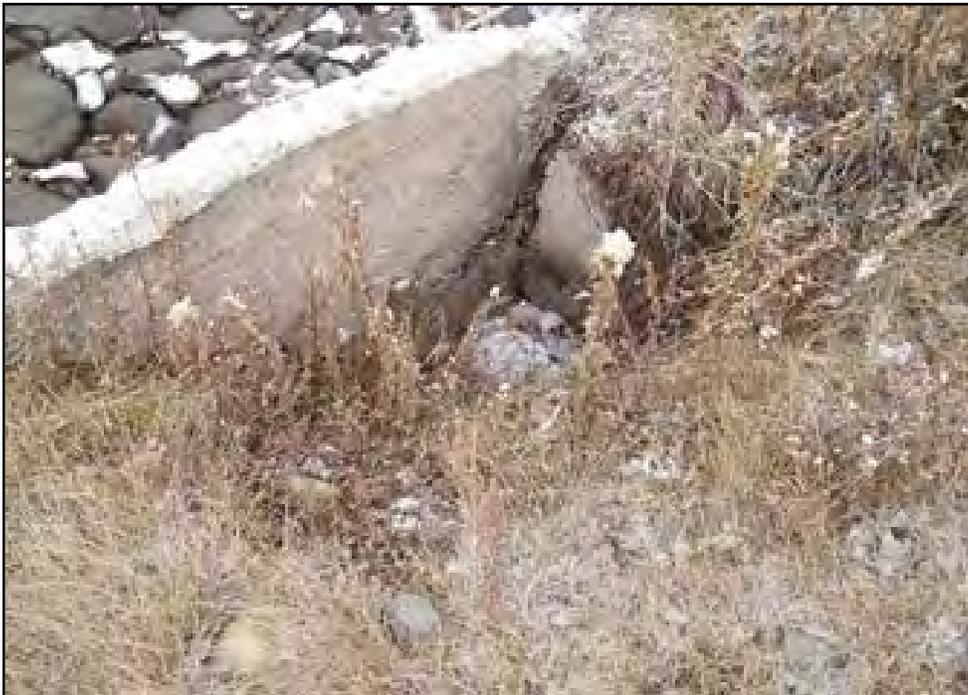
A section of the left wingwall (perpendicular to end of the plunge pool) appears to be failing as shown in Figure 4.6.9. Rebar is exposed on the downstream face of this wall and a seep hole has developed along the opposite side of this wall as shown in Figures 4.6.10 and 4.6.11, respectively. Sink holes are an indication of the loss of backfill soil due to seepage. Also, severe deterioration of the concrete has occurred on the vertical face of the plunge pool with rebar exposed as shown in Figure 4.6.12. Water in the plunge pool prevented a complete inspection of the condition of the lower walls or slab. It appears that the downstream section of the chute floor, just before the vertical drop, is possibly settling as evidenced by the type of cracking and opening of joints within the chute section also shown in Figure 4.6.12.

Figure 4.6.11 Sink hole developing behind north wingwall of Drop No. 2 (11/10/04).

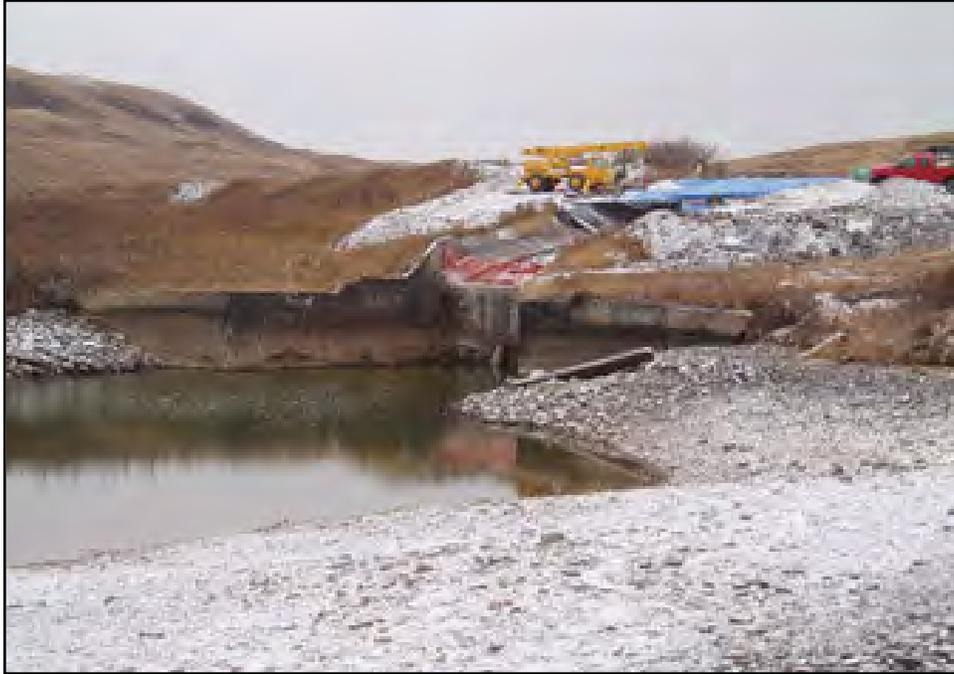
Drop No. 3 has a total length of approximately 139.5 feet and a vertical drop of approximately 27.8 feet. An overall view of the structure is shown in Figure 4.6.13. At the time of the inspection, a BOR maintenance crew was in the process of replacing the entire chute slab from the first joint downstream of the ogee crest to the end of the chute. This work is shown in Figures 4.6.13 and 4.6.14. In talking with the crew, upon removal of the slab, there was no evidence of piping or voids observed in the foundation materials below the chute slab. The foundation was noted to consist of large cobblestones with drains along the full length of the chute at the slab to chute wall interface.

Figure 4.6.13 Looking upstream toward Drop No. 3 (11/10/04).

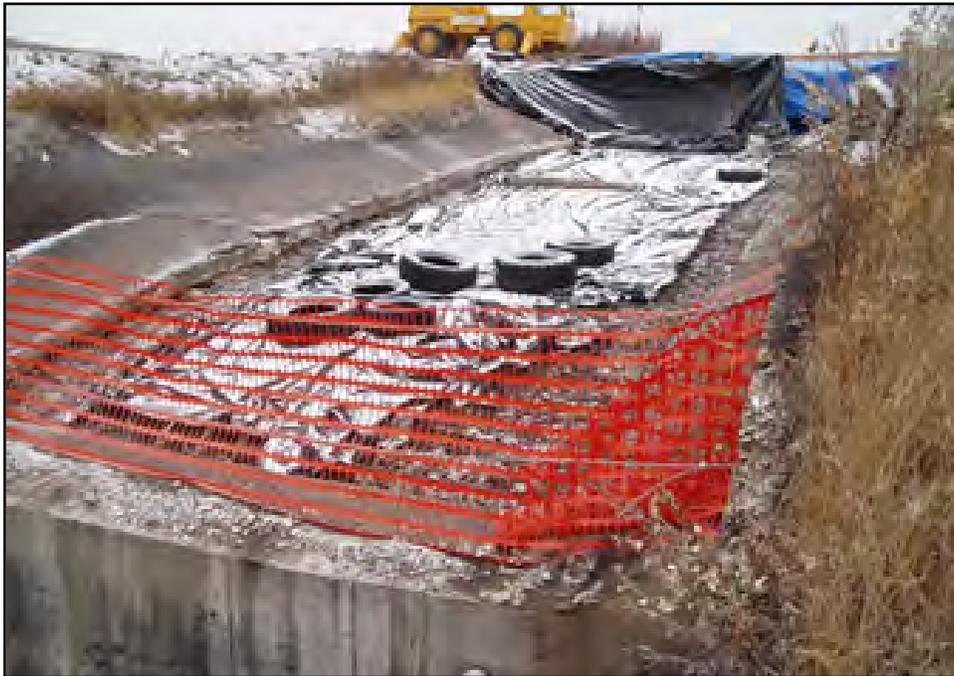
Figure 4.6.14 Photo shows maintenance work being performed on Drop No. 3 (11/10/04).

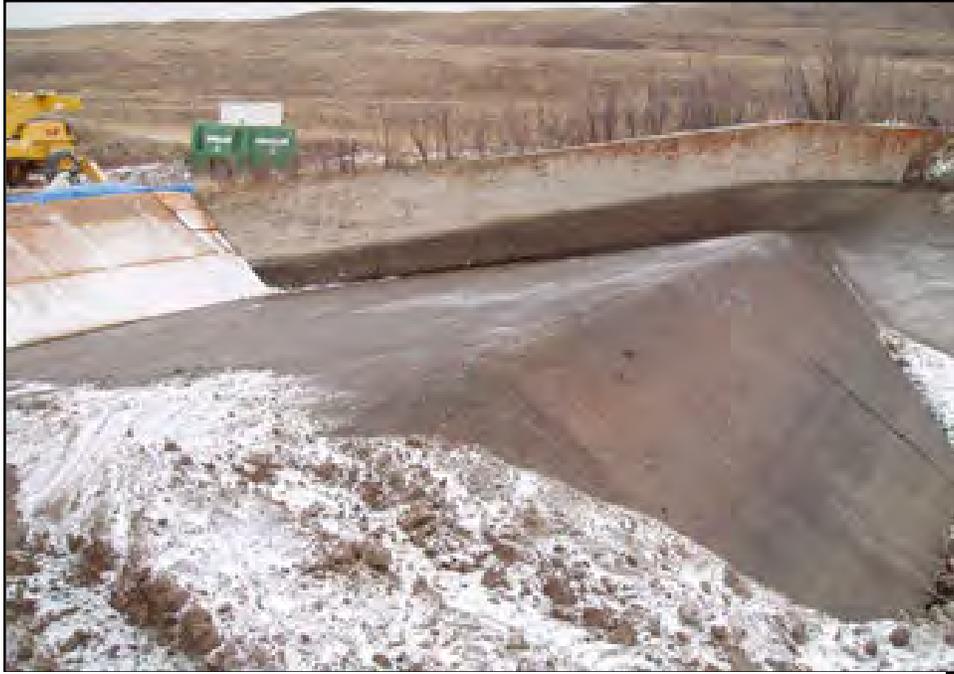
The approach and ogee crest section appear to be in good condition as shown in Figure 4.6.16. The concrete is deteriorated with exposed rebar on the vertical face of the plunge pool as shown in Figure 4.6.17. Water in the plunge pool prevented a complete inspection of the condition of the lower walls or slab. Extensive concrete deterioration has also taken place near the base of the retaining wall on the right side of the plunge pool as shown in Figure 4.6.18. As has already happened at the base of the left wall and as discussed in the previous paragraph, it may only be a matter of time before the concrete deterioration extends through the thickness of the right training wall resulting in similar piping and subsequent sinkholes on the backside of these walls.

Figure 4.6.16 Ogee section of Drop No. 3 (11/10/04).

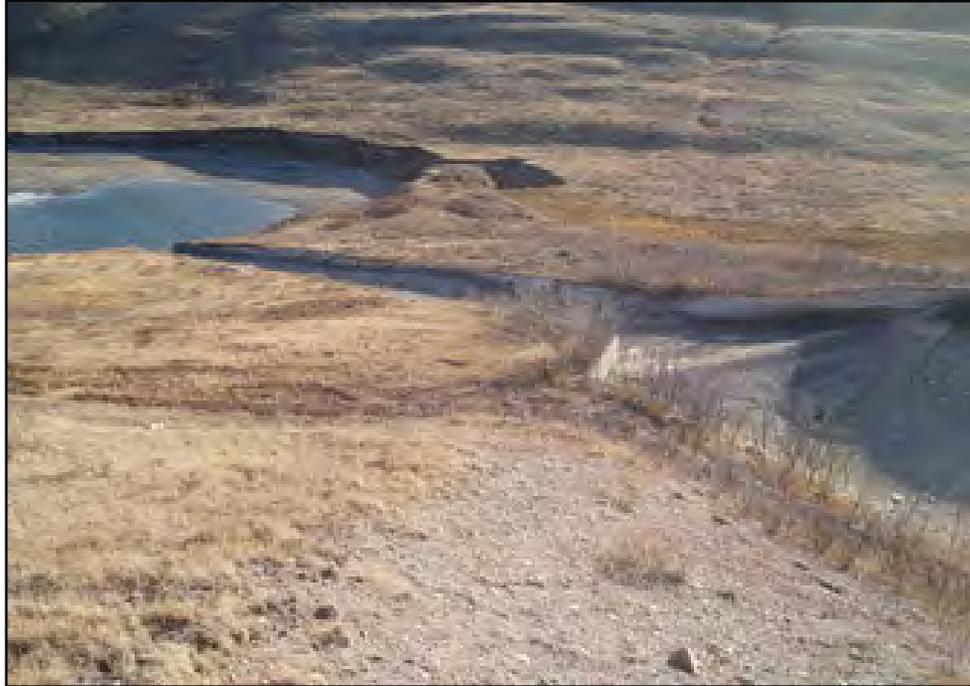
Drop No. 4 has a total length of approximately 340 feet and a vertical drop of approximately 67 feet. An overall view of the structure is shown in Figure 4.6.19. The chute is in poor to marginal condition as shown in Figure 4.6.20. There are several areas within the chute that have severe deterioration. For example, the deterioration in the chute slab (approximately 4 inches wide by 6 inches long) shown in Figure 4.6.21. and in the chute side wall slab (approximately 28 inches wide by 32 inches long) shown on the left side of Figure 4.6.22 is of concern. These deteriorated areas vary from partial depth to full depth of the concrete and could result in piping under the slab or complete blowout of the slab concrete if not corrected soon. Widespread spalling of the concrete is evident near the downstream end of the chute as shown in Figure 4.6.23.

Figure 4.6.19 Looking downstream at Drop No. 4 (11/10/04).

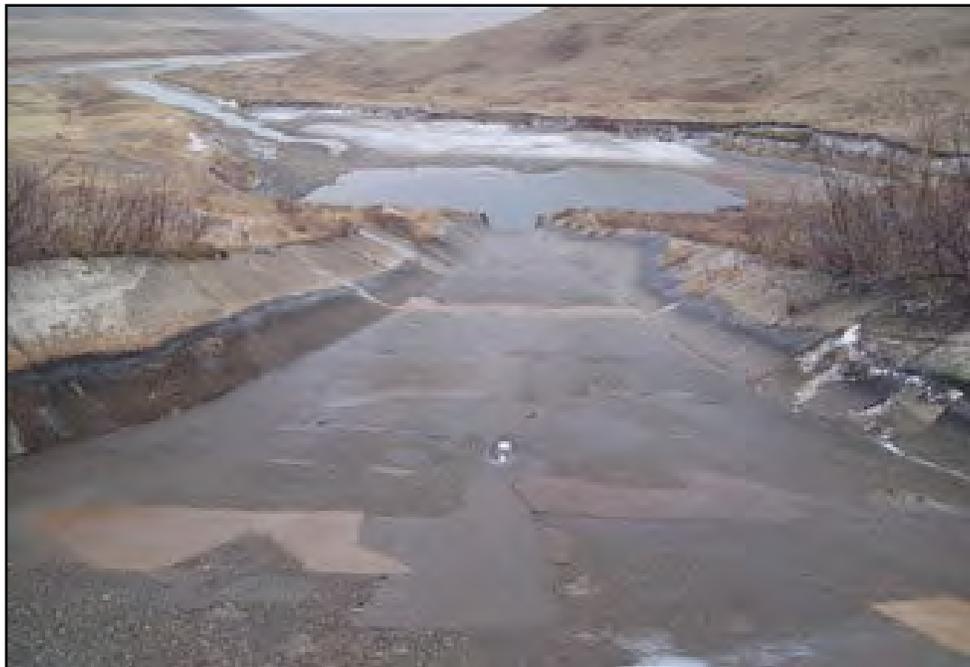
Figure 4.6.20 Looking at chute section of Drop No. 4 (11/10/04).

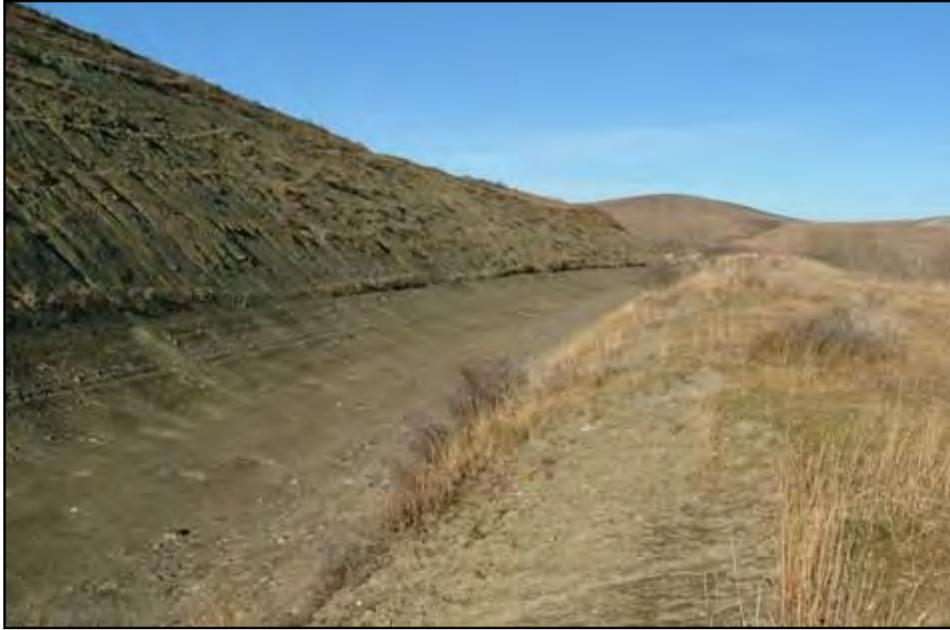
Figure 4.7.5 One-bank canal section downstream of St. Mary River Siphon. This reach is excavated into bedrock and is stable (11/11/04).

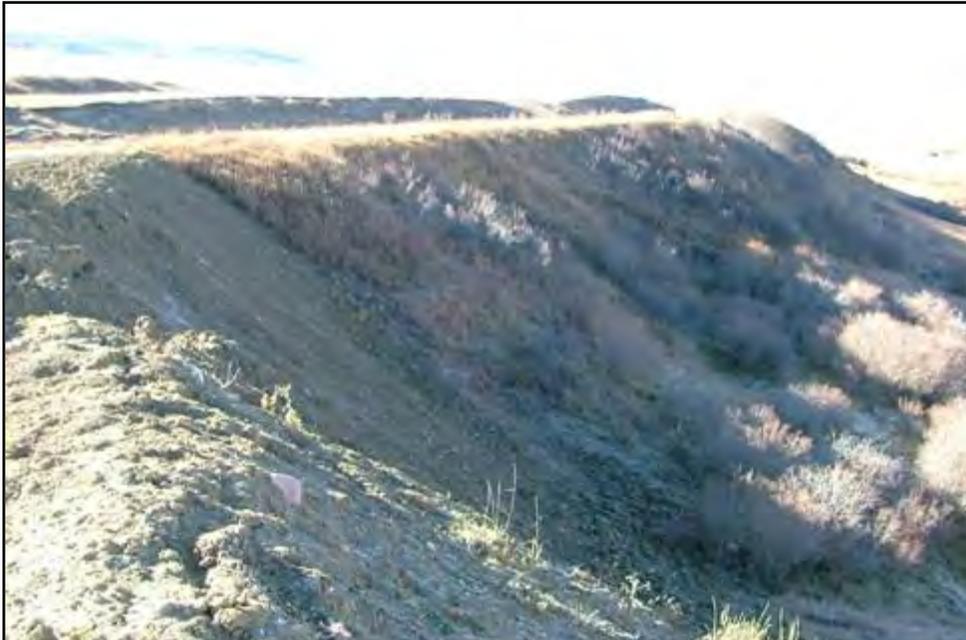
Figure 4.7.6 Typical fill-section of canal at edge of coulee downstream of Spider Lake check structure (11/11/04).

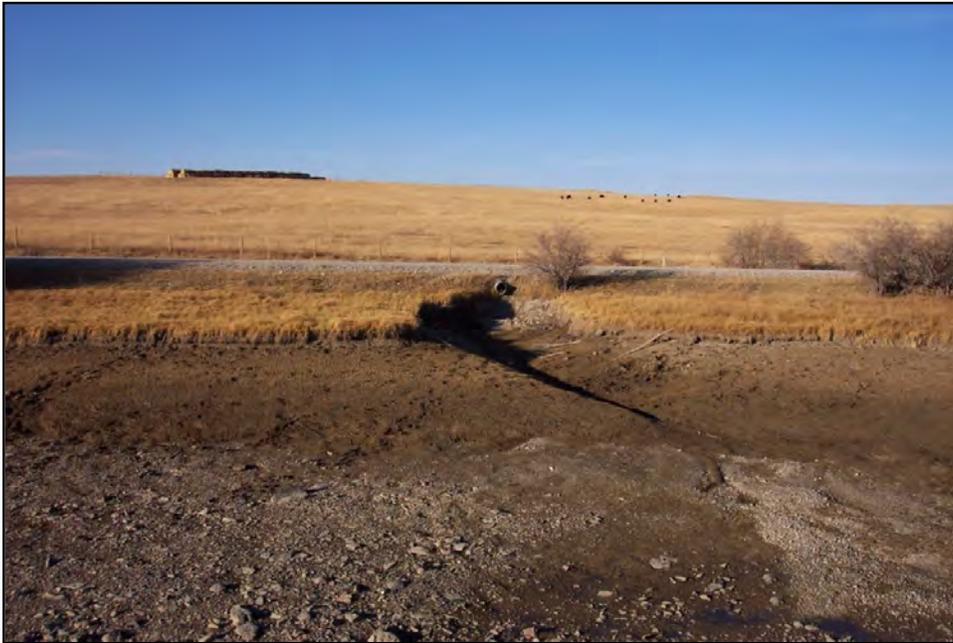
4. *Local Runoff.* Some fairly large drainage areas contribute runoff directly into the canal. In general, little or no erosion protection has been provided at drainage culverts that divert water into the canal. As a result, severe erosion has occurred at numerous locations.

Figure 4.7.9 Severe inflow erosion at drainage culvert (11/11/04).

While addition of water to the canal may be beneficial under certain circumstances, it can be a major problem at other times. The canal should either be oversized with sufficient free board to carry the additional inflows with overflow or wasteway structures used for emergencies, or under-flow, cross-drainage beneath the canal should be provided. The former is preferred.

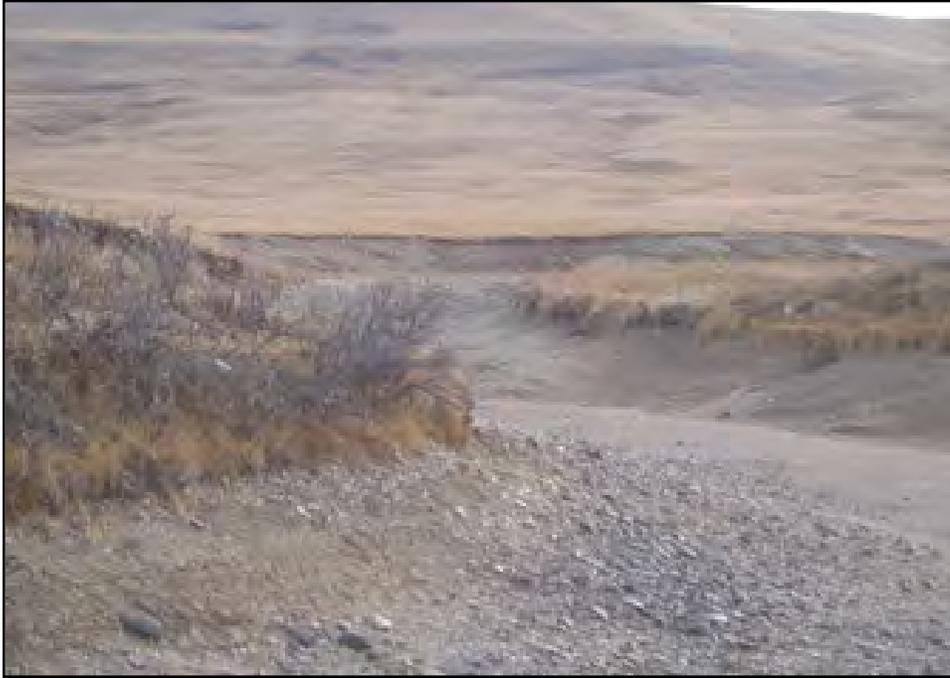
6. *Sinuosity*. Numerous curves exist in the canal alignment. Each curve causes a loss of hydraulic momentum, which reduces the overall capacity. Minimizing the curves is recommended for any future canal improvements. Also, increased sinuosity increases both erosion and deposition within the canal prism. Erosion can increase instability issues of the canal side slopes. Examples of inefficient canal alignment (sinuosity) are shown in Figures 4.7.3 and 4.7.11.

Figure 4.7.11 Typical canal section showing sinuosity inherent to contour canals in rolling terrain (11/11/04).
