PAINTED ROCKS DAM  
2016 SPILLWAY CHUTE INVESTIGATION  
INFORMATION PACKET

# PAINTED ROCKS SPILLWAY

INVENTORY NO.: MT-19  
 HAZARD CATEGORY: HIGH  
 TYPE OF DAM: Zoned Earth Fill  
 YEAR BUILT: 1938  
 YEAR REHABILITATED: 2011-2015

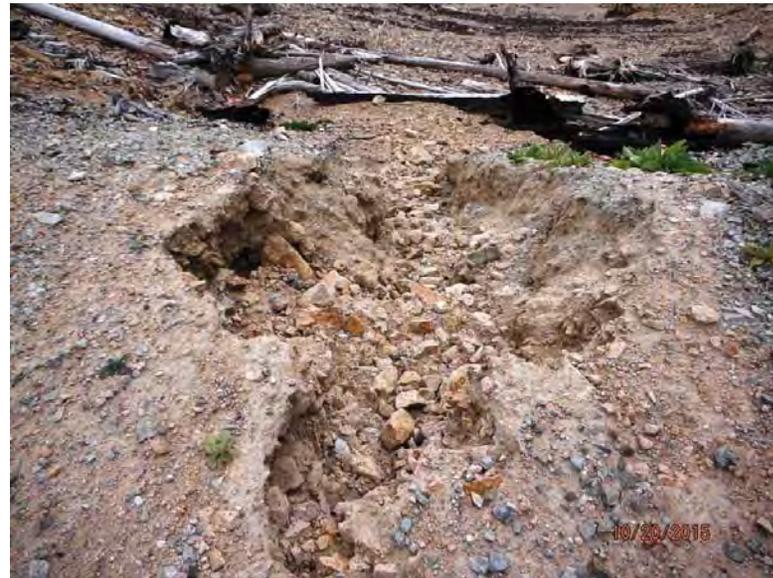
**Photo 16 Erosion near left upstream end of dam. Erosion is in material that is regularly replaced.**

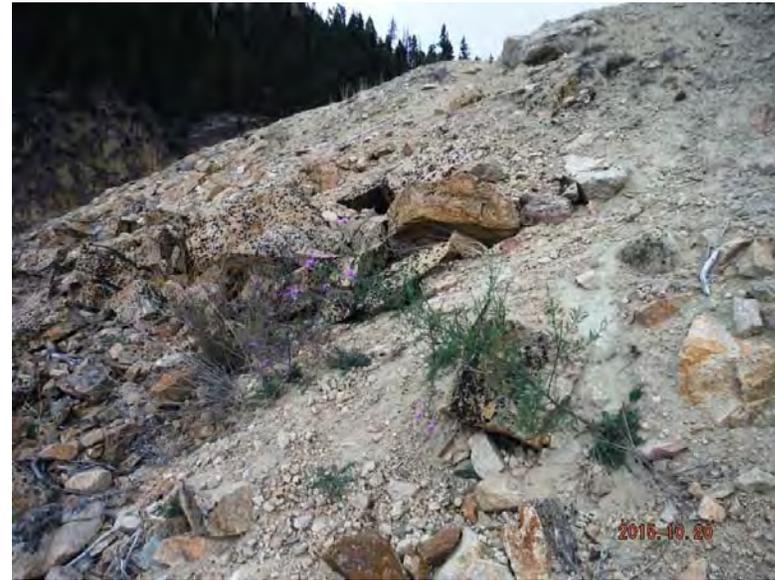
**Photo 18 Knapweed on upstream face / right abutment**

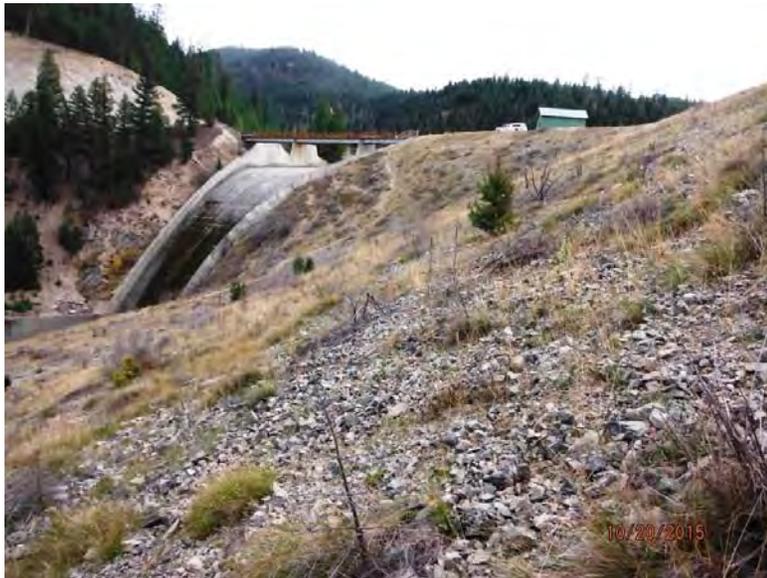
**Photo 19 Downstream view of dam, looking right, note small trees**

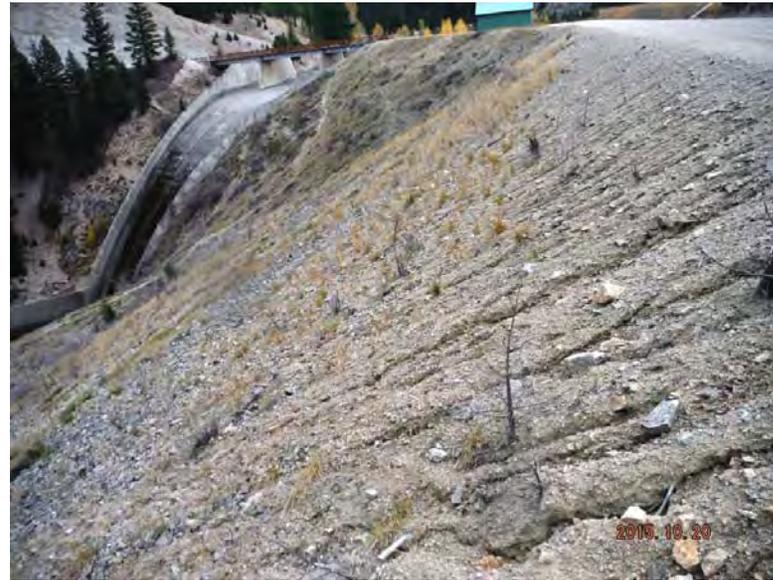
**Photo 22** Shallow erosion, note that erosion is limited to the location / material related to crest material cast-off

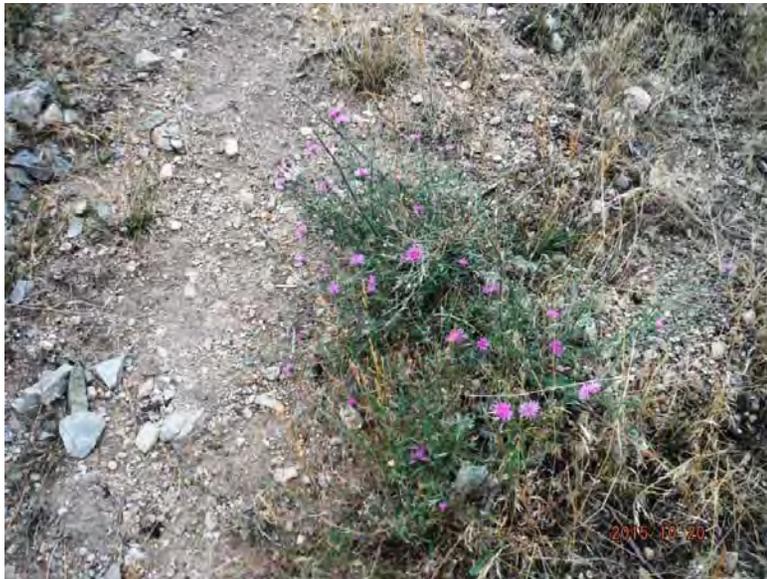
**Photo 23** Knapweed, downstream face of dam

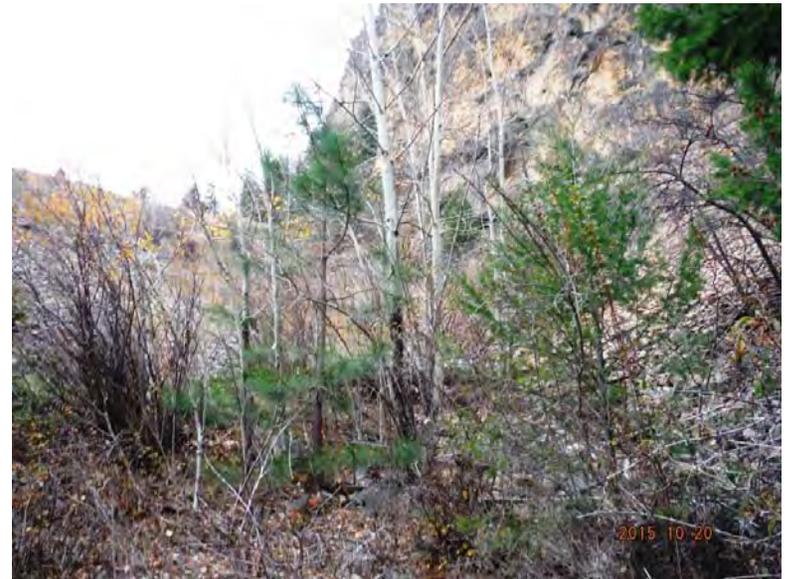
**Photo 28 Brush and small trees in left downstream groin**

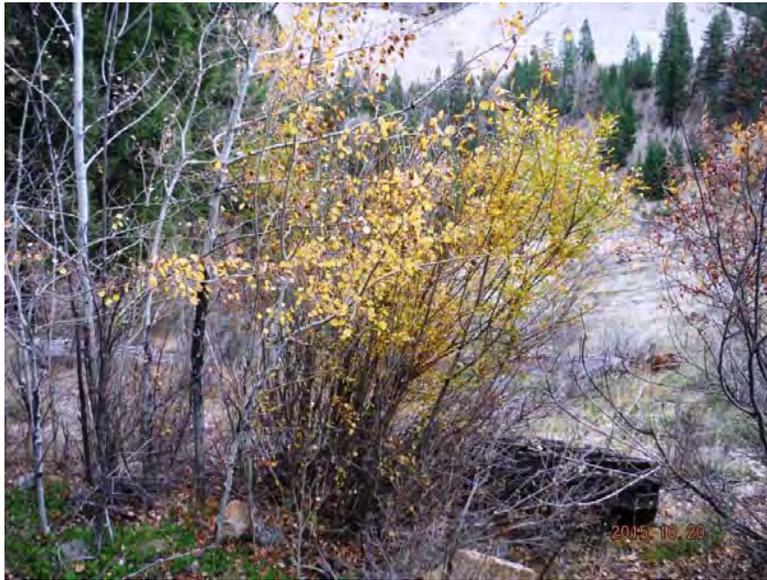
**Photo 29** Brush and small trees in left downstream groin

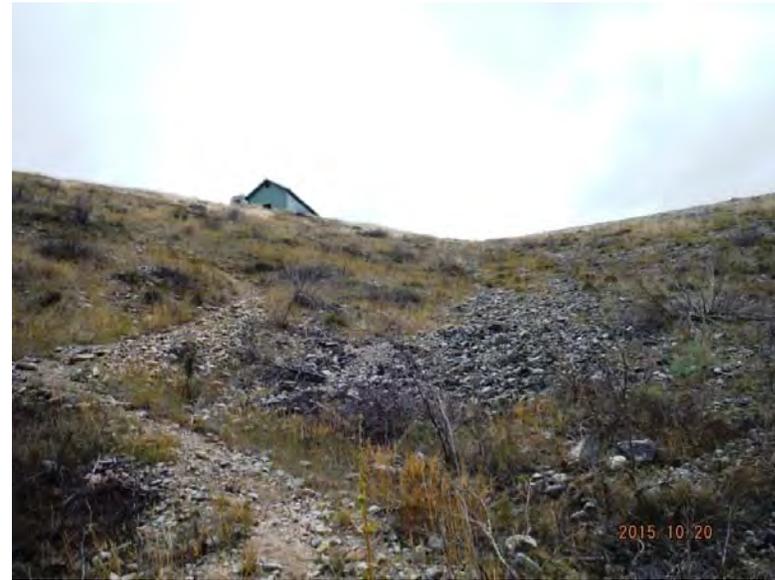
**Photo 30** Right downstream groin

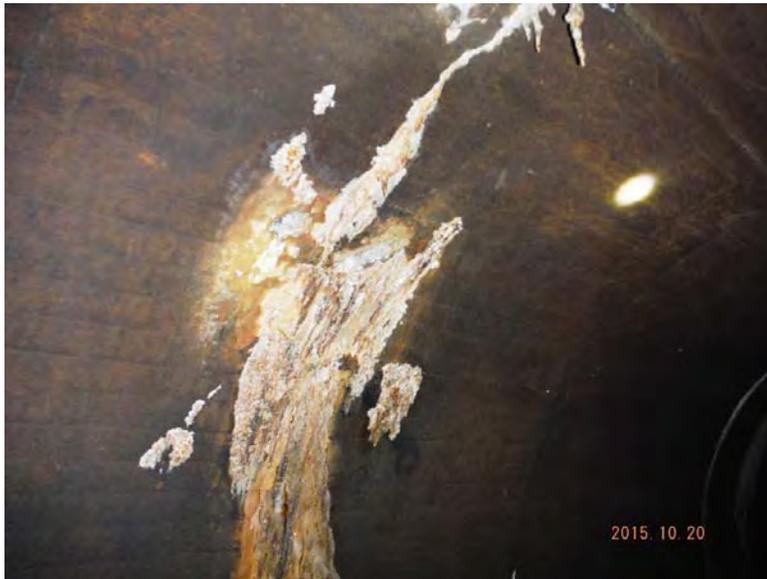
**Photo 35 Condition of old repair in conduit**

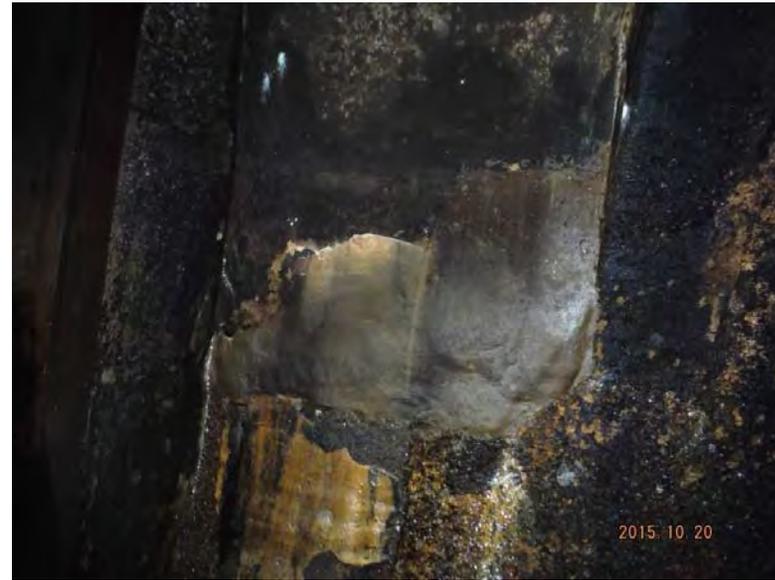
**Photo 42 Condition of 2013 cavitation repair - in great shape with only minor edge loss**

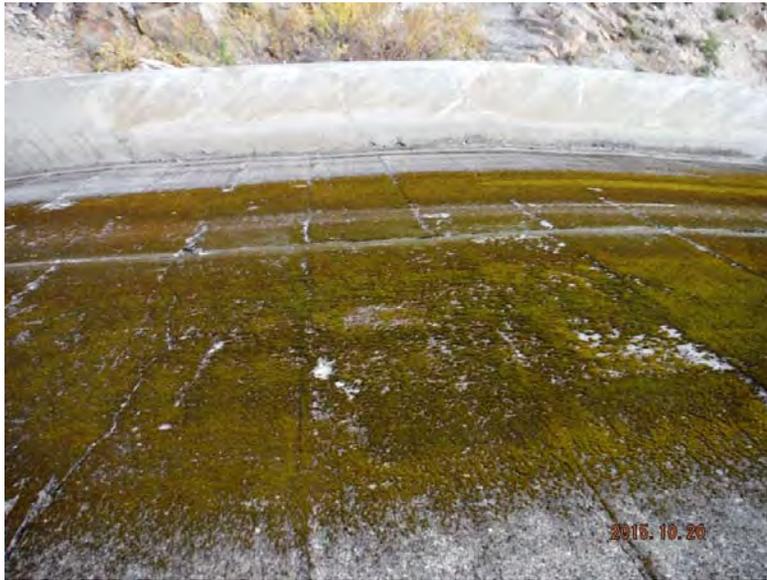
**Photo 61** View across steep portion of spillway - white areas void of moss may be concrete spalling / erosion, or wear moss is eroded from concrete

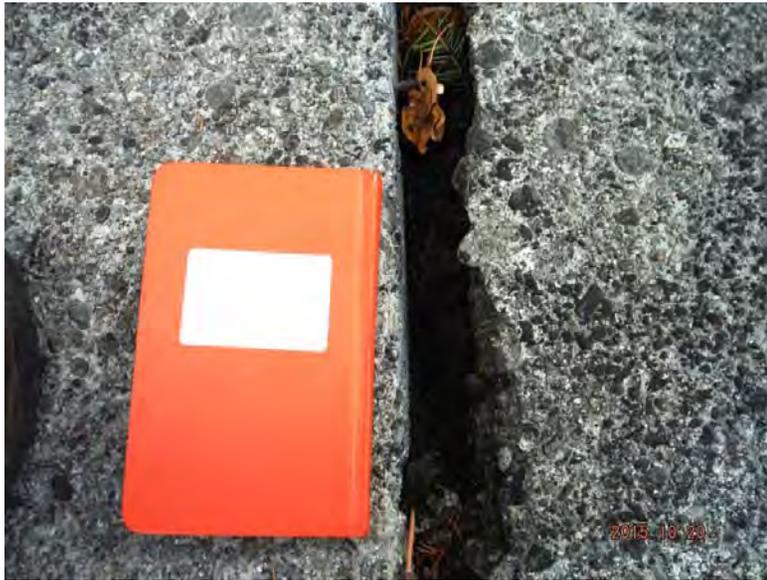
Photo 65 Transverse joint separation - spillway upper right

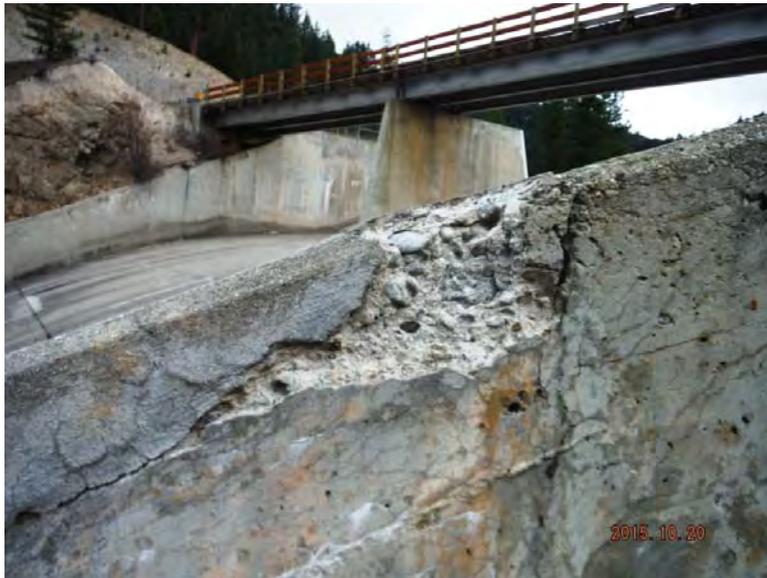
Photo 67 Concrete damage at top of left spillway wall

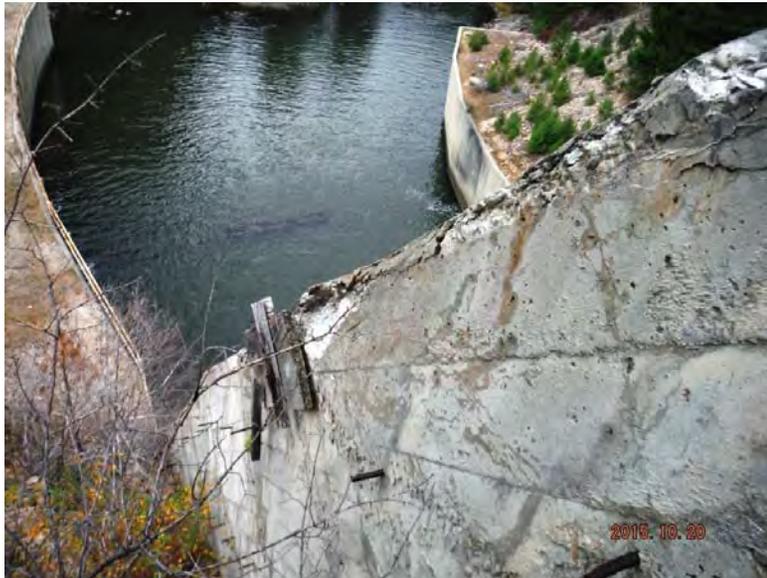
Photo 71 Concrete damage at top of left spillway wall

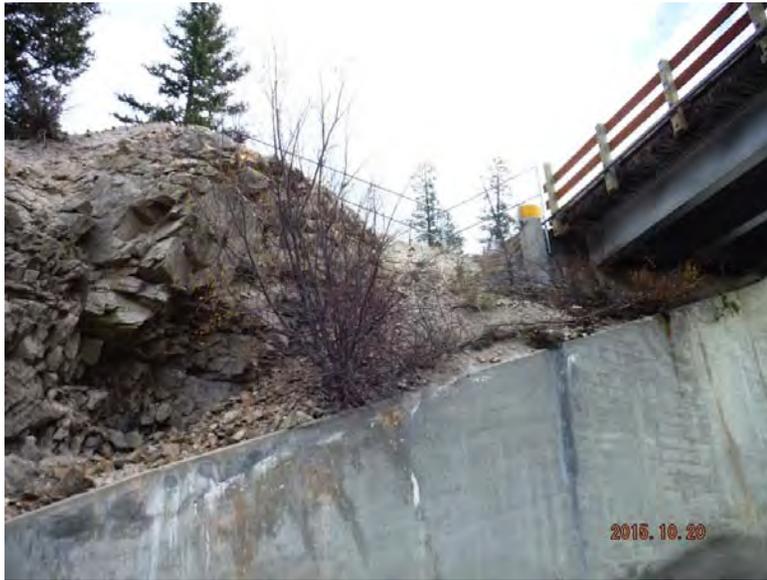
**Photo 73 Debris and brush at top of right spillway wall**

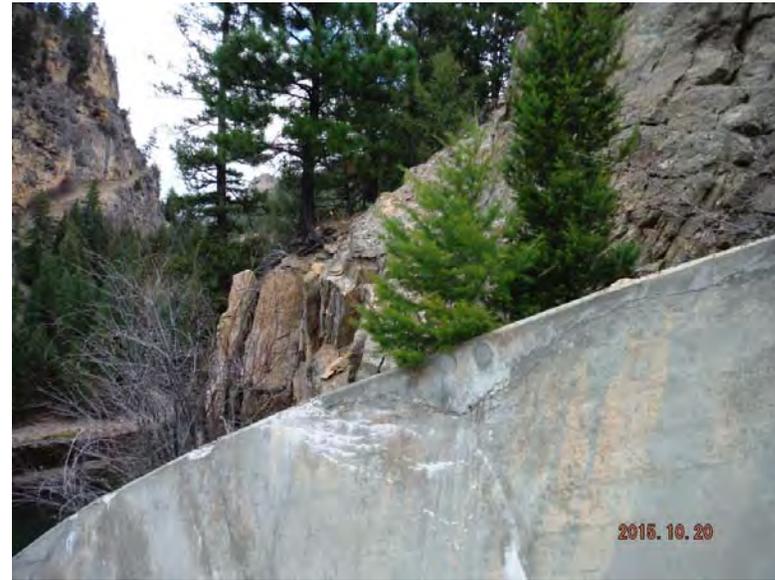
**Photo 74 Trees and brush adjacent to right spillway wall**

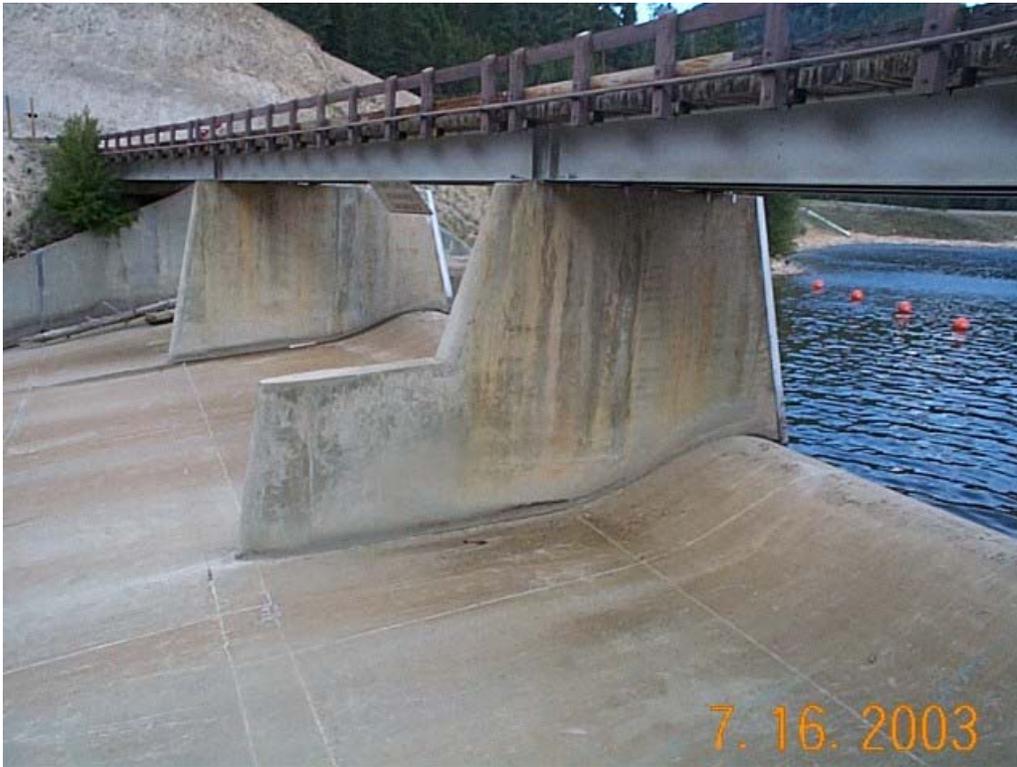
- The spillway floor at the spillway crest appears to generally be competent with minor abrasion damage. Previous spalling damage has been repaired with grout and spillway joints have been filled. There was minimal spalling or cracking observed at the entrance to the spillway. **Refer to Photographs 23 through 28.**

**Photograph 23** General Arrangement of Spillway Crest and Bridge Piers. (2003 Photo by DNRC).

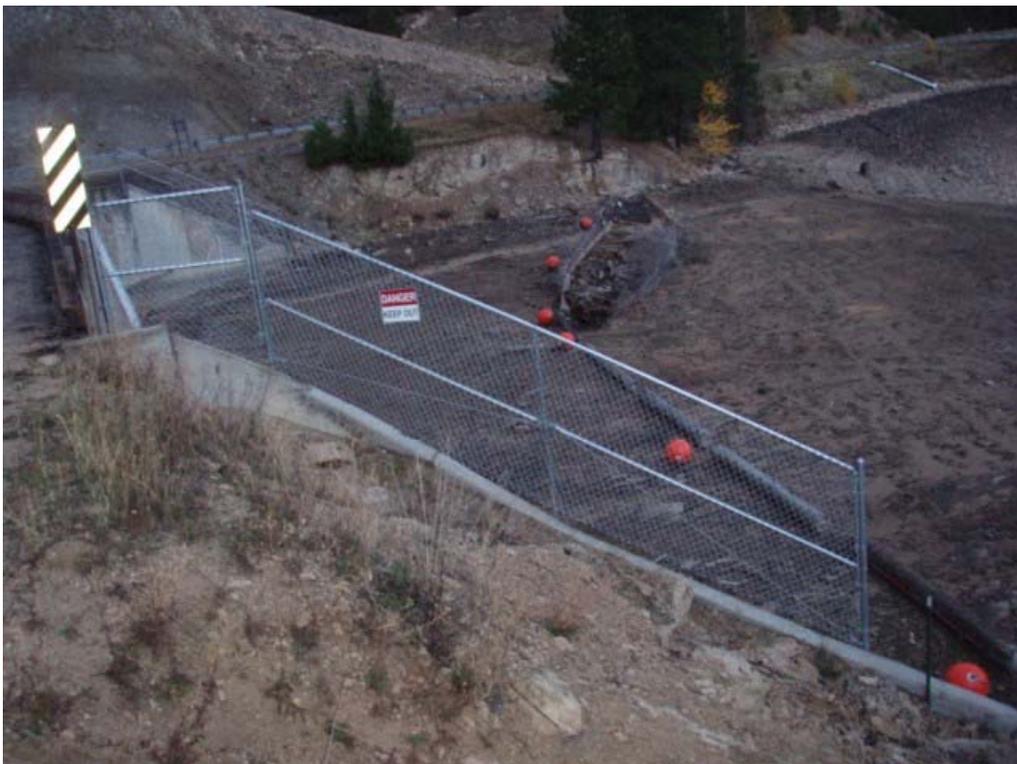
**Photograph 24** General View of Spillway Crest and Bridge Piers.

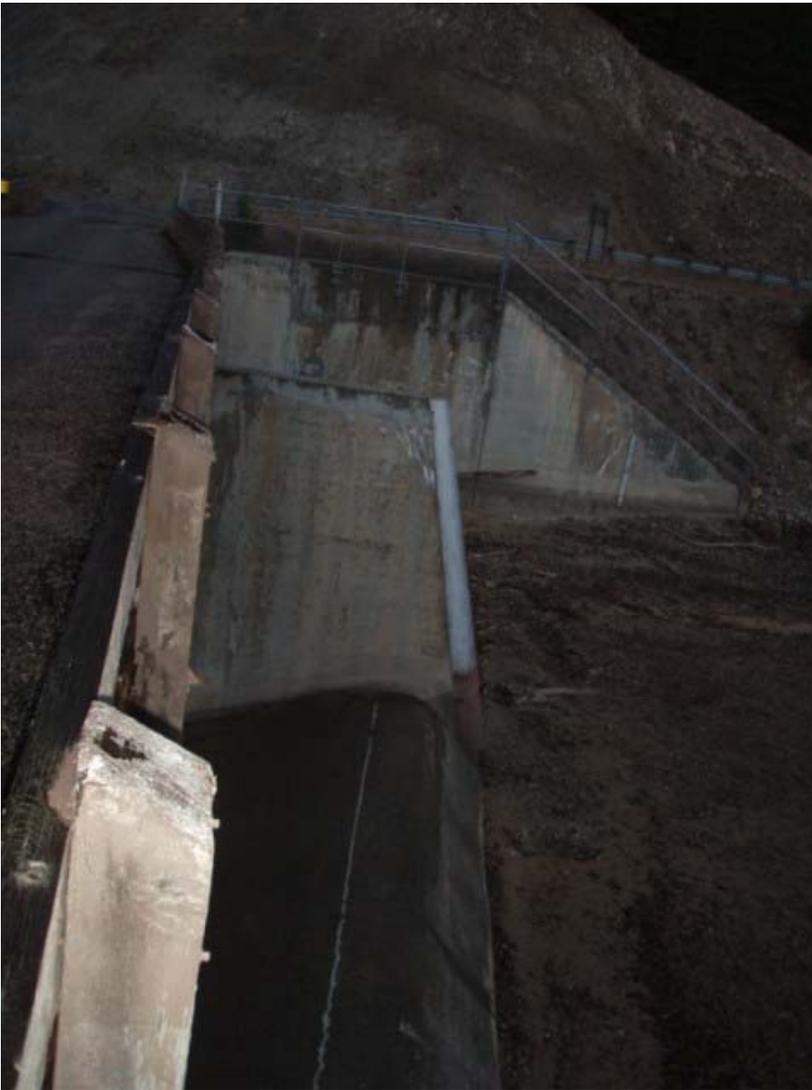
**Photograph 25 Spillway Chute and Right Training Wall.**

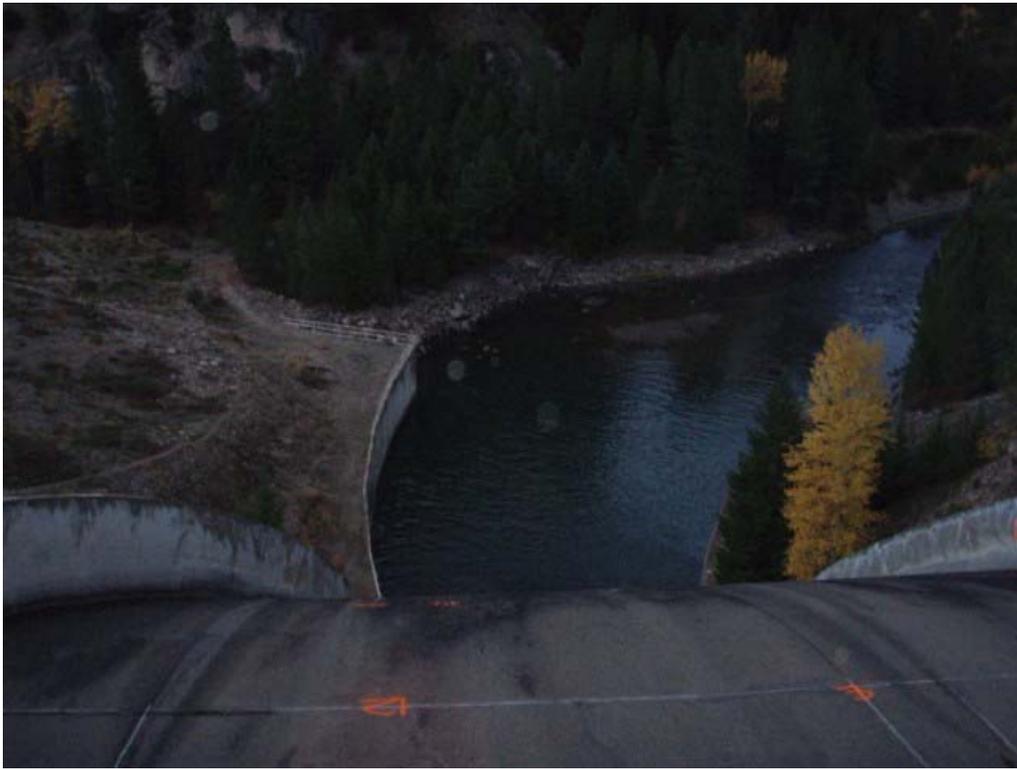
**Photograph 26 Spillway Chute and Right Training Wall.**

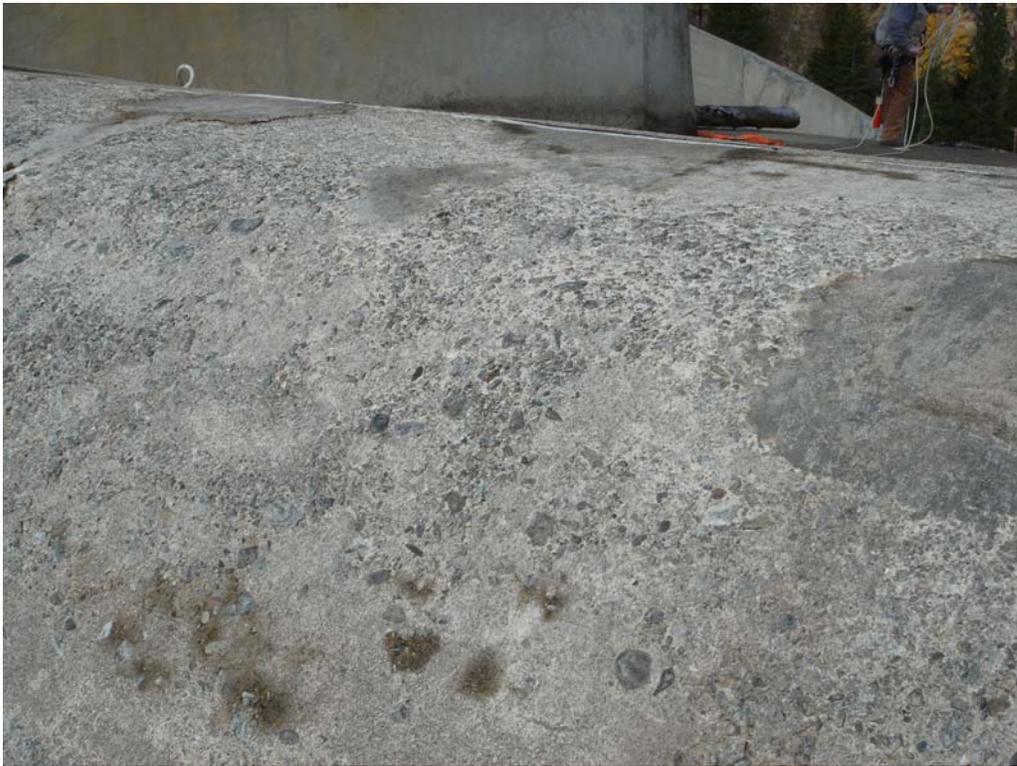
**Photograph 27 Spillway Crest.**

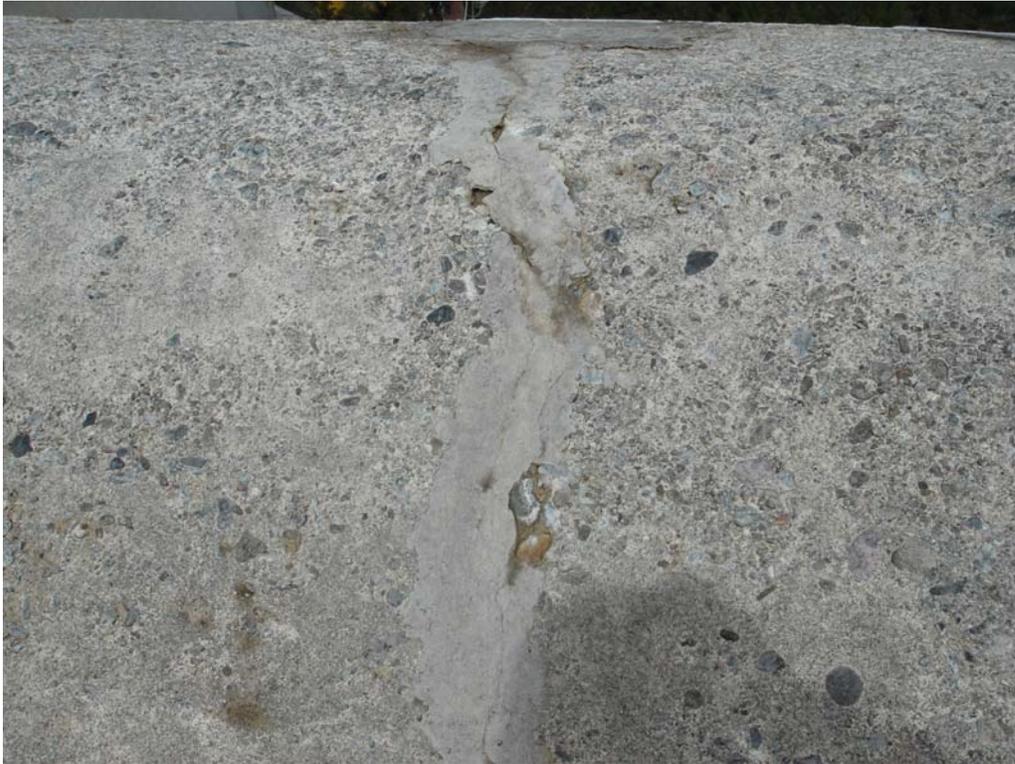
**Photograph 28 Spillway Crest Repair.**

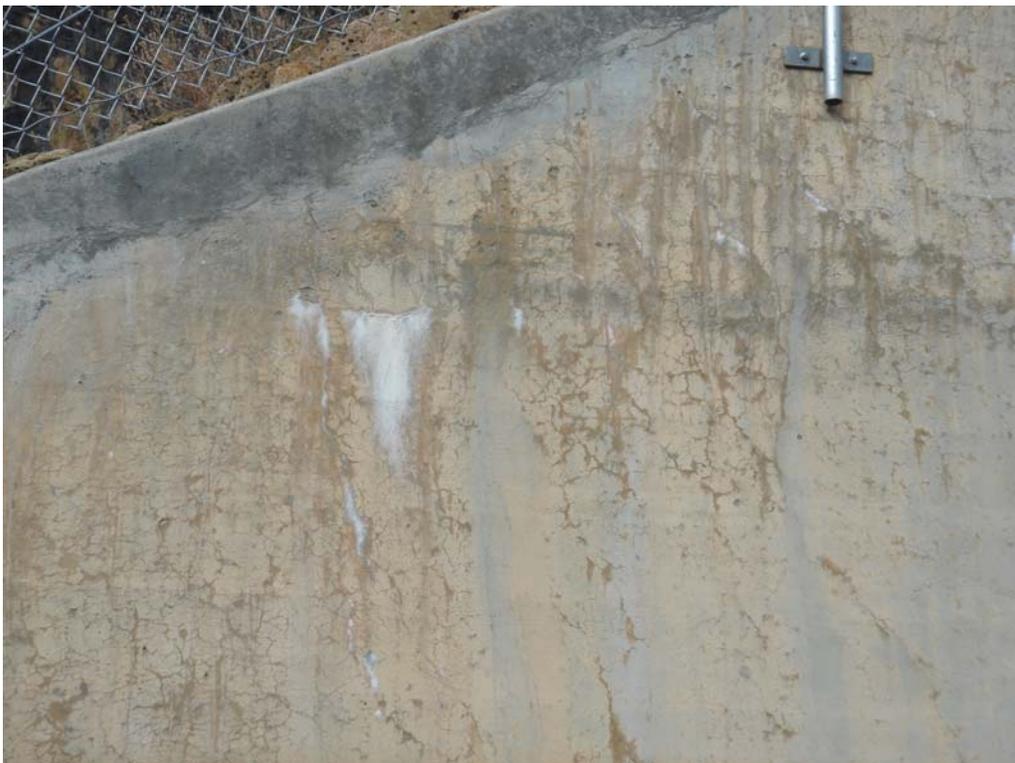
- Wing walls at the spillway crest showed significant portions of medium pattern cracking and efflorescence. Previous work has been done to repair the top portions of these walls. **Refer to Photograph 29 and 34.**

**Photograph 29 Left Wing Wall.**

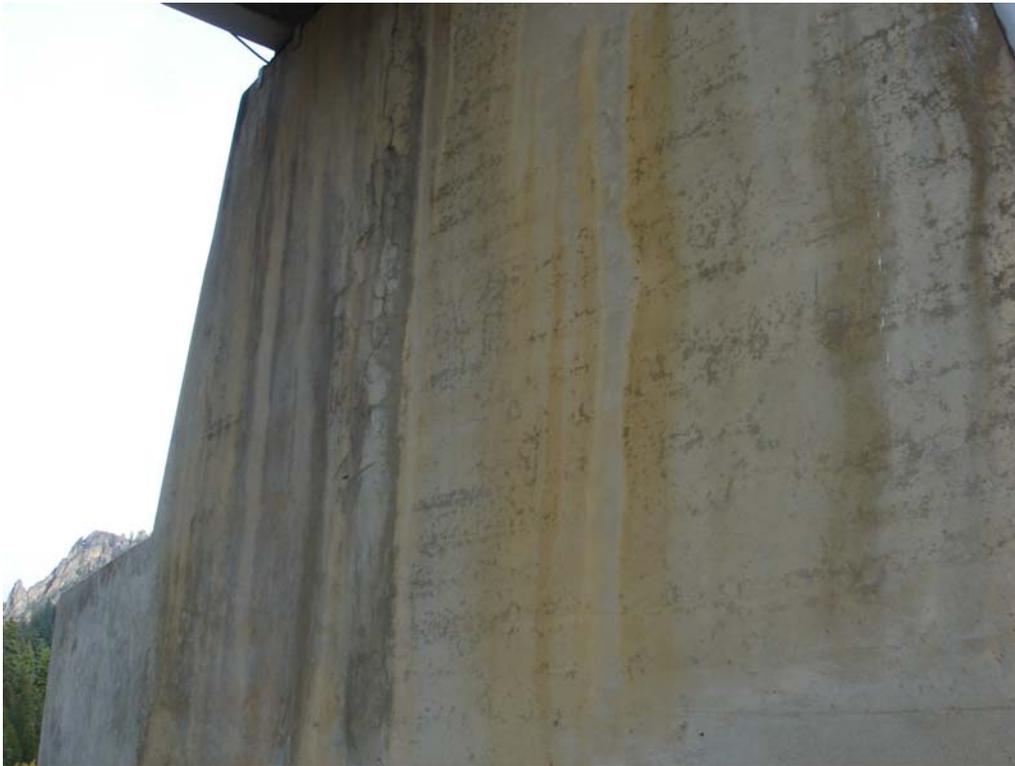
- Localized efflorescence and medium pattern cracking was observed in key locations on the spillway bridge piers. Schmidt hammer readings of 18 indicate a concrete cylinder compressive strength of approximately 1,350 psi. **Refer to Photographs 30 and 31.**

**Photograph 30 Spillway Bridge Pier.**

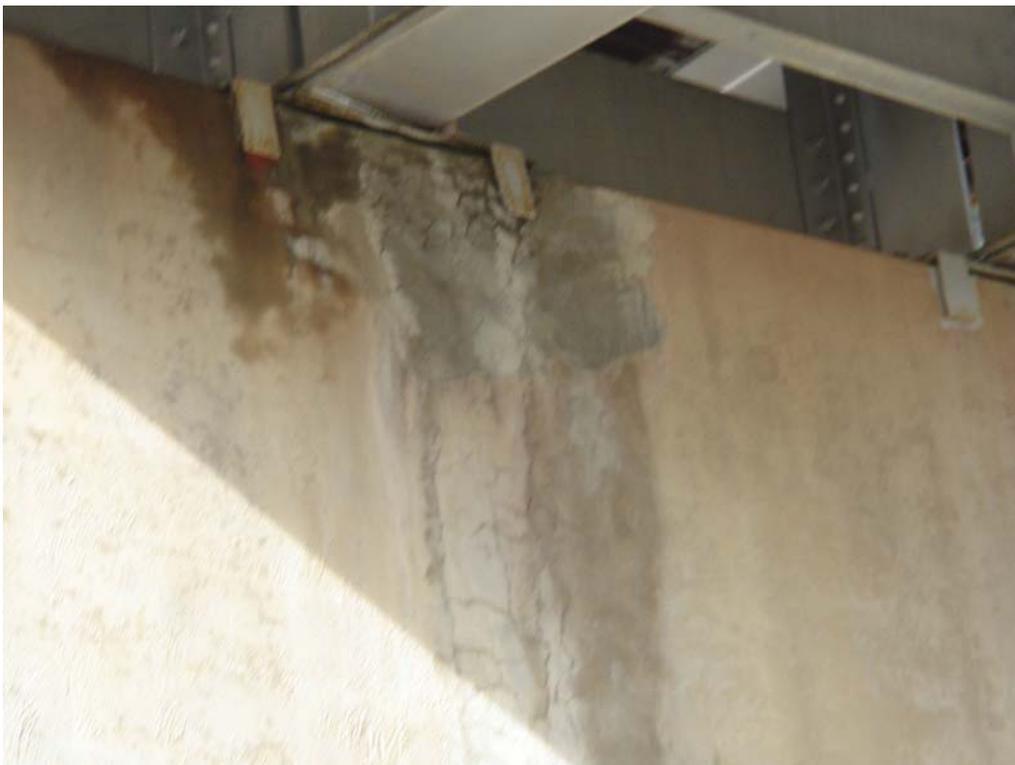
**Photograph 31 Spillway Bridge Pier Bearing Seat.**

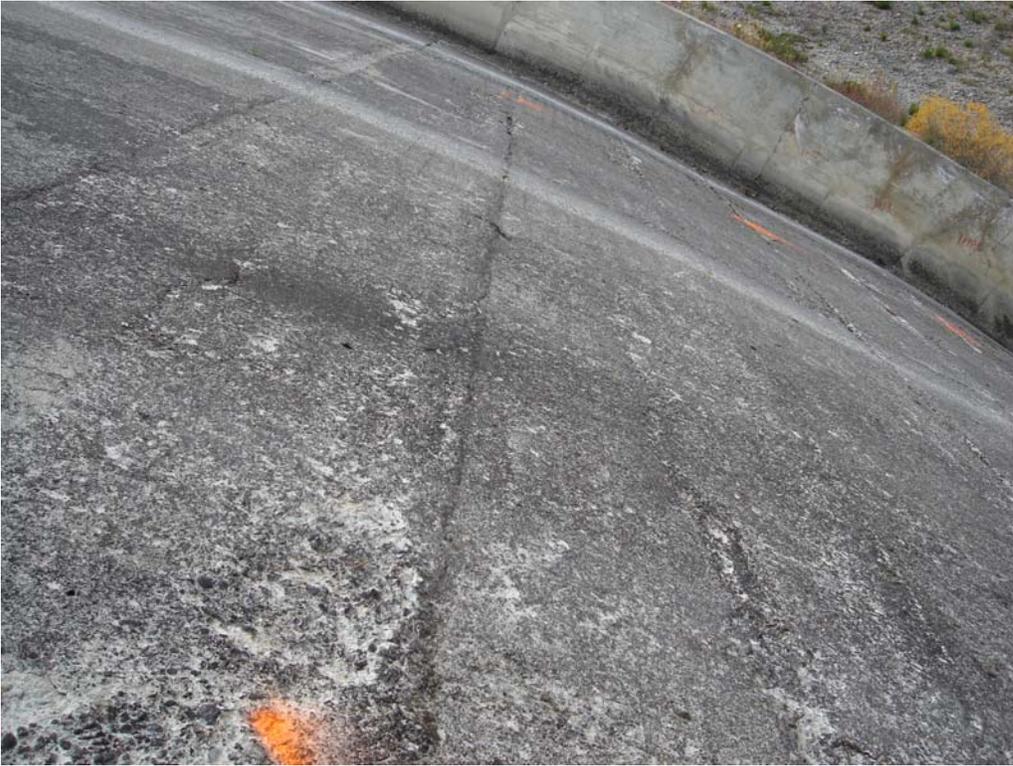
- The upper portion of the spillway floor (above approximate Station 3+55) was noted to have spalling/pitting over the majority area, ranging from 1/8-inch to 2-inches deep. Floor slab cracking was observed to generally run perpendicular to the spillway, but some longitudinal cracking is also present. **Refer to Photograph 36 through 38.**

**Photograph 36 Spillway Floor & West Training Wall.**

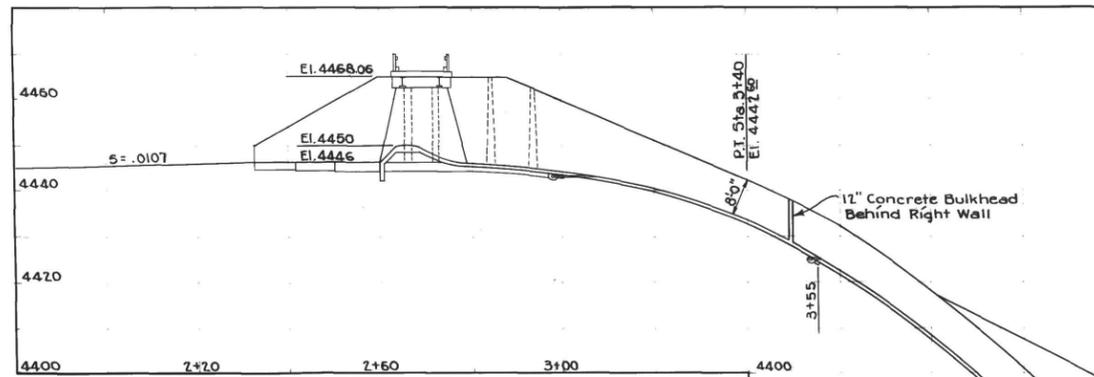
- ± 1/8" DEEP ABRASION/CRACKING OVER MAJORITY OF FLOOR; ± 1/4" DEEP ABRASIONS NEAR INTERSECTION OF JOINTS; SEALED FLOOR JOINTS; LONGITUDINAL FLOOR CRACK, 15 FT. LEFT OF CENTERLINE, 1/2" TO 1 1/2" WIDE.

- 1/4" TO 1/2" PITTING OF FLOOR SLAB; LOCALIZED AREA OF PITTING TO 2" AT JOINT.
- PITTING AND EXPOSED AGGREGATE TO 2" DEEP AT JOINTS; LONGITUDINAL CRACK 1/4" WIDE

- LARGE PITTING/SPALLING AT CENTER JOINT; ABRASION SURFACE > 1" DEEP WITH EXPOSED STEEL PLATE; TRANSVERSE CRACK 1" - 5" WIDE, 3" DEEP AND CONTINUES UP WALL; SEVERELY DETERIORATED IN THIS AREA.

- HORIZONTAL CRACKS 2" - 3" DEEP, UP TO 4" WIDE
- LARGE CRACK NEAR LEFT TRAINING WALL, 8" WIDE, 2 1/2" - 3" DEEP; CRACK NARROWS TO 4" WIDE TOWARDS THE CENTER OF THE SPILLWAY, 2" - 3" DEEP; CRACK DOES NOT APPEAR TO GO THROUGH ENTIRE SLAB; LARGE AREA OF INCREASED SPALLING 1/2" - 2"+; POROUS/PITTING TO 4" W/EXPOSED REBAR; SEVERELY DEGRADED CONCRETE OBSERVED IN THIS AREA.

- SPALLING FROM 1/2" TO 3/4" OVER SPILLWAY FLOOR AND UP TO THE WATER LINE ON THE TRAINING WALLS. LOCALIZED DISCOLORATION OF CONCRETE WITH SEVERELY DETERIORATED CONCRETE; TRANSVERSE CRACK AT COLD JOINT 1" - 2" DEEP, 1/2" - 2" WIDE; CONTINUED ABRASION 1/2" TO 1" OVER REMAINDER OF SPILLWAY FLOOR AND UP TO THE WATER LINE ON THE TRAINING WALLS.

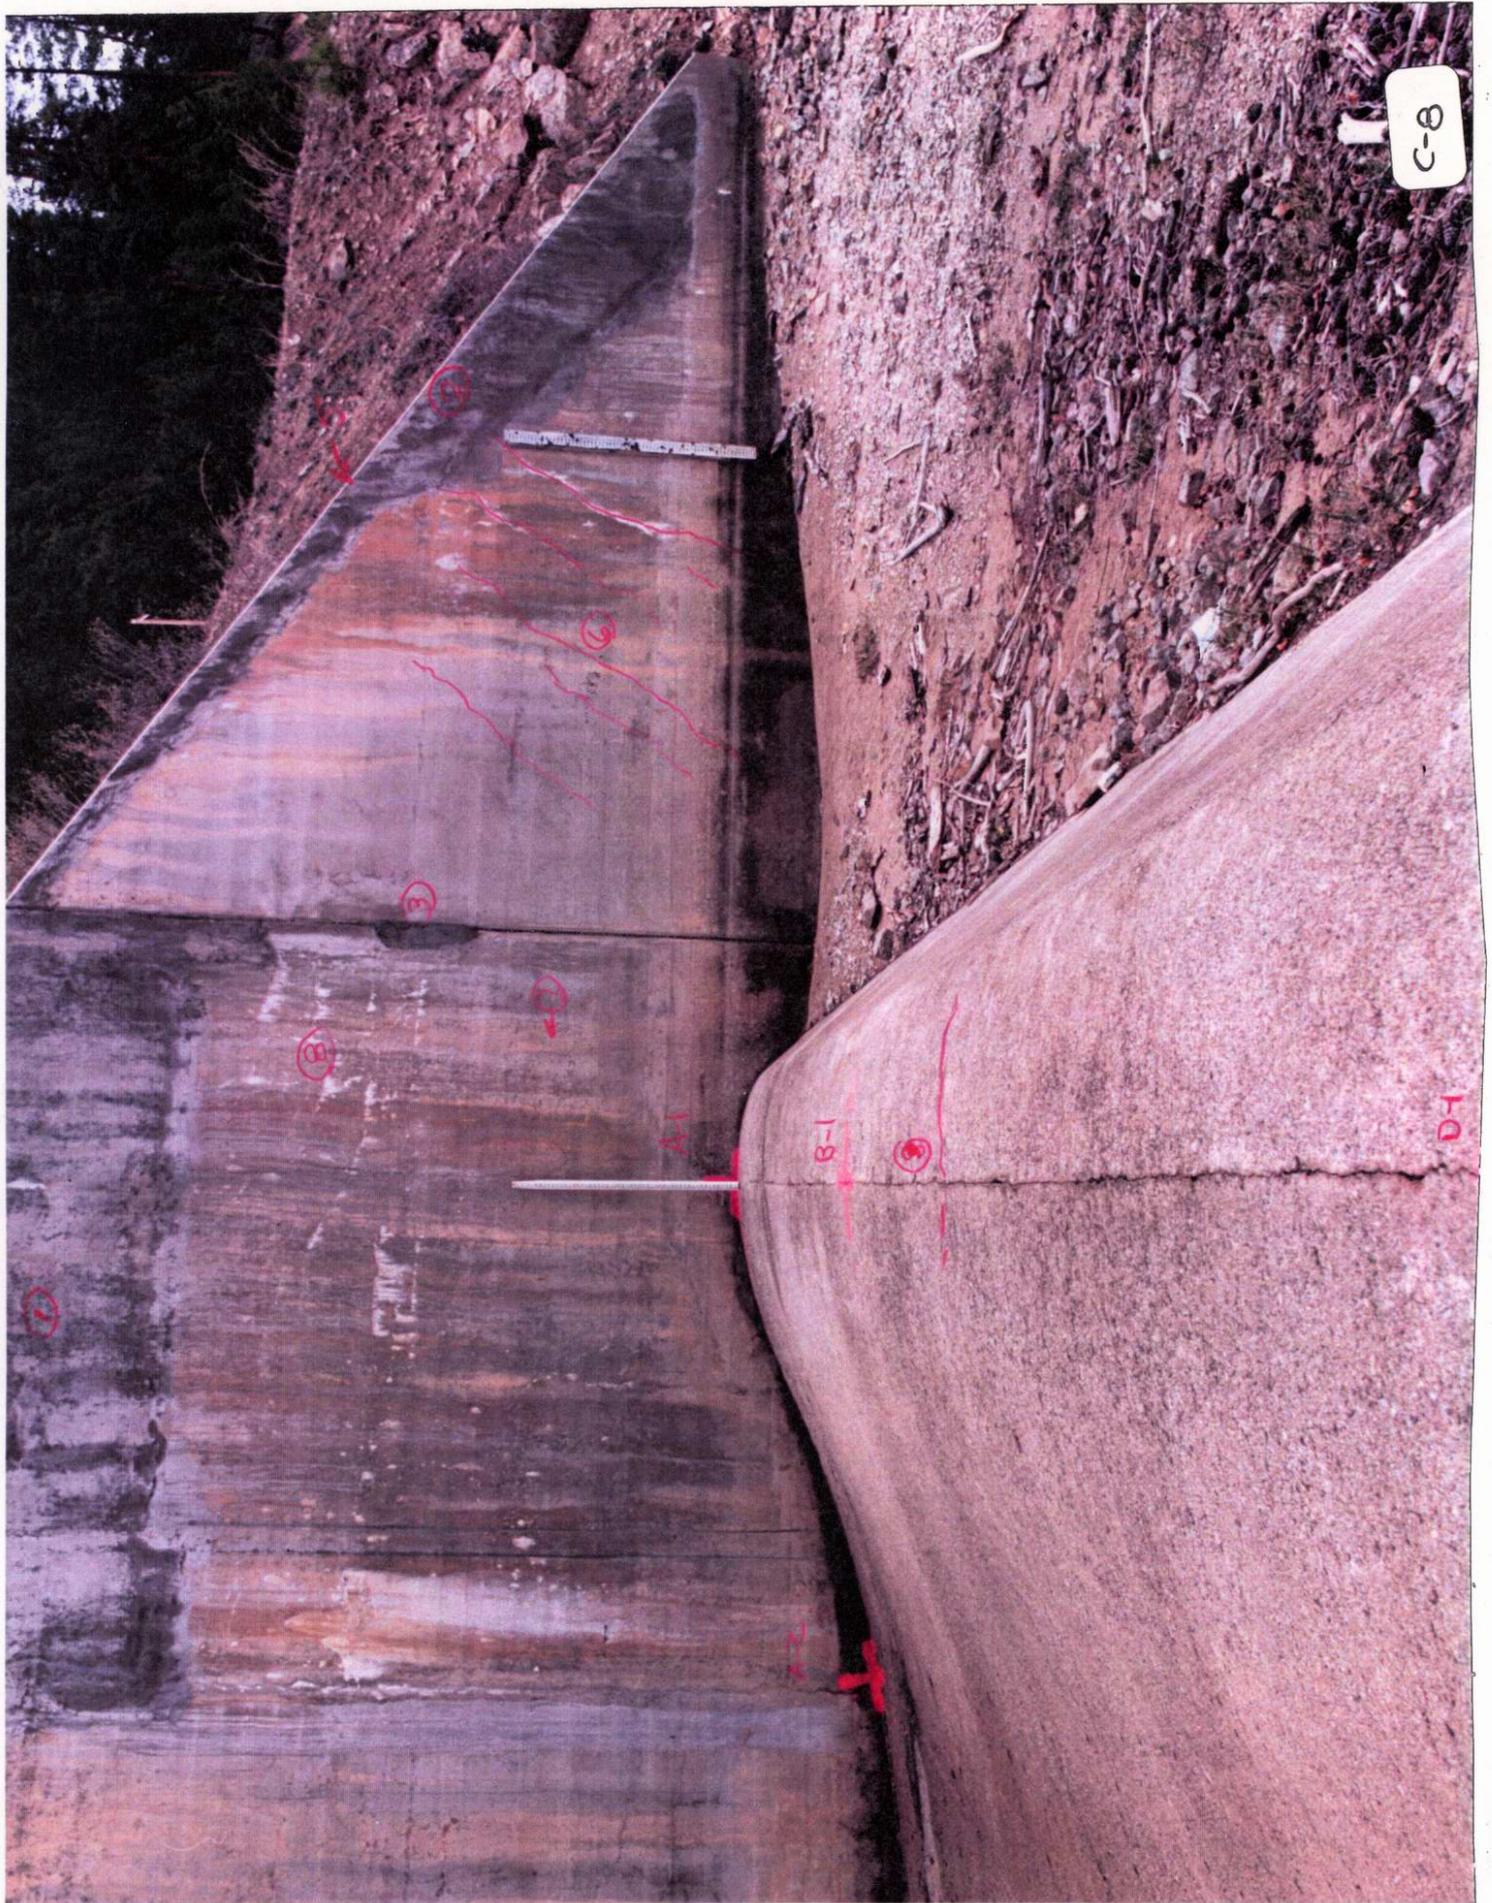
C-8

8. Depicts the horizontal cracking along the right spillway wall. The leaching coming from these cracks causing the white staining in the photographs indicate that these cracks most likely go through the wall. The spacing is from 1/2 inch to approximately 1 foot in distance. The leaching buildup comes out from the wall surface up to a maximum of 1 inch in this area. A coarse crazing pattern also exists through these fractures.

9. A transverse crack that goes through the crest about 7 feet downstream of B-1 and goes through the construction joint and continues on down through the next concrete construction section. Crack openings from 1/2 inch to 1 inch with an average of 1/16 to 1 inch opening. It should be noted that minor spalling in two or three locations was found at the reservoir and crest contact.

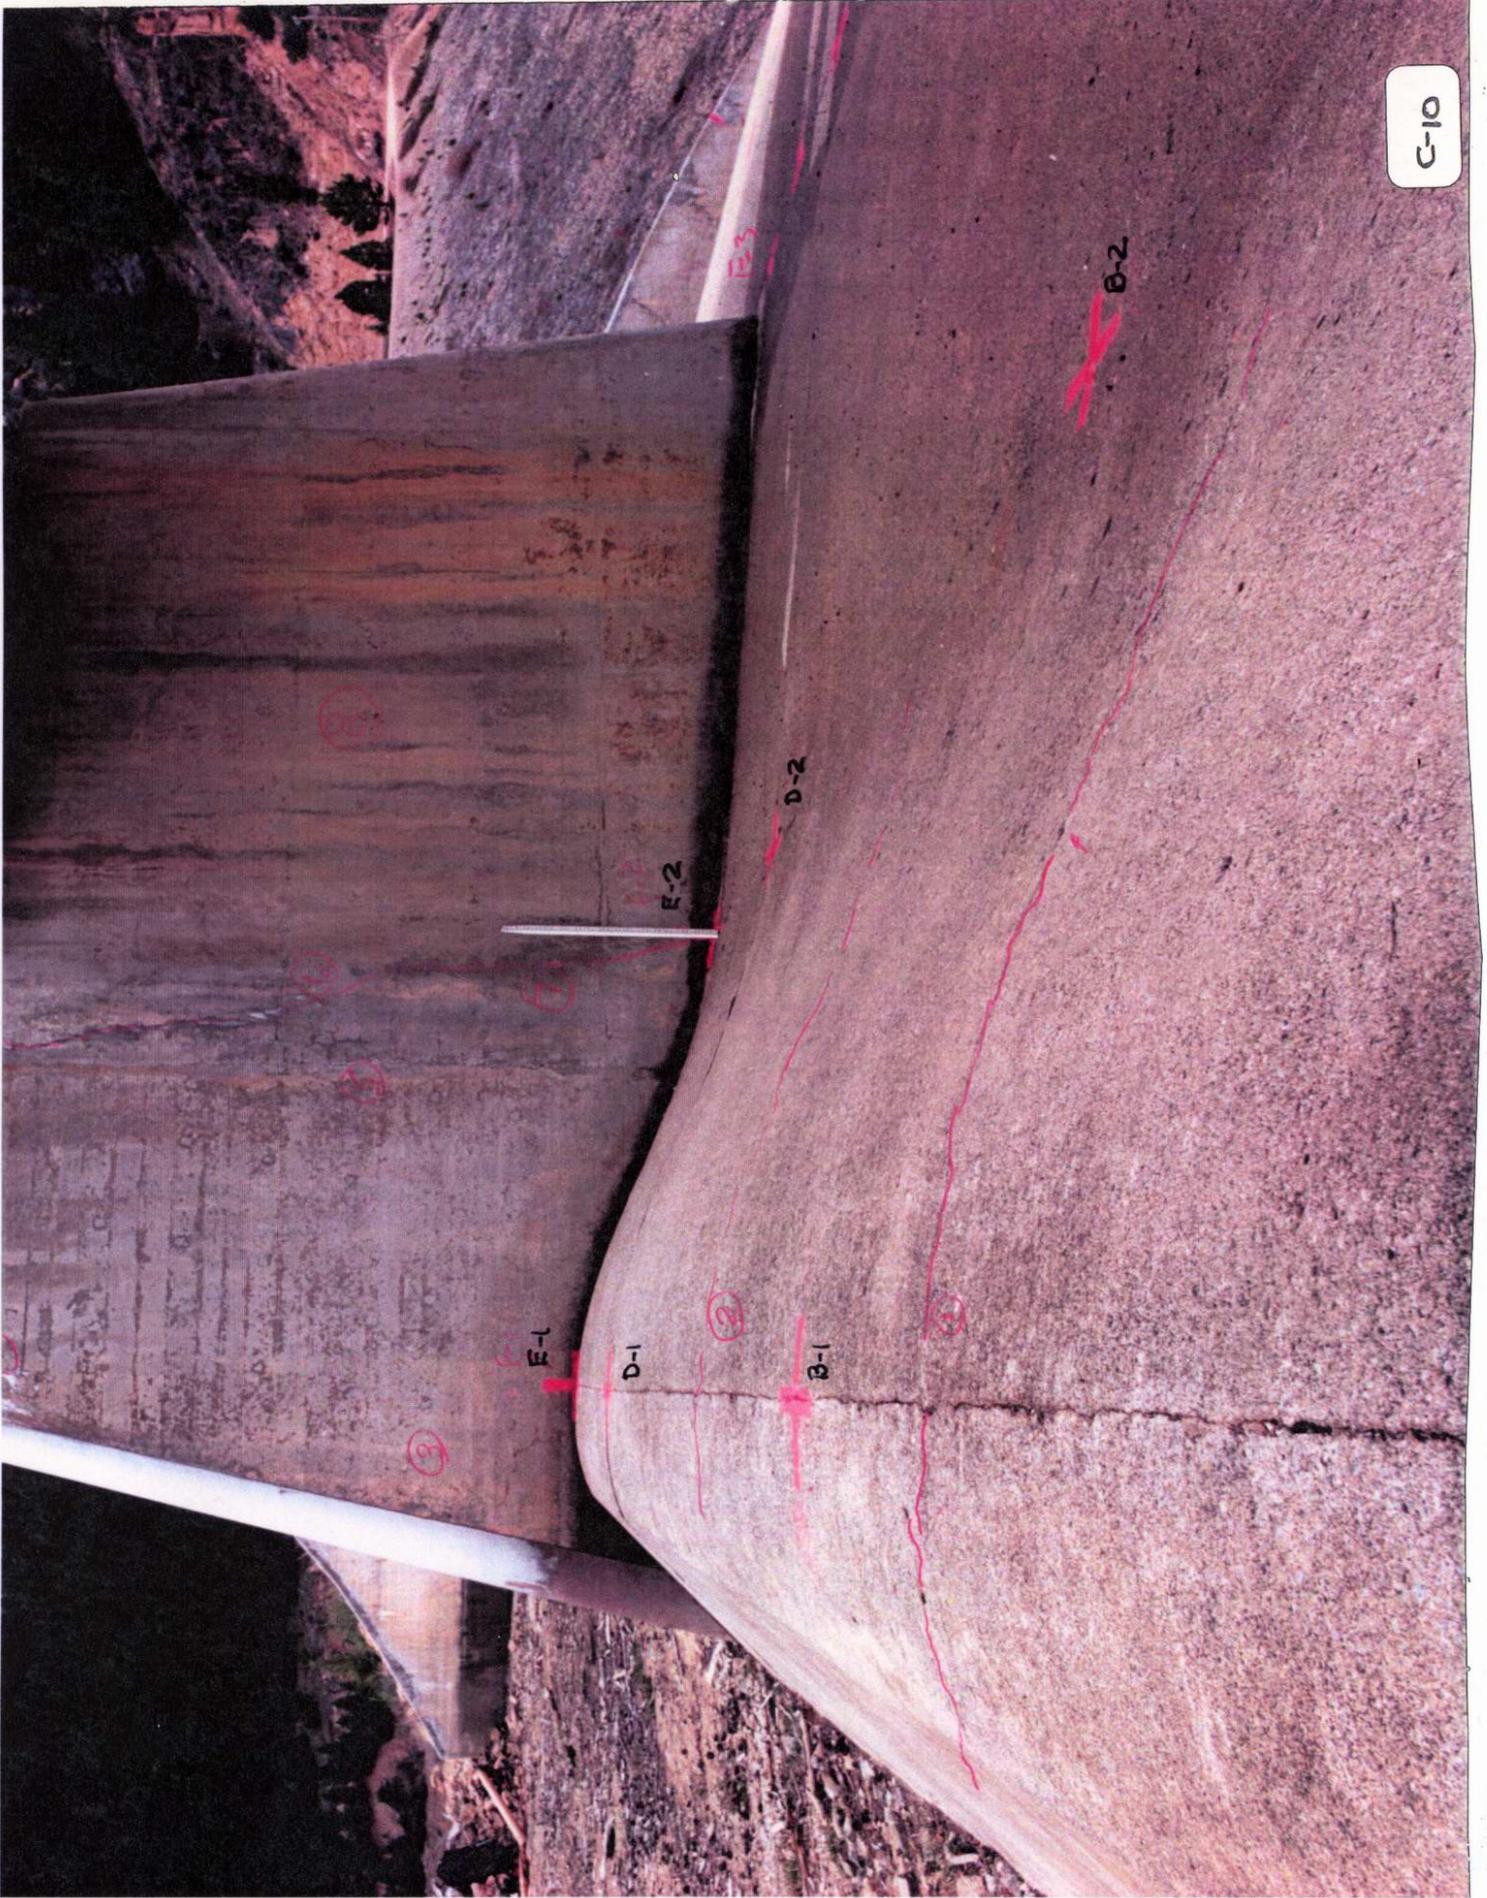
## SUMMARY SHEET PHOTO C-10

8. The downstream end of the pier, indicates the surfacing has been trowelled to subdue and underlying concrete conditions. There is a crazing pattern of fine to medium texture reflecting through and so areas in this section show some small portions of hairline type cracks. Small pieces only an inch or two in length could be observed in this area. The circular grout filings for the tiebacks can be seen throughout this section. General comments - It should be noted that the two different types of work are the earlier work using board forming with the horizontal board pattern shown and then the edge where a plywood forming was obviously to give a much bigger forming section.
