PAINTED ROCKS DAM  
2016 SPILLWAY CHUTE INVESTIGATION  
INFORMATION PACKET

# PAINTED ROCKS SPILLWAY

INVENTORY NO.: MT-19  
 HAZARD CATEGORY: HIGH  
 TYPE OF DAM: Zoned Earth Fill  
 YEAR BUILT: 1938  
 YEAR REHABILITATED: 2011-2015

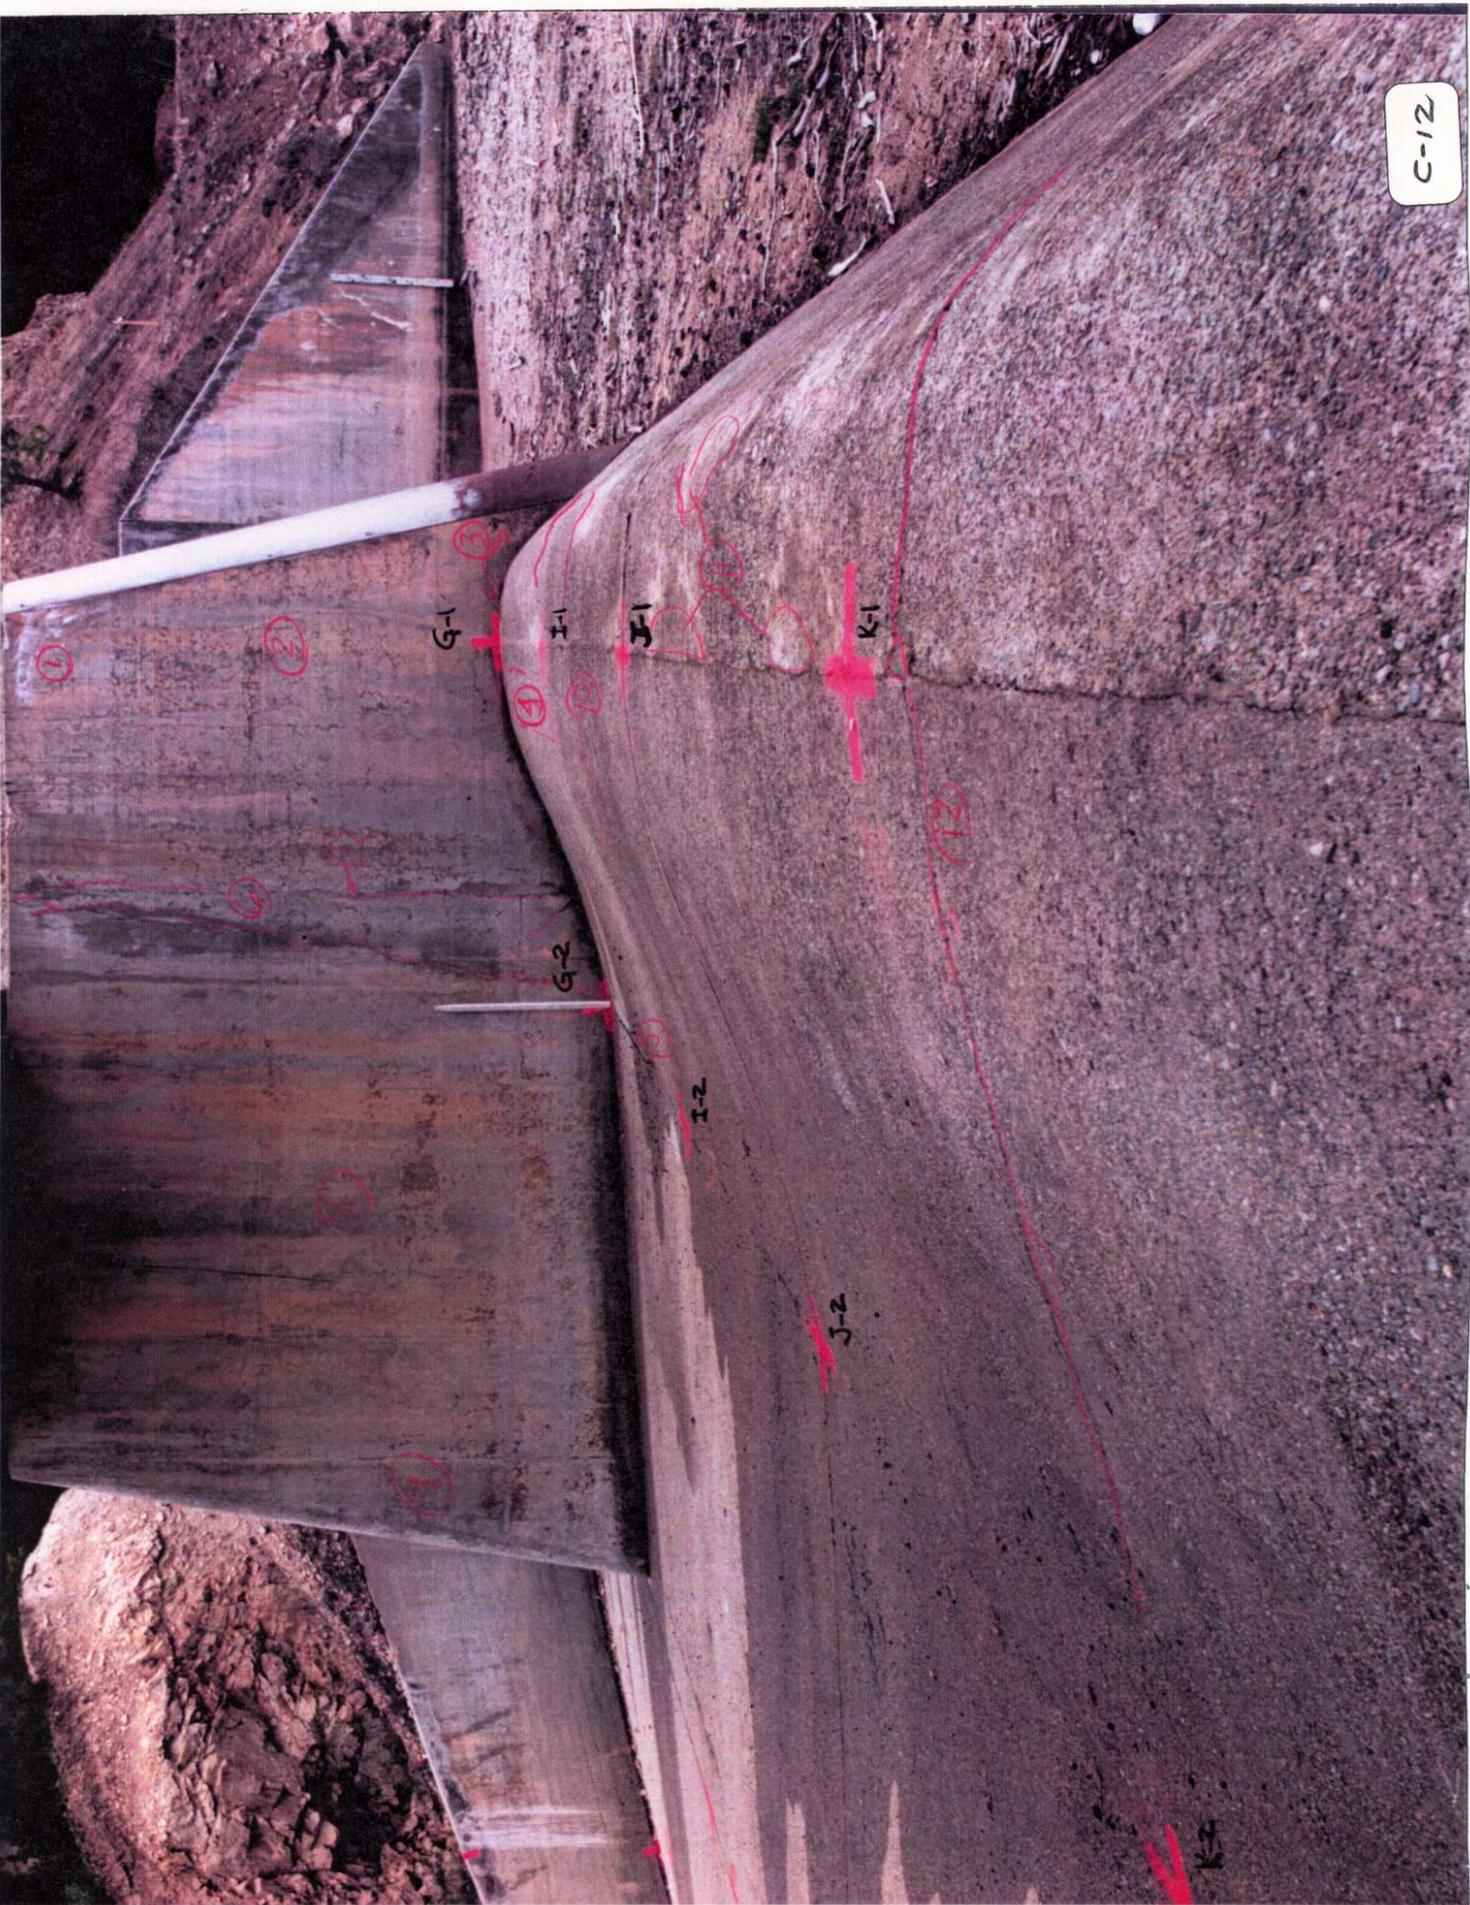
C-12

8. The new finishing with a topping coarse that is masking the concrete below, similar to the other side of this pier.
9. Downstream edge of this pier shows a fine to medium crazing pattern developing in parts of this structure.

10. Transverse cracking between I-1 and J-1 along the crest of the spillway. Note on the reservoir side some spalling associated with the longitudinal crack. Crack is about 1/8 to 1/4 inch in width and moves down to line 2 of the next concrete pour. Old patch lines developing between K-1 and J-1 along the crest line that have some the upstream portion shows some radial-type minor cracking. At J-1 there is a small longitudinal crack parallel to the joining D-like cracking pattern. It's very small and is the first one noted. Large longitudinal crack on the upstream edge, some spalling, some rock aggregate exposed. There is obviously a need for some minor repair work on this crack. This crack is quite strong, it's anywhere from 1/2 inch to 3/4 inch throughout it's length and goes down through K-2 and into the next slab.

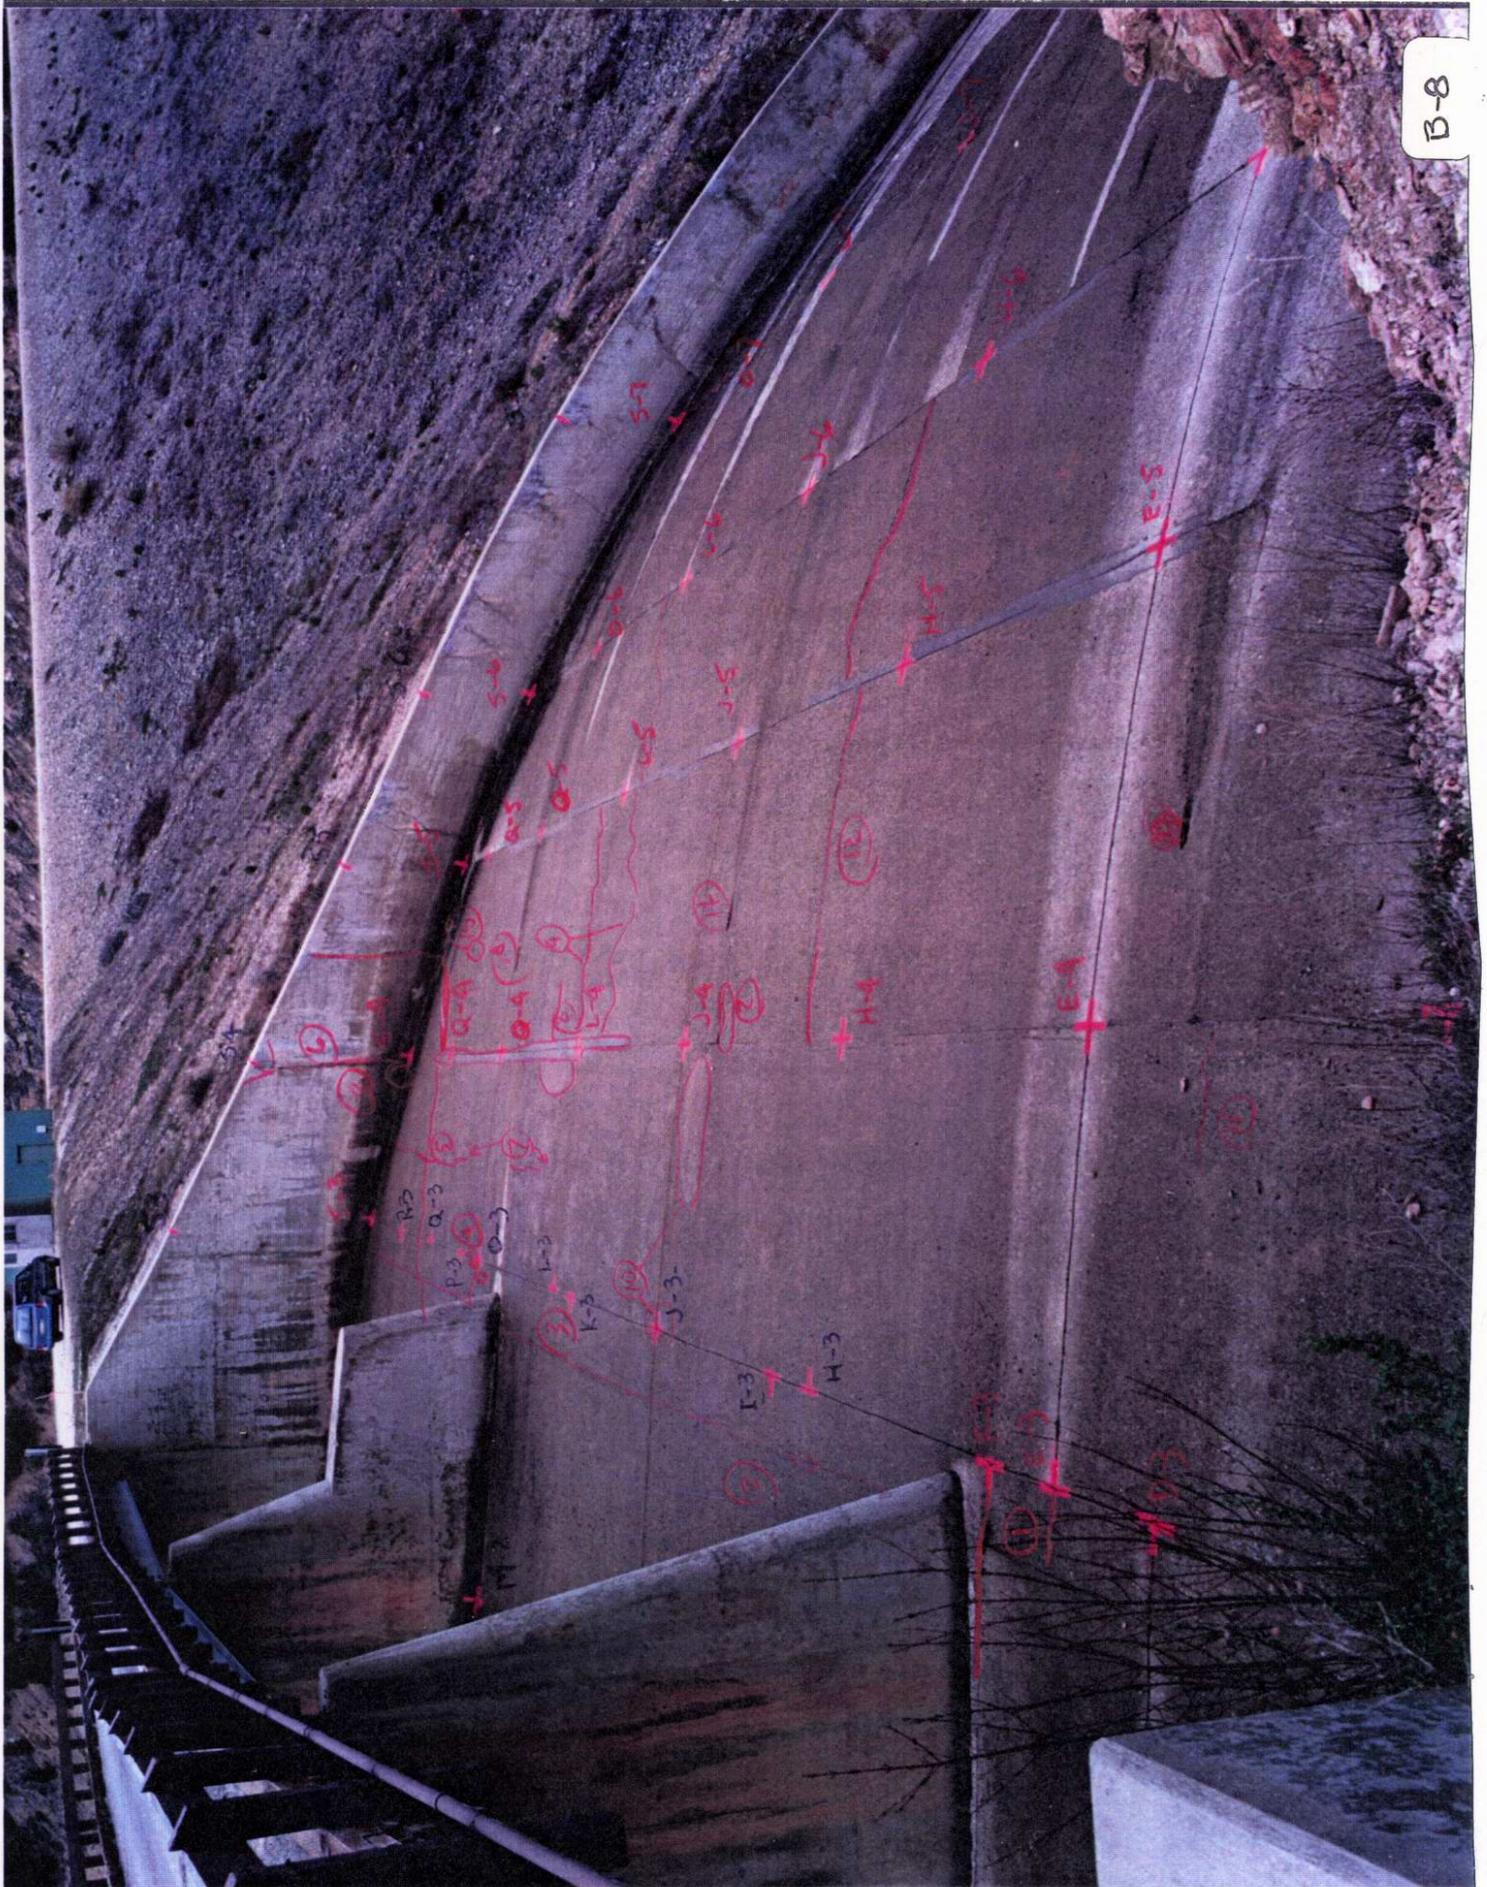
B-8

9. Is a 7 to 8 foot long transverse crack from line 4. It goes to the next construction joint about 5 feet north of L-5.
10. A large patch with some of the medium to fine crazing cracking, There is also a transverse crack which may actually be a small joint in the concrete. The square patch that is found at J-3 control point is new in 2 parts. There is no cracking in it, and it may be a good monitoring point.

11. Hairline to 1/16 inch longitudinal crack. Looks like it has been there for quite a while and has very little activity.
12. Is a longitudinal crack about 3/4 inch wide at the downstream side down to 1/8 of an inch at the joint at the upstream side. It's an old fracture, and it doesn't appear to have movement recently.
14. Upper weep holes. The three drain pipes that were placed along the spillway all show fairly good staining, indicating the drainage is working.
15. A small round 1/2 inch pop-out. The pop-out is quite deep, and there is a lot of iron staining coming out from under it. It's interesting because the pop-out and iron ball are not very common in this concrete.

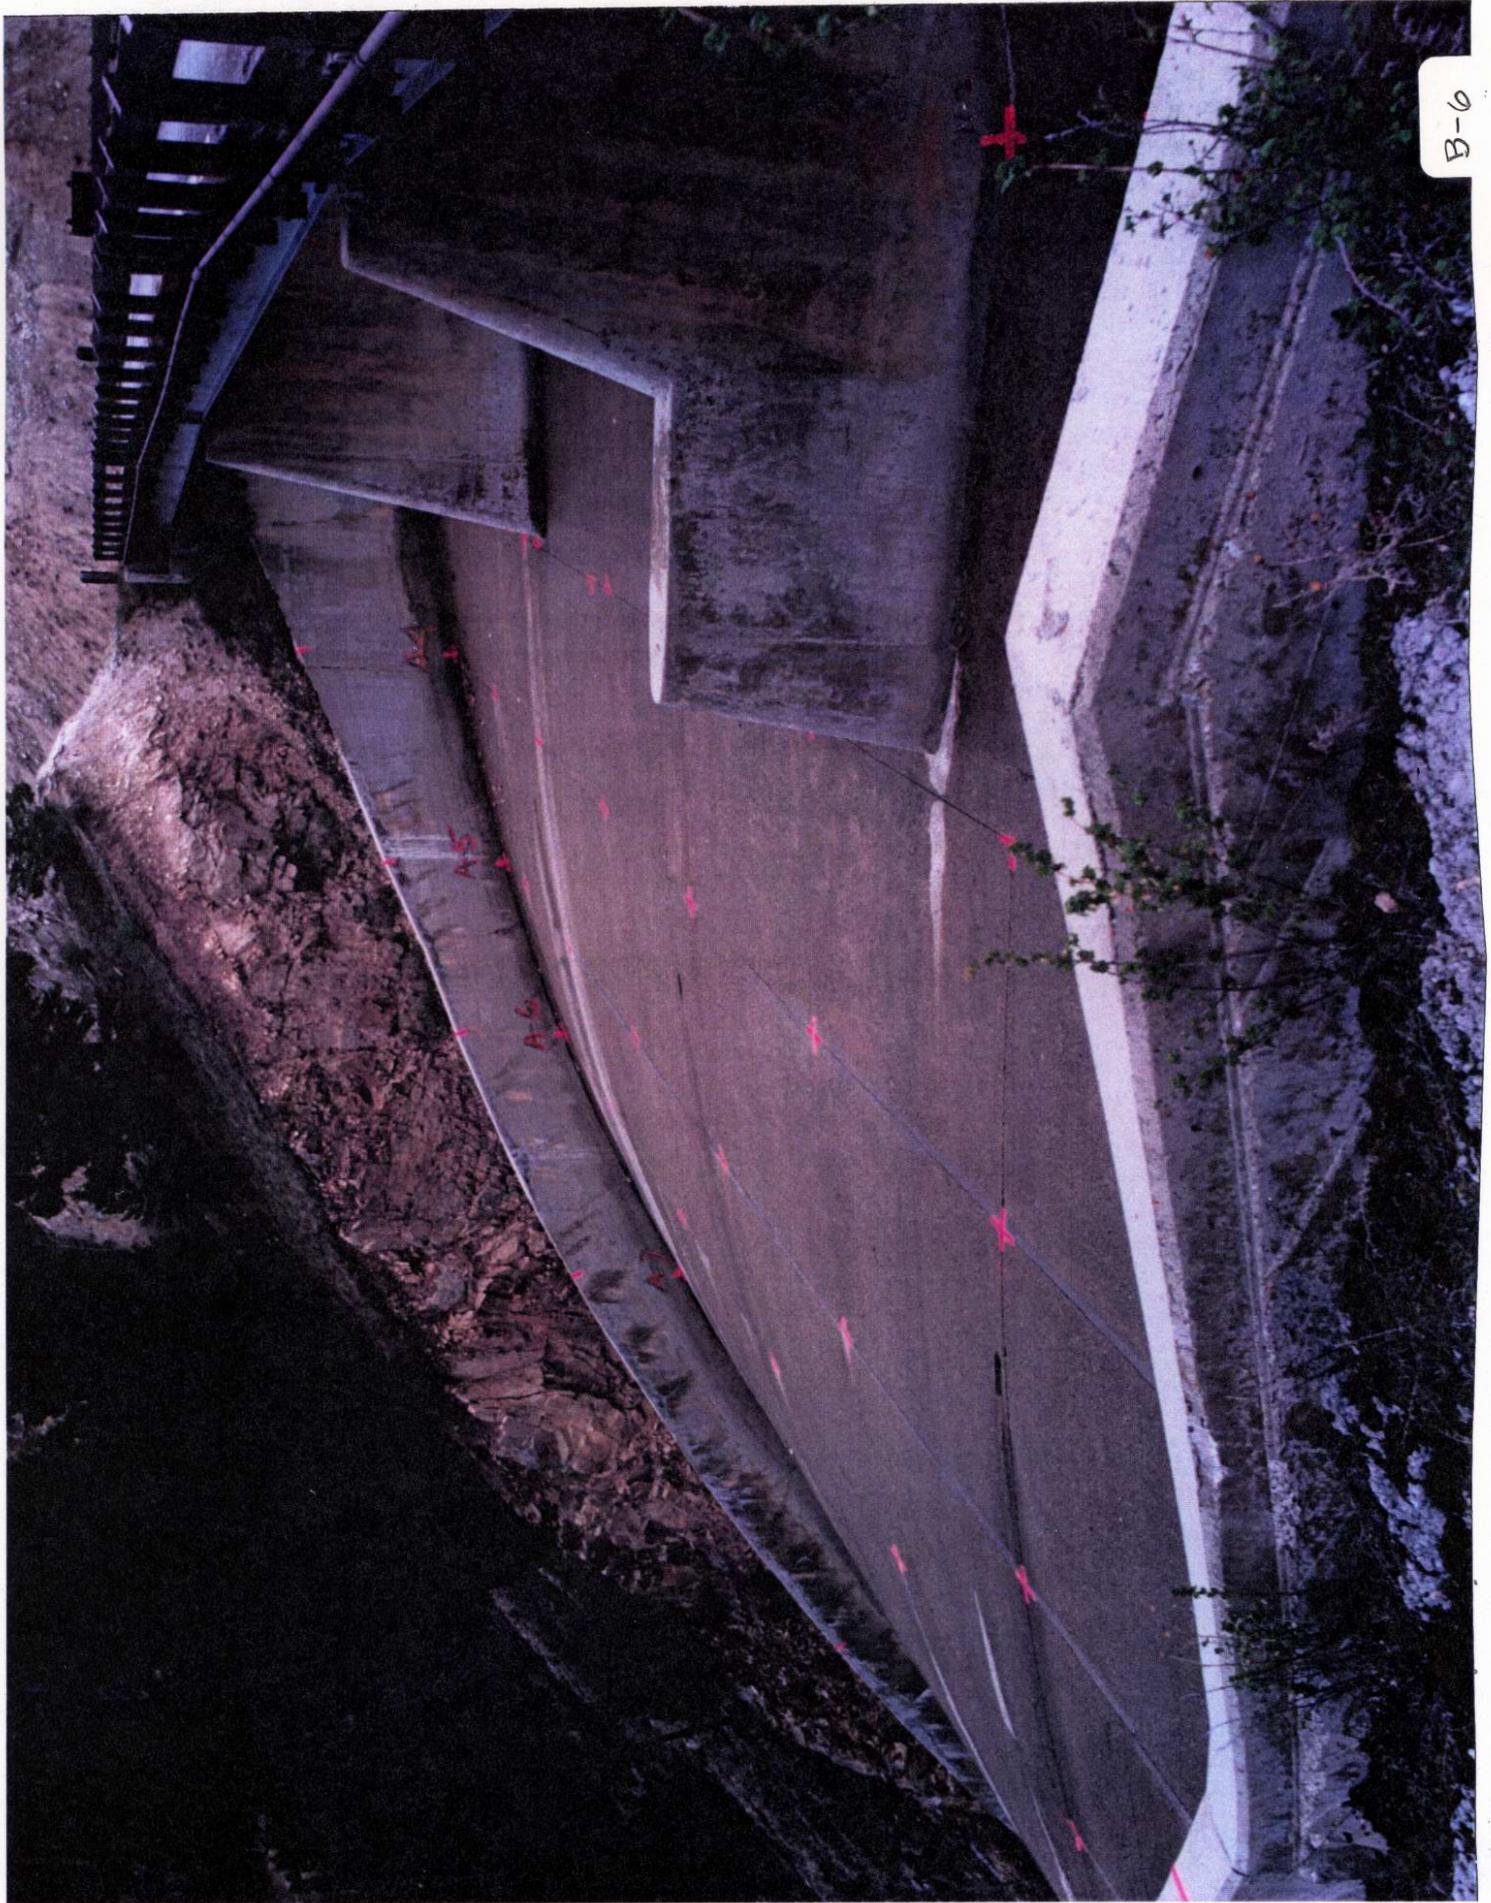
Photograph B-6 has been covered by Photo E-2.

1. Use Photograph E-2 as a close-up. It should have a better definition than this photograph.
2. This photograph is useful for the extensive view of the overhanging rock outcrop above the right wall.

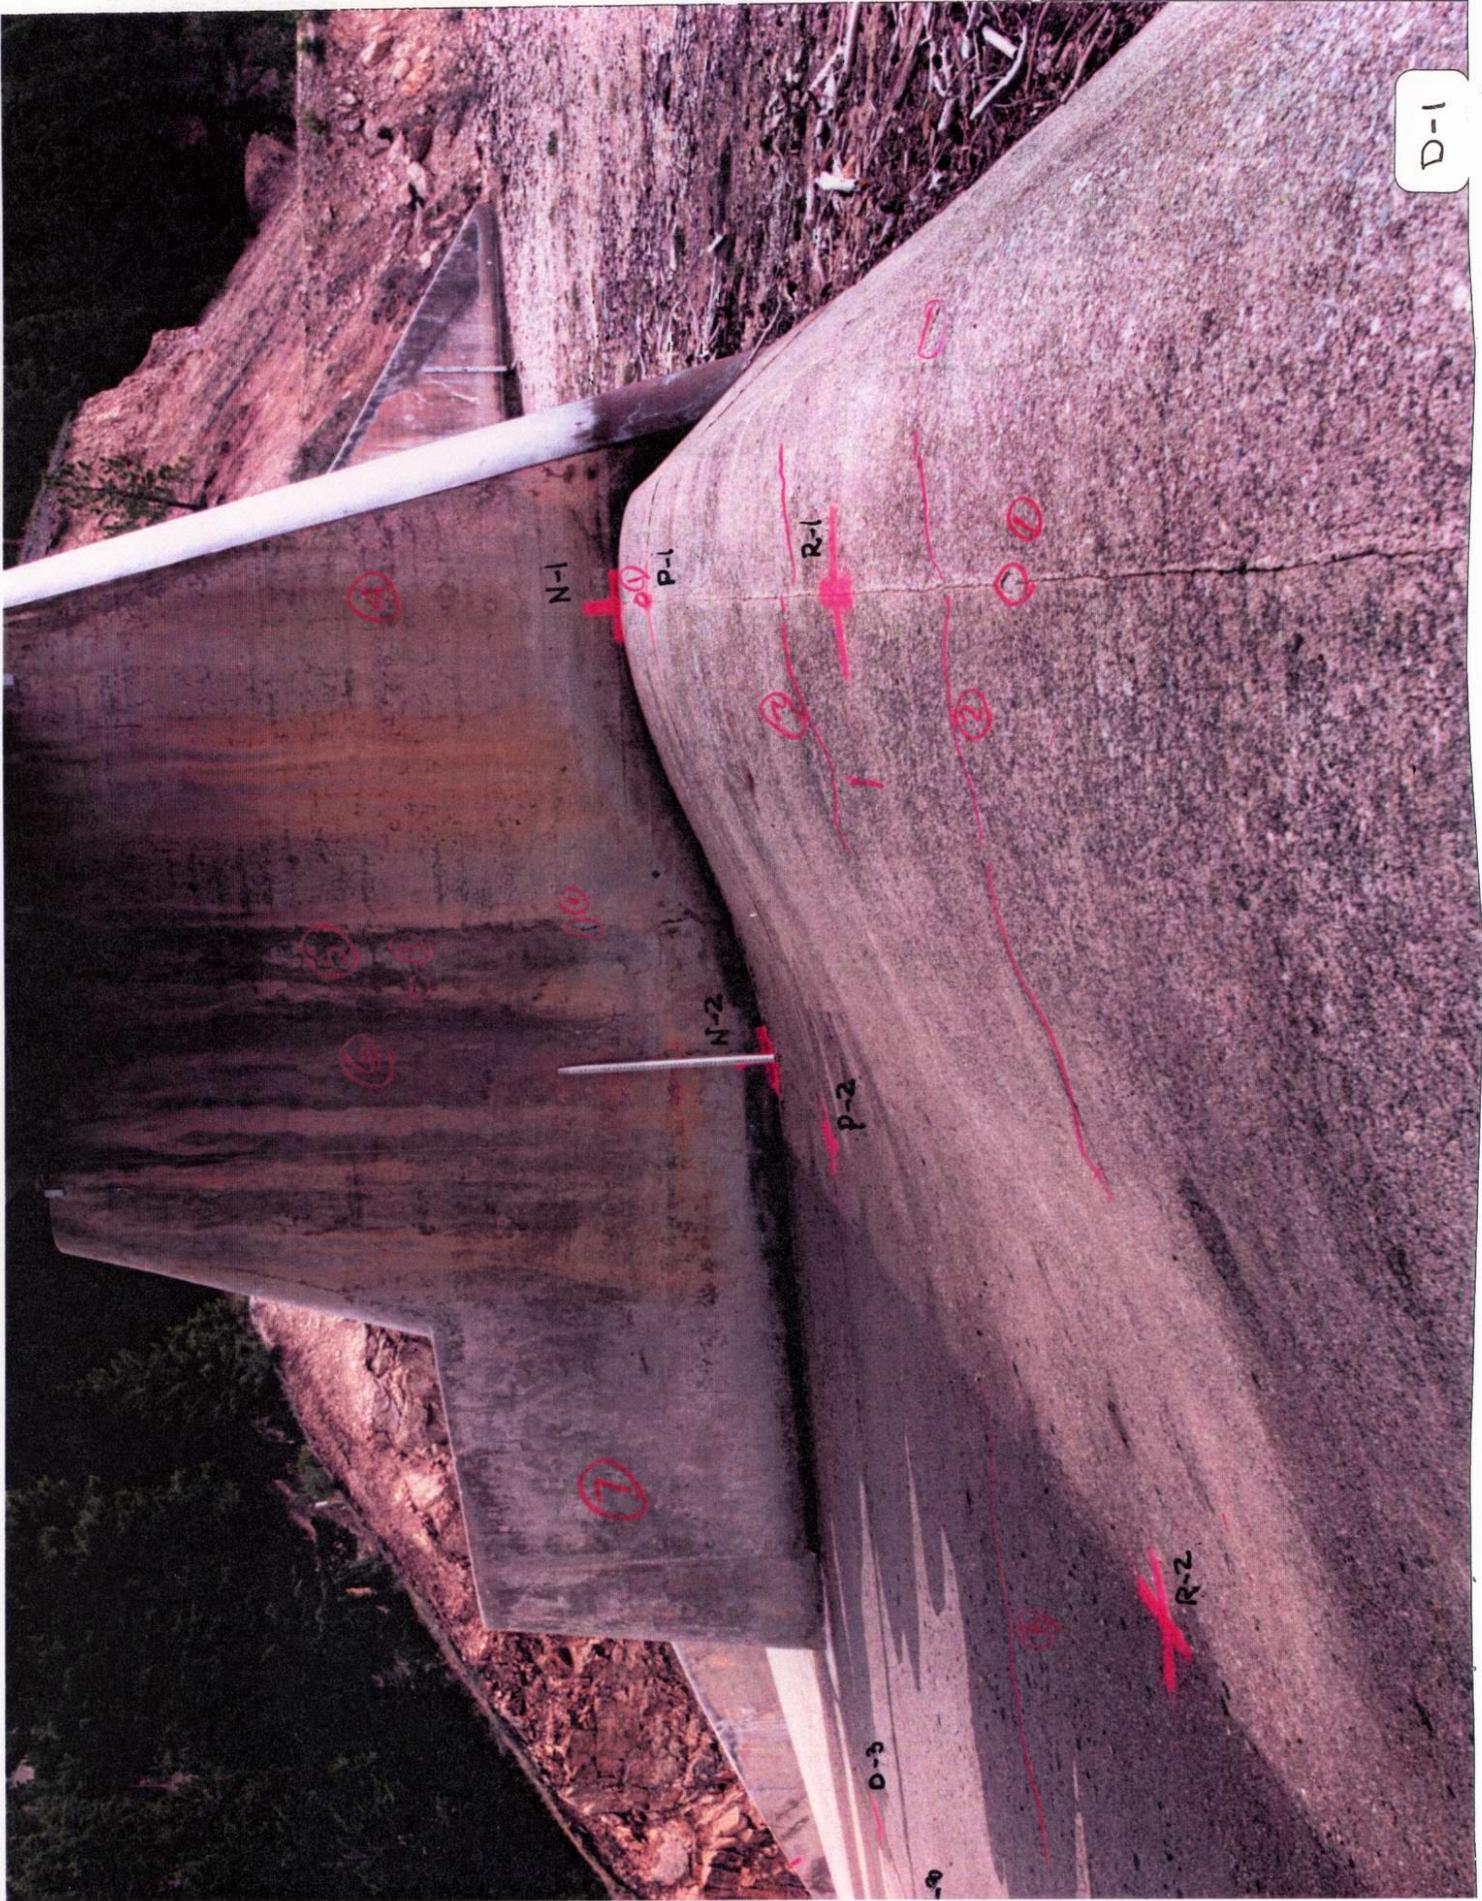
D-1

6. A very fine crazing cracking is reflected through the surfacing with a very small 1/2 inch or less in pattern extending for about 4 feet wide on the downstream section. The yellowish looking concrete has a coarser pattern of the crazing cracking with a few of the tieback grouted hole reflecting through.

7. Gray colored concrete with a surface cover. Craze cracking has been reflected through all the surfacing on a very fine pattern to medium size pattern as you get to the end of the pier downstream. These are all hairline cracks.

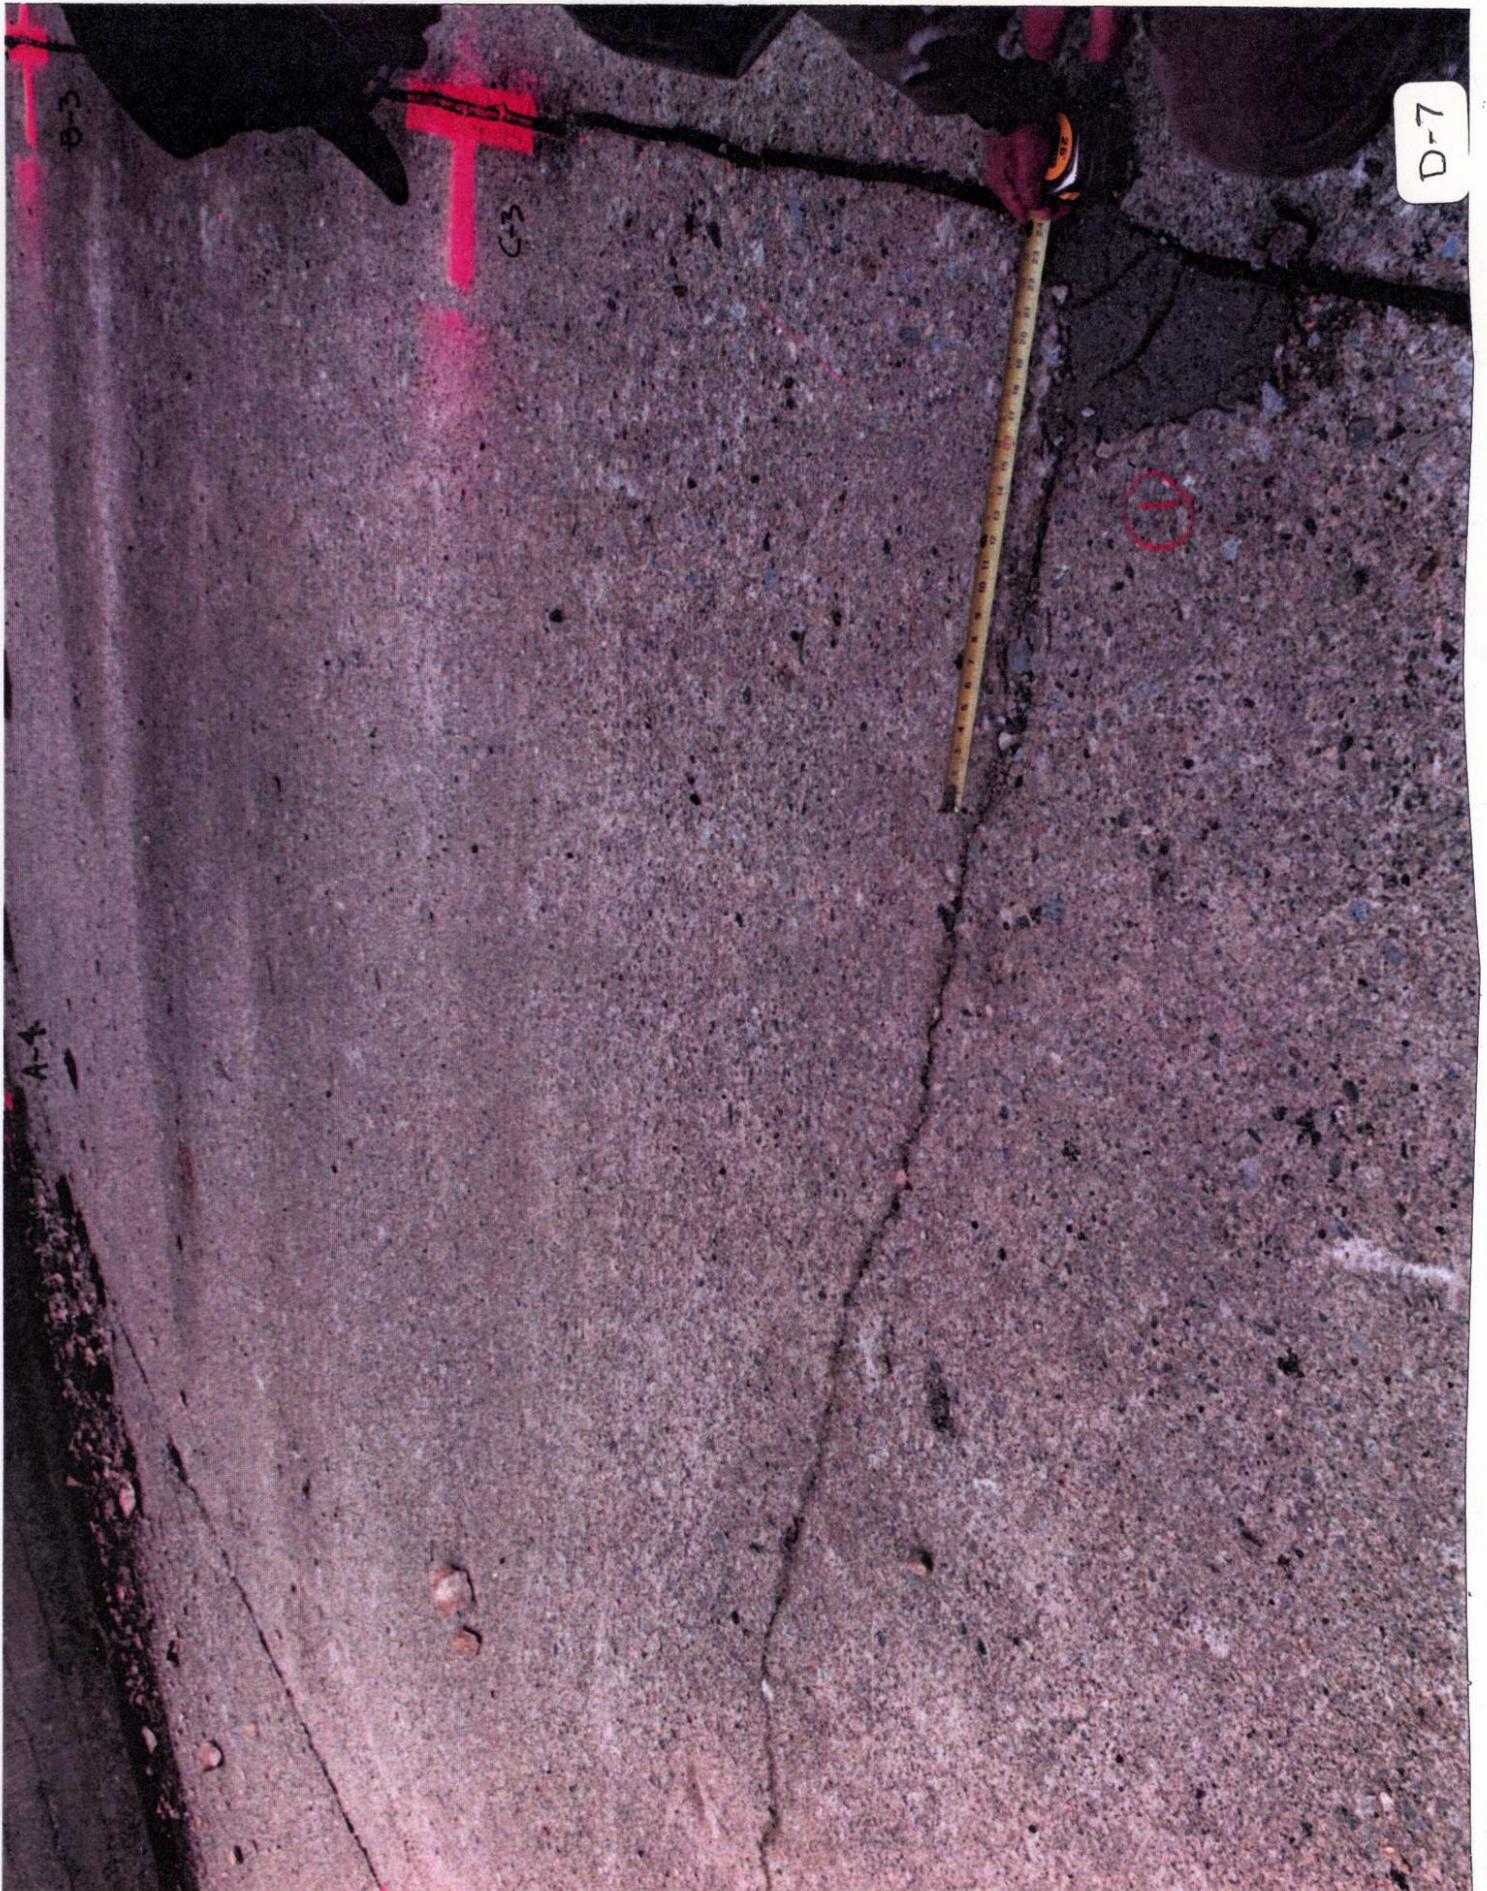
D-7

1. Shows the patch left of C-3. Note the big cracks in the patch. See comment on photograph D-6.

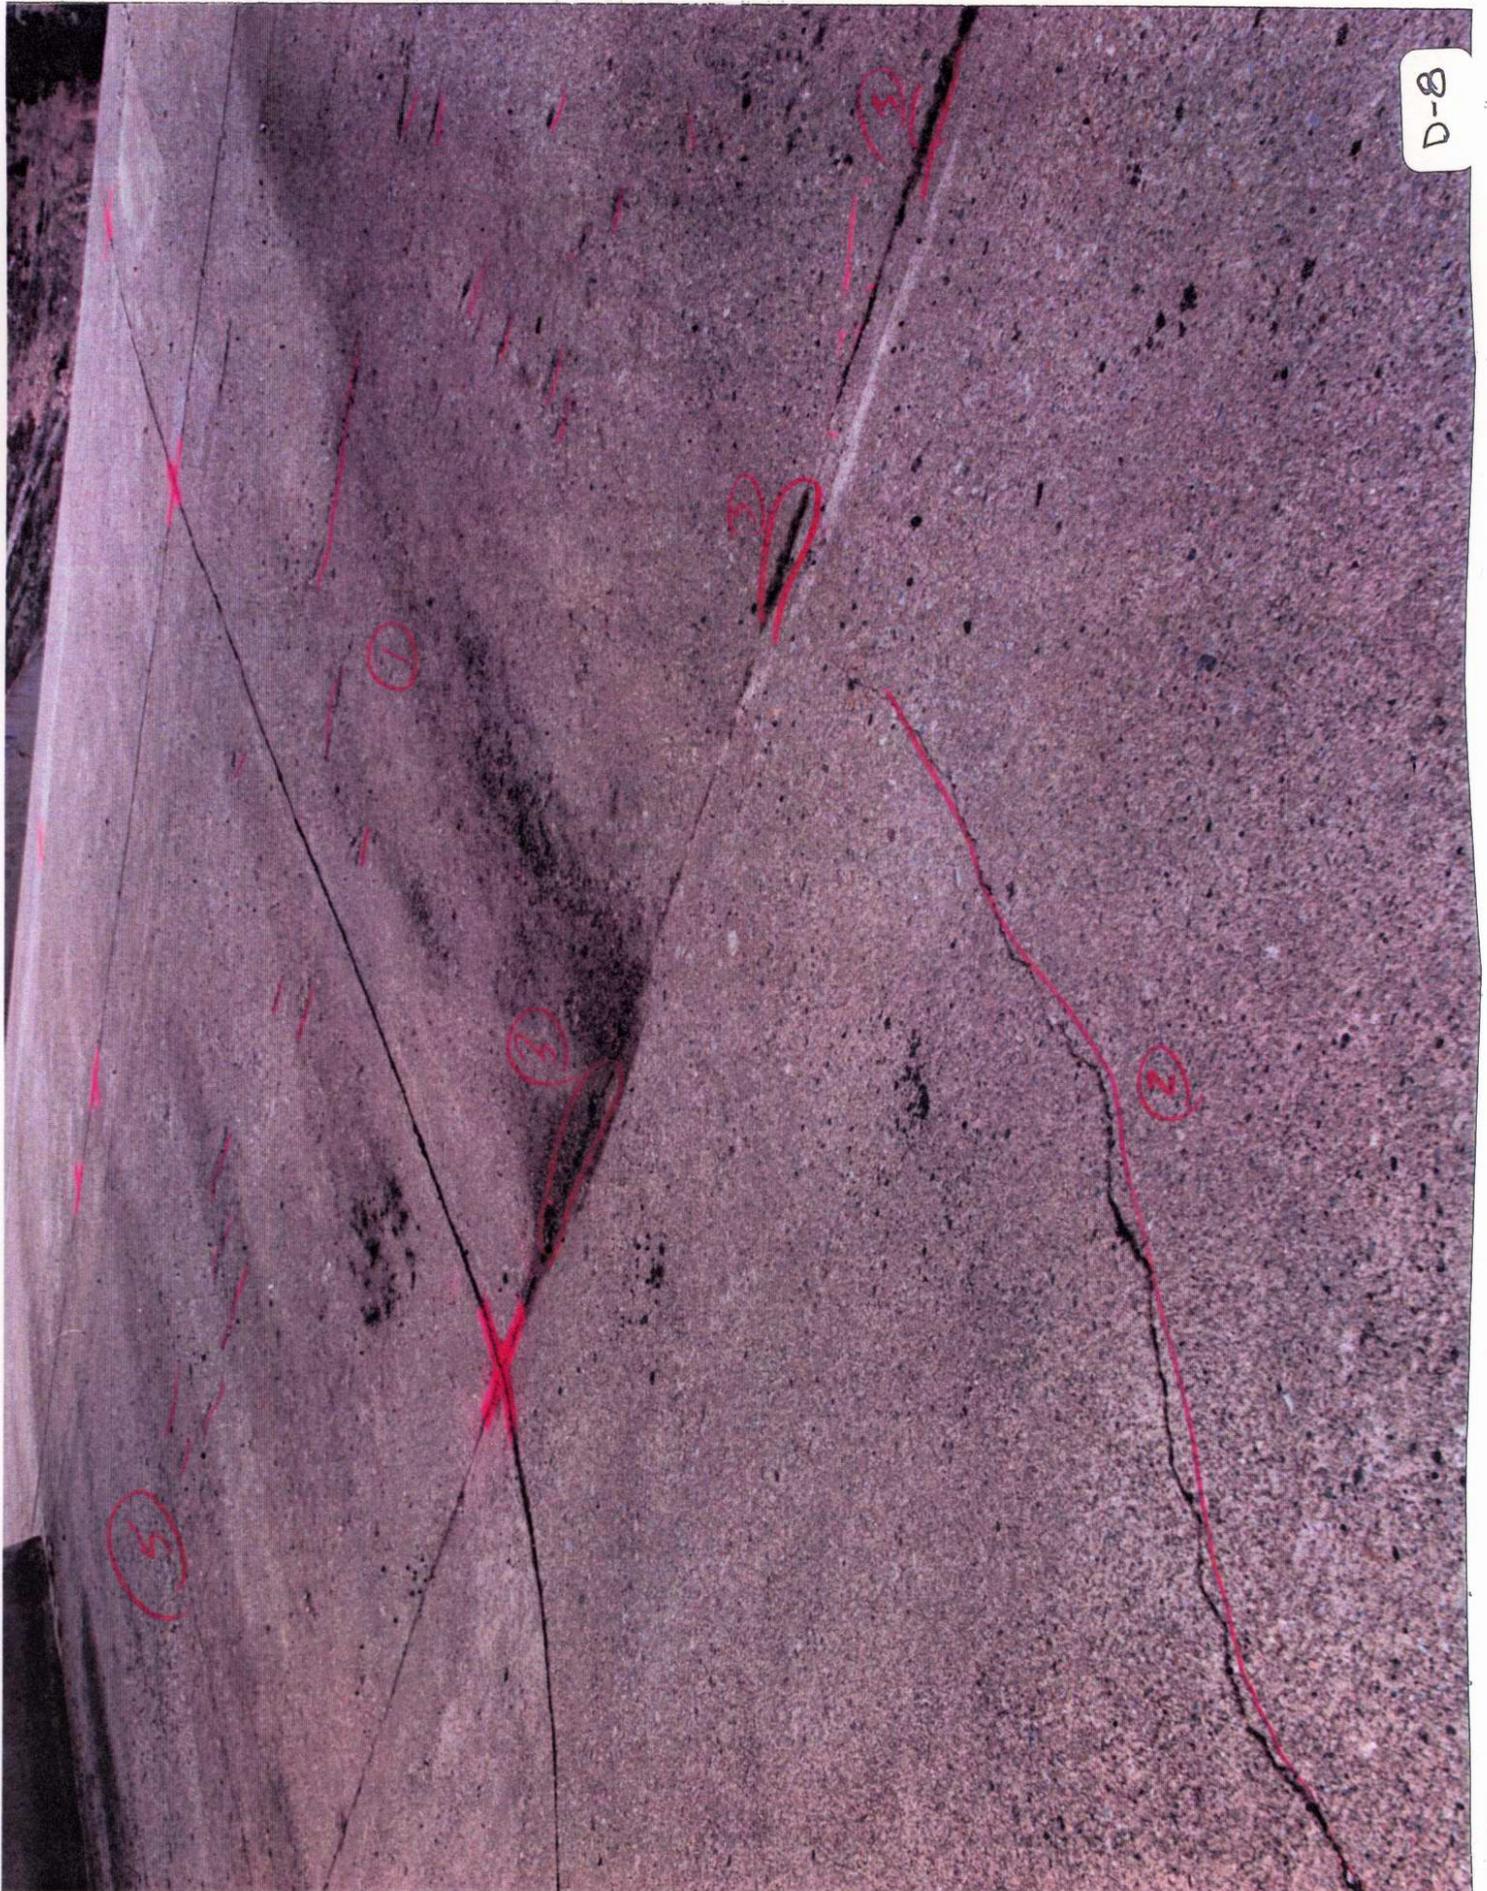
D-8 View downstream of upper spillway floor. General - field observations were not recorded and the observed cracking is shown without comments and will require field examine to evaluate these cracks.

1. Short transverse cracking described in comment No. 3 on Photo D-6.
2. Longitudinal crack.
3. Spalling cracks along construction joint.
5. Longitudinal crack.

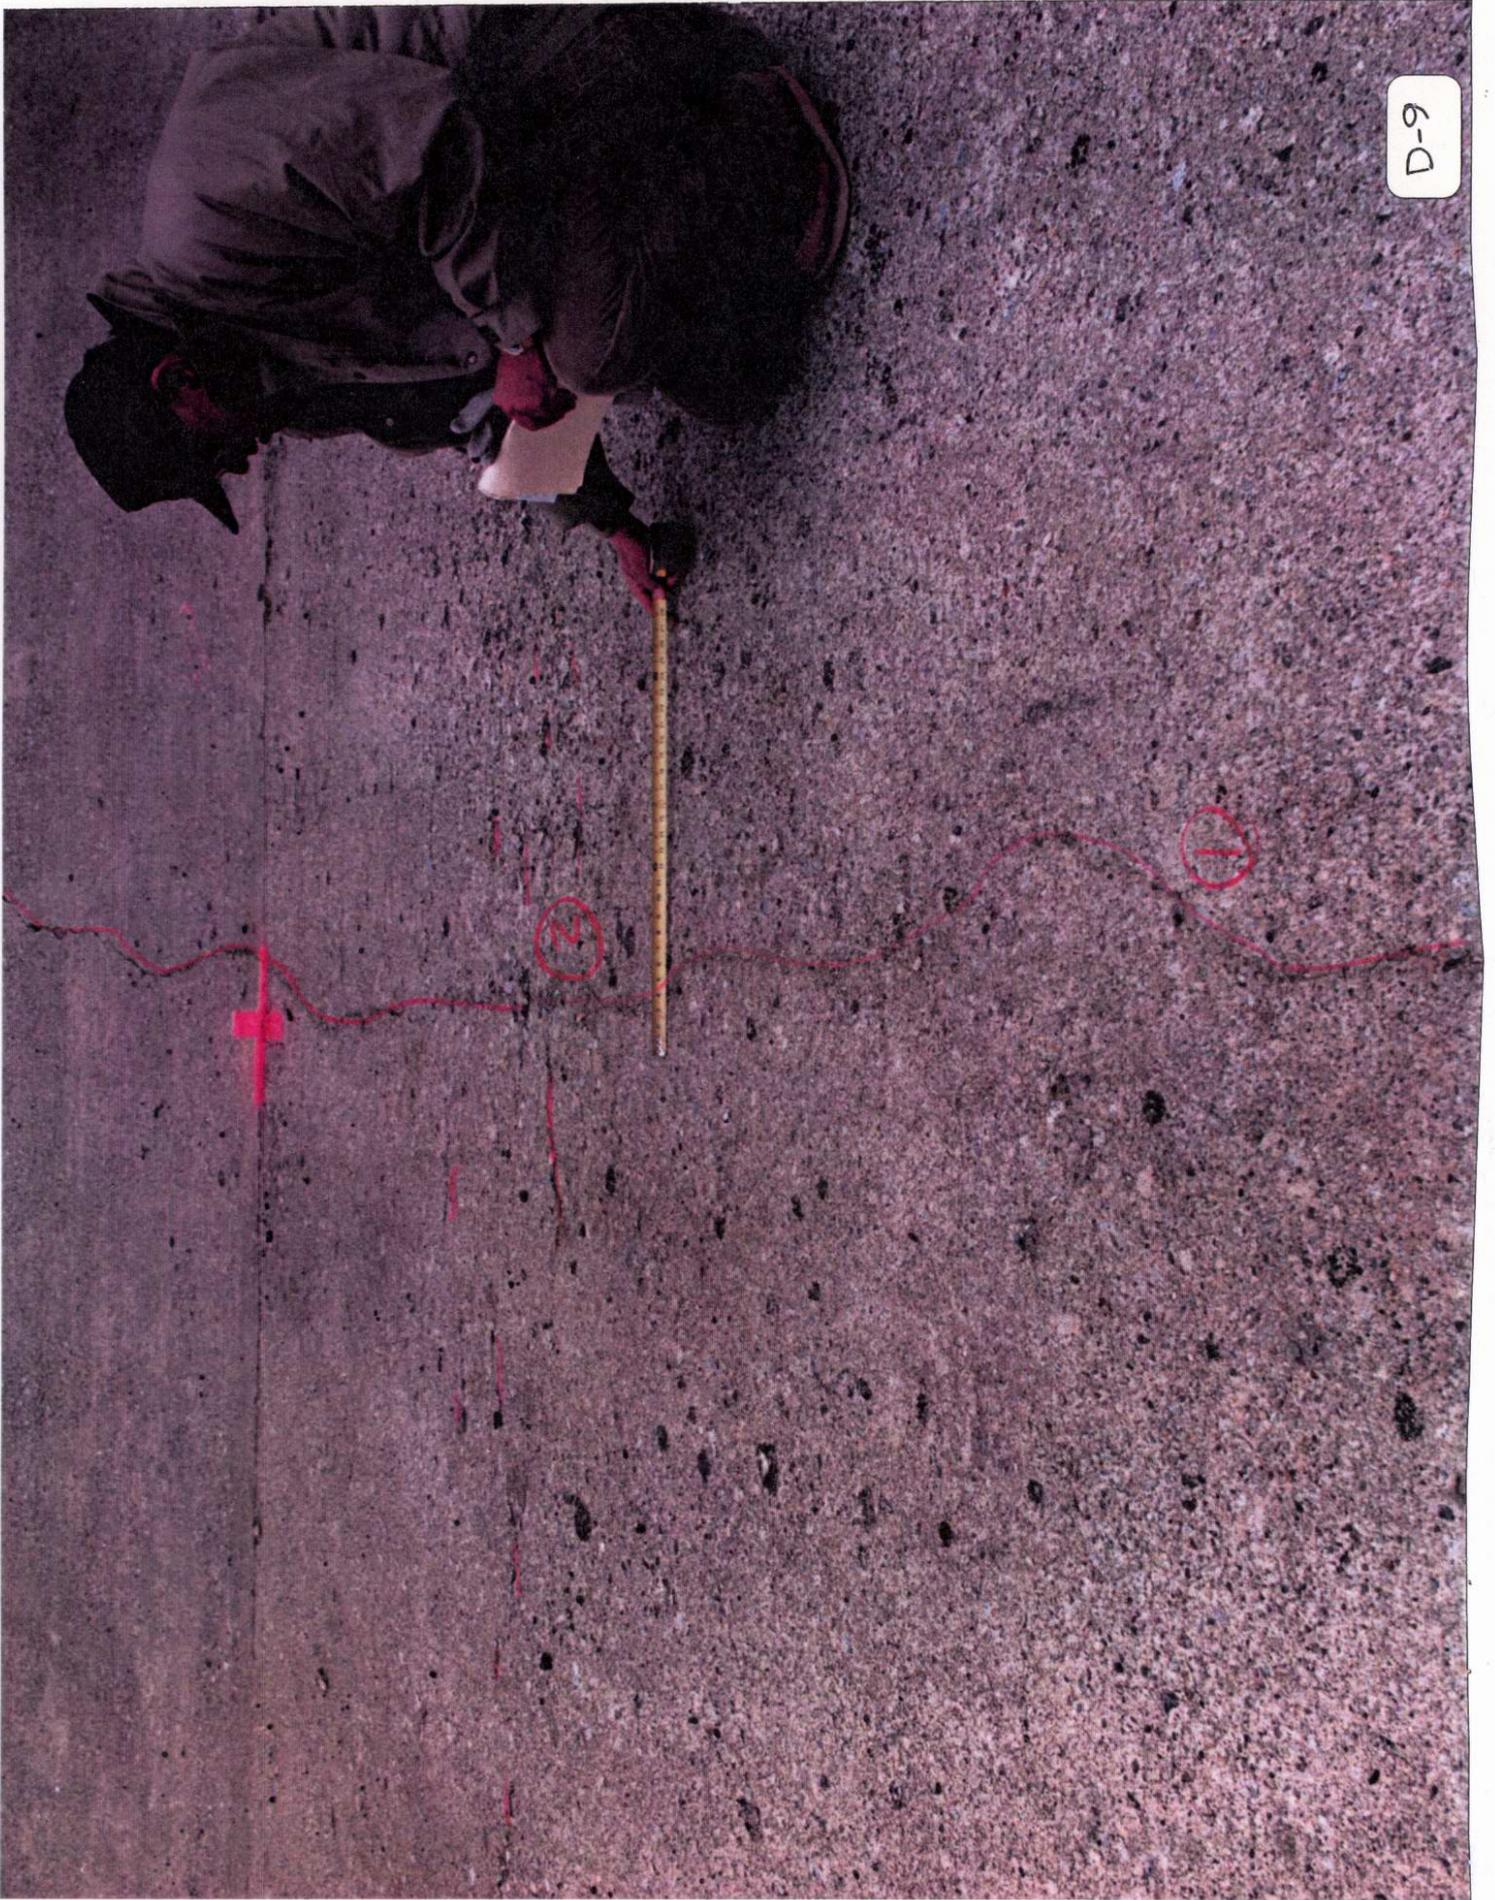
D-9 View downstream of upper spillway floor. General- field observations were not recorded and the shown features will require field examination for cracking details.
