PAINTED ROCKS DAM  
2016 SPILLWAY CHUTE INVESTIGATION  
INFORMATION PACKET

# PAINTED ROCKS SPILLWAY

INVENTORY NO.: MT-19  
 HAZARD CATEGORY: HIGH  
 TYPE OF DAM: Zoned Earth Fill  
 YEAR BUILT: 1938  
 YEAR REHABILITATED: 2011-2015

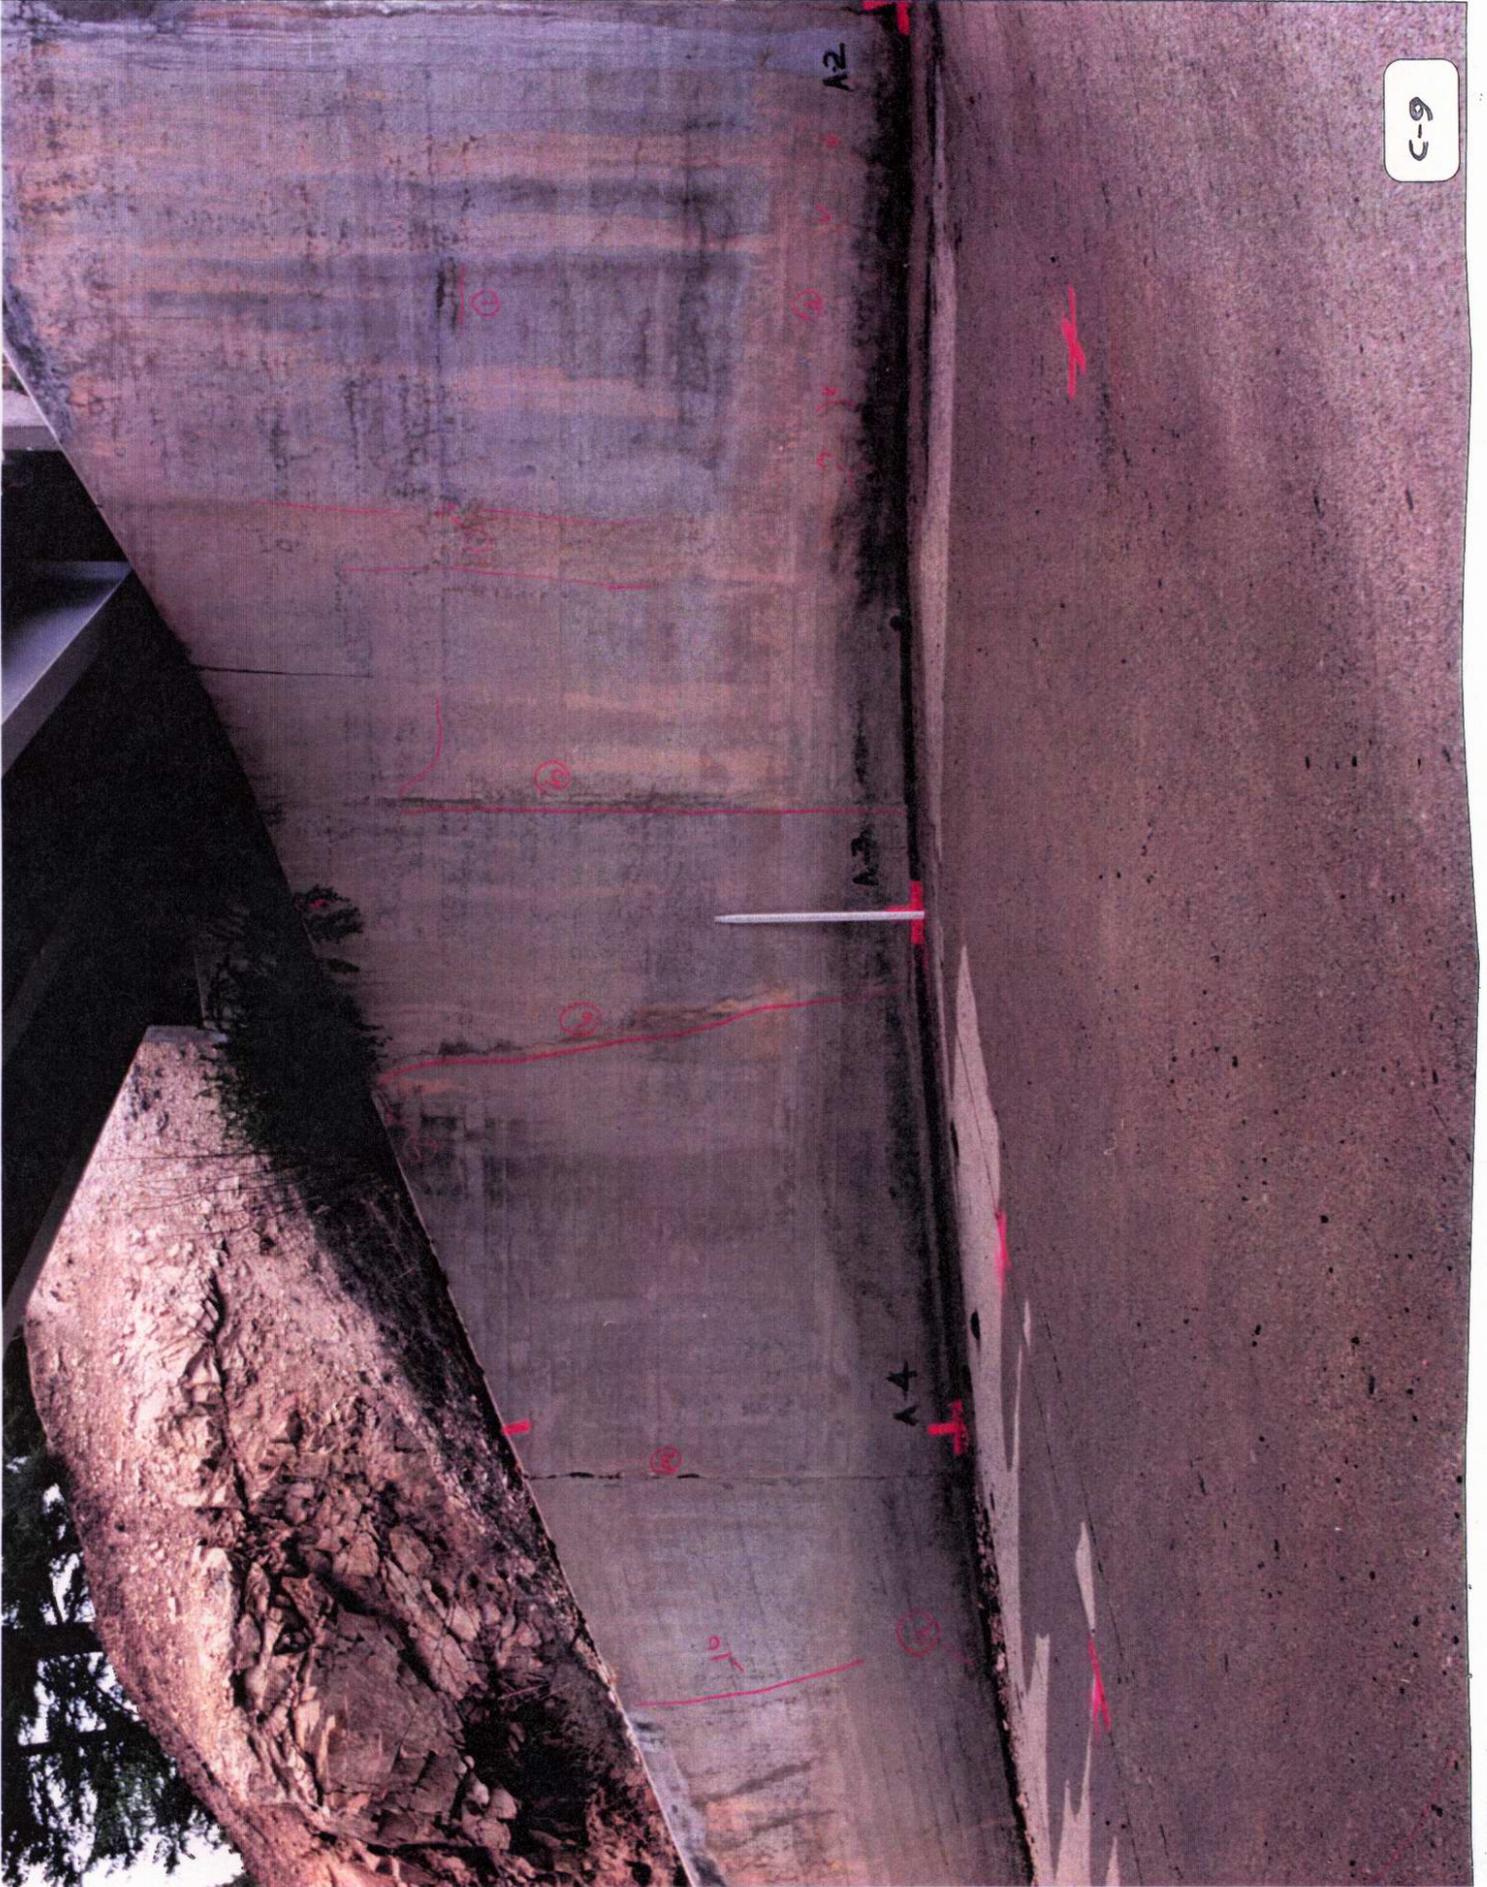
C-9

8. Is a vertical crack running full height of the right upper chute wall. It appears to be a construction joint and is opened up as much as 2 1/2 to 3 inches. The concrete aggregate is exposed, and it's one of the more severe cracks on the structure.

9. References the wood form marks in the wall. You also see some of the normal rock fallout from the outcrop directly above the wall.
10. Parallels a hairline crack that runs through the wood form marks in the wall it stops about 3 feet from the top of the wall.

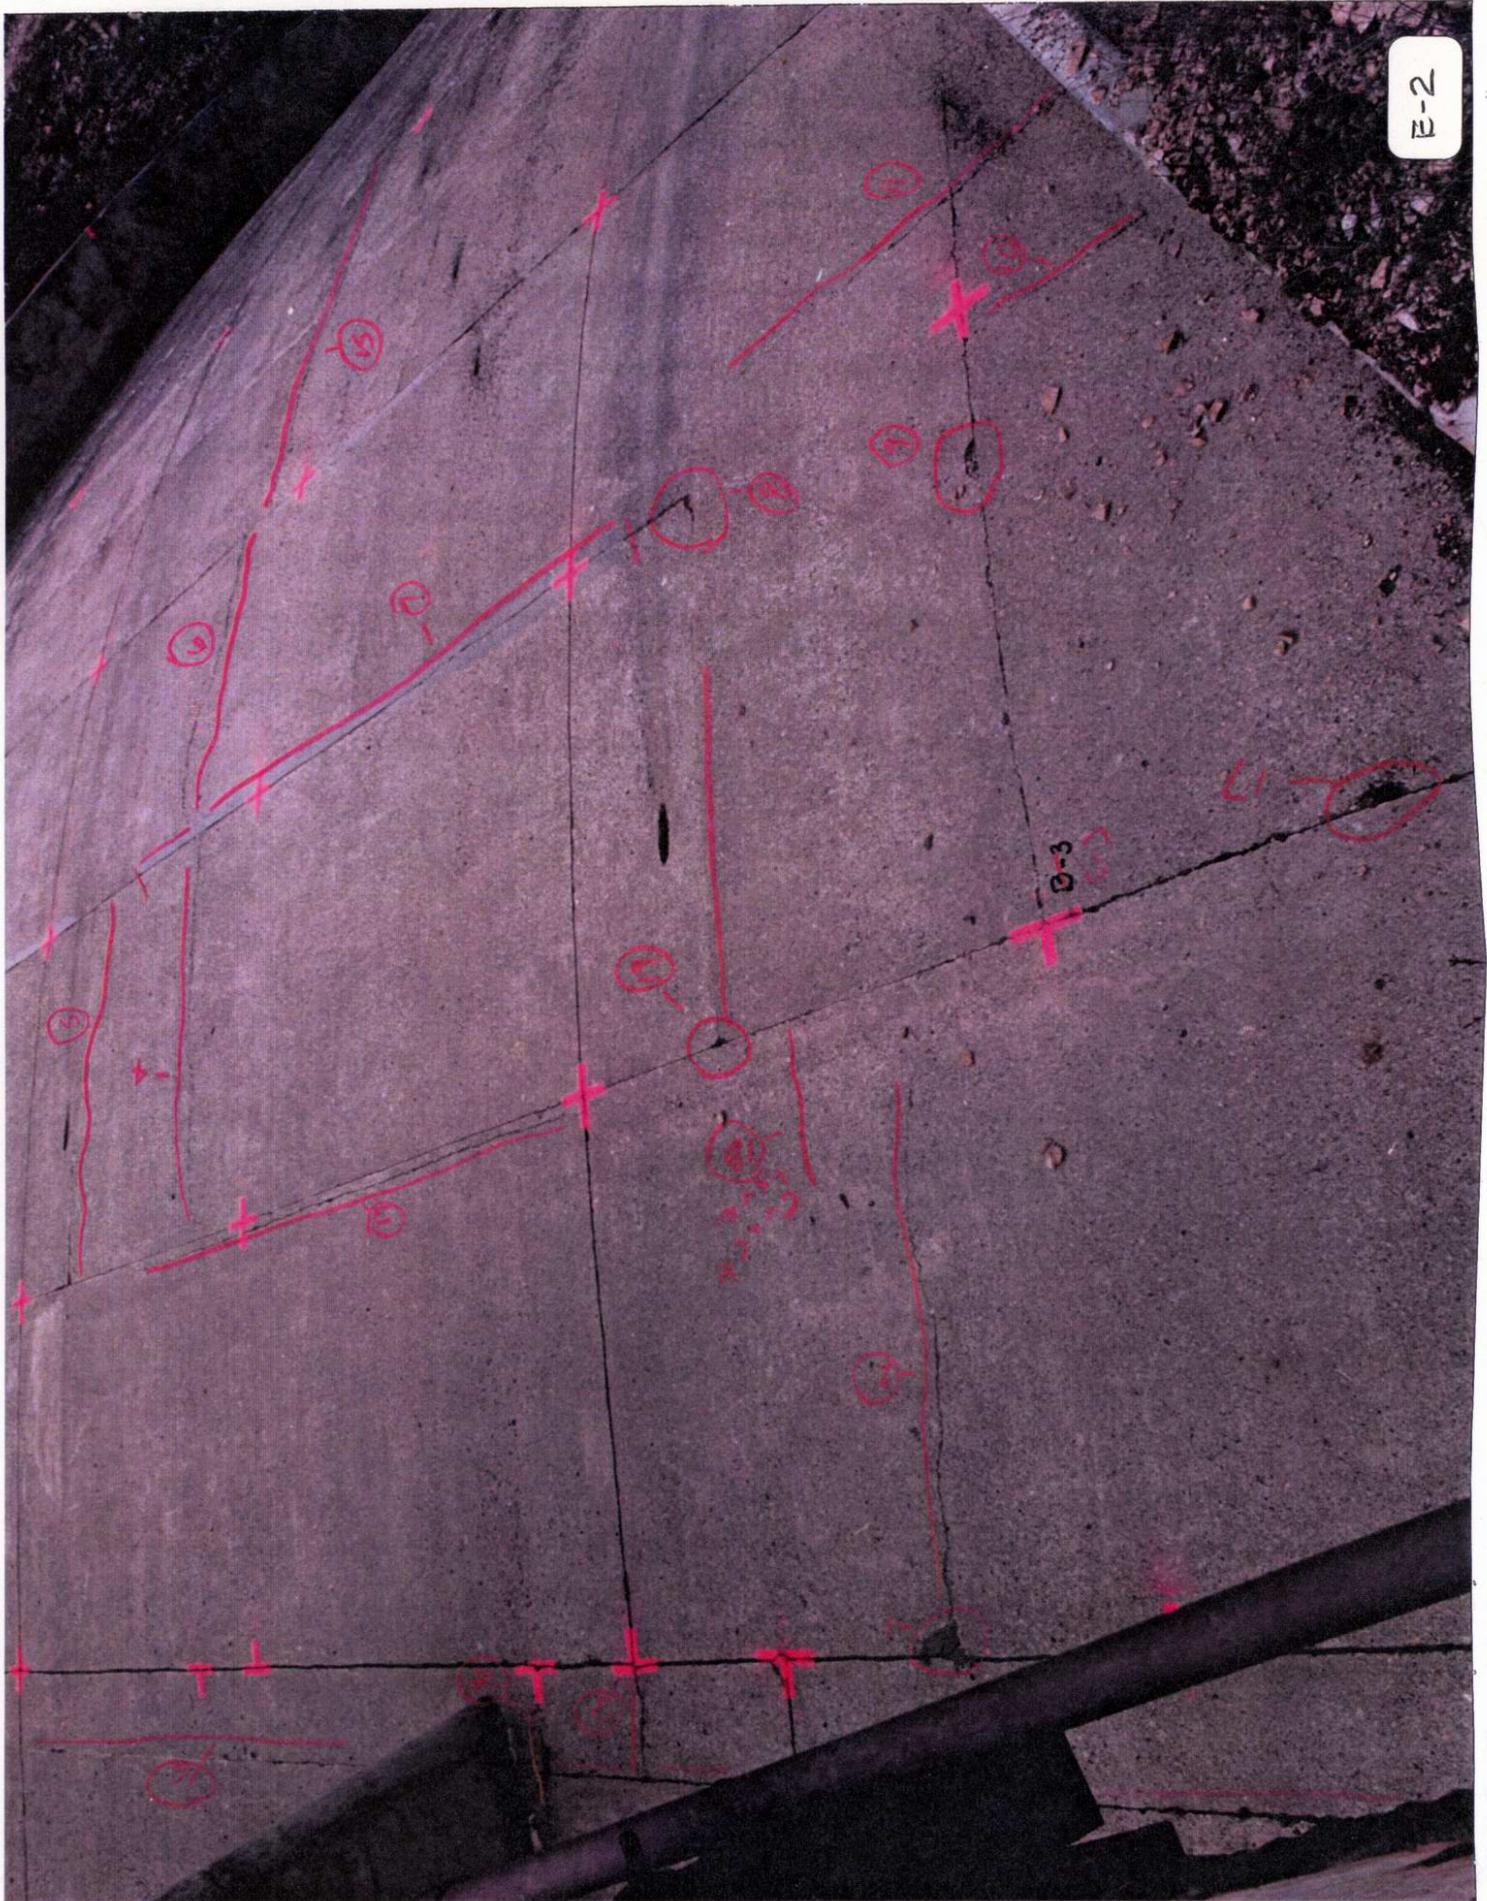
E-2 View from spillway bridge of upper floor spillway floor

14. Crack that ranges from greater than a hairline at the narrow spot up to about 3 inches across where 4 panels come together at the corner.

15. Longitudinal cracking. Crack is full panel length and it looks to be greater than 1 inch wide continuous. It has some vegetation growing in the crack at this time.
16. A construction joint running from the right retaining wall to the full width of the spillway. It appears to be undergoing some distress from original construction and it varies in width from about 1/8 to 1 inch in width.
17. A chunk of concrete that's missing along the construction joints. It's about 2 inches in depth about 9 inches in length. Part of the upper panel is exposed.
18. A longitudinal crack. It's about 1/8 of an inch at the narrowest part and flares out to an inch of disturbance at the top of the crack.
19. Construction joint that comes longitudinally down the spillway. The area is spalled approximately 1 1/2 inches in diameter and 3/4 in depth.

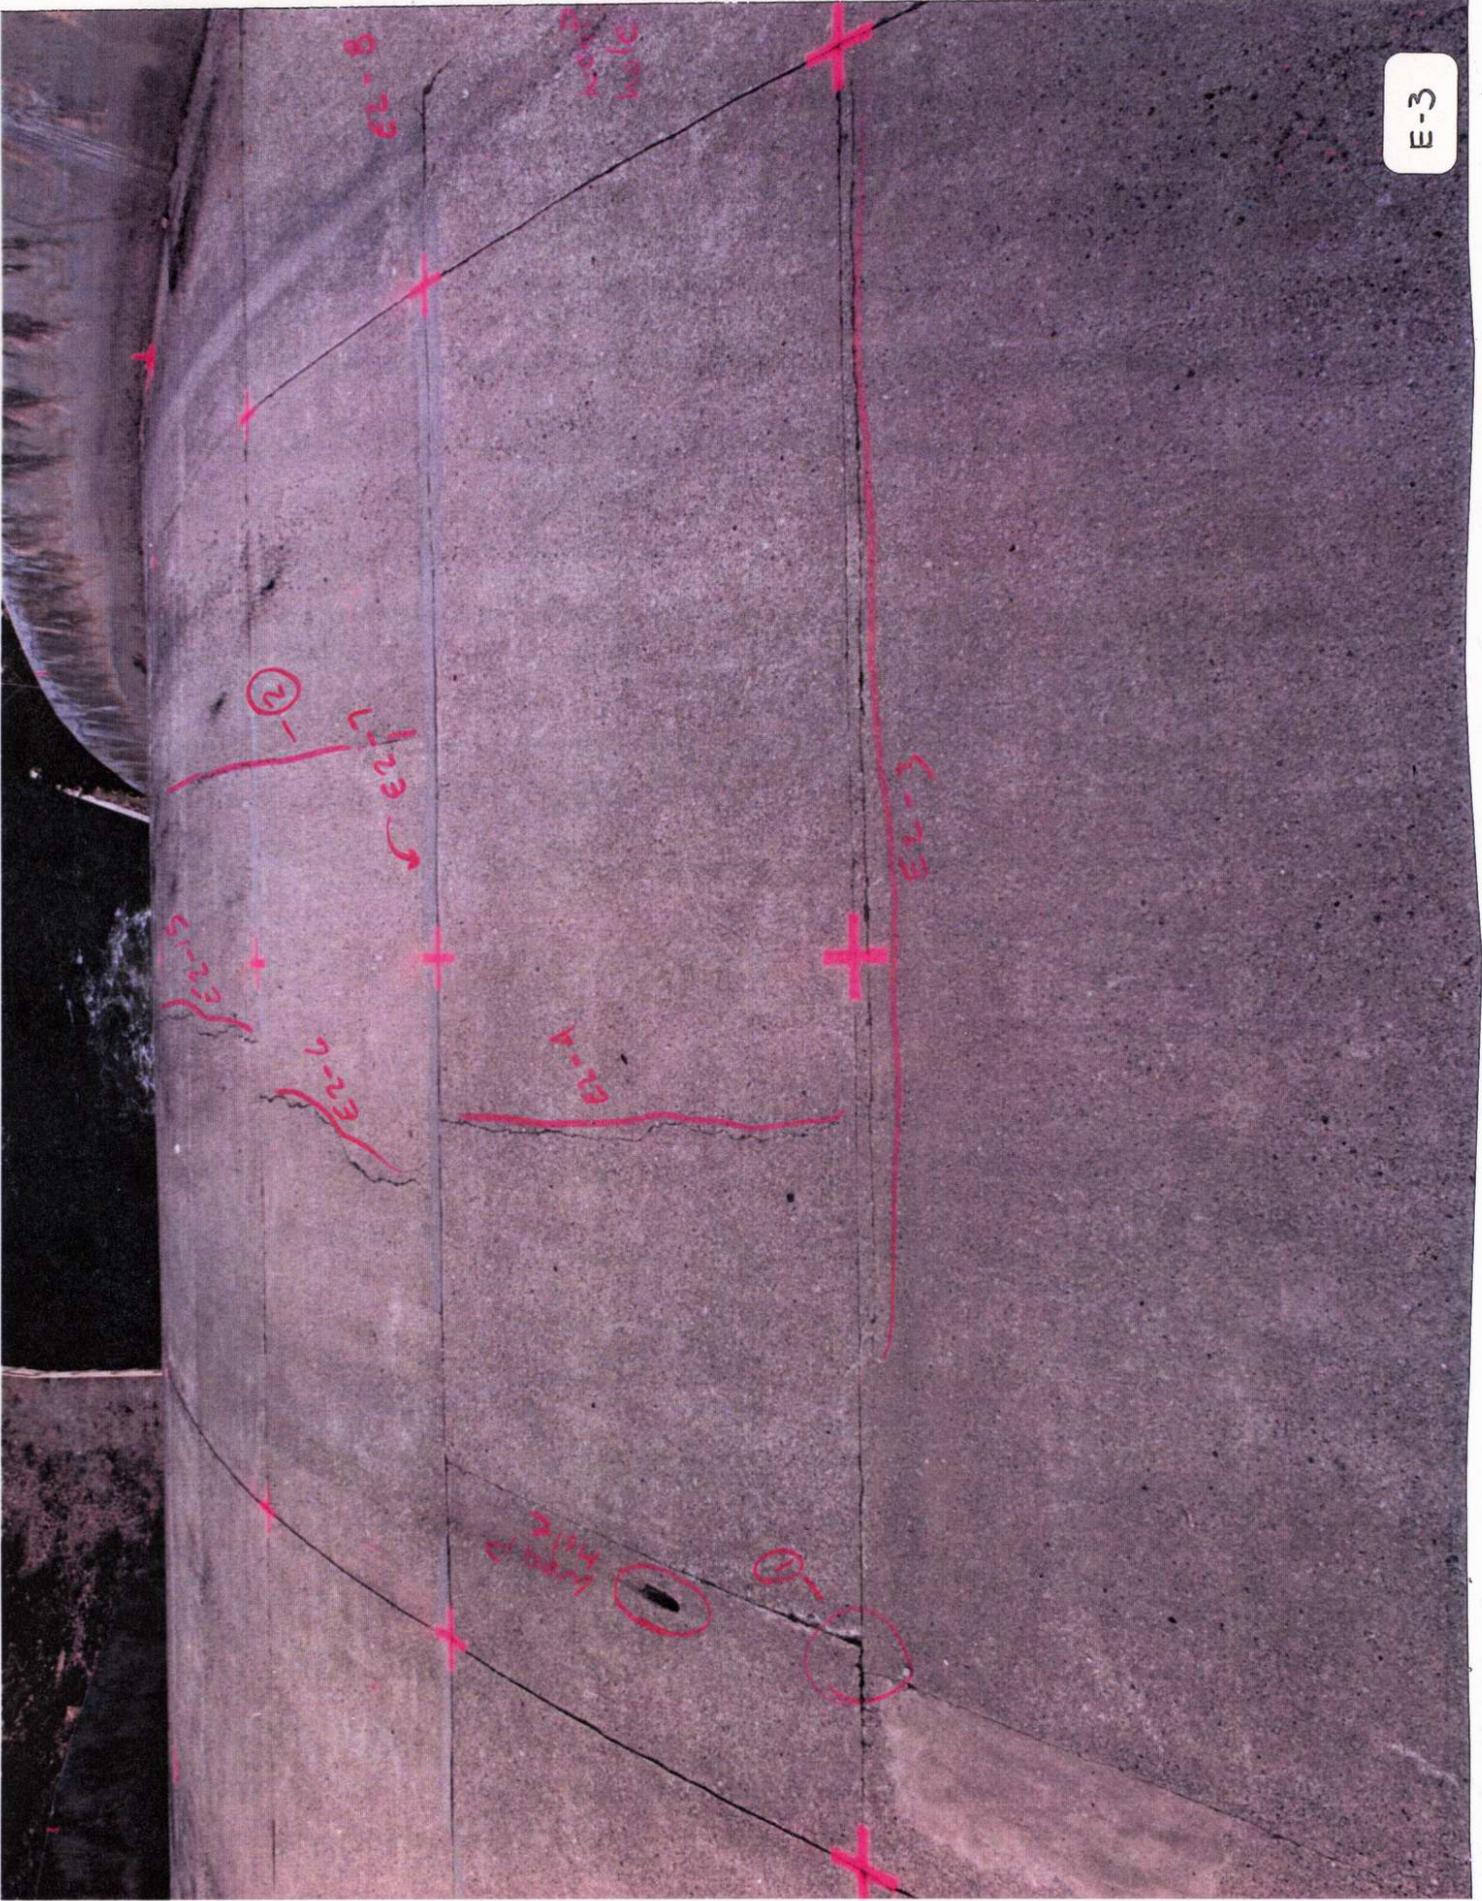
E-3

1. Just above the weep hole there is a bad panel connection. Quite a bit of concrete is spalled out of the panels (It's right near note No. 5 on photograph E-2).
2. A longitudinal joint that has quite a bit of spalling and disturbance on the joint line. It's spread about 3/8 inch at the maximum.

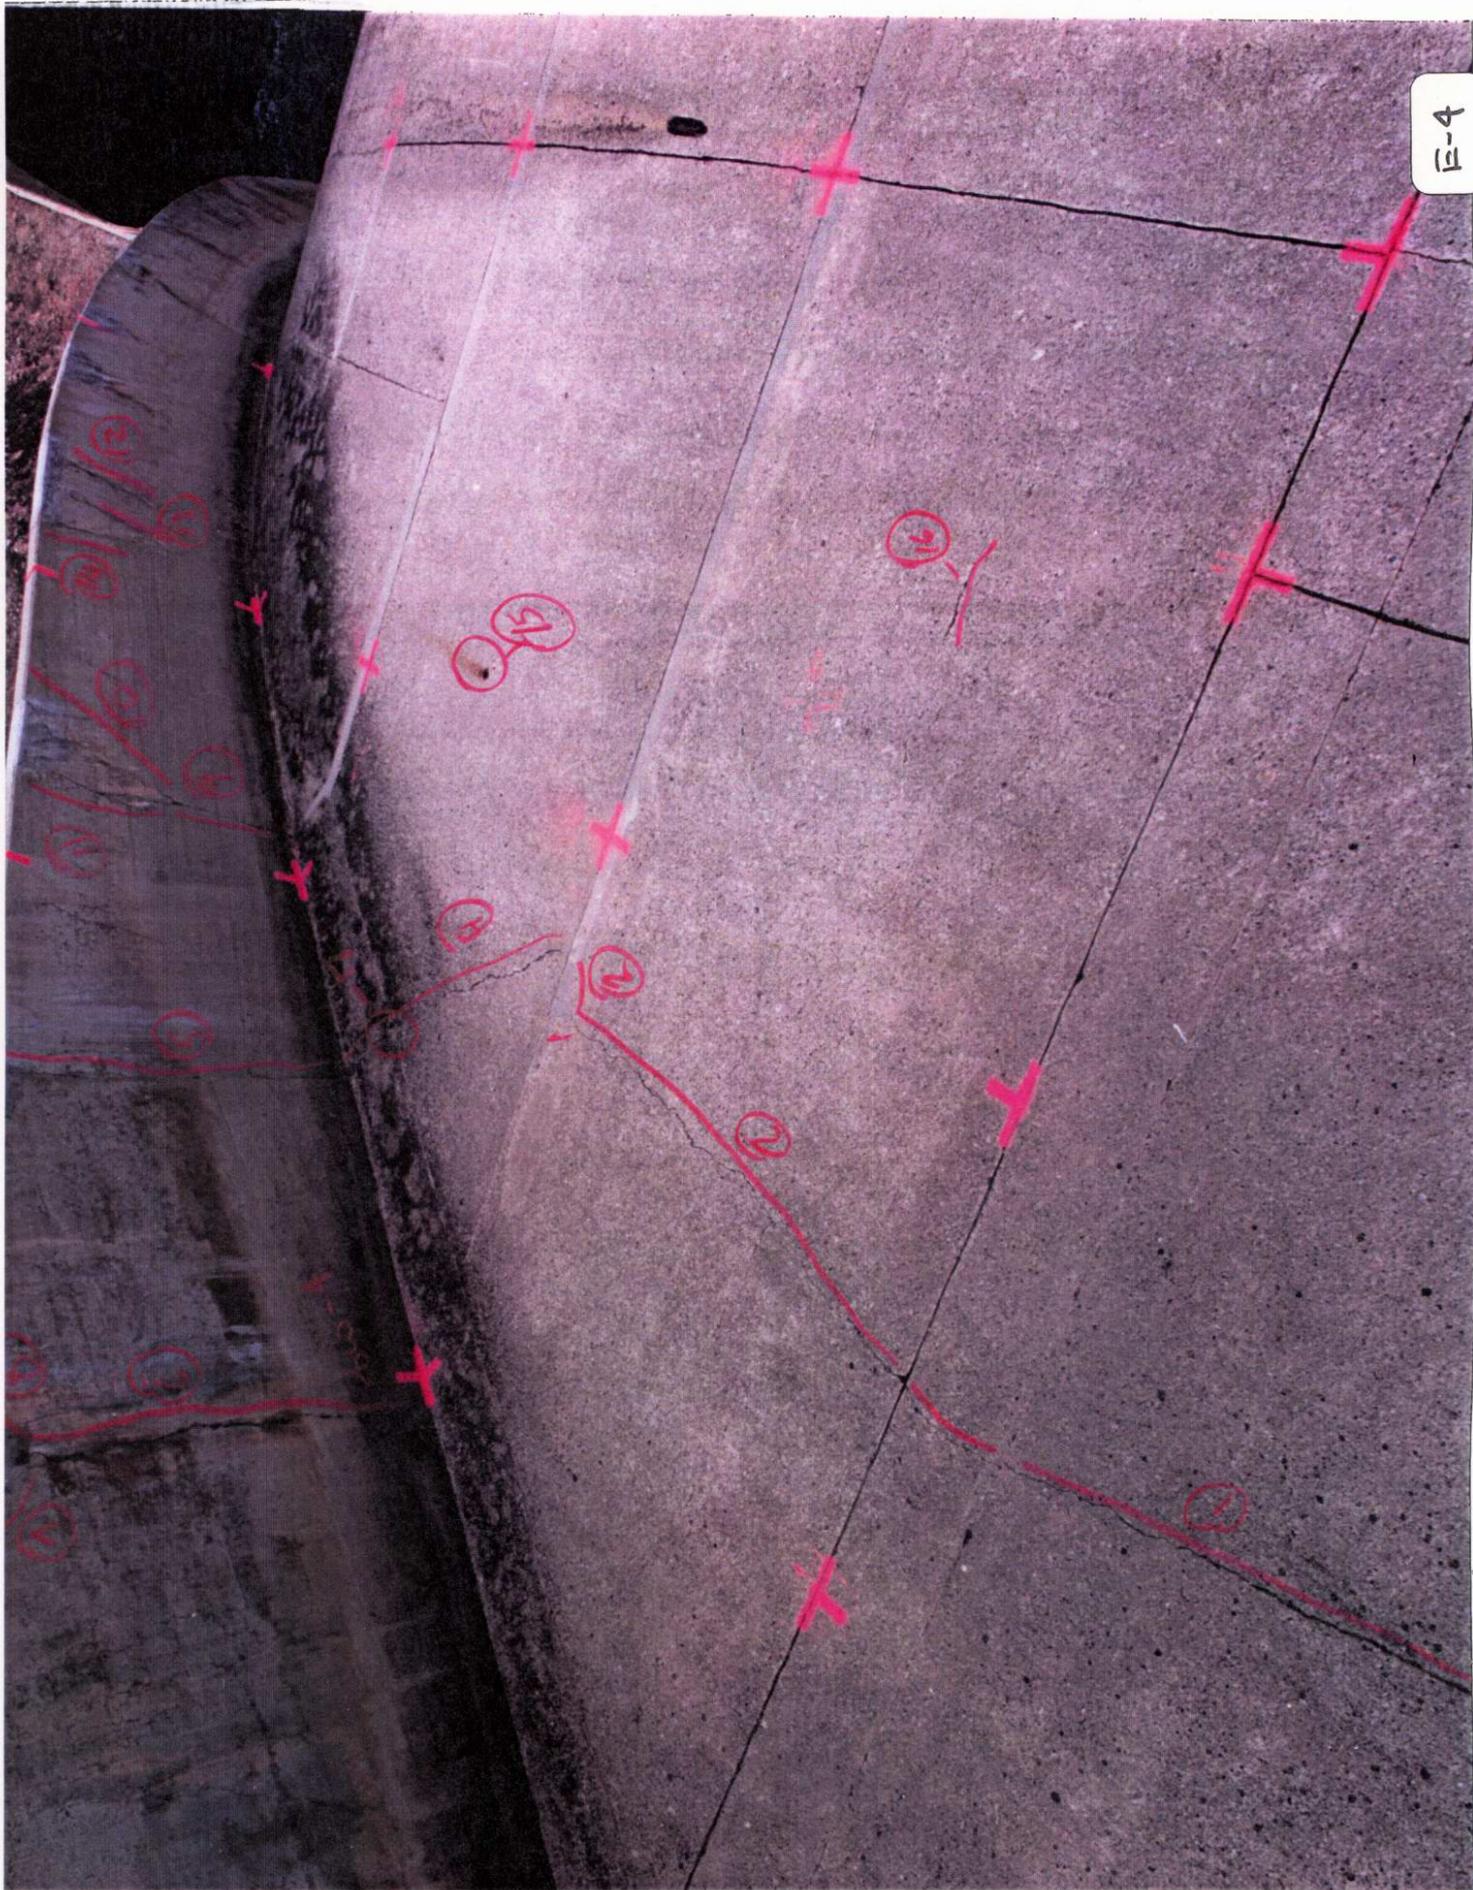
### E-4 View downstream of upper left chute wall

14. A vertical crack on the upper part of the left chute wall. It ranges in width from about 1/16 to 1/4 inch. Cracks 12 and 13 are also vertical cracks on the left chute wall. They are hairline type and appear to be less that 1/32 inch in width.

15. A 1 1/2 inch diameter weep hole. The hole appears to have been cut into the spillway, and it appears to go full depth of the concrete.
16. A transverse crack approximately 9 inches long and a width of 5/8 of inch maximum. There are several of these cracks in this panel which is in between row 3 and row 4. The other cracks don't show up on the photograph very well.

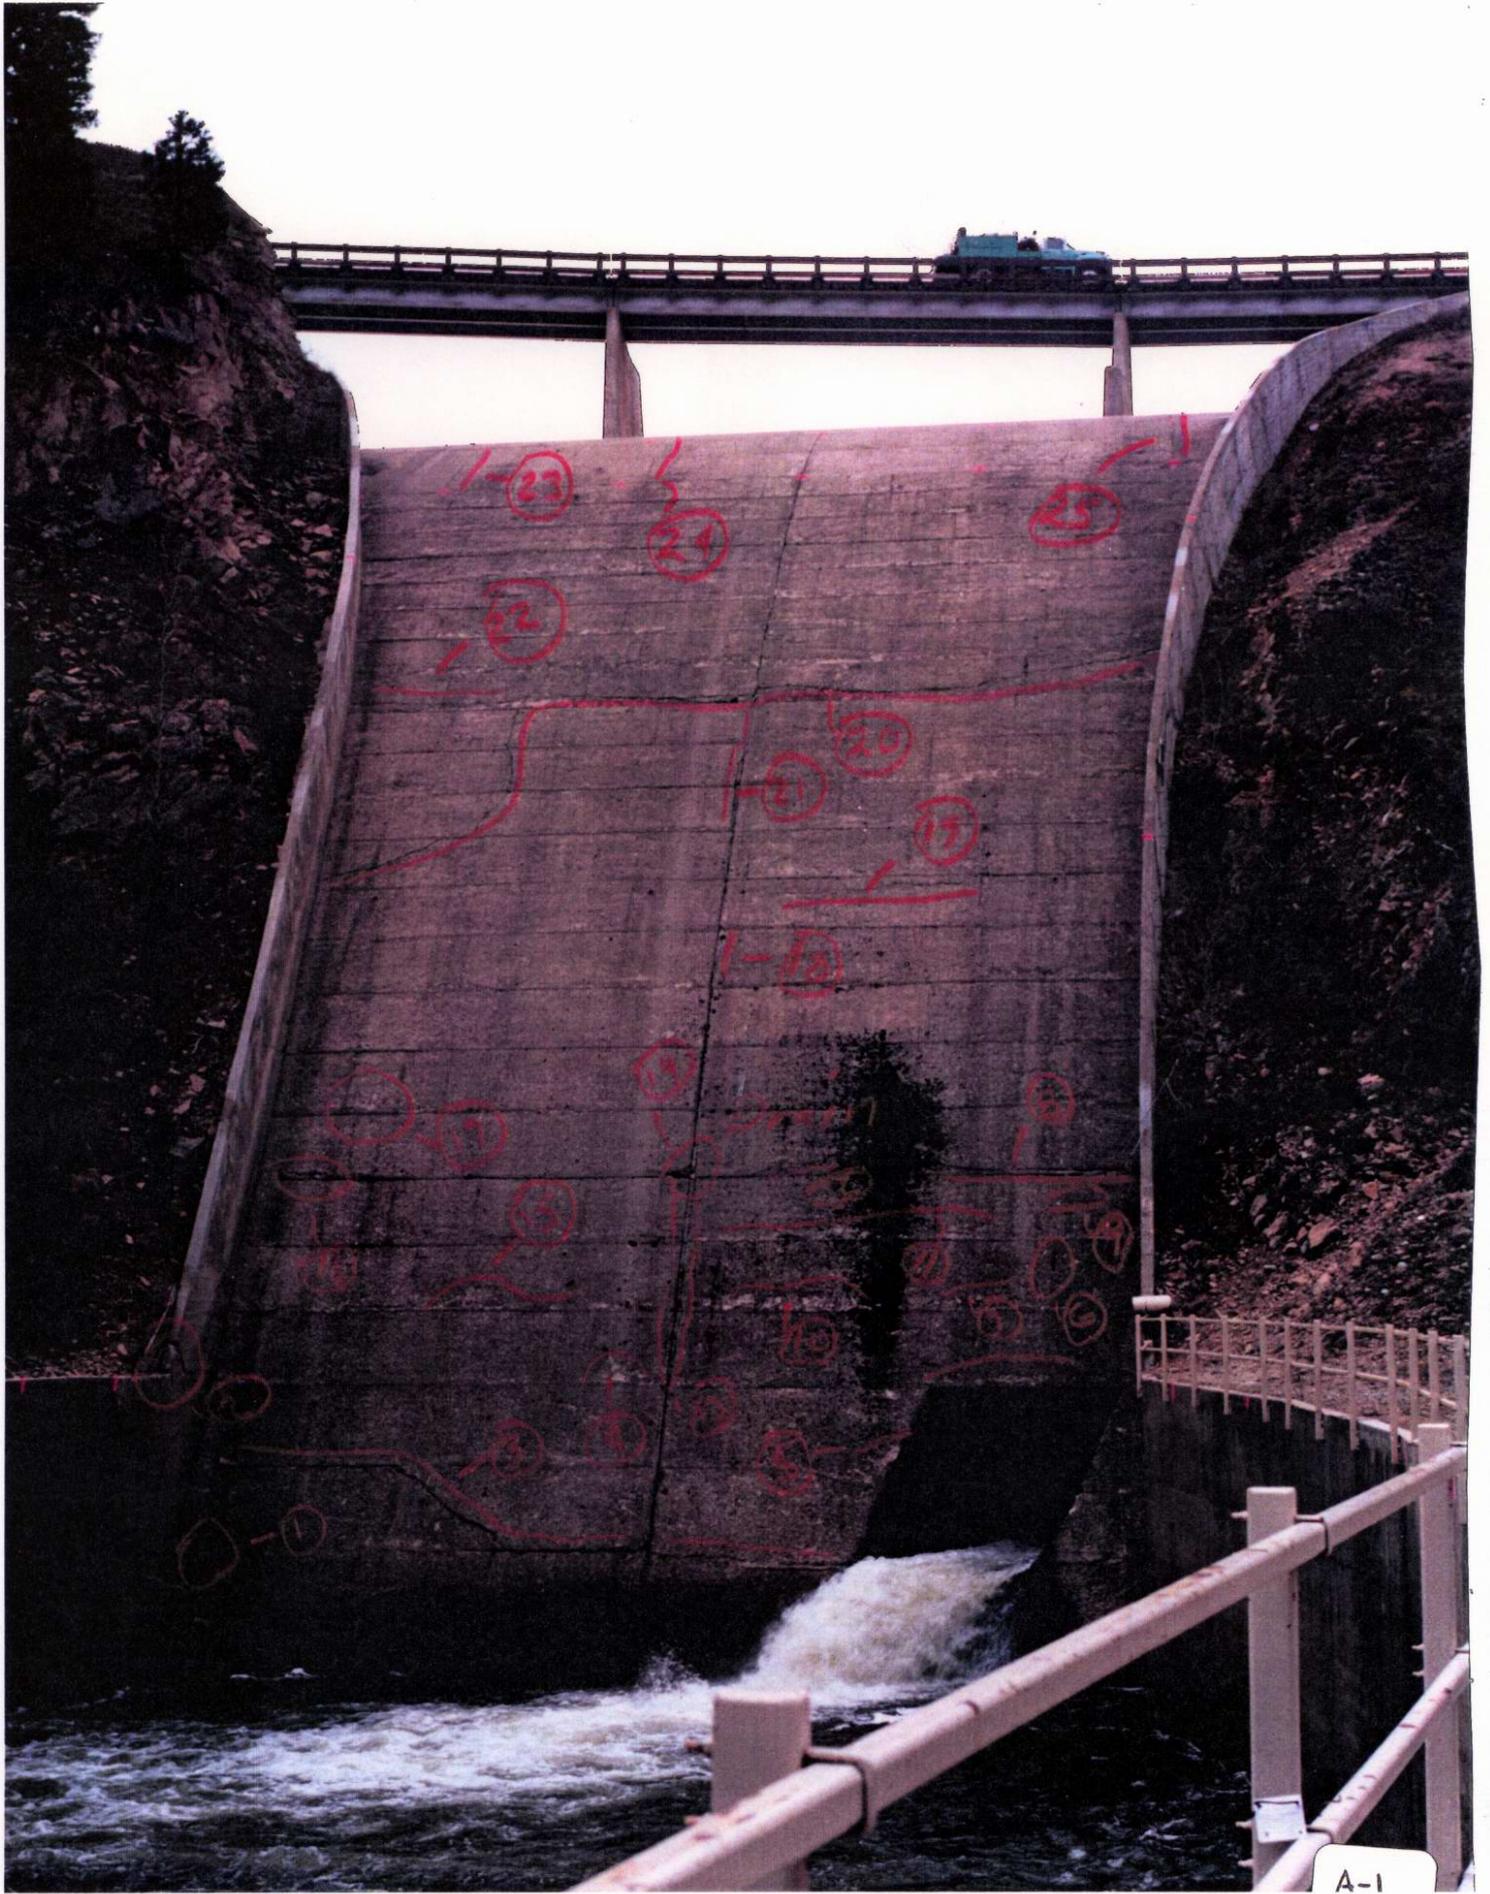
A-1

21. A vertical crack right below the one just described on item 20 above.
22. A translational crack that starts over near the right side retaining wall. The maximum width appears to be greater than 1 inch and about 5 feet in length.

- 23 to 25 Vertical cracks up on the transition on the upper portion of the spillway, the very steep face of the spillway.

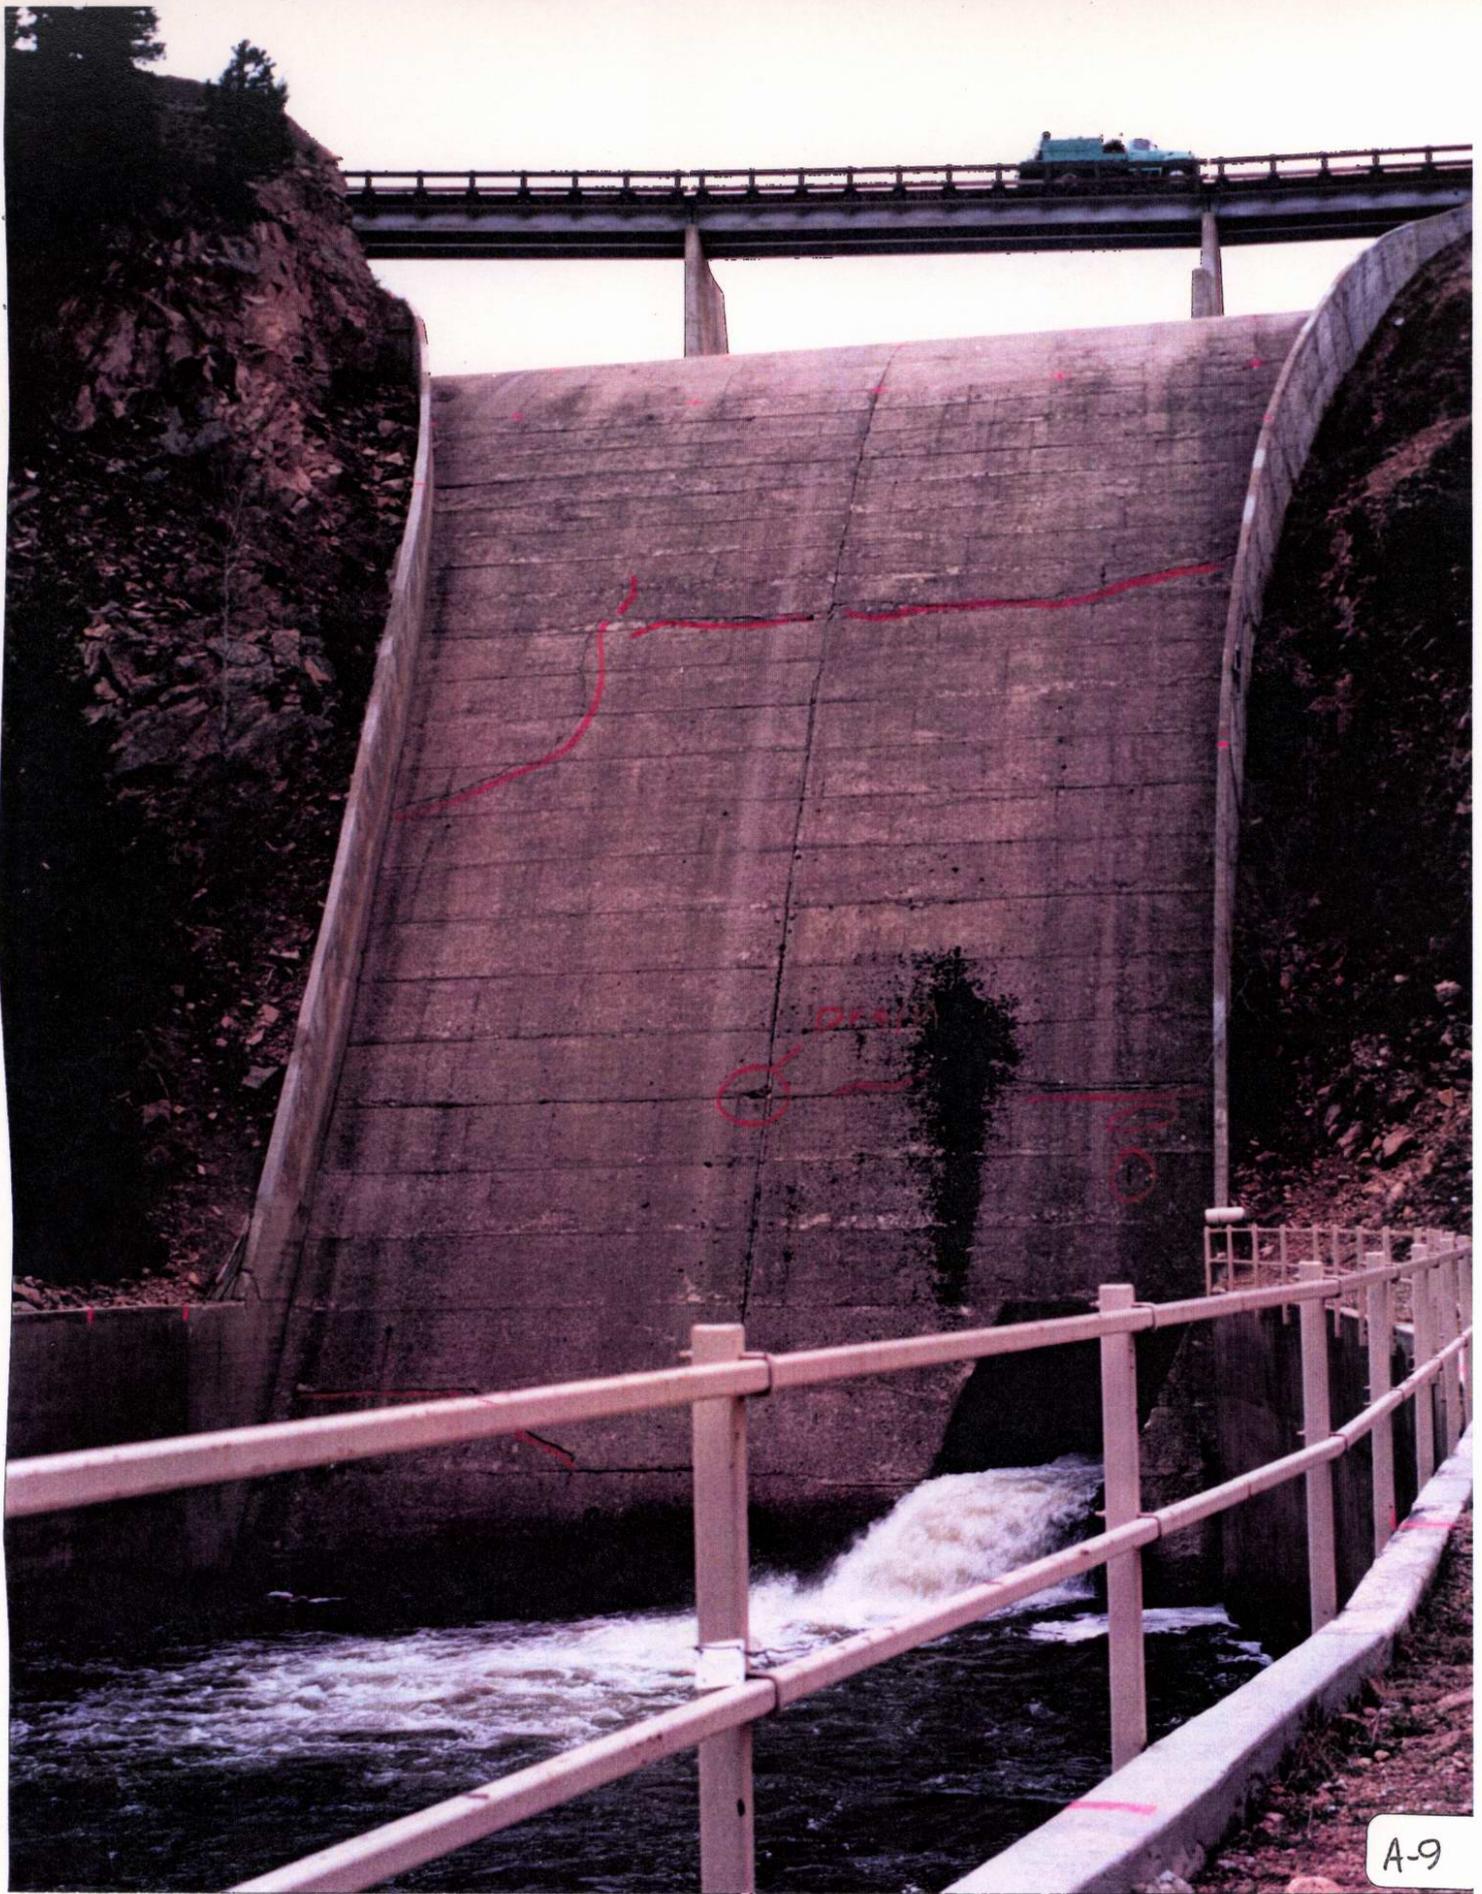
A-9 A view upstream of the chute area

1. See comments on Photo A-1.

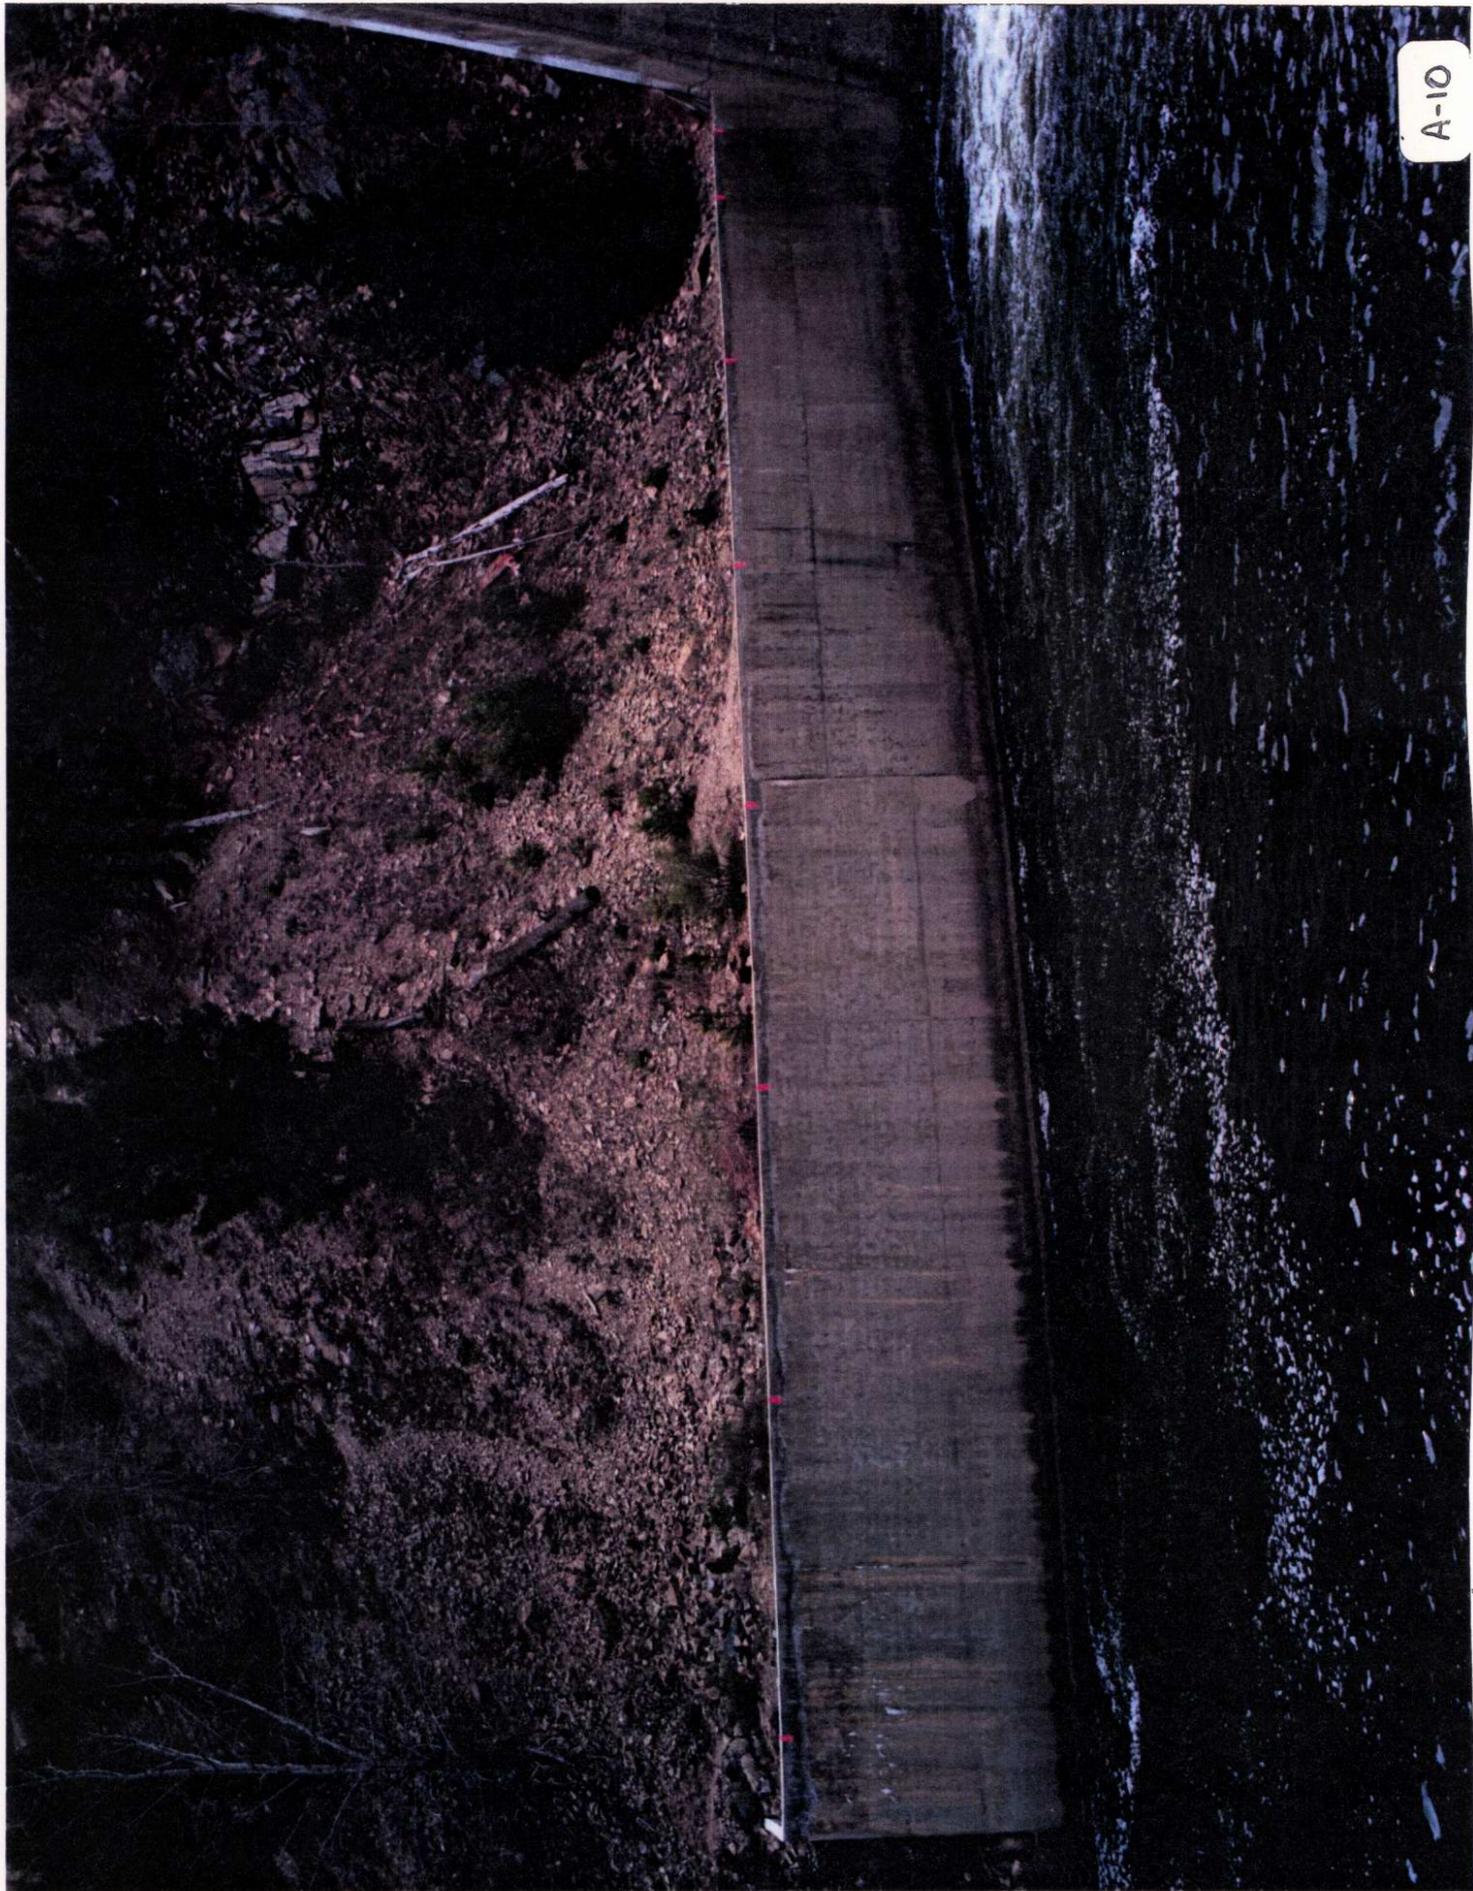
A-10 A view of the right basin wall

1. See Photo A-6 for comments.
