PAINTED ROCKS DAM  
2016 SPILLWAY CHUTE INVESTIGATION  
INFORMATION PACKET

# PAINTED ROCKS SPILLWAY

INVENTORY NO.: MT-19  
 HAZARD CATEGORY: HIGH  
 TYPE OF DAM: Zoned Earth Fill  
 YEAR BUILT: 1938  
 YEAR REHABILITATED: 2011-2015

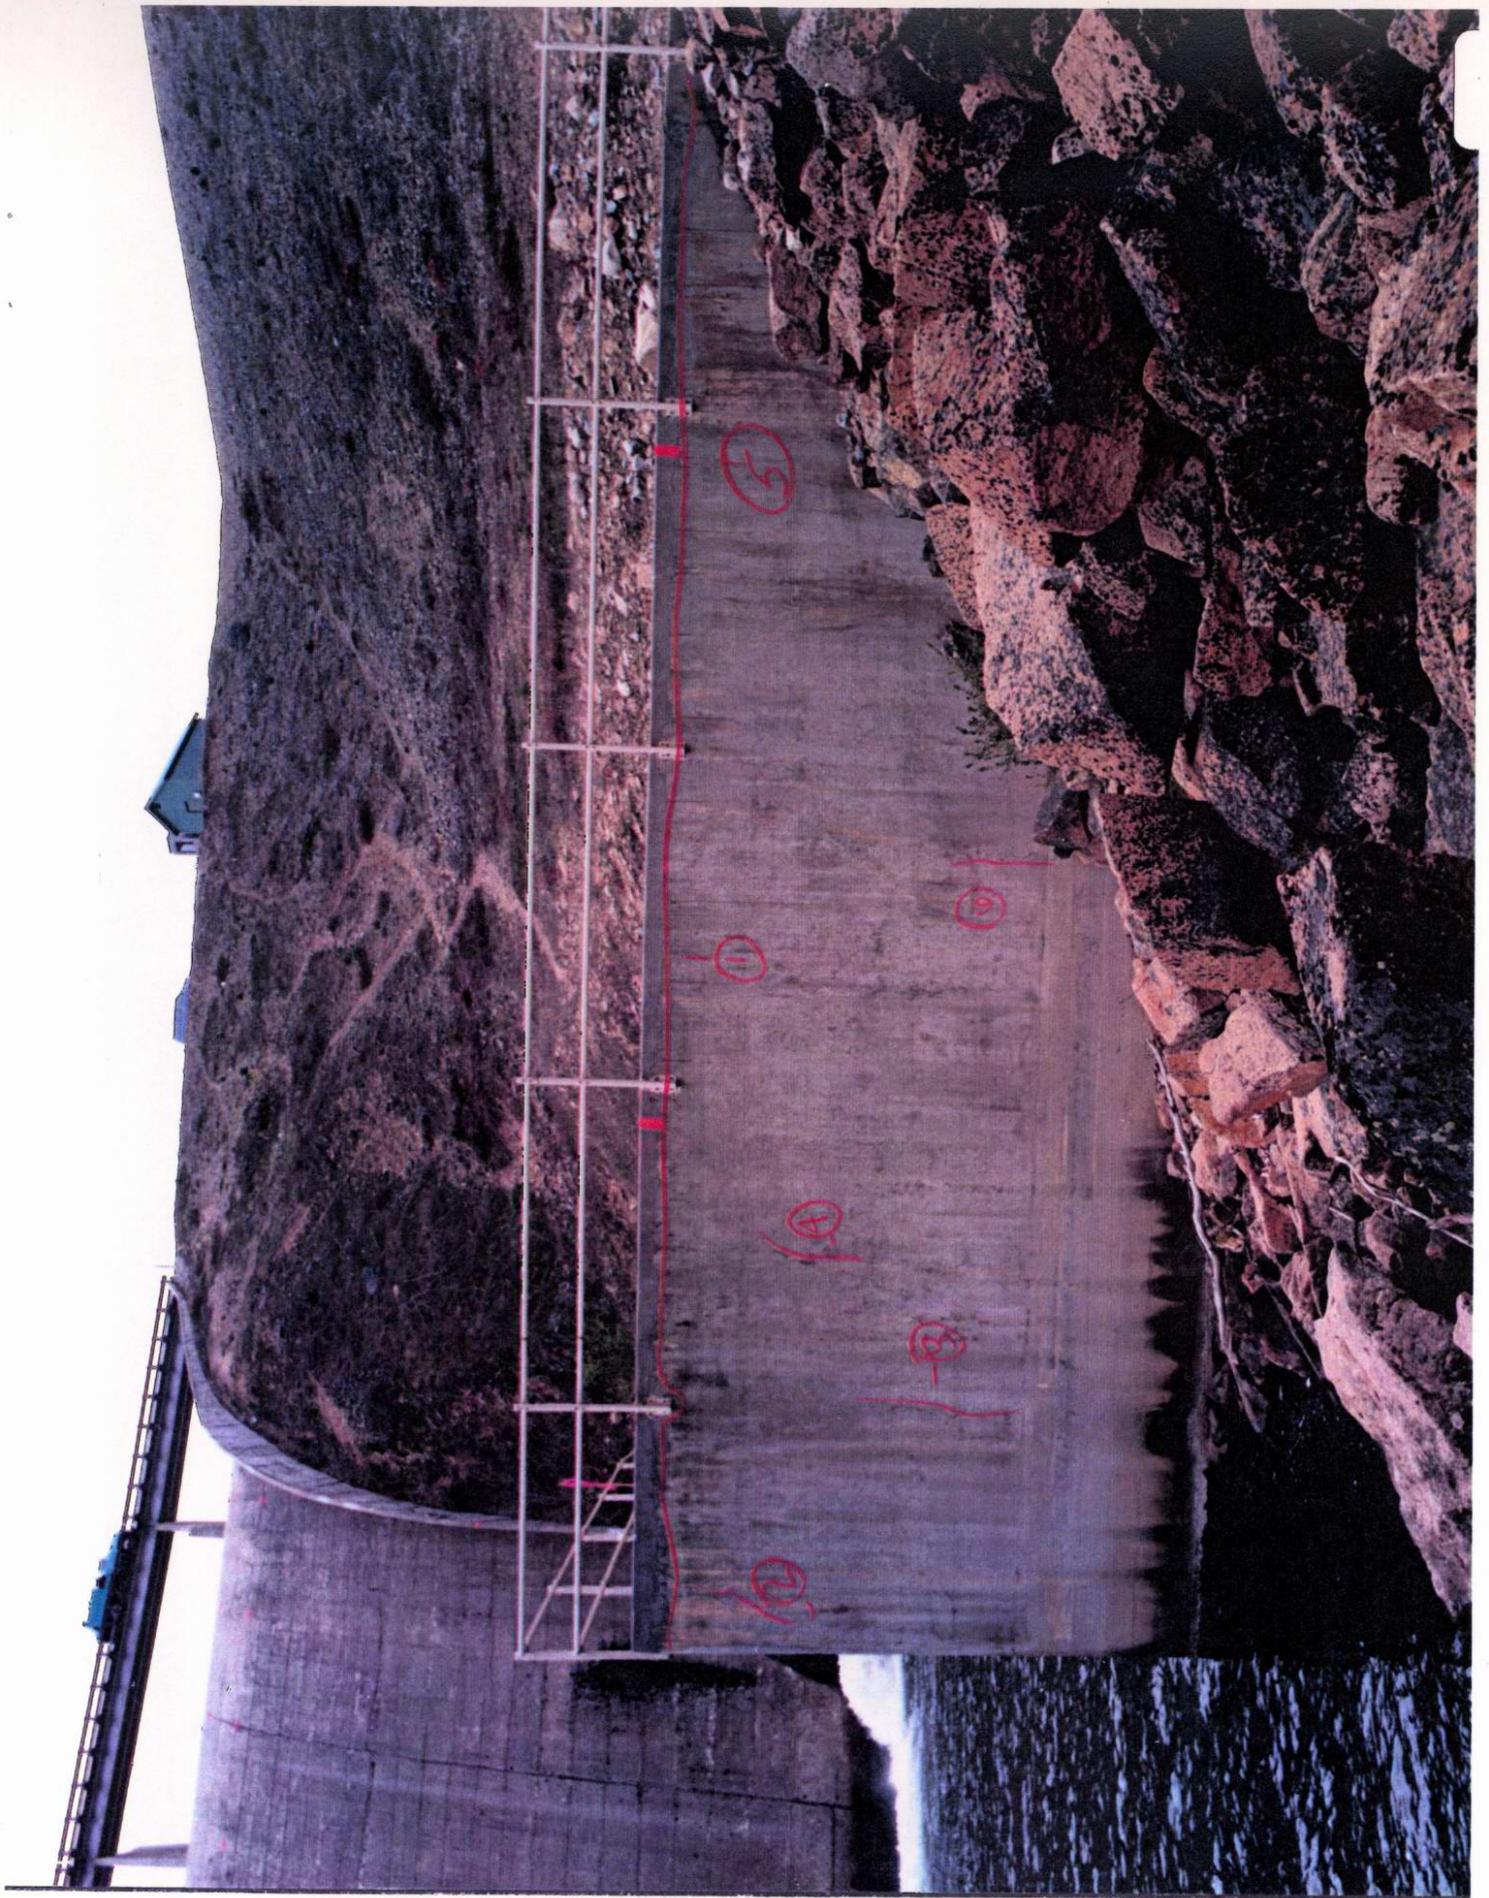
A-11 Left end wall - View upstream

1. Dental work along the end wall.
2. A vertical hairline crack and possibly some crazing cracking.
3. Vertical hairline cracks.
4. Vertical hairline crack.
5. Coarse to medium type crazing cracking.
6. A vertical crack which is slightly bigger than hairline.

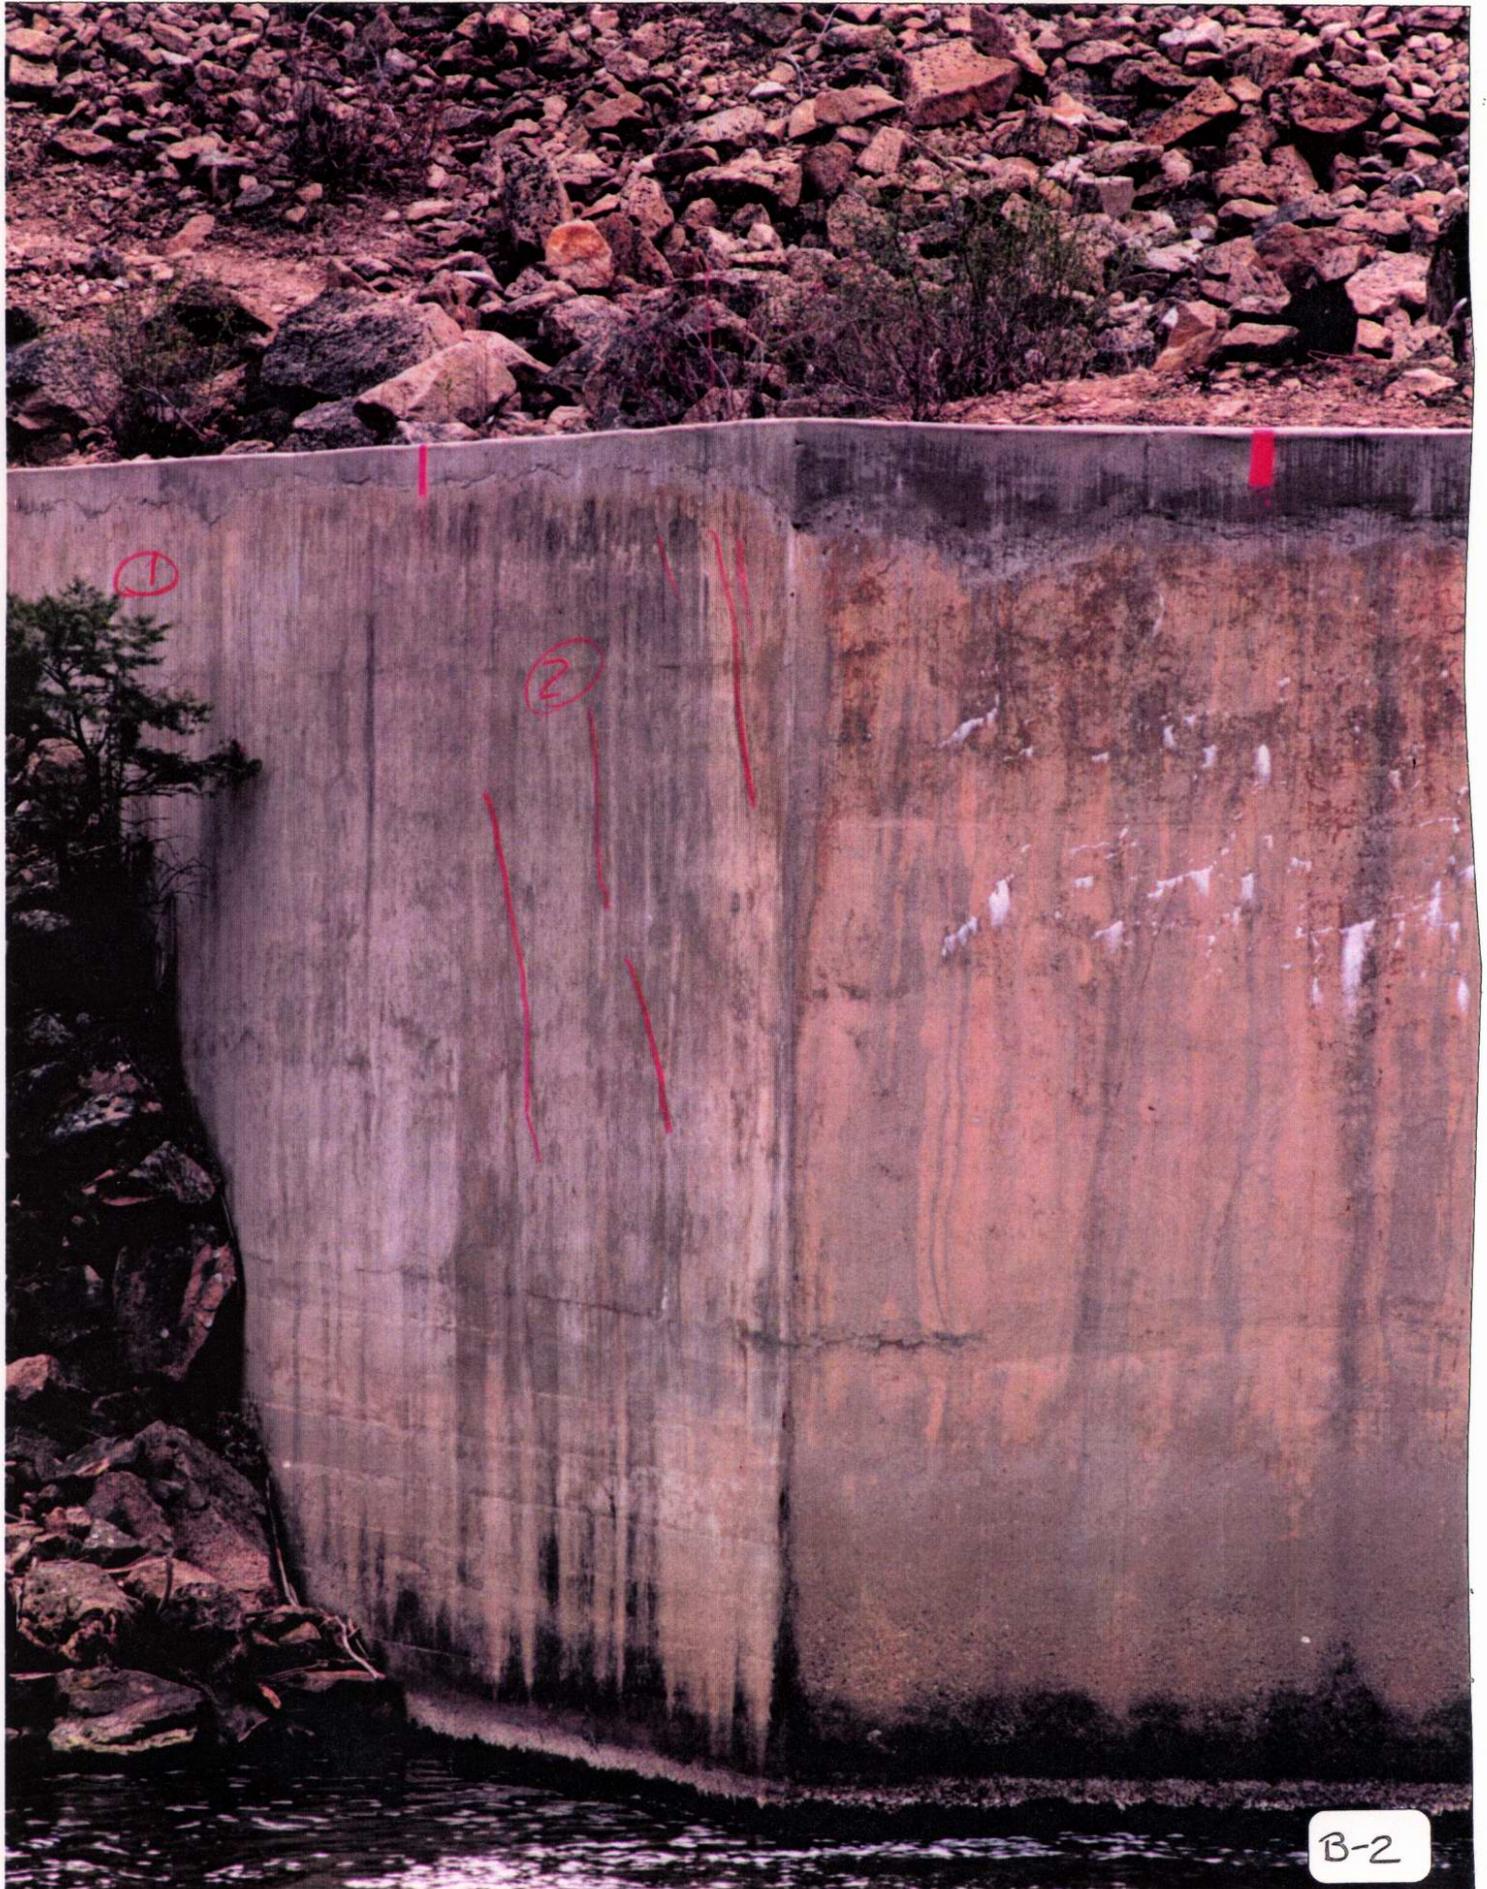
B-2

Transverse cracks along the top of the stilling basin wall - right side were counted by standing on the wall. 56 transverse cracks from the corner of the stilling basin wall and the end wall going upstream showed 1 to 2 foot spacings. 22 transverse types of cracks normal to the end wall with spacing from 1 to 2 feet were observed along the top of the right end wall. Most of these cracks are contained in the capping corrective work and do not reflect into the original wall.

2. At the corner of the right end - stilling basin wall are 2 transverse cracks reflecting the construction of the corner joint.
3. 3 areas were observed along the right stilling basin wall that indicate rockfall hits on the inside since the dental capping work.
4. Note leached grazing cracks on the downstream portion of the stilling basin wall.

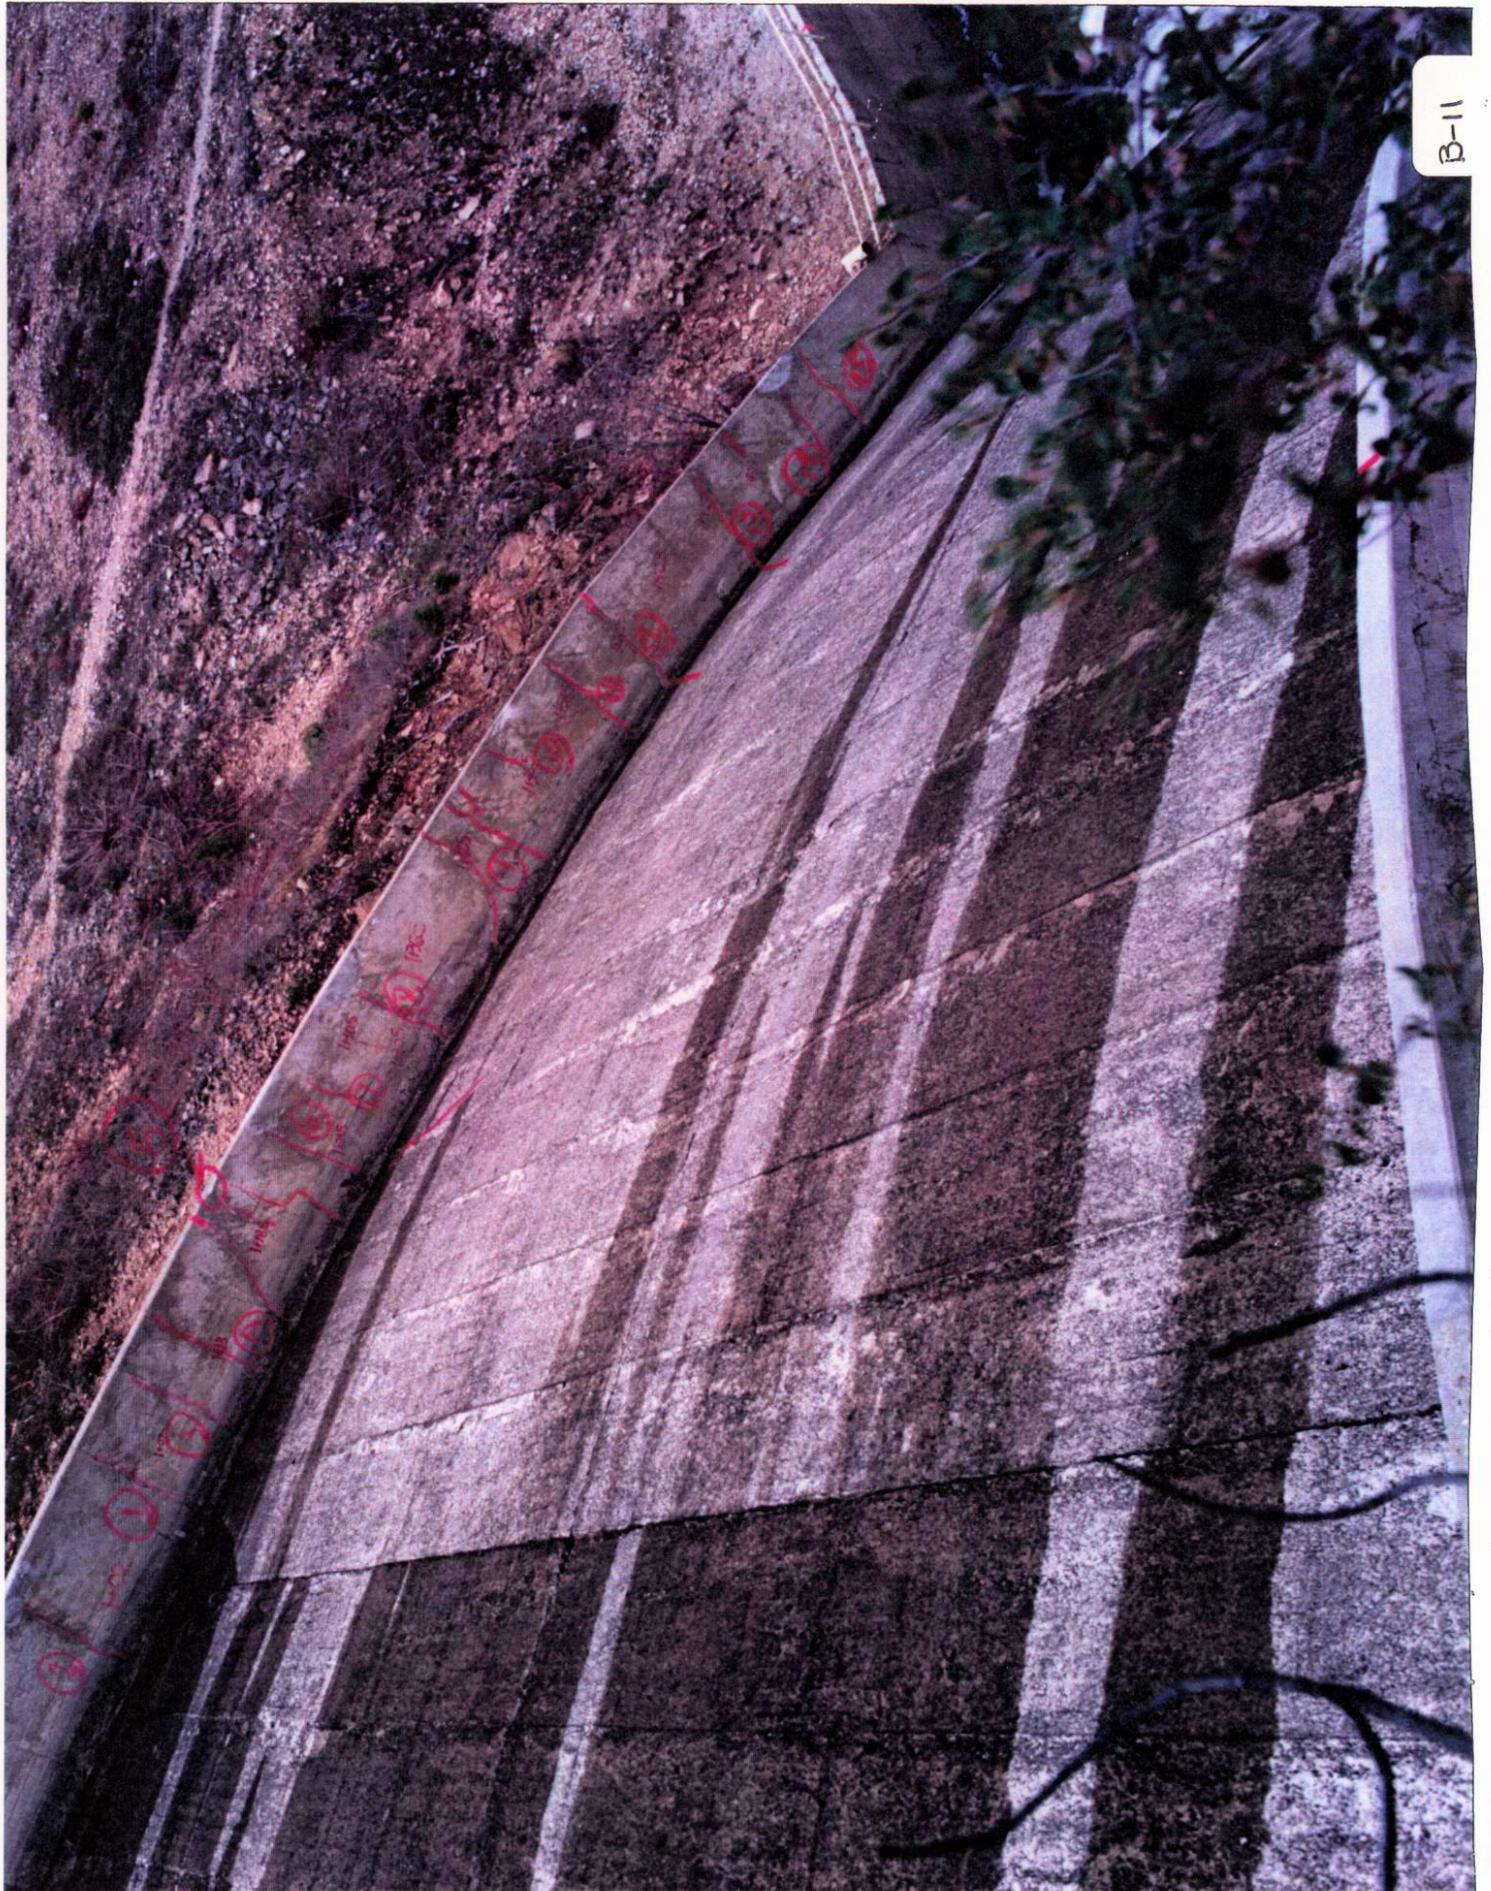
## SUMMARY SHEET PHOTO B-11

- B-11 Left spillway wall and the chute section of spillway. There's old numbers that were put in there by the DNRC that will be used for reference.
1. A diagonal joint upstream from 1 to 7. It's an open joint and has 2 spalled areas, one about a foot from the top and the other about a foot from the bottom of the chute. The spalled areas look to be about 2 inches deep and about 1 1/2 inches across and 3 inches long.

2. A diagonal/transverse crack. It begins at the top of the spalled dental work section and is a fairly tight joint.
  3. A tight hairline diagonal crack.

4. A series of diagonal and perpendicular or vertical the same as 1 and 3. They are actually vertical cracks probably. Moisture is seeping from the lower three cracks in number 4 area above. The diagonal cracks are all around 1+18.5.

5. A large spalling area on the top of the wall at the 18.5 mark.
  6. An open crack begins at the dental work at the top of the wall just upstream from 1+24.5. On the upstream side of that dental work there is a crack that exists. This crack is open to probably up to 1/2 inch size.

7. A tight vertical crack. Starting at station 1+24.5 there is a transverse very deep, very large crack that is very well pronounced in the photograph, That crack undoubtedly is cracked clear through the floor.

8. A vertical crack, beginning again at the base of the dental work. This dental work has some fine hairline cracks in it.
  9. Three vertical cracks. The first crack goes right through the one that has a kind of diagonal and vertical combination to it. There's a repair of a spall near the base of the wall. The next vertical crack is rather open at the top. Both of these cracks have transverse cracking across the top of the new dental work on the top of the wall. There is also some salt seeps in this area. The second crack area has small opening parts about 6 inches or 7 inches, but generally it's very tight. The first one seems to be quite tight as well, it also has leached salt stains. It also has seepage salts. The third crack is a much smaller and is tight. There is some radial spalling cracks along the leading edge of the wall in this area also above 1+48.5. Leachate precipitation is there too.

12. A vertical transverse crack. It's open and there's several small spall areas along the sides of it. It also extends into a transverse crack along the floor. It goes through 1+60.5.

13. A vertical/diagonal crack just down stream from 1+72.5. It's open 1/16 inch, and reflects through the top. It goes out into the floor pretty close to the joint about 8 feet, just above the, heavy moss stain.

14. A crack through the new dental work. It goes down right through the floor and comes off in a transverse crack across the floor or into a joint. There's some leaching salt in the open crack. It has some 1/4, 1/16 inch opening in few places along that are normally tight. A little salt leaching in this crack.

15. Dental work with some crazing cracking. It looks like there might have been more than 1 patch in this area, but there is a medium textured crazing right at the lower end of the patching. The last vertical joint that is shown as number 15 is filled leached salts. It's undoubtedly the same thing. It does not go across the floor.

General note - the floor cracking was not mapped on this photograph. It's interesting to note that the seepage that was wetting the concrete nearly ended near station 1+02, that crack was large enough, it accepted most of the water into that crack.

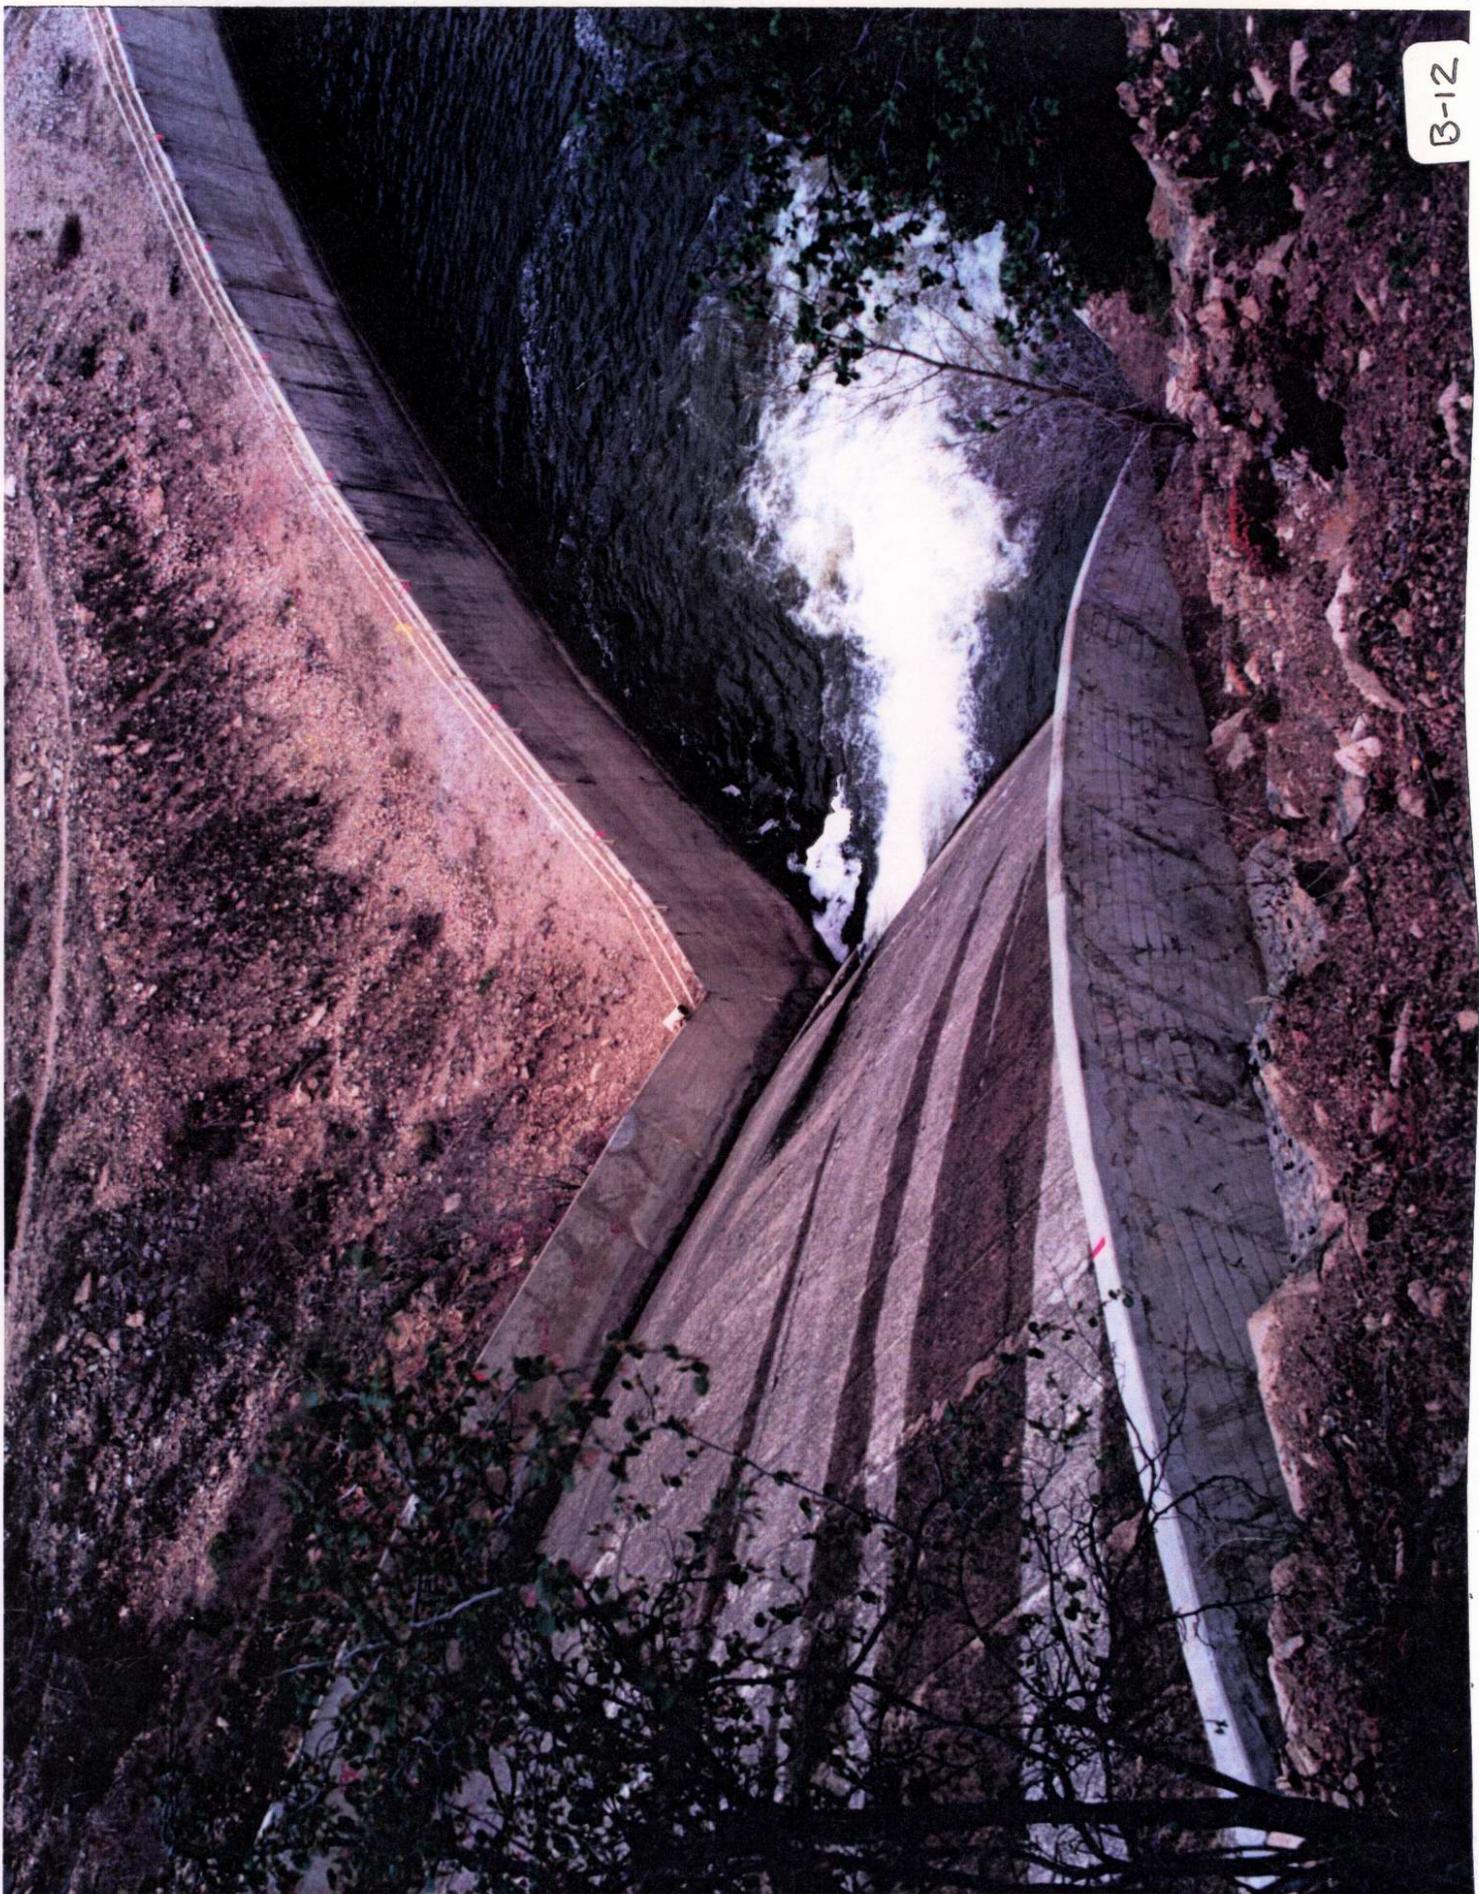
SUMMARY SHEET  
PHOTO B-12

B-12 View of the back side of right spillway wall and lower spillway area

No marks are made on the photograph, but there are several transverse cracks on the outside of the wall. These vary in size but are assumed to be associated with the transverse type freeze-thaw conditions. Note the new cap over the entire top of the wall in the chute area.

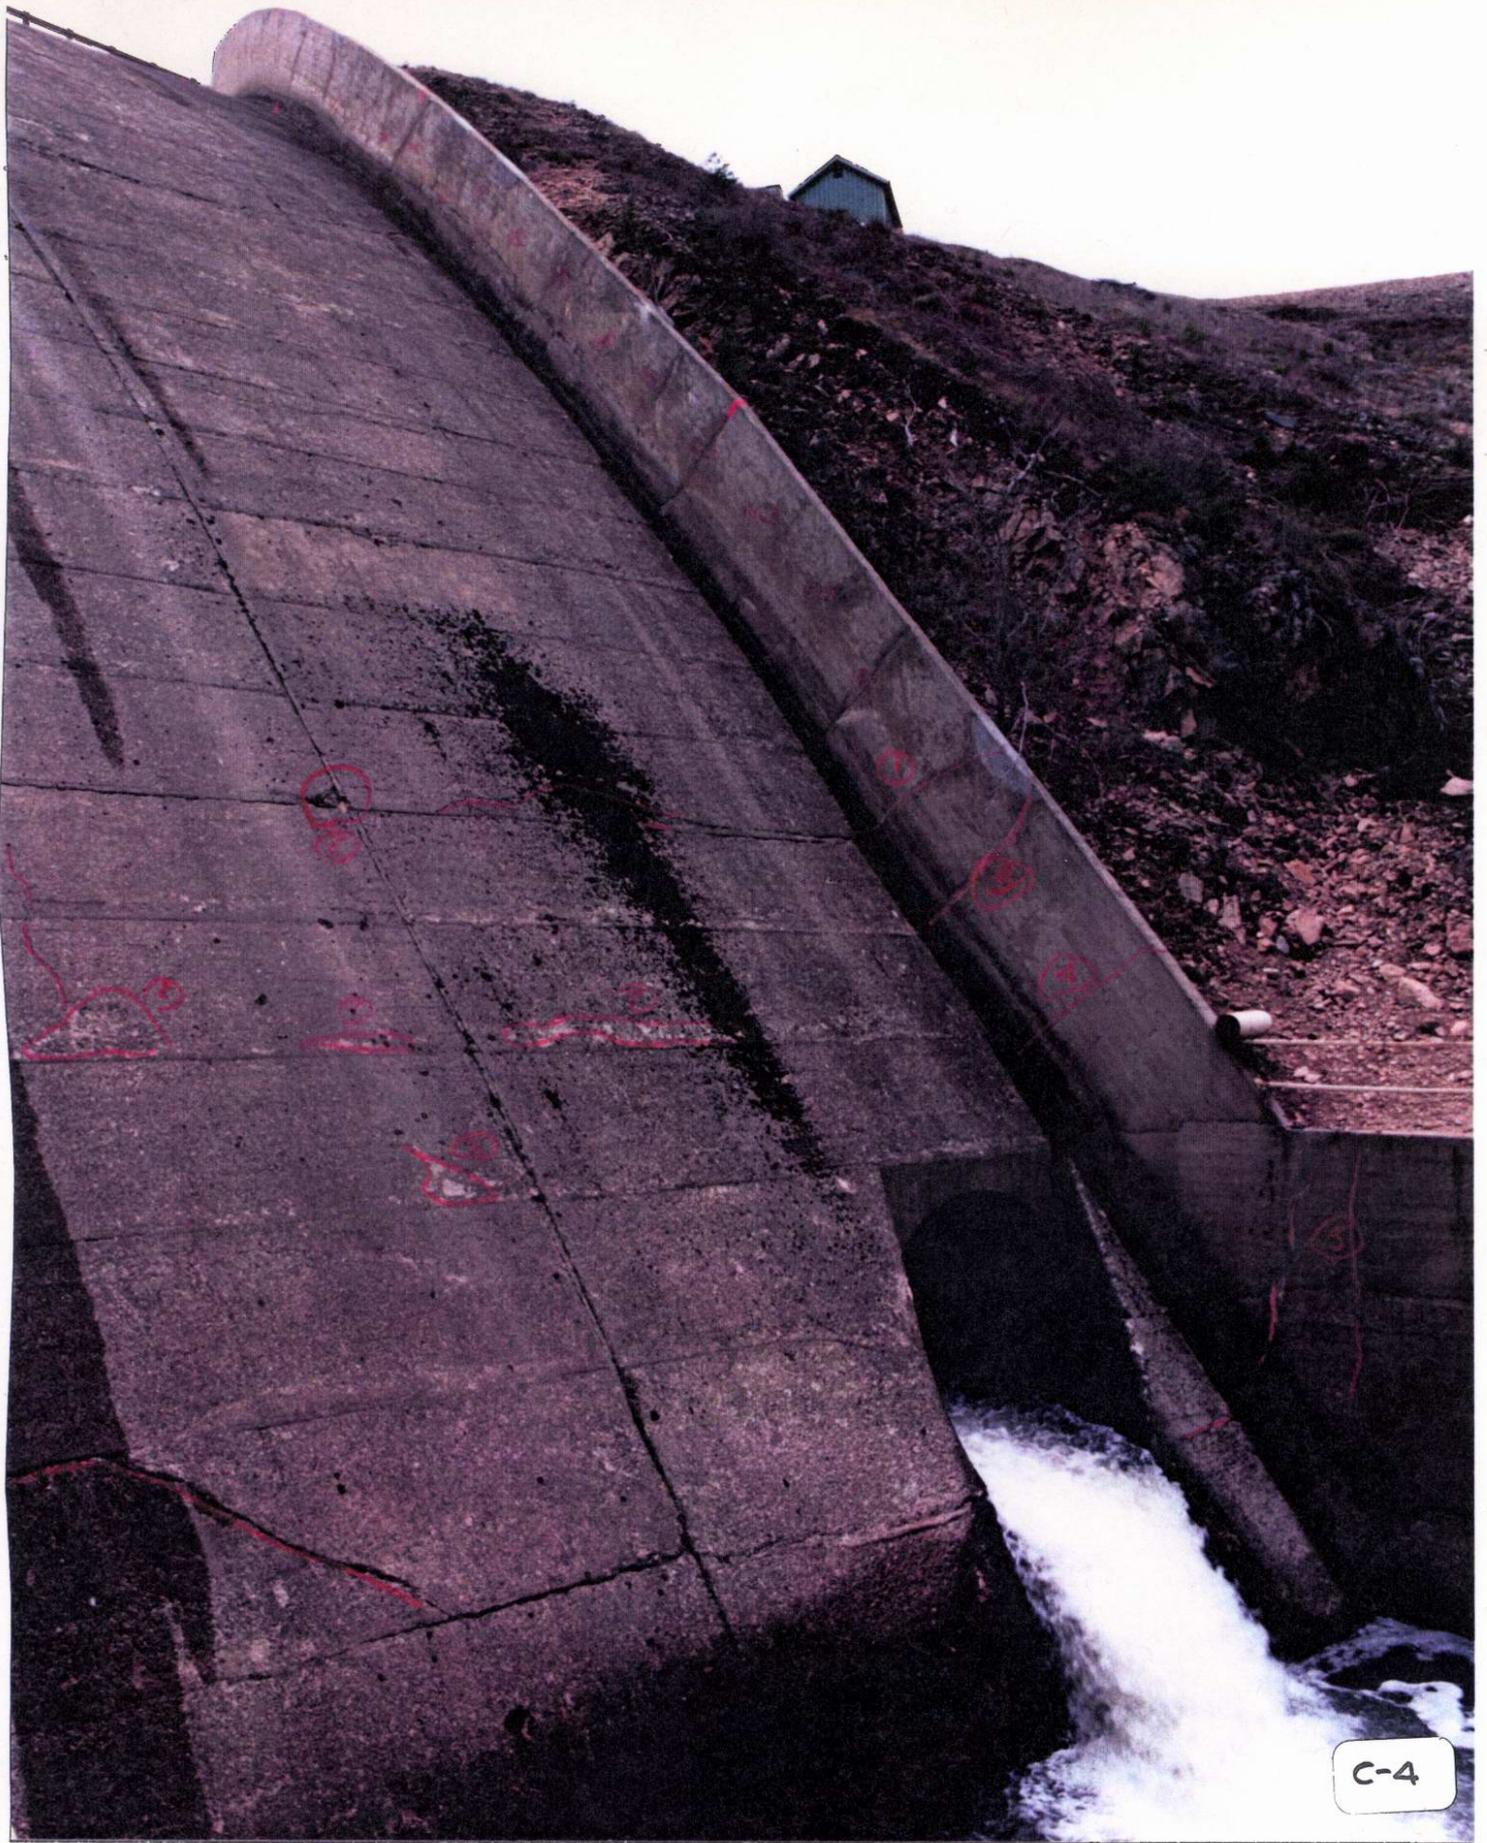
SUMMARY SHEET  
PHOTO C-4

C-4 View of lower left spillway

1. A vertical diagonal crack. It extends into a transverse crack across the floor of the spillway. Note that this crack extends through the most recent repair work on the left wall indicating activity along this crack line.
2. Drain hole and spalled concrete. Is shown in several other places in this lower part of the chute floor.
- 3 & 4 Very tight diagonal vertical cracks. There is also a transverse crack along the surface which goes through some of the repair work.
5. Two vertical cracks, the upper parts have been grouted and replaced. However there is a hairline in the lower downstream one and then there are a couple cracks at the base and along the edges of the upstream of this crack. This cracking goes right over to a construction joint and then goes on across to the tunnel outlet.

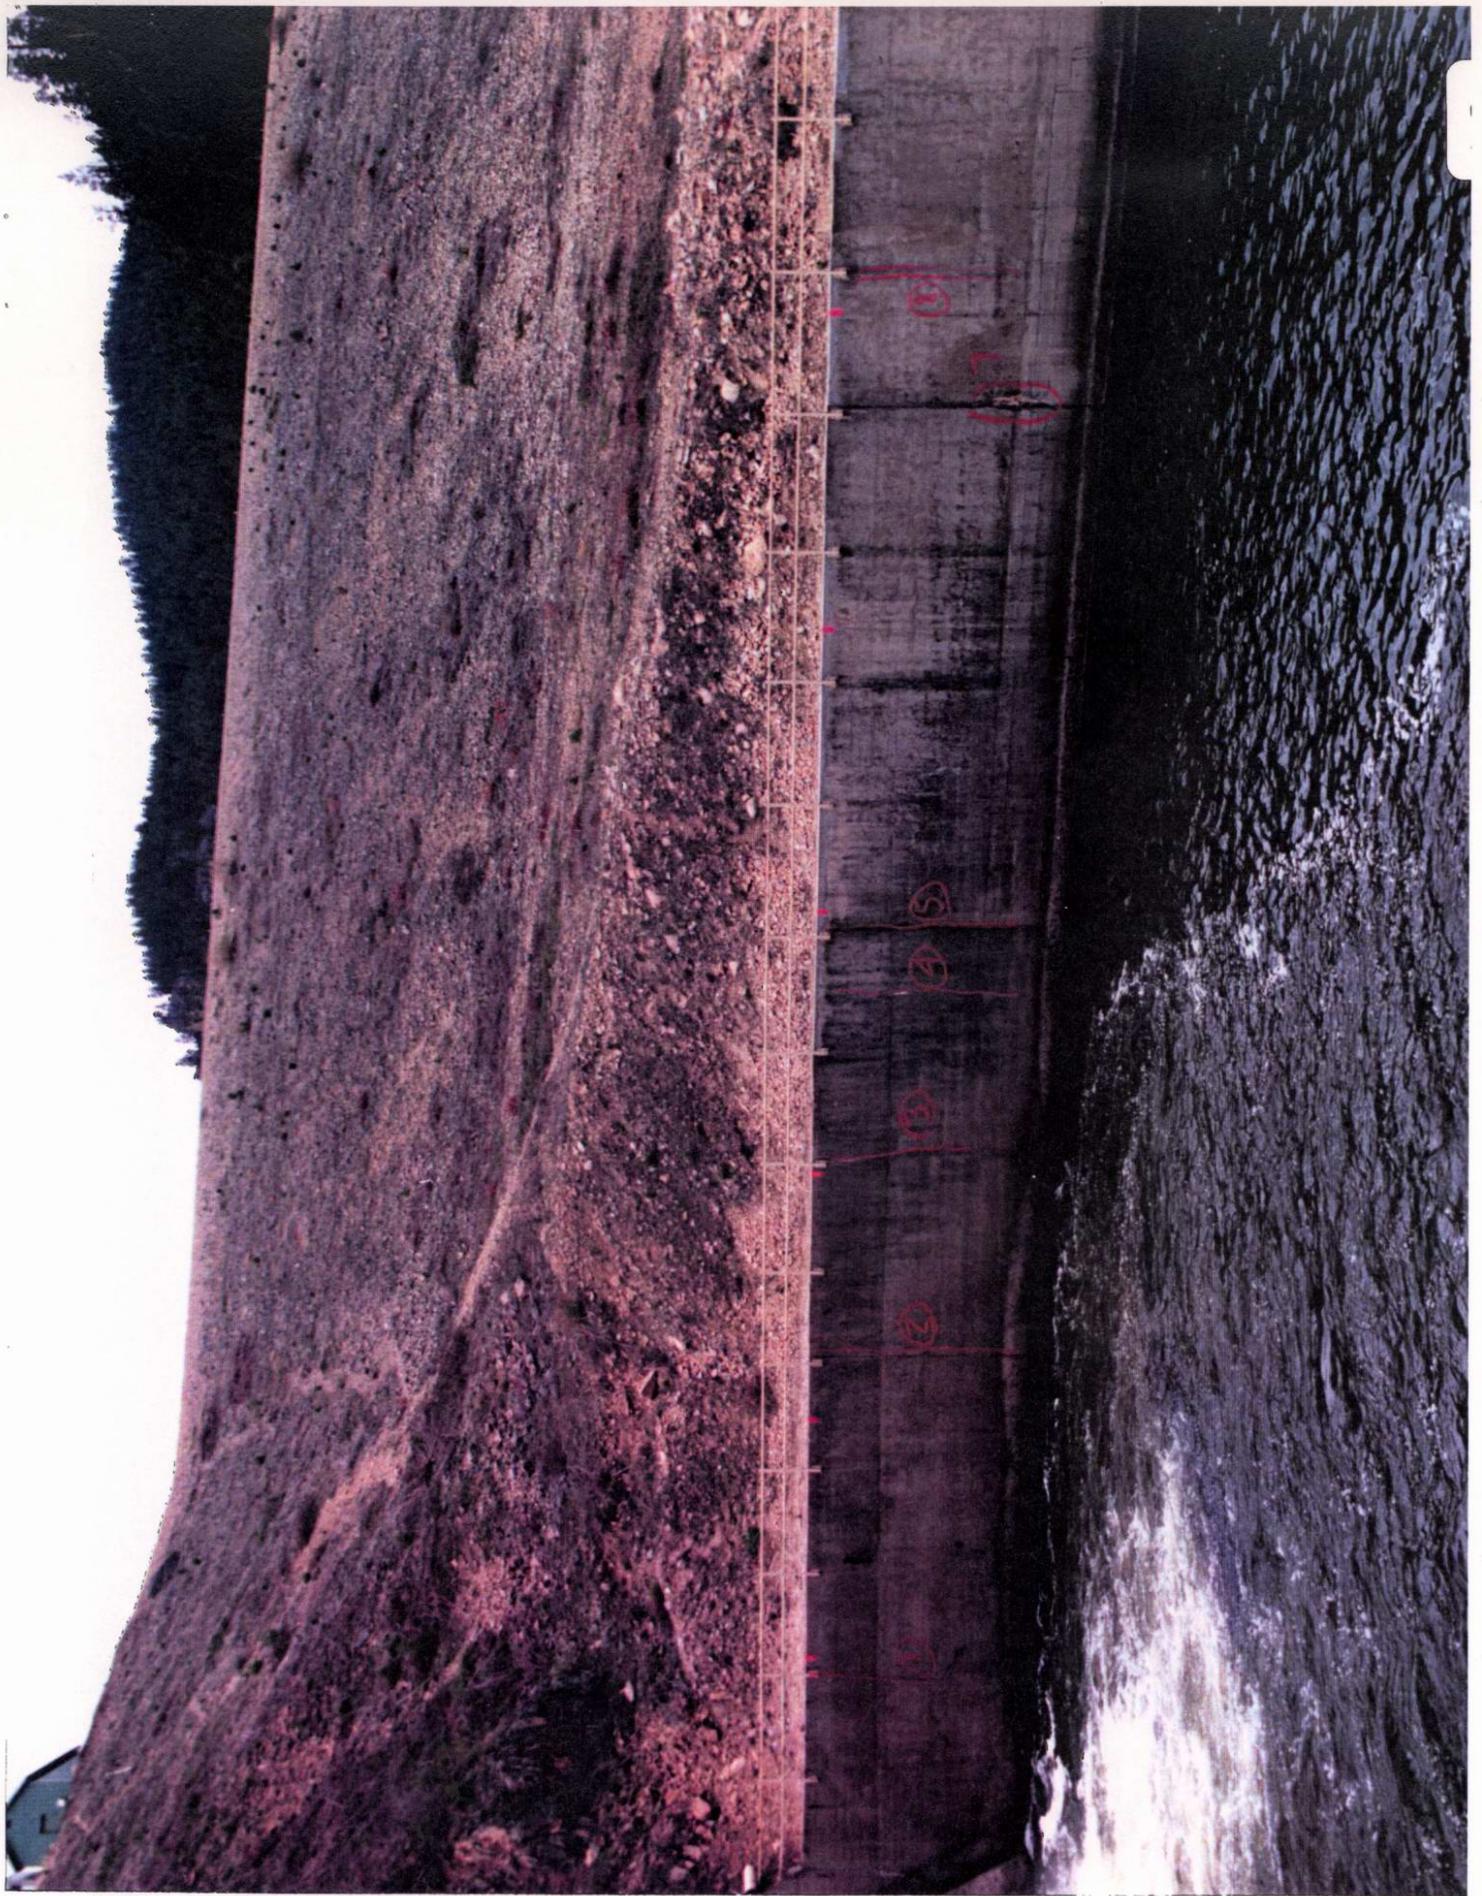
SUMMARY SHEET  
PHOTO C-2

C-2 View left of stilling basin wall

1. A vertical open crack goes to about 2/3 of the way to the water line, then stops. Maximum opening would be 1/4 inch.
2. A construction joint. There is minor spalling along the joint.
3. A leached filled crack that is tight. It goes half way down the wall.
4. A vertical crack. It is very tight and with leached infilling almost to the water's edge.
5. A tight crack, near a possible construction seam joint. Some seepage, more recent on this. Note the dental patch all along the top of the wall.

General note - There seems to be an absence of crazing cracking from 1 to number 5, then crazing seems to be more common towards the end of the stilling basin wall.

7. Spalling along the construction joint. The spalling is pretty extensive in the area circled.
8. Two vertical hairline cracks.

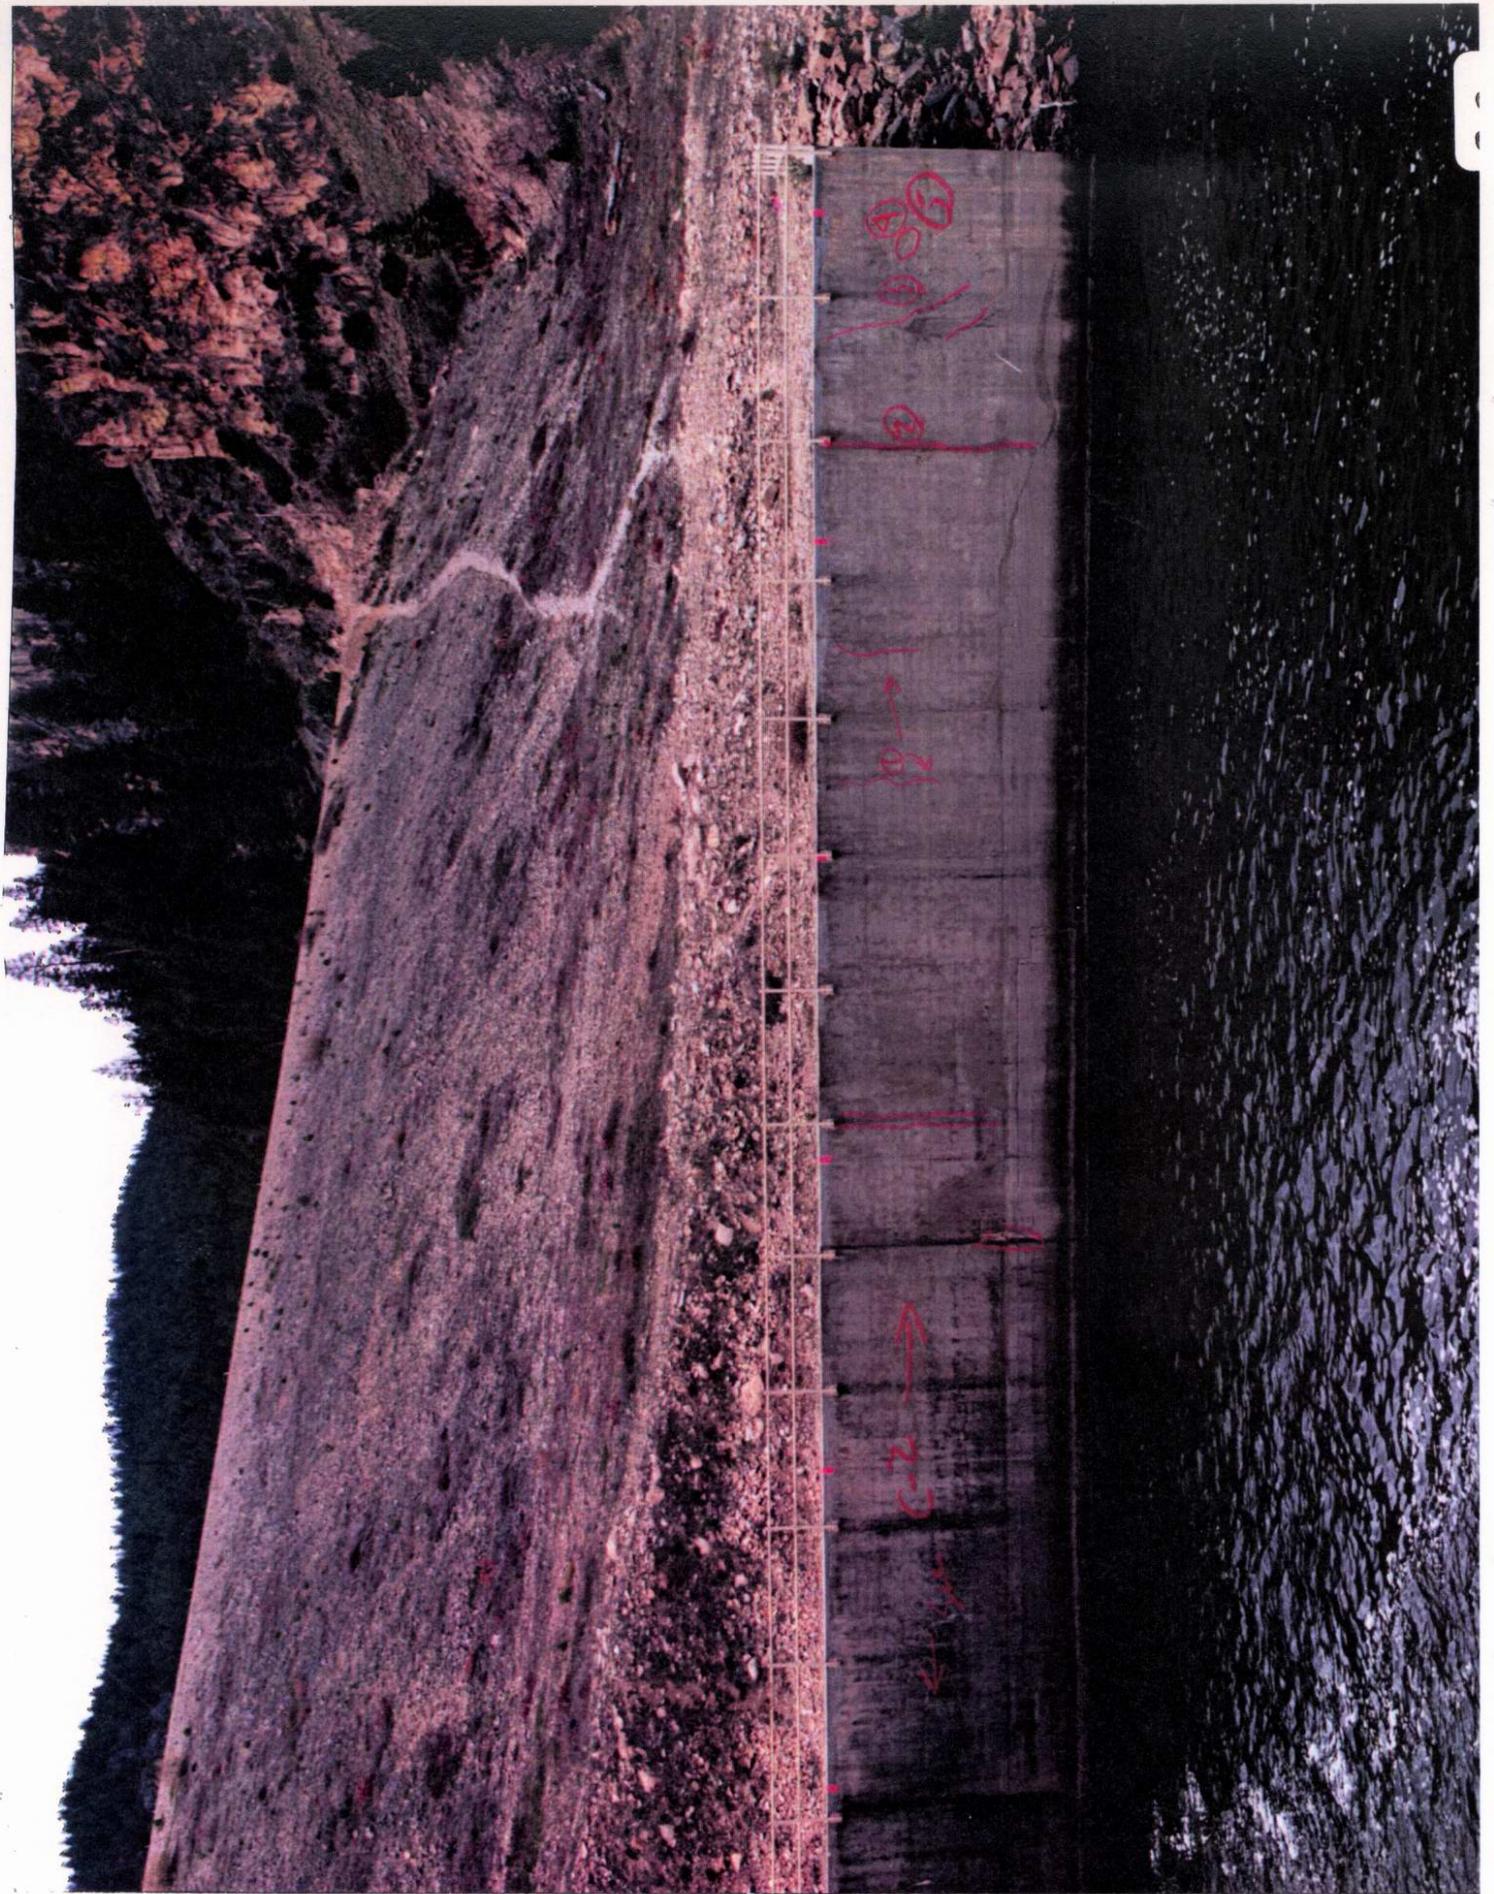
SUMMARY SHEET  
PHOTO C-3

C-3 View to left of stilling basin wall

1. A fine, vertical hairline crack.
2. A fairly tight vertical crack. This crack is probably near a construction joint and shows some seepage.
3. Diagonal fine cracking with small amounts of seepage. Generally the concrete quality of the wall looks a lot better in the stilling basin wall area than it does in the chute area.
4. A spalled area.
5. Fine crazing cracking.
