PAINTED ROCKS DAM  
2016 SPILLWAY CHUTE INVESTIGATION  
INFORMATION PACKET

# PAINTED ROCKS SPILLWAY

INVENTORY NO.: MT-19  
 HAZARD CATEGORY: HIGH  
 TYPE OF DAM: Zoned Earth Fill  
 YEAR BUILT: 1938  
 YEAR REHABILITATED: 2011-2015

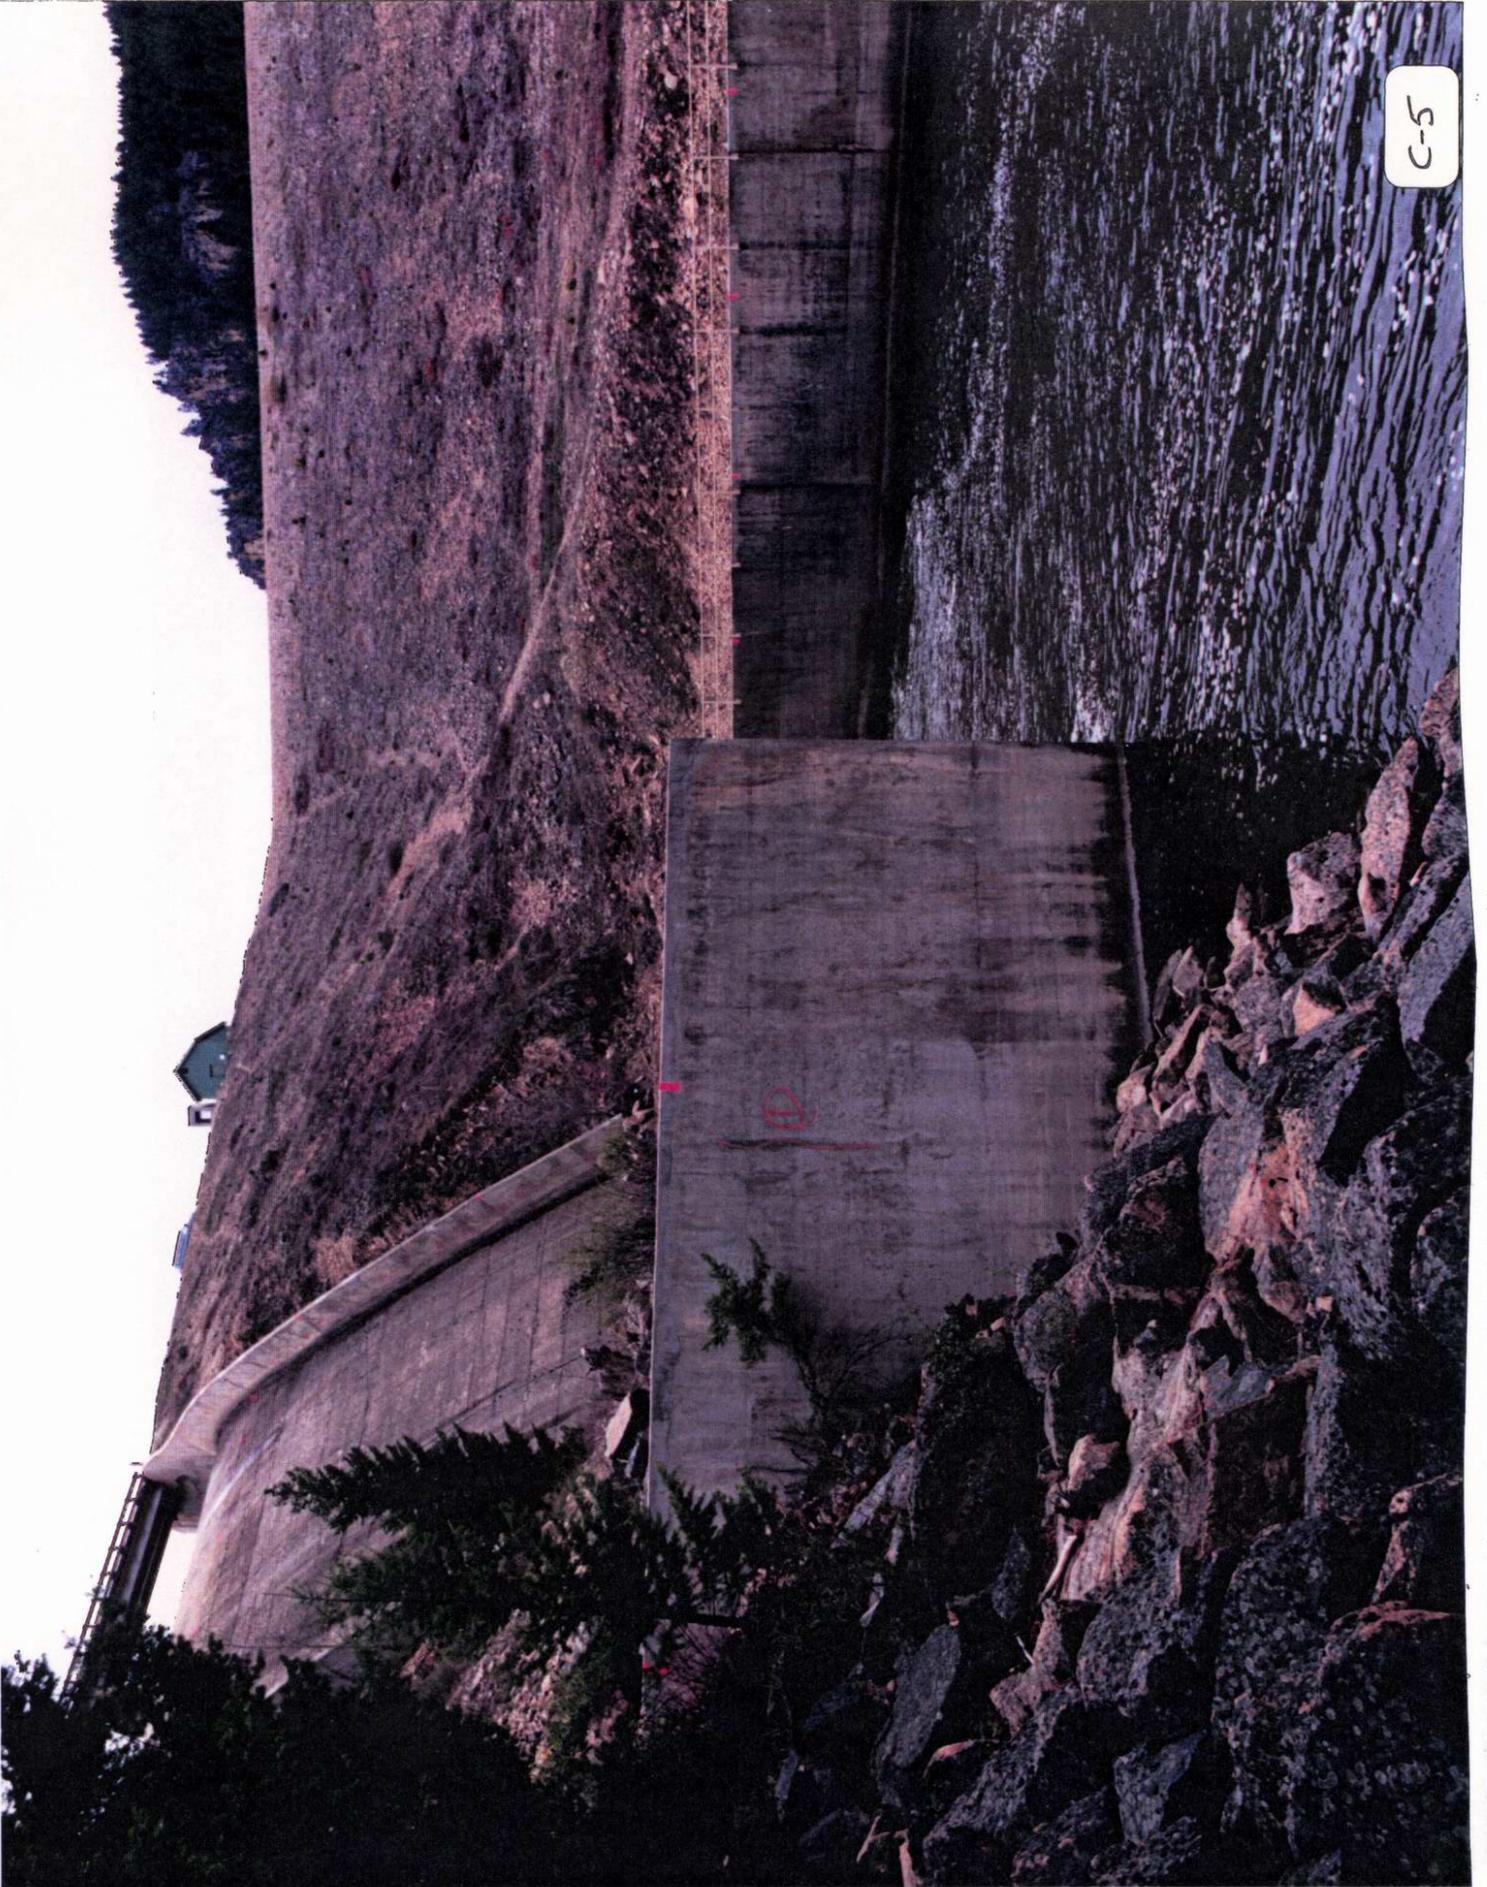
SUMARY SHEET  
PHOTO C-5

C-5 Right end wall

1. A medium crazing to a large crazing pattern that beginning area of the end section.
2. Some diagonal cracking right at the end section. Cracks show some seepage in parts of them. They probably connect to the concrete or surfacing finishing coat that has been put on part of this end section. Some of the crazing cracking is beginning to reflect through at this time. The construction joint is about 5 feet from the water surface and shows some signs of seepage.

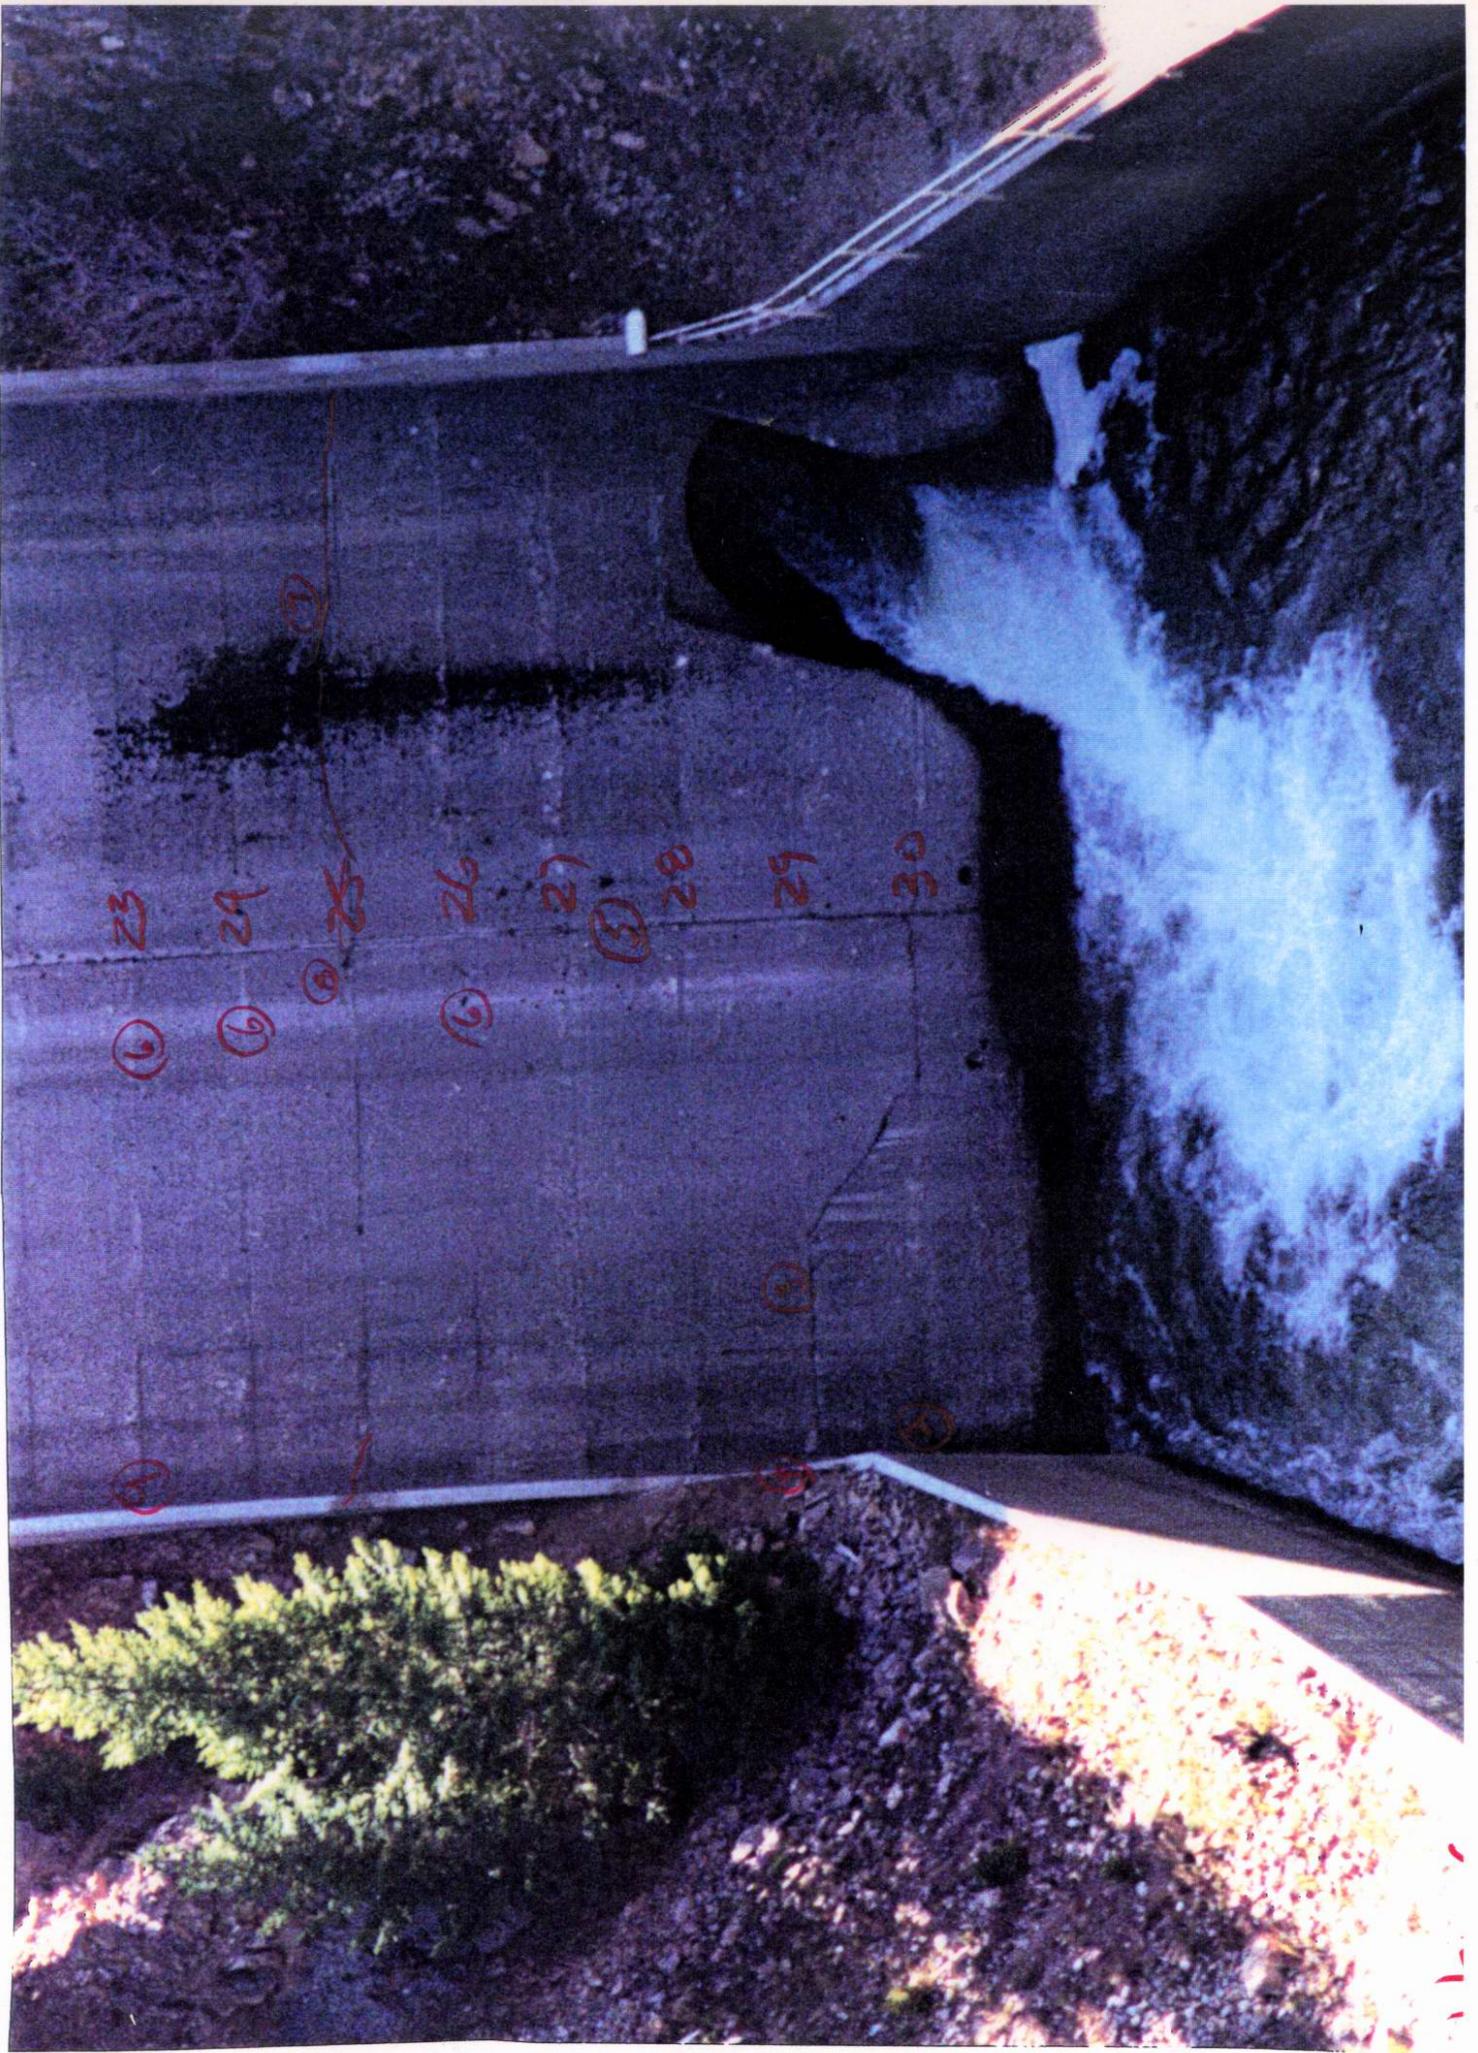
1. A diagonal crack that begins at the top and the cracked or spalled area right at the horizontal and diagonal wall line fracture breakout. That fine line is a diagonal line and goes down and meets the floor at a minor spalled area it's a hairline fracture. With the next major spalling area which is only about 2 feet on the incline wall from the horizontal intersection, the spalled area is about 2 1/2 feet long and roughly 8 inches wide at the end of that is another diagonal crack that is open for about 2 feet with a small spalled area, then it becomes a hairline crack down to the floor and crosses the floor into the minor spalled area, on the floor at point number 2.

3. A major crack opening that begin at joint number 29 and then moves diagonally down along the floor to joint number 30. This is a very large crack and it's open. The photograph indicates leakage from underneath, staining and there is minor spalling or scour along this joint fracture opening. The remaining part of joint number 29 is tight and looks good to the outlet tunnel.

4. A seepage drain hole that is functioning quite regularly indicating some seepage near the toe of the chute area. Joint 30 is fairly tight all the way to the intersection of the fracture mentioned in note number 3. The joint becomes open from the connection of that joint to the main longitudinal construction joint. Left of the longitudinal construction joint, the joint is tight to, the tunnel. Joint number 28 is tight for the entire width.

5. The longitudinal joint appear to be fairly well eroded from the activity on the spillway. There is minor cracking, almost D-type cracking, along large parts of this.

6. Construction joint 26 is tight.
7. A transverse crack and it's horizontal component from the drain hole at number 8 is rather tight. The main part of the crack begins from joint 25 and is open with a crack of perhaps 1 inch in width. It's an older crack along the left portion, seems to be a little bit newer crack in the mid section of near mid chute floor. When this crack hits joint number 25 that joint appears to be fractured and open. A defined fracture moves off diagonally along the edge of the construction joint and the right half appears to have that joint open. From the intersection of the fracture on number 7, on the left half of the bridge deck seems to be tight.

8. The longitudinal drain hole is in an area that is badly spalled in the intersection between joint and joint number 25. It appears that this is very little leakage from this particular drain hole. No staining can be noted, or very little at least in the photograph and on the concrete floor.

9. Joint number 23 is tight for it's entirety. There is a diagonal fracture that is controlled to this construction joint on the right wall, fairly tight.

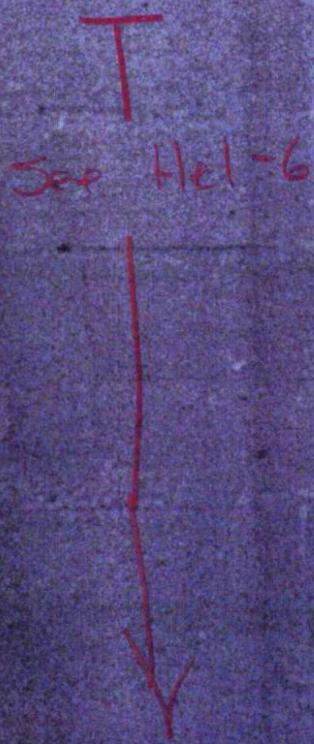
HEL-5

## PHOTO H-5

Note that from construction joint 23 to bottom of the chute floor is covered in helicopter - 6 photograph. This photograph will use just the right half of the floor from 22 to 16.

1. A transverse crack. It's slightly open and less than 1/8 of an inch in width. Some minor spalling has occurred along this crack. This crack works it's way to the construction joint 20, and it appears to be open with some minor leakage along that joint. The remaining portion of this joint (right half) is tight.
2. See comment number 20 on A-1.
6. Tight solid construction joints.

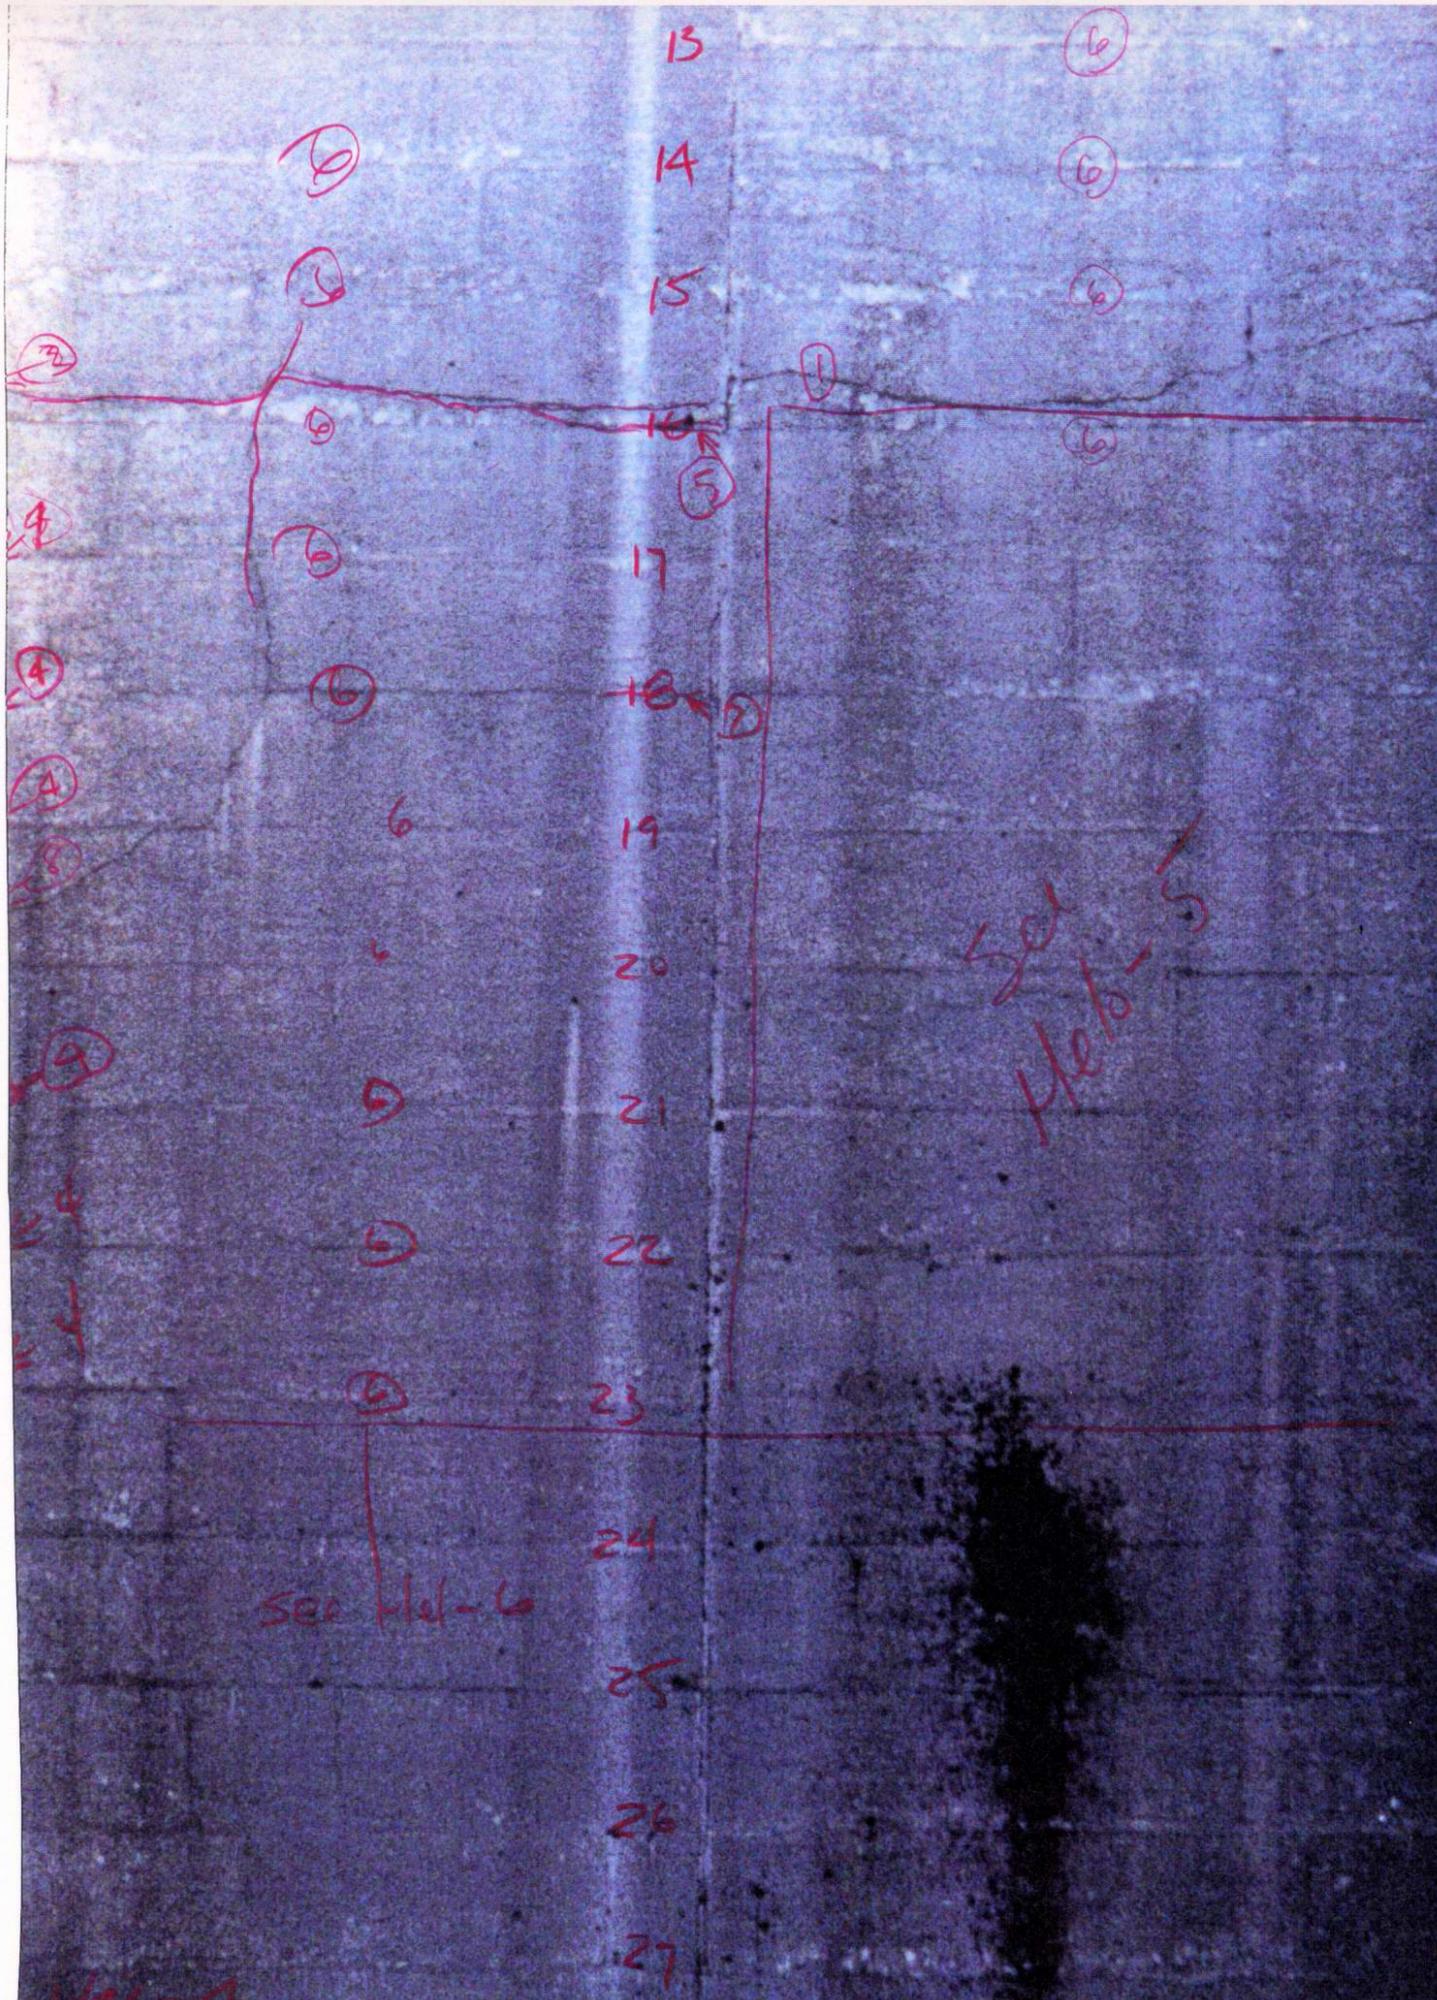
1. Note amount of erosion and deterioration on this larger crack. Large pieces have been broken out, reflecting the poor condition of the concrete in this area.

7. Right from the longitudinal joint out a short distance on 18 there is some moss that appears be growing in this crack which has a little opening for a short distance. Joint 19 is tight all the way, except where the large longitudinal crack is controlled by joint 19 for a short distance, approximately a foot, other than that, that joint is tight. Also the construction joint acts as a diagonal cracking at the wall.

8. The floor cracking that comes into the wall also is a point for a slight 1/4 inch to hairline crack diagonally up on the wall. Also the crack shows some leaching on the wall face.

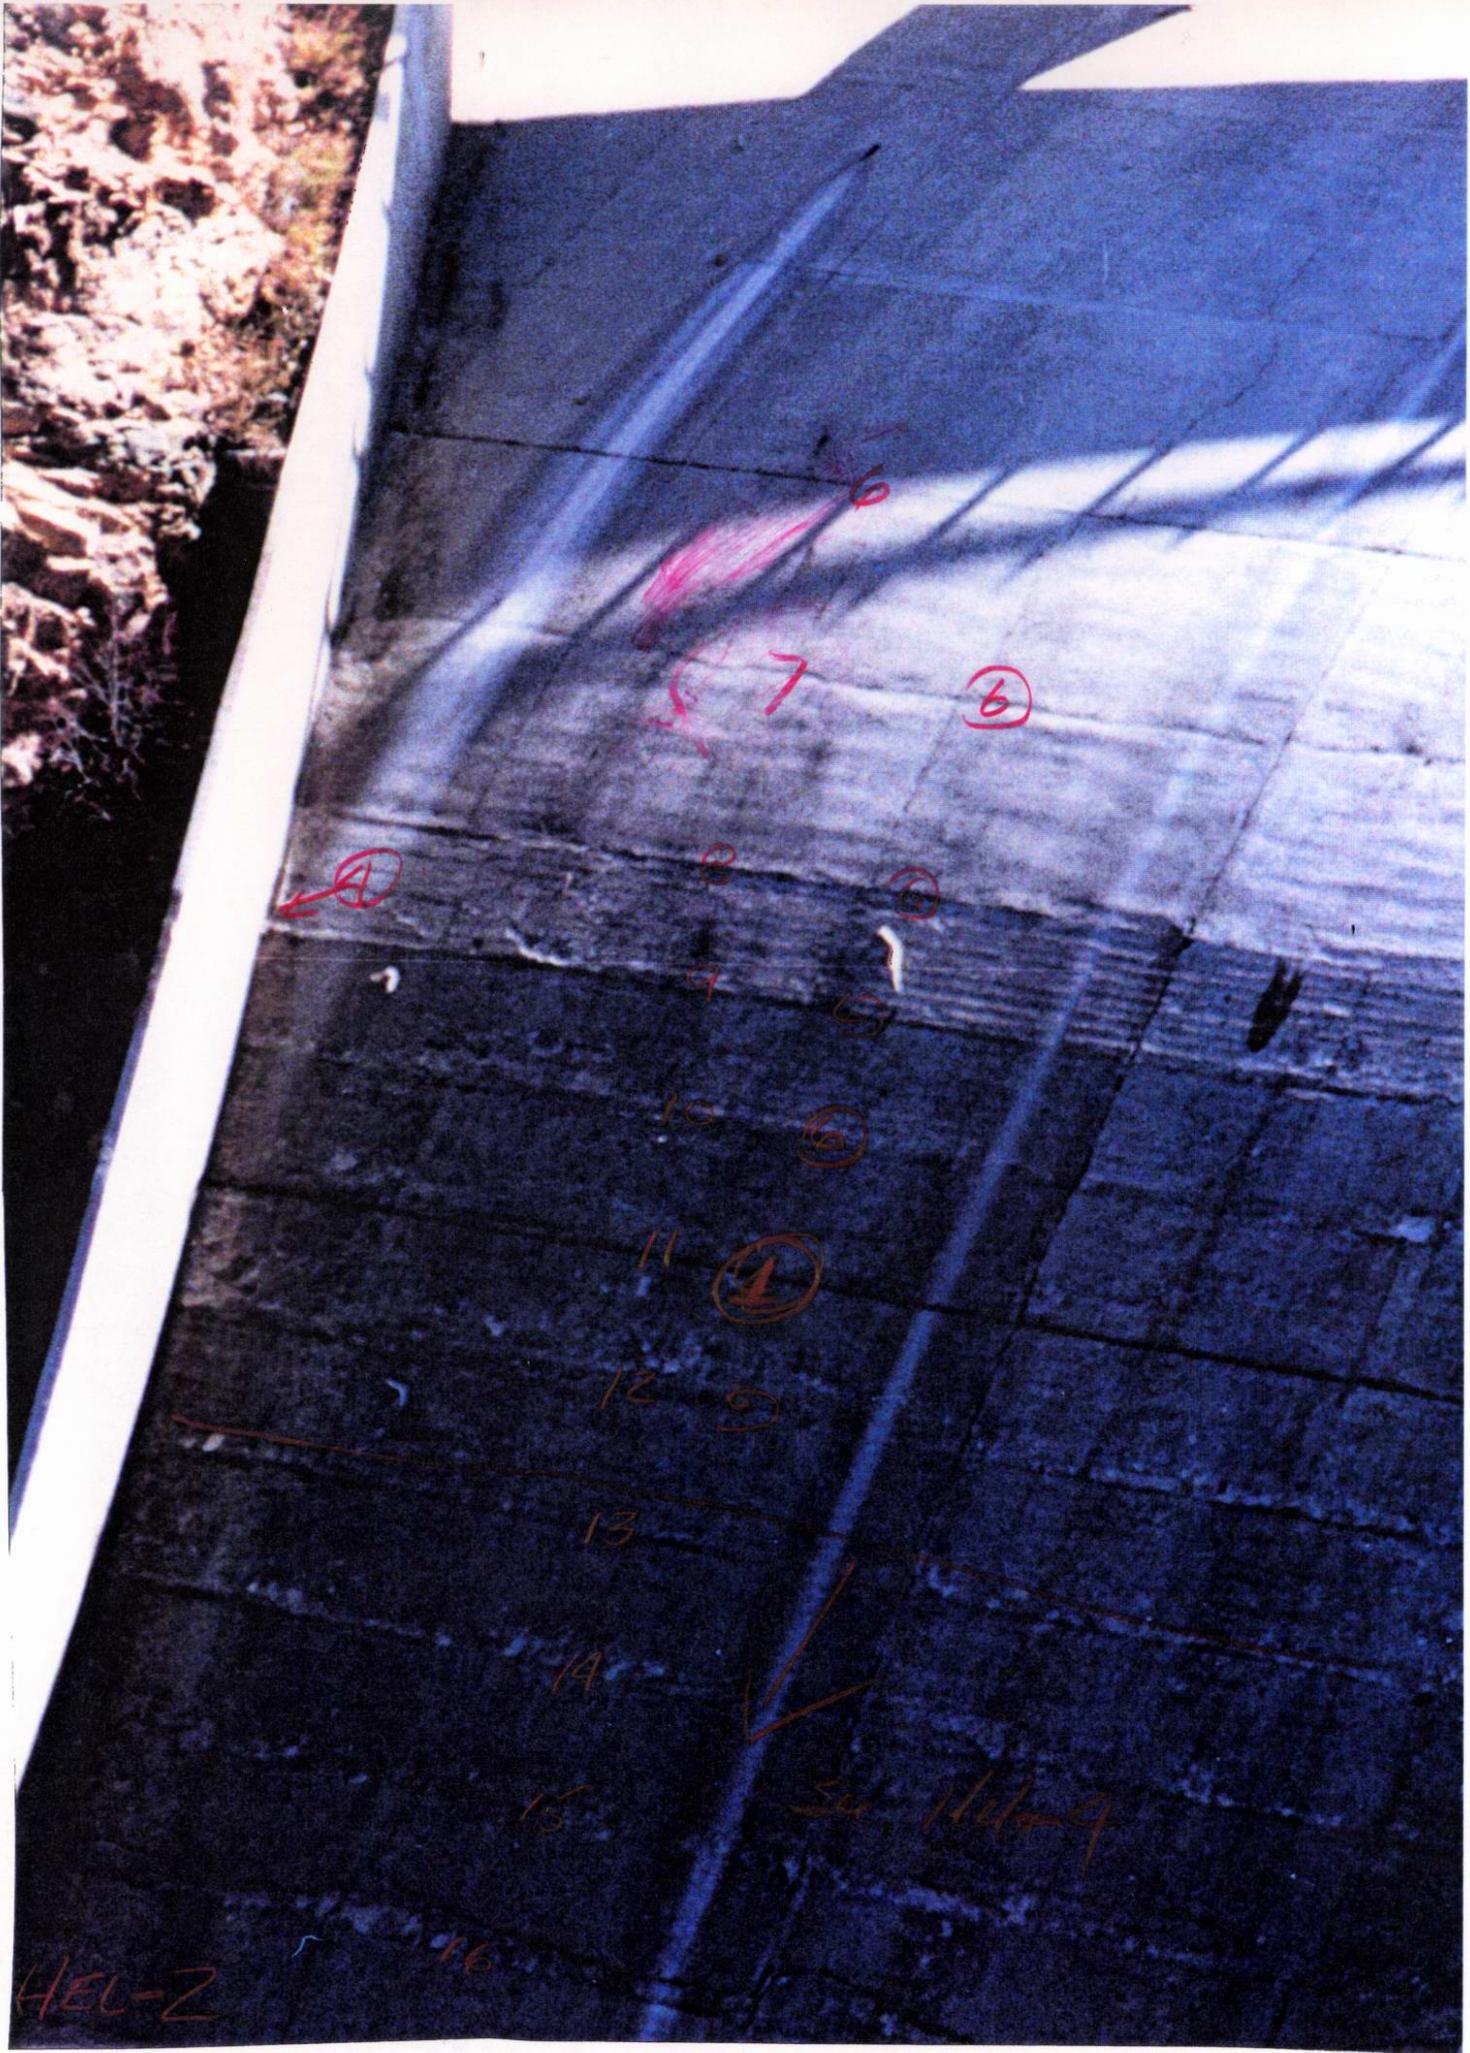
Helicopter-2

1. Joint is open.
4. Diagonal crack that is related to the construction joint.
6. Tight joints.
