MANUAL ON CORRUGATED METAL PIPE IN DAMS FOR MONTANA DAM OWNERS

Problem Identification and Evaluation, Inspection, Rehabilitation, Repair, and Replacement

**MANUAL ON CORRUGATED METAL PIPE IN EMBANKMENT DAMS
FOR MONTANA DAM OWNERS**
PROBLEM IDENTIFICATION AND EVALUATION, INSPECTION, REHABILITATION,
REPAIR, AND REPLACEMENT

Great West Engineering, Inc.
2501 Belt View Drive
Helena, MT 59601

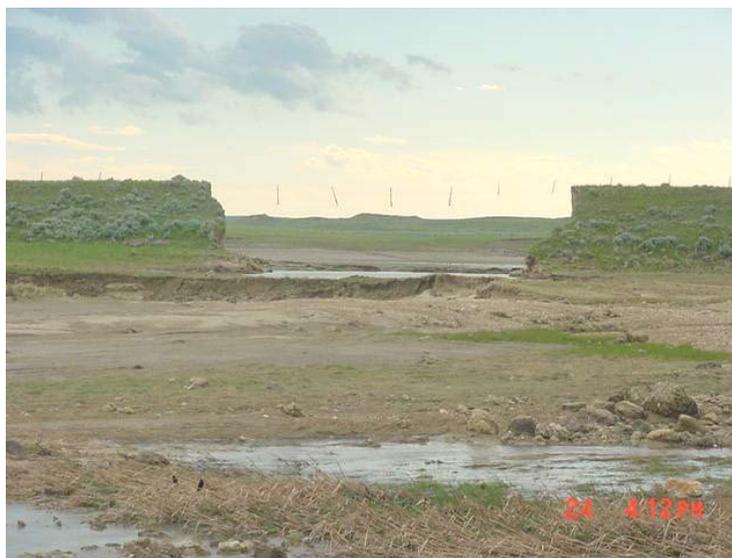
Figure 1: Photo of a dam failure in Garfield County (MT DNRC).

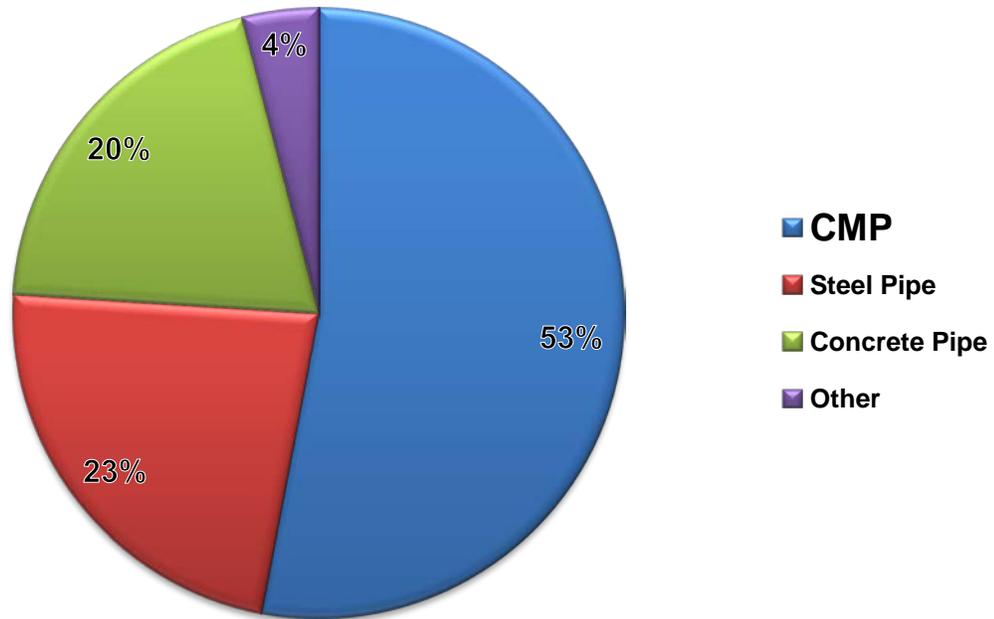
Figure 6: Composition of conduits in embankment dams needing repair from 1998 study (FEMA 2005).

A 1998 survey of State dam safety programs (with 14 states responding to the survey) estimated that 1,115 embankment dams will need repair over the next 10 years. The graph in Figure 6 shows the material makeup for the conduits in these dams.

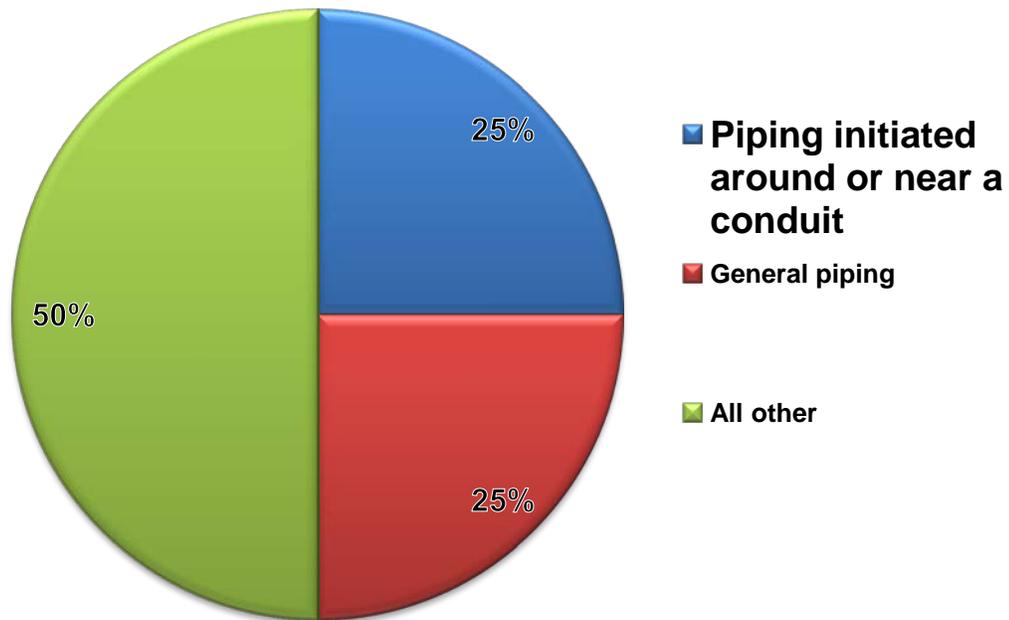
Figure 7: Failure mode of large embankment dams.

In observed failures of large embankment dams, it has been determined that about one-half are attributable to some form of piping. Approximately half of these piping failures are known to have initiated around or near a conduit. See Figure 7 below.

This graph shows that approximately 25% of all dam failures are a result of piping associated with conduits (Foster, Fell and Spannagle 2000).

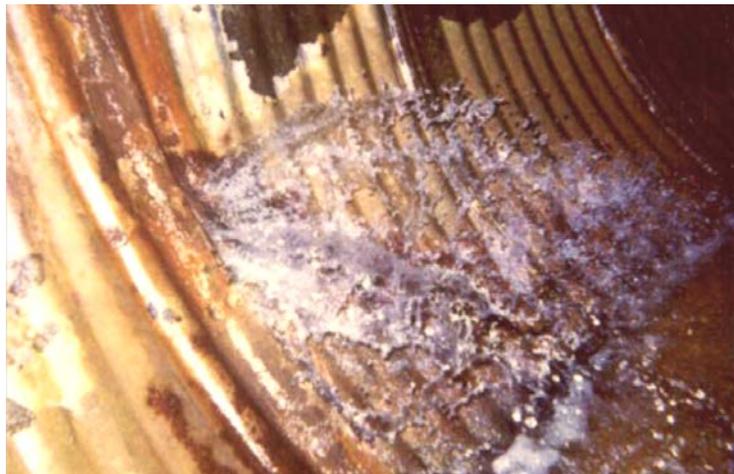
Figure 8: Photo of corrosion at joints (FEMA 2005).

Uncoated CMP is susceptible to corrosion from a number of sources: soil, groundwater, and water in the pipe. Corrosion is defined as the “deterioration or breakdown of metal because of a reaction with its environment” (Ohio Department of Natural Resources 1999); the mechanics of corrosion are further described in Section 2.3. When the corrosion advances to a point where holes begin to develop, water flows into or out of the pipe and begins to erode the soil around the pipe. The Figures below show what corrosion can do to the body of the pipe.

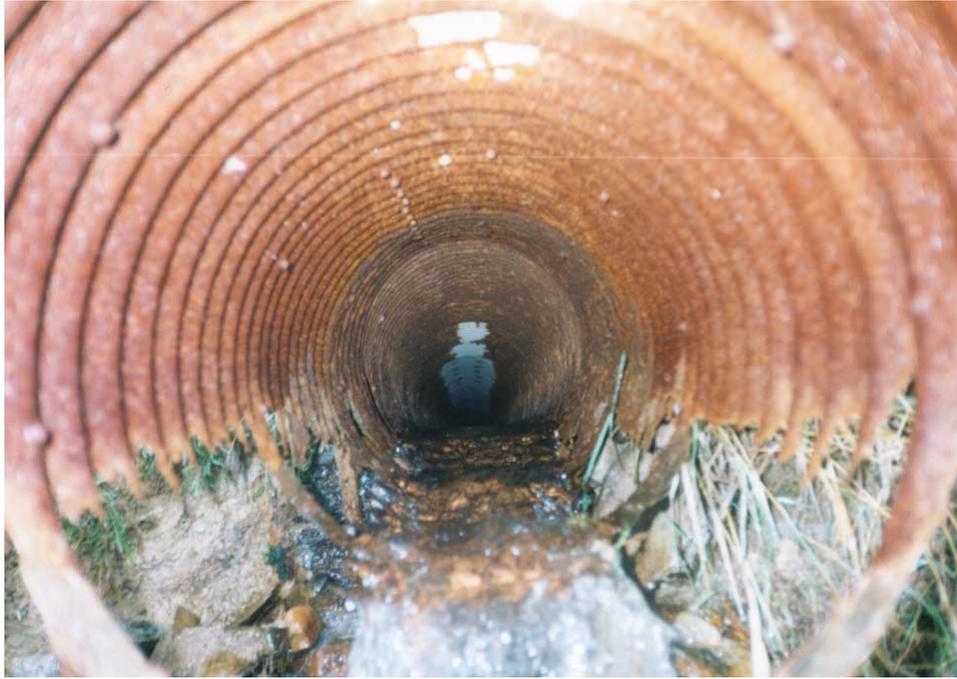
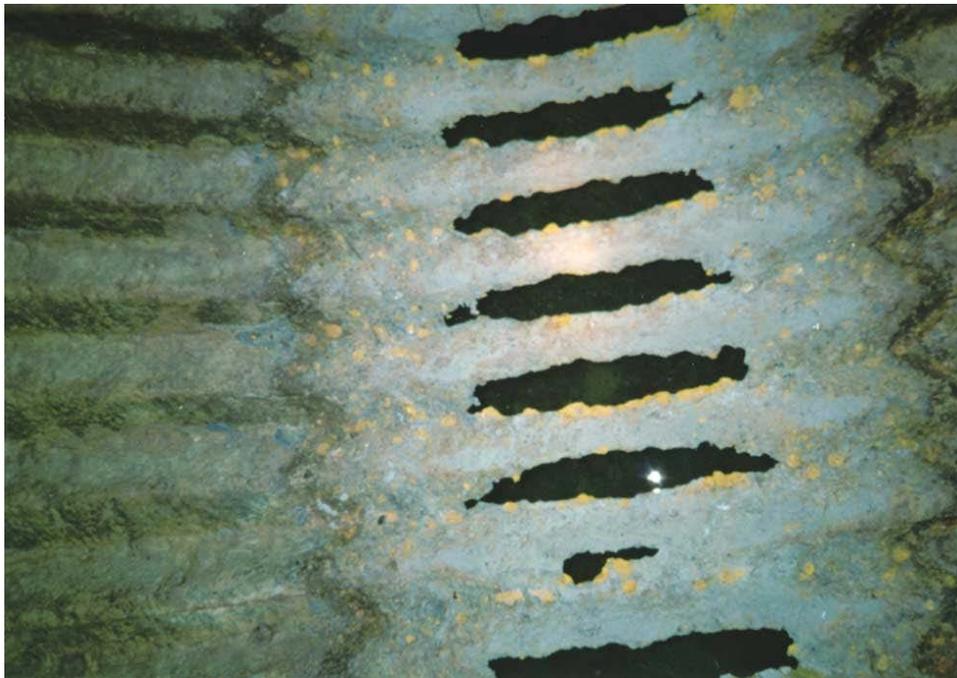
Figure 9: Photos of corrosion of CMP pipes in two Montana dams (MT DNRC).

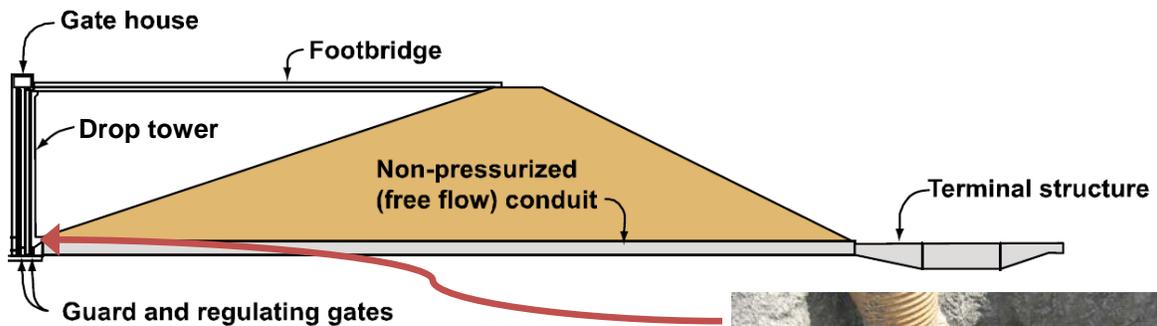
Figure 10: Corrosion at connection between drop tower and conduit. Figure above courtesy of FEMA. Photo at right: Failed dam in Petroleum County (MT DNRC).

Corrosion is also a concern where the drop tower connects to the outlet conduit. A dam configuration like this is shown in Figure 10 below.

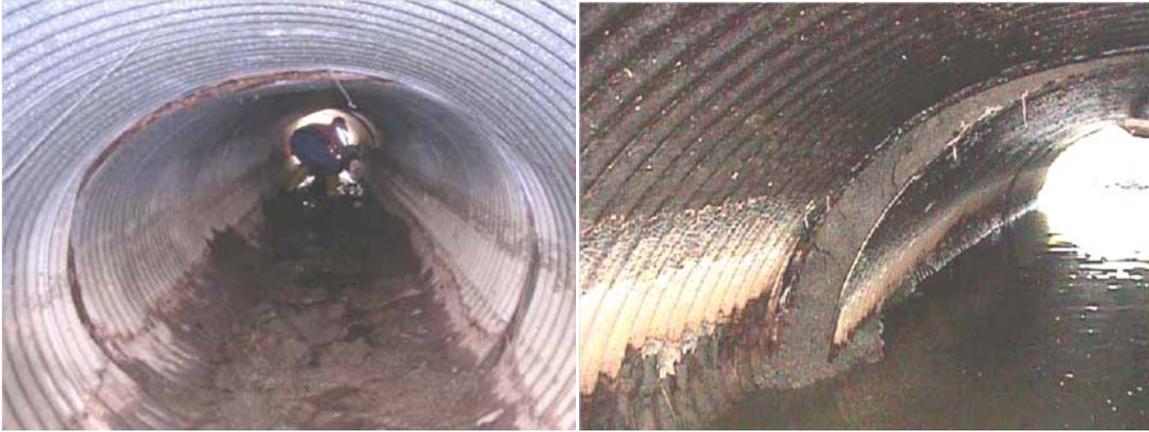
Figure 11: Photos of joint separation (U.S. Department of Transportation, FHWA 2010).

Joint separation, which leads to leaking joints, is mostly attributable to improper construction techniques. These include: damaged pipe section ends from transport or installation, gaskets not used at joints, or helically corrugated pipe ends may not have been re-rolled to provide for proper joint contact (Kula, Zamensky and King 2000). All of these issues may ultimately lead to water leaking into or out of the pipe and eroding the soil adjacent to the pipe. See Figure 11 below for photos showing examples of joint separation.

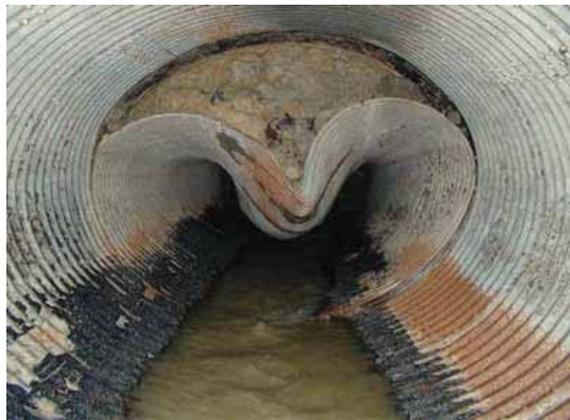
Figure 12: Photo of CMP structural failure and collapse (U.S. Department of Transportation, FHWA 2010).

Unlike rigid pipes (e.g. concrete, ductile iron), CMPs obtain their structural support from the surrounding soils. “Because they are flexible, they are designed to deform somewhat against the adjacent backfill and mobilize lateral resistance of the soil. This lateral resistance acting against the sides of the pipe stiffens the shell and provides its vertical load carrying capacity” (Kula, Zamensky and King 2000). If the backfill is not adequately compacted, the pipe can deform, resulting in structural failure or even collapse. See Figure 12 and Figure 13 for photos showing examples of pipe deformation.

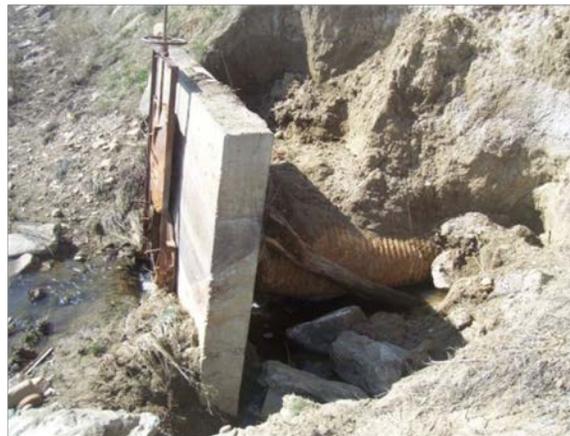
Figure 13: Photo of collapsed outlet works in a Chouteau County dam (MT DNRC).

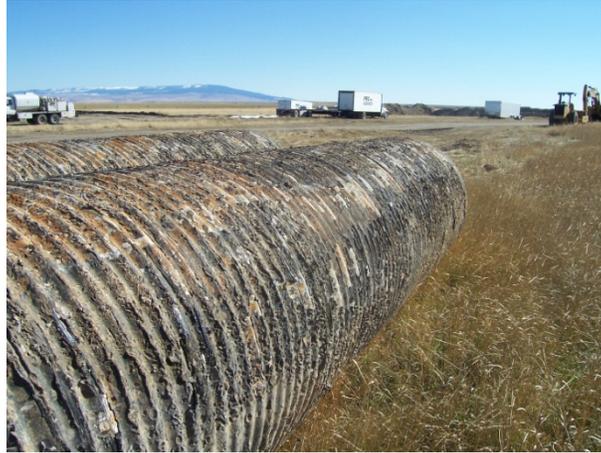
Figure 14: Photo of bituminous coated CMP from a dam in Judith Basin County, installed circa 1950 (MT DNRC)

Asphalt (or bituminous) coatings have been used historically and have been very effective, as shown in Figure 14 and Figure 16. These pipes survived over 60 years while still maintaining their structure. Asphalt coatings are applied after the pipe is manufactured, and therefore, are limited to larger diameter pipes which allow for man-entry.

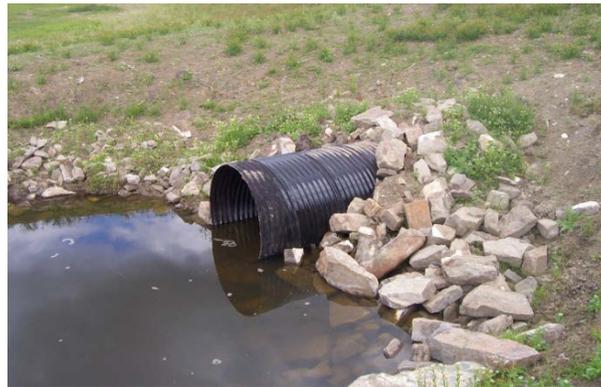
Figure 15: Photo of polymer coated CMP used for replacement of outlet pipe in a Fergus County dam (MT DNRC)

Polymeric coatings were introduced in the 1970’s (National Corrugated Steel Pipe Association 2008) and come in several varieties, including ethylene acrylic or polyvinyl chloride plastisol (PVC). The polymer coating is applied over the galvanized coating and provides excellent adhesion to the base steel, as well as extended corrosion and abrasion resistance.

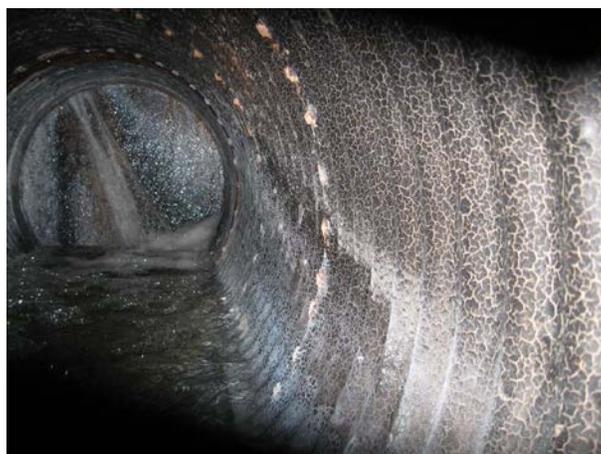
Figure 16: Photo of deteriorated bituminous coating on outlet pipe in a Park County dam (MT DNRC)

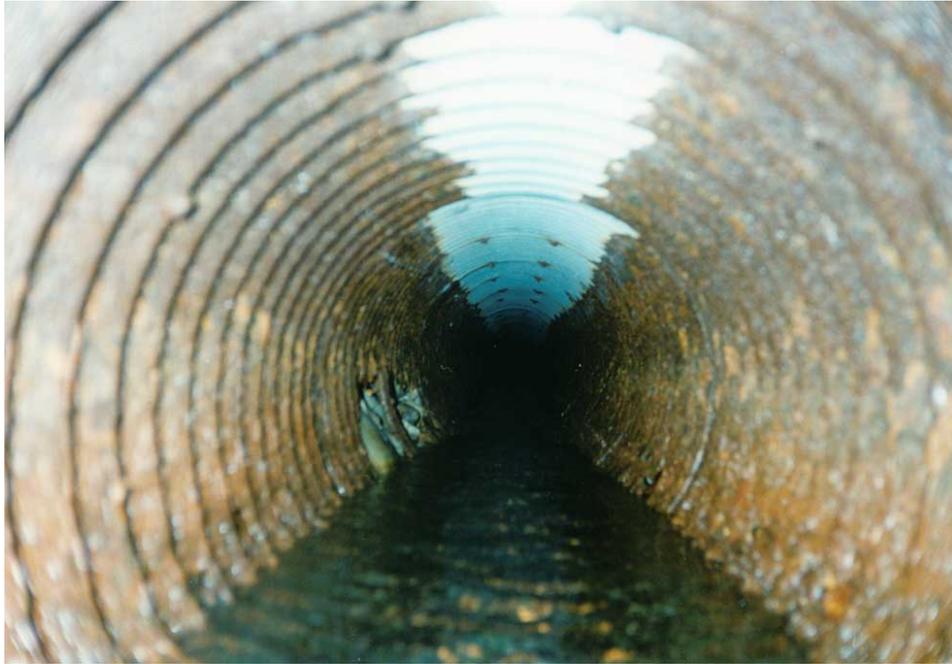
Figure 17: Photo of corrosion in a CMP outlet pipe in a Missoula County dam (MT DNRC).

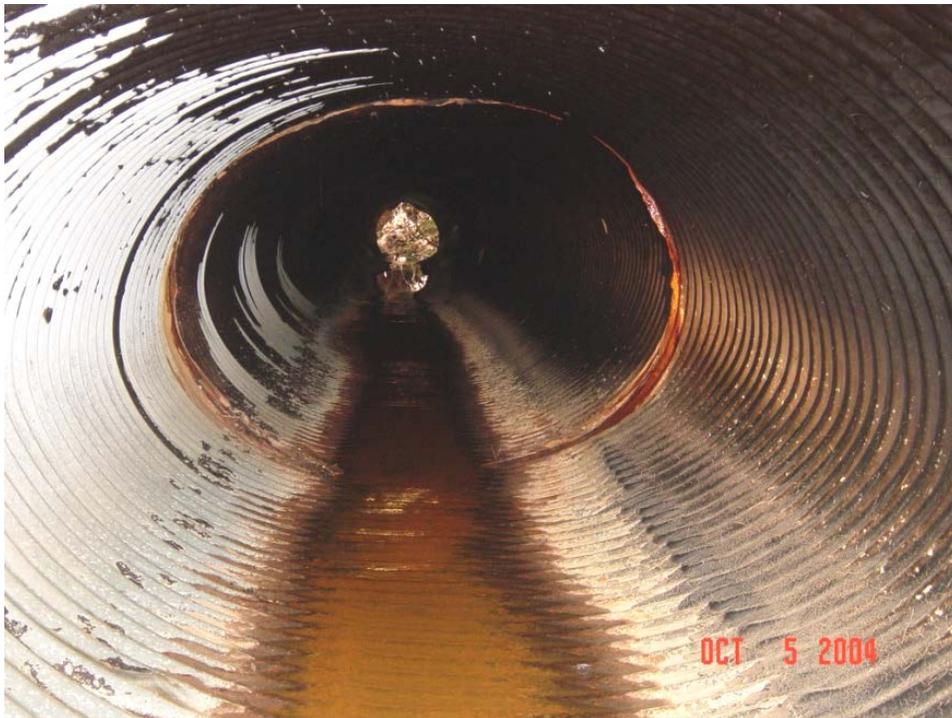
Figure 18: Photo of damage to polymer coating on a CMP from abrasion (source unknown).

Abrasion is defined as the process of scraping or wearing down by friction. In CMPs, it is primarily a concern for coatings on the pipe. “Abrasion is caused by water flowing through a conduit at high velocities and containing silts, sands, gravels, or stones” (FEMA 2005). When a coating becomes damaged, leaving the bare steel open to direct contact with water, the potential for corrosion increases substantially.

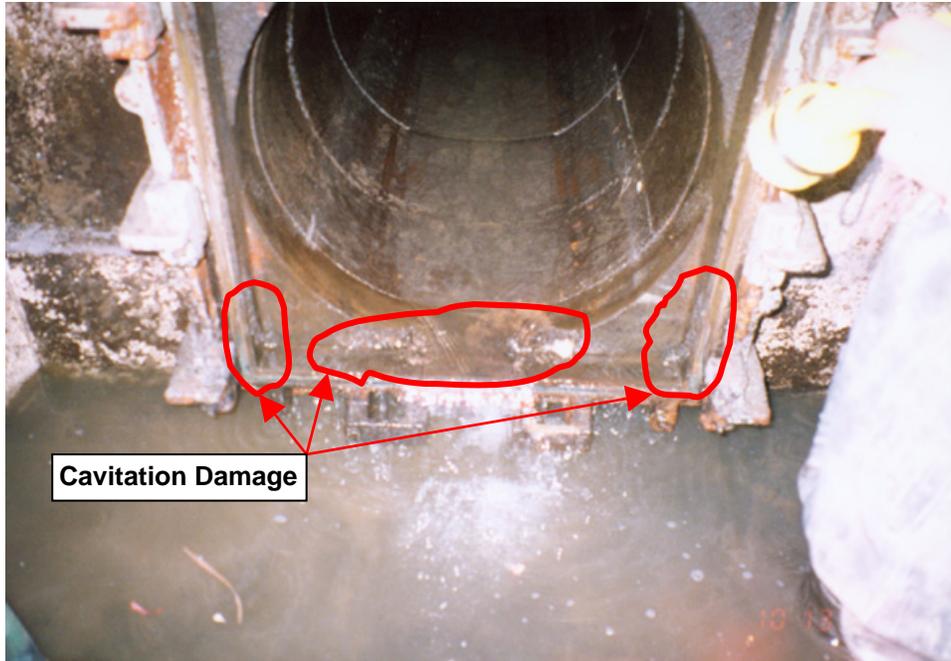
Figure 19: Photo of cavitation damage on outlet works at Beaver Creek Dam, Hill County, Montana (photo courtesy of Great West Engineering, Inc.)

Cavitation is a technical term for the “boiling” of the water, except that it occurs far below the boiling temperature of water. In the right conditions of high velocities and misalignments or discontinuities in the pipe, the water actually bubbles. “When these bubbles travel downstream and collapse next to the conduit surface, the high pressure impact removes small particles of the conduit surface (pitting)” (FEMA 2005). This process continues and builds on itself and can eventually damage the conduit.

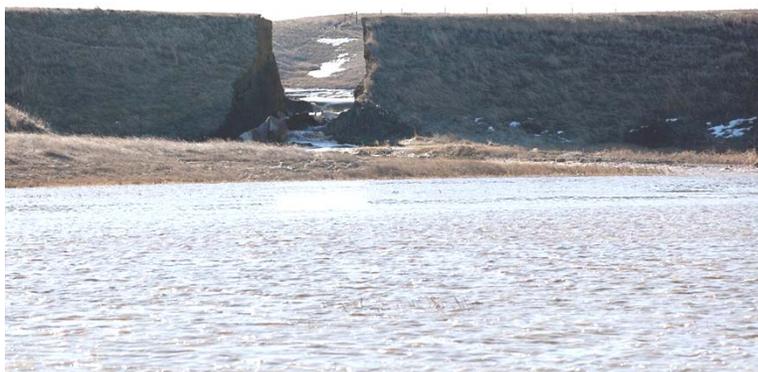
Figure 20: Photo of a dam failure in Chouteau County. Failure was caused by piping around outlet pipe (MT DNRC).

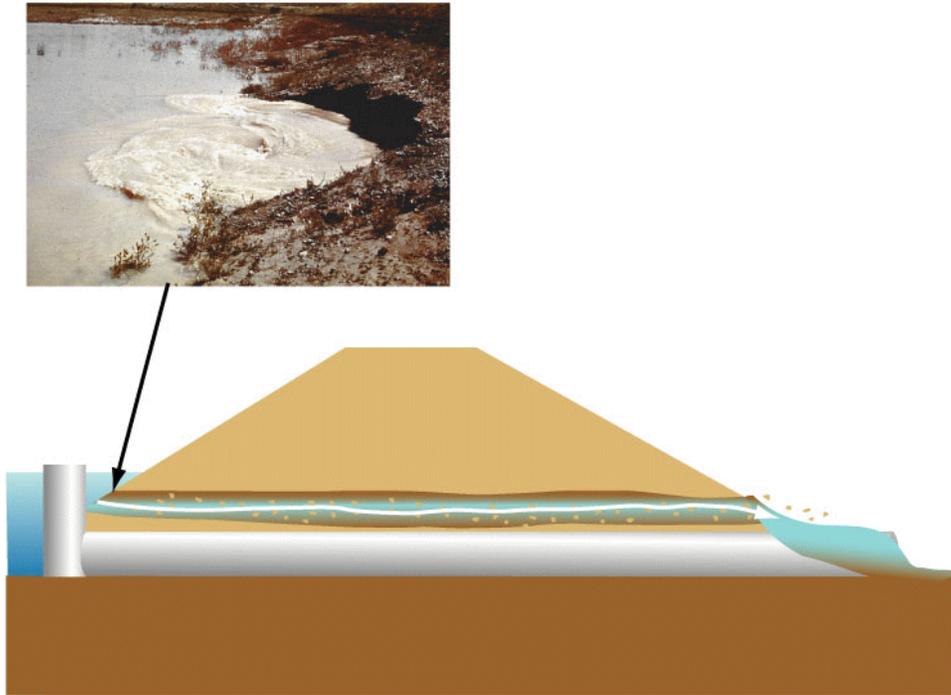
Figure 21: Schematic of piping near a conduit. A vortex may form where the water from the reservoir enters the fracture (FEMA 2005).

All of the problems with CMP described above in Section 2.2 can ultimately lead to the failure of the dam. When water escapes the conduit and enters the surrounding soil, it increases the seepage pressure from what is normally “seen” by those soils. The water can develop flow paths through the soil and can erode the fill. The process by which the soil erodes through the dam has been termed “piping”. Piping is a general term, and there are different types of piping that distinguish between the mechanisms by which the water moves through the soil. Figure 21 and Figure 22 below show schematics of the piping process.

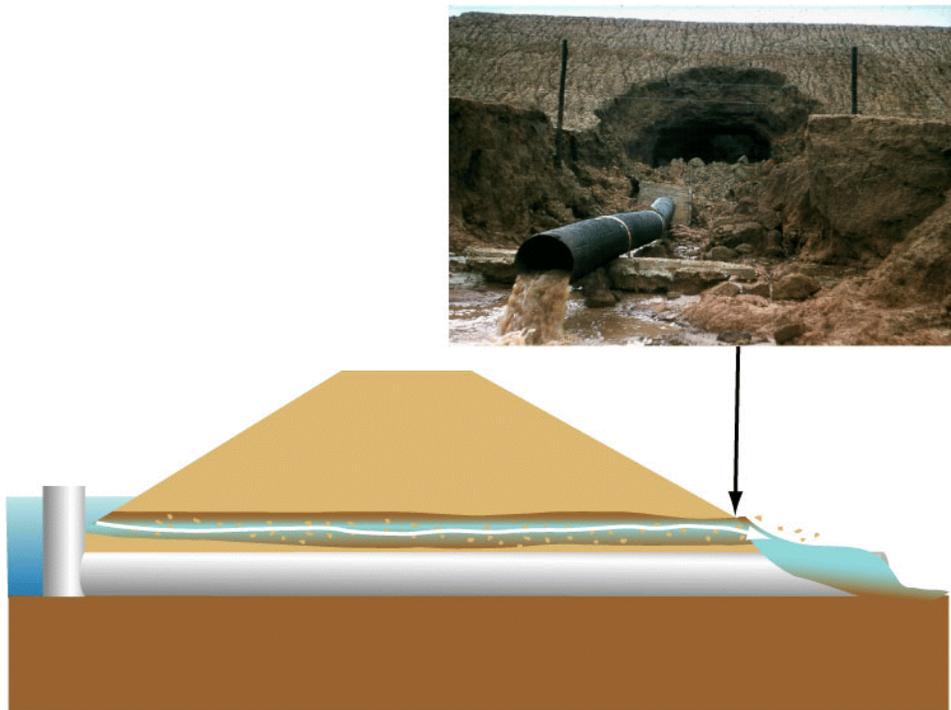
Figure 22: Schematic of piping near a conduit. Photo of a tunnel-shaped void at outlet (FEMA 2005).

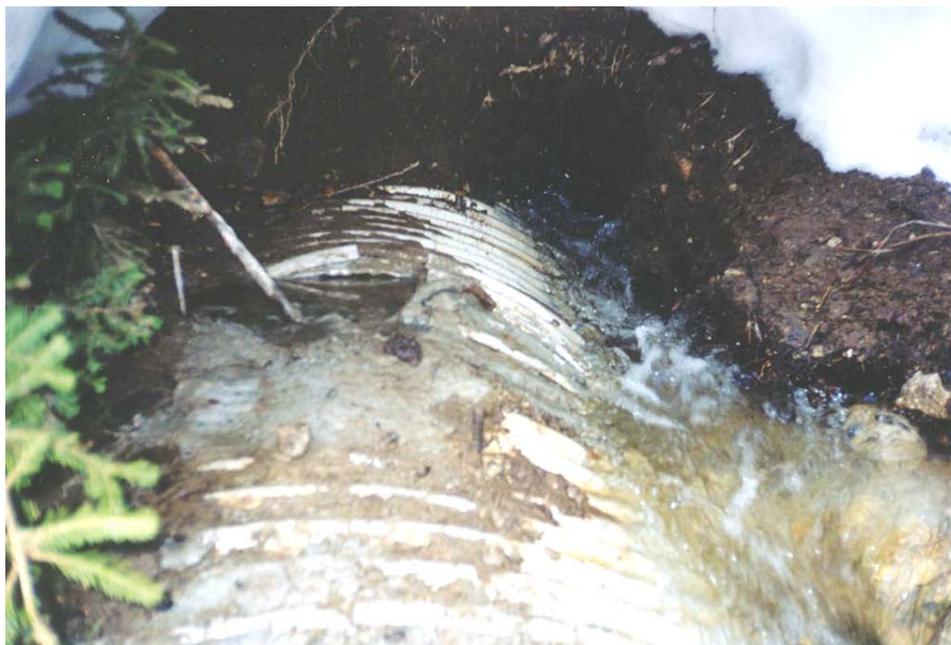
Figure 23: Photo of piping around culvert at outlet of a Ravalli County dam (MT DNRC).

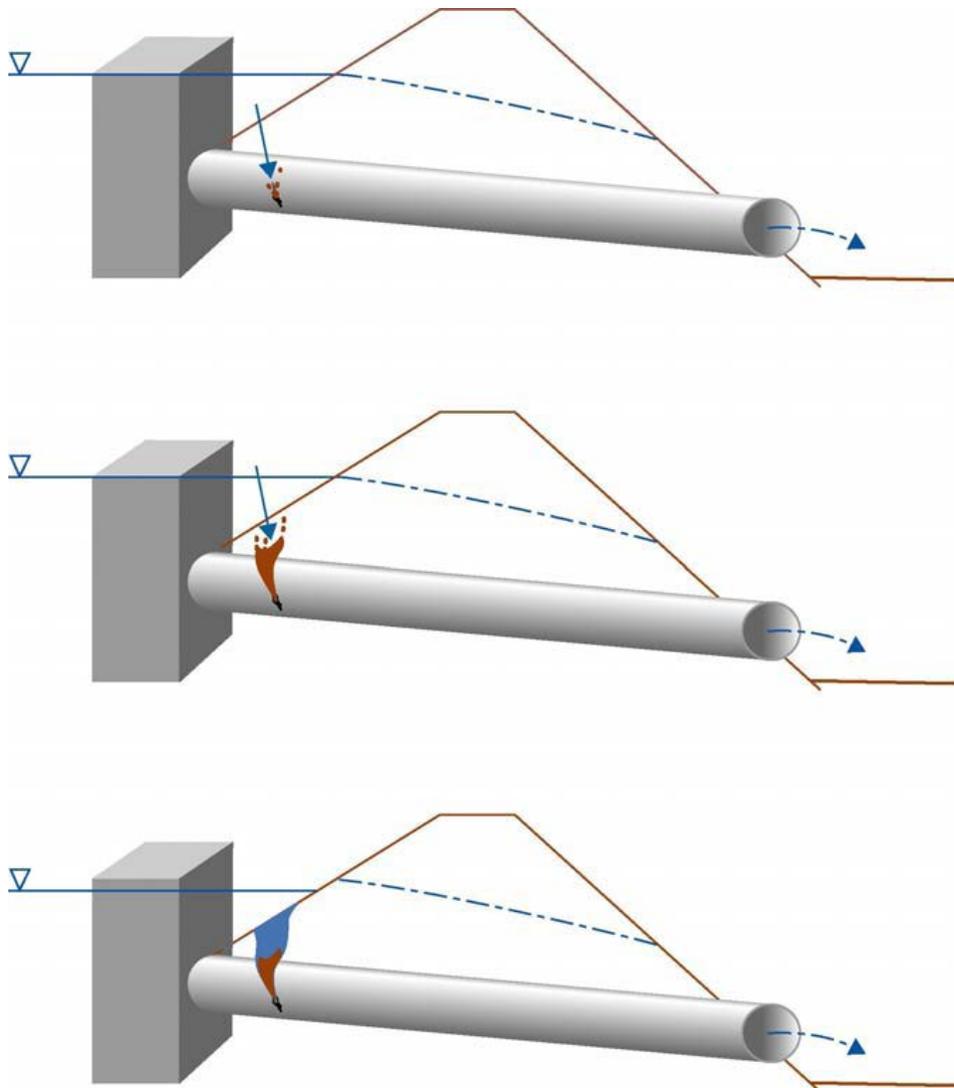
Figure 24: Schematic of piping surrounding a defect in a non-pressurized conduit (FEMA 2005).

1. The reservoir is filled, and seepage develops through the embankment (no dam is waterproof).
2. Seepage enters holes or gaps in the CMP and carries soil particles with it.
3. Preferential flow paths develop through the soil, and water from the reservoir flows along these “cracks”.
4. Soil continues to be eroded, and a tunnel or sinkholes may develop.
5. Reservoir loses ability to hold water, and a complete breach may occur.

See Figure 24 below, which shows a schematic of this failure mode.

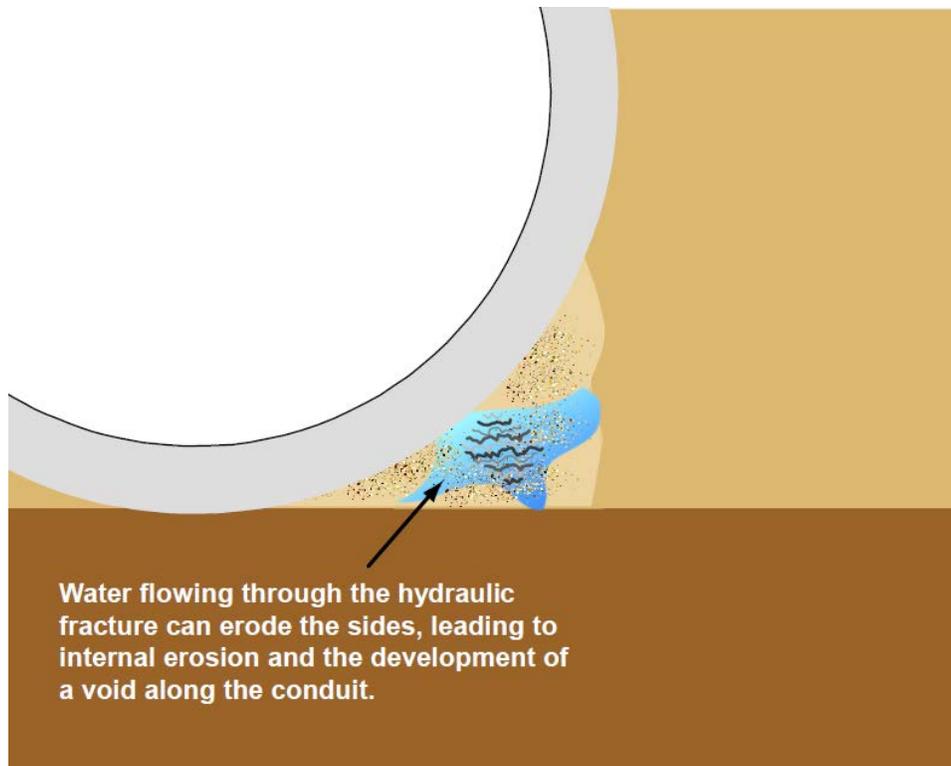
Figure 25: Figure of poor compaction of soil around conduit (FEMA 2005).

Conduits inherently introduce an irregularity through an embankment. In addition, it is difficult to uniformly compact soils surrounding a conduit with respect to the rest of the embankment. Inadequate compaction often creates low density zones immediately adjacent to conduits, which create pathways for seepage. See Figure 25 and Figure 26 below.

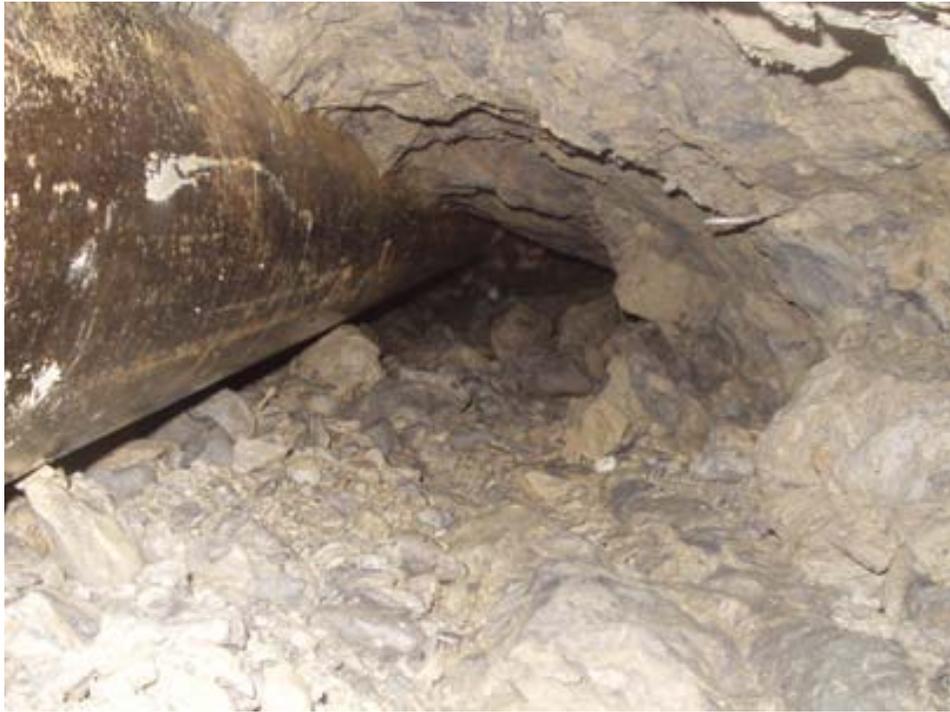
Figure 26: Photo of piping resulting from poor compaction around conduit (FEMA 2005).

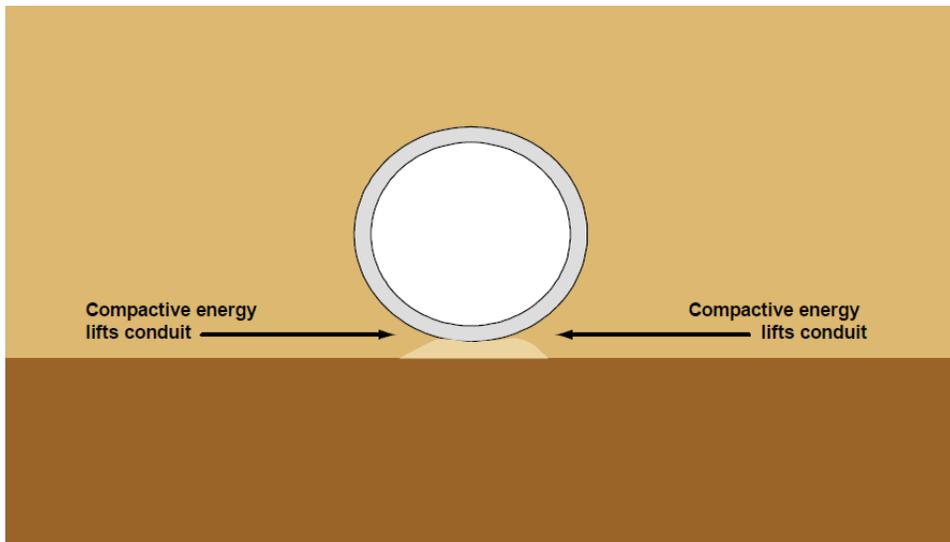
Figure 27: Figure showing how compactive energy can raise conduit (FEMA 2005).

Another construction issue related to compaction near the conduit is when the compactive energy actually lifts the conduit, creating a low density zone beneath. This also creates a pathway for seepage. See Figure 27 below.

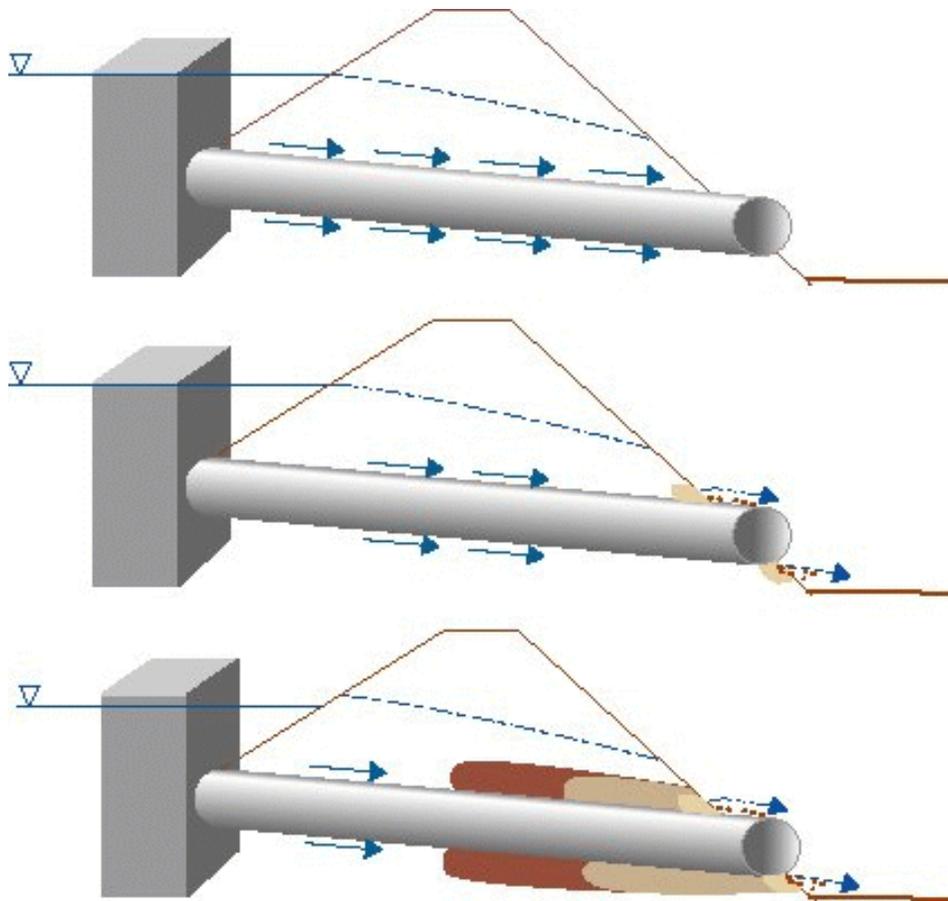
Figure 28: Schematic showing piping at the interface between the conduit and surrounding soils (FEMA 2005).

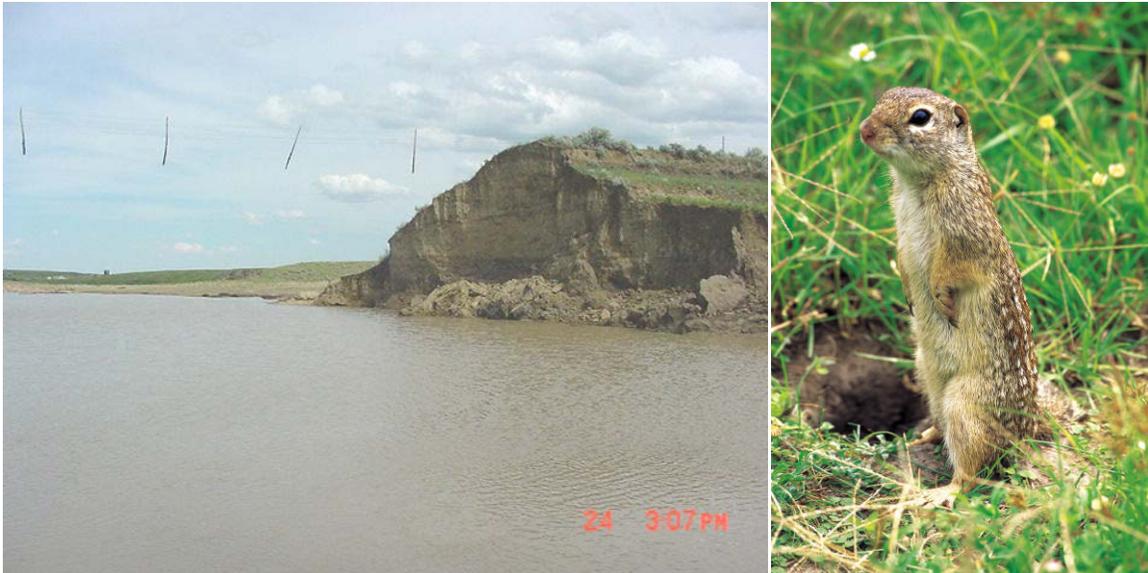
Figure 30: Photo of a Garfield County dam failure and the culprit (MT DNRC).

The Garfield County dam near Jordan, Montana failed in June of 2002. The failure was believed to have been caused by a large rodent hole, accompanied by intense rainfall.

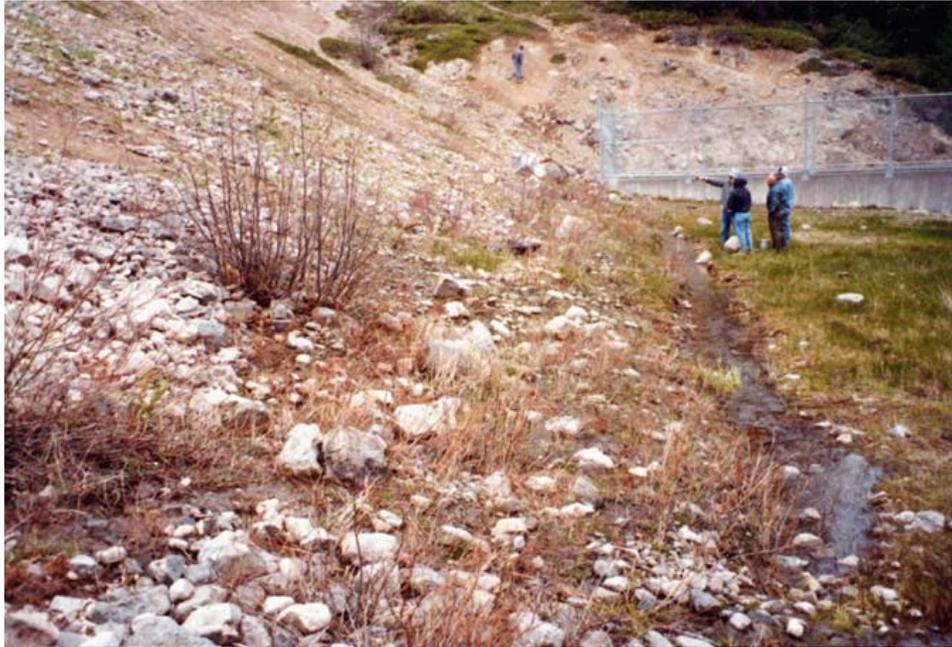
Figure 31: Seepage at the downstream face of an embankment dam (FEMA 2005).

Wet areas that are noticed on the downstream face of the embankment should be flagged and monitored. If seepage is actually flowing from the dam, actions should be taken to measure the quantity of flow. “Measurement of flow by a stopwatch and bucket is a simple way to collect flow information. Installation of a weir and staff gauge is preferred for more uniform data collection under longer term conditions” (FEMA 2005). See Figures 31-34 below.

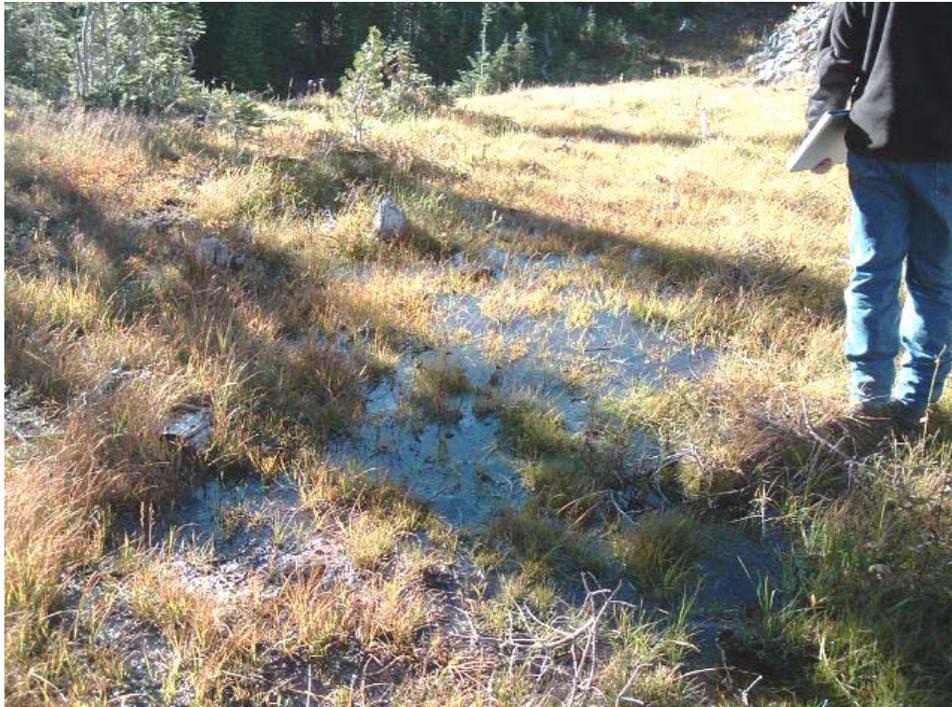
Figure 32: Photo of seepage below dam (Fischer, Tips and Tricks for Inspecting Dams and Canals n.d.).

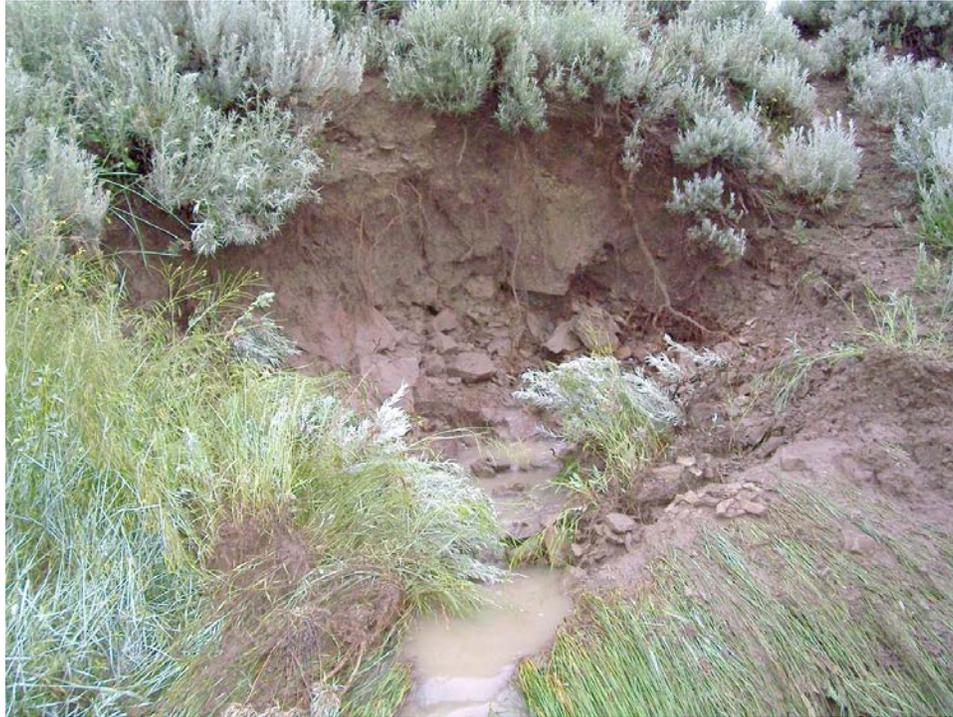
Figure 33: Photo of seepage and sinkhole (Fischer, Tips and Tricks for Inspecting Dams and Canals n.d.).

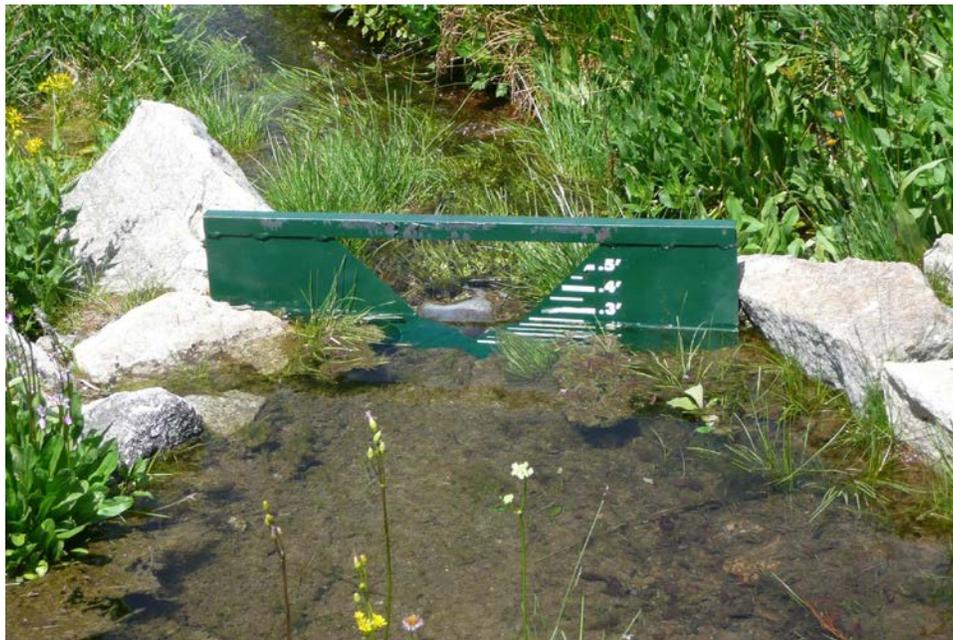
Figure 34: Photo of seepage and flow measurement weir (Fischer, Tips and Tricks for Inspecting Dams and Canals n.d.).

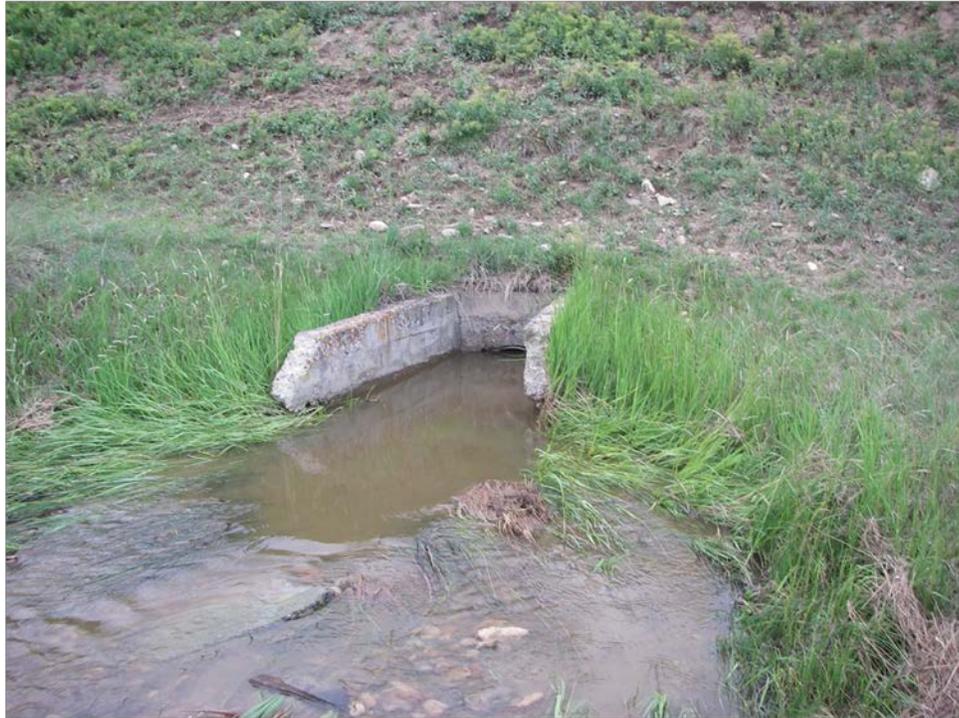
Figure 35: Photo of off-color discharge from conduit in a Cascade County dam (MT DNRC).

Water flowing in the vicinity of the conduit should be observed to see if it is cloudy or has soil particles in it; this could be a sign of piping. See Figure 35 below.

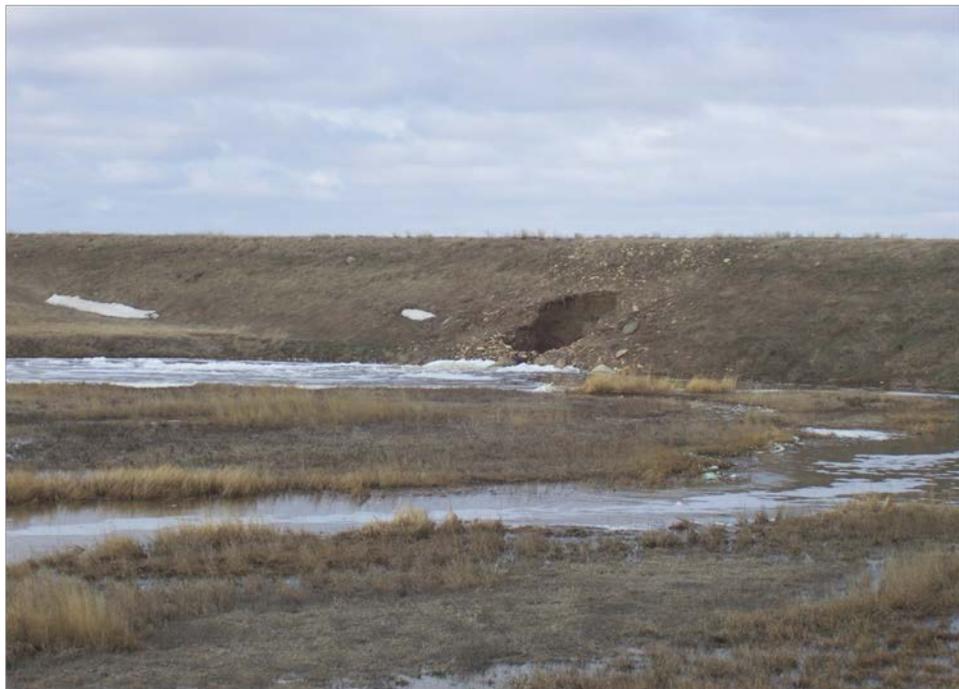
Figure 36: Photo of sinkhole at conduit outlet in a Chouteau County dam (MT DNRC).

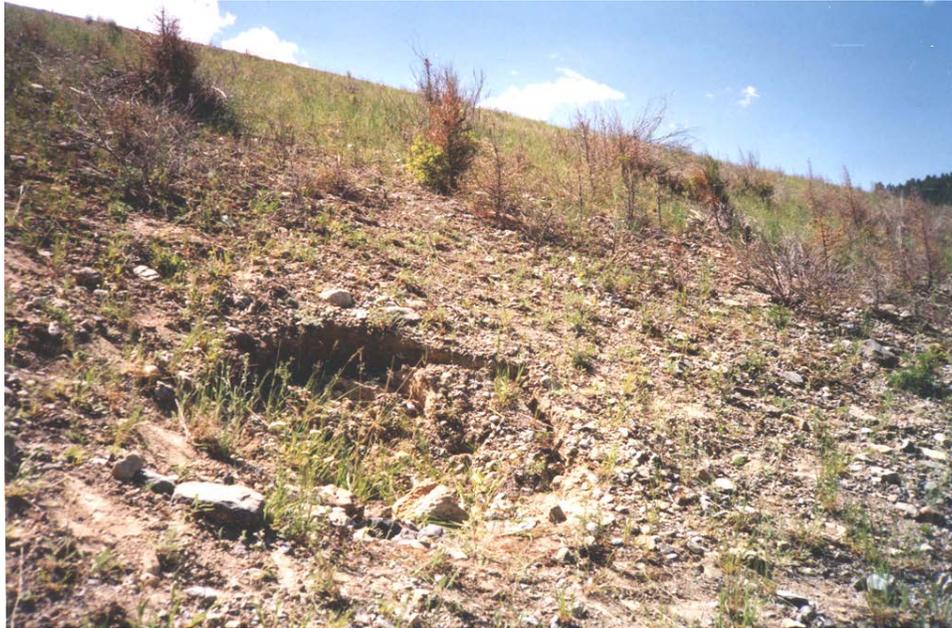
Figure 37: Photo of developing sinkhole at dam in Granite County. Caused by piping around deteriorated CMP drain pipe (MT DNRC).

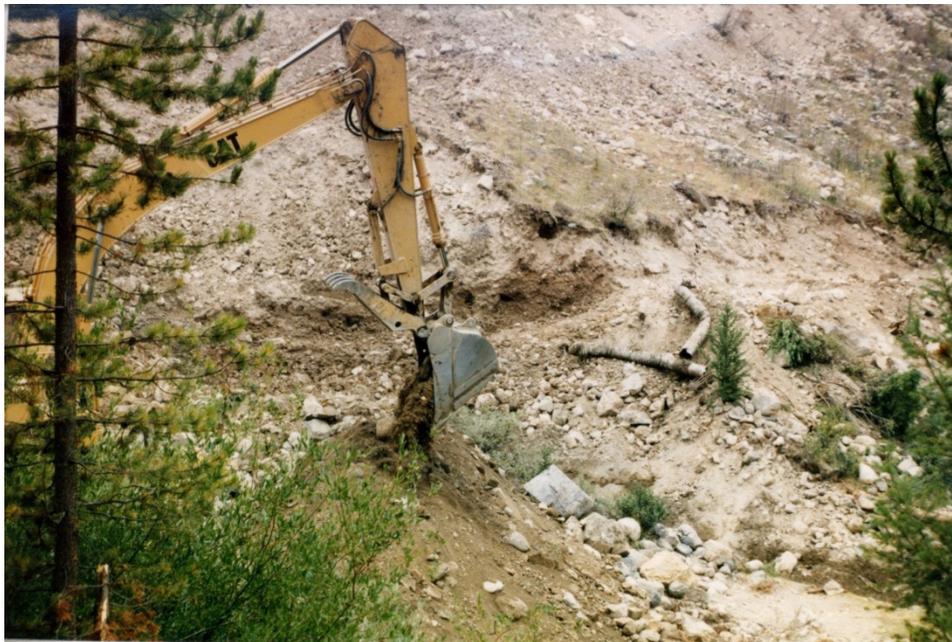
Figure 38: Digging up deteriorated CMP drain pipe – cause of sinkhole in Photo 37.

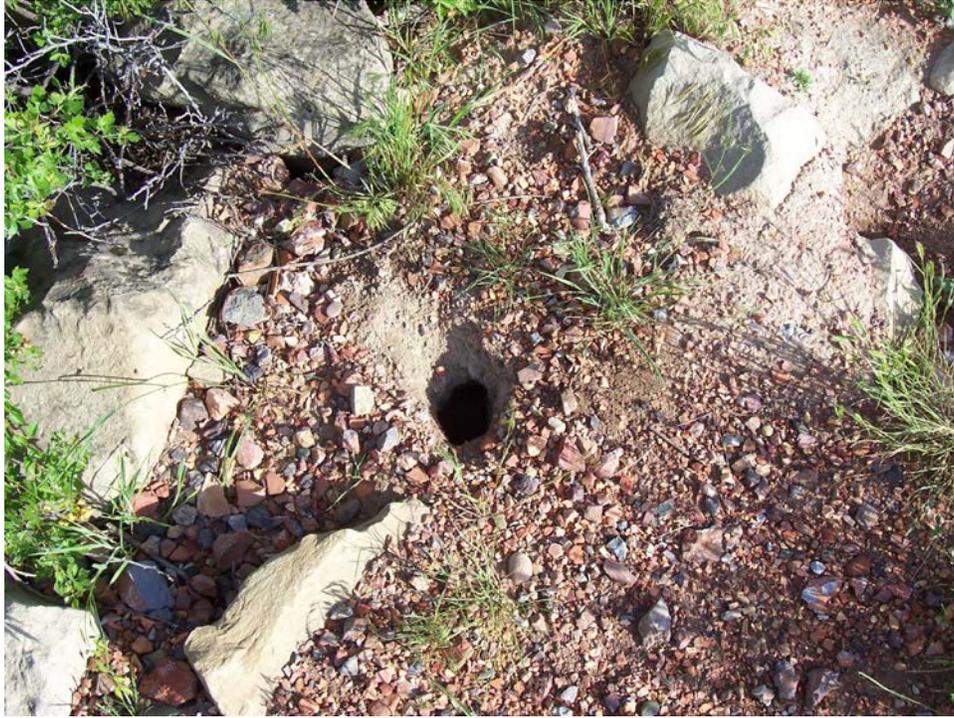
Figure 39: Photo of rodent hole in embankment (Fischer, Tips and Tricks for Inspecting Dams and Canals n.d.).

Rodents burrow in the embankment and create natural paths for the water to follow. See Figure 39 below.
