MANUAL ON CORRUGATED METAL PIPE IN DAMS FOR MONTANA DAM OWNERS

Problem Identification and Evaluation, Inspection, Rehabilitation, Repair, and Replacement

**MANUAL ON CORRUGATED METAL PIPE IN EMBANKMENT DAMS
FOR MONTANA DAM OWNERS**
PROBLEM IDENTIFICATION AND EVALUATION, INSPECTION, REHABILITATION,
REPAIR, AND REPLACEMENT

Great West Engineering, Inc.
2501 Belt View Drive
Helena, MT 59601

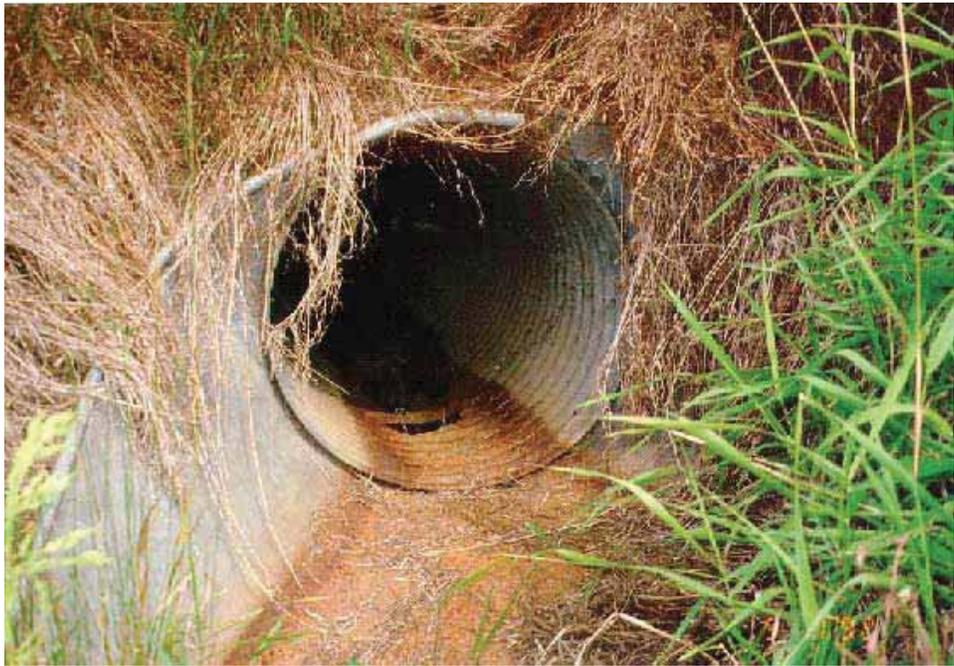
Figure 40: Photo of corroded CMP outlet (U.S. Department of Transportation, FHWA 2010).

Deterioration of the exterior of the CMP gives good indication that the same may be occurring on the interior of the pipe. See Figure 40 below.

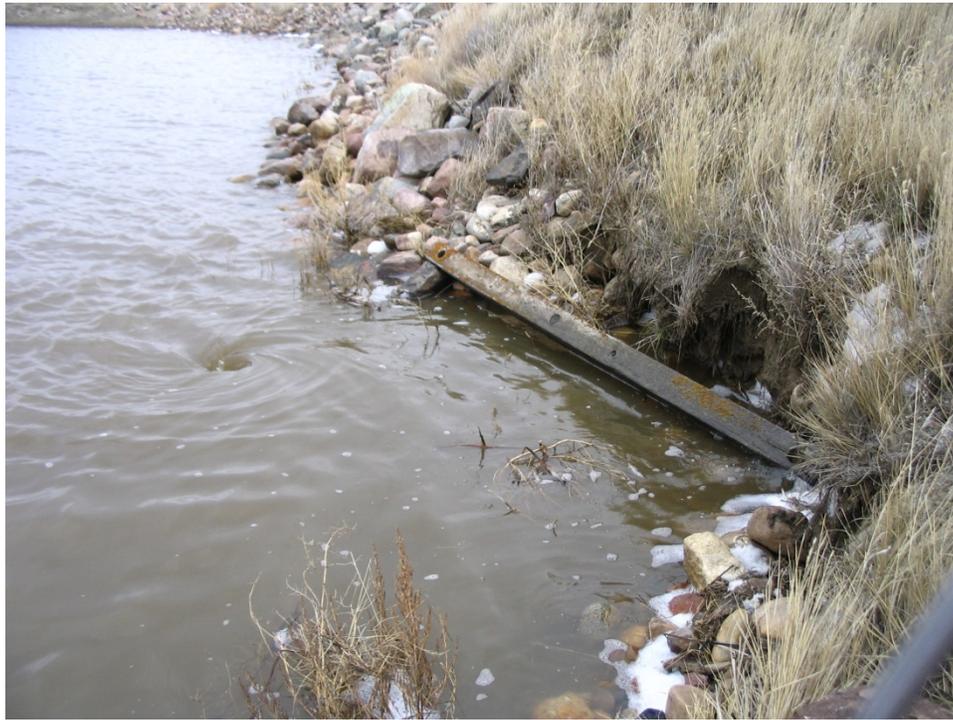
Figure 41: Photo of whirlpool in a Chouteau County dam (MT DNRC).

Whirlpools can indicate that there is a problem with the drop tower. See Figure 41 below.

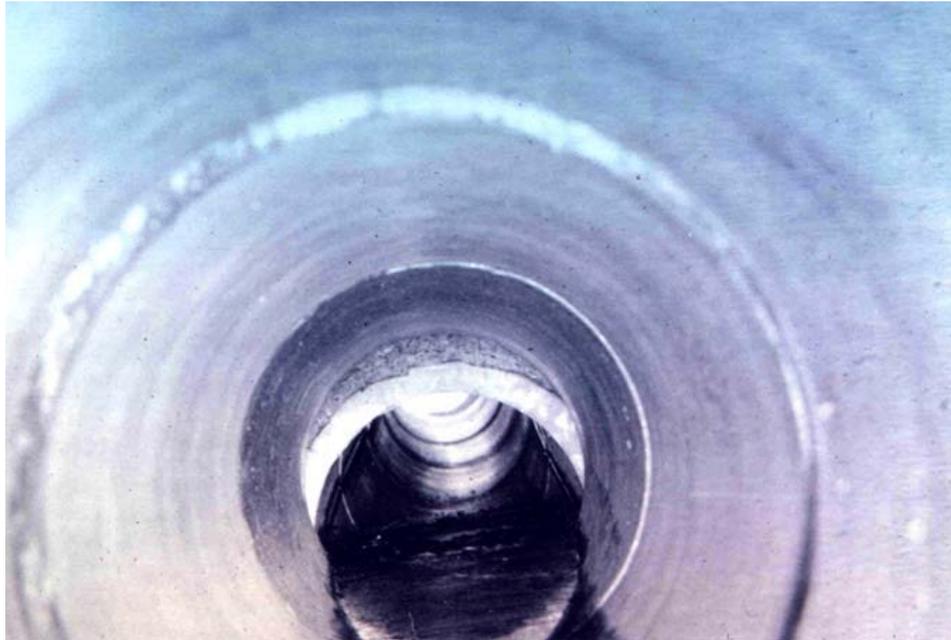
Figure 42: Settlement in conduit causing ponding of water at invert (FEMA 2005).

The CMP was likely initially installed at a downhill grade from upstream to downstream. Ponding at the outlet may be evidence of settlement farther up the conduit. See Figure 42 below.

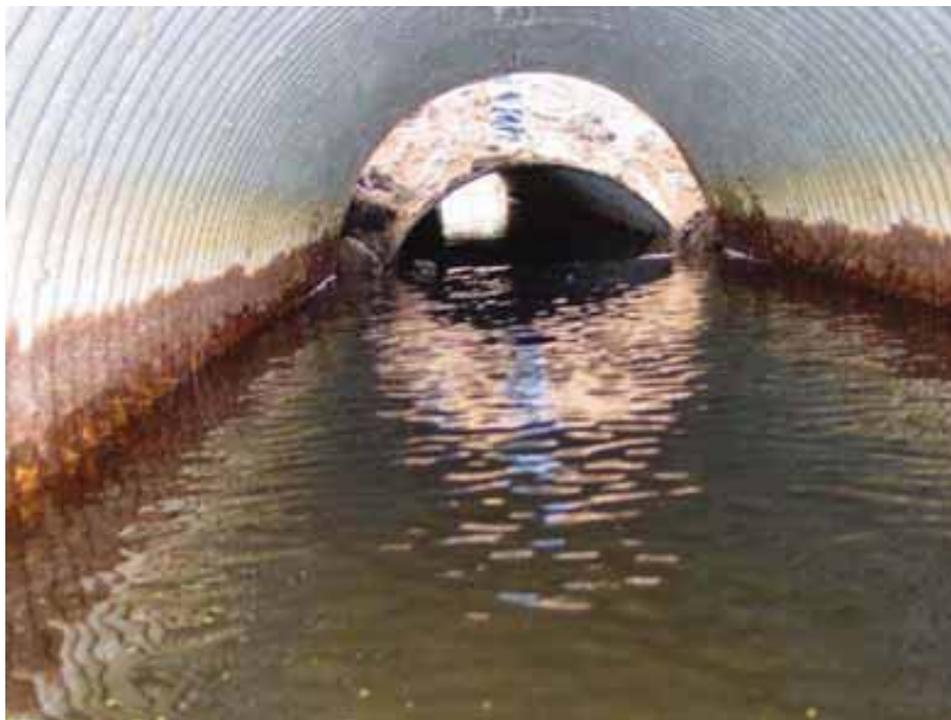
Figure 43: Photo showing joint separations in CMP (U.S. Department of Transportation, FHWA 2010)

- **Joint separations and misalignment of CMP sections.** See Figure 43.

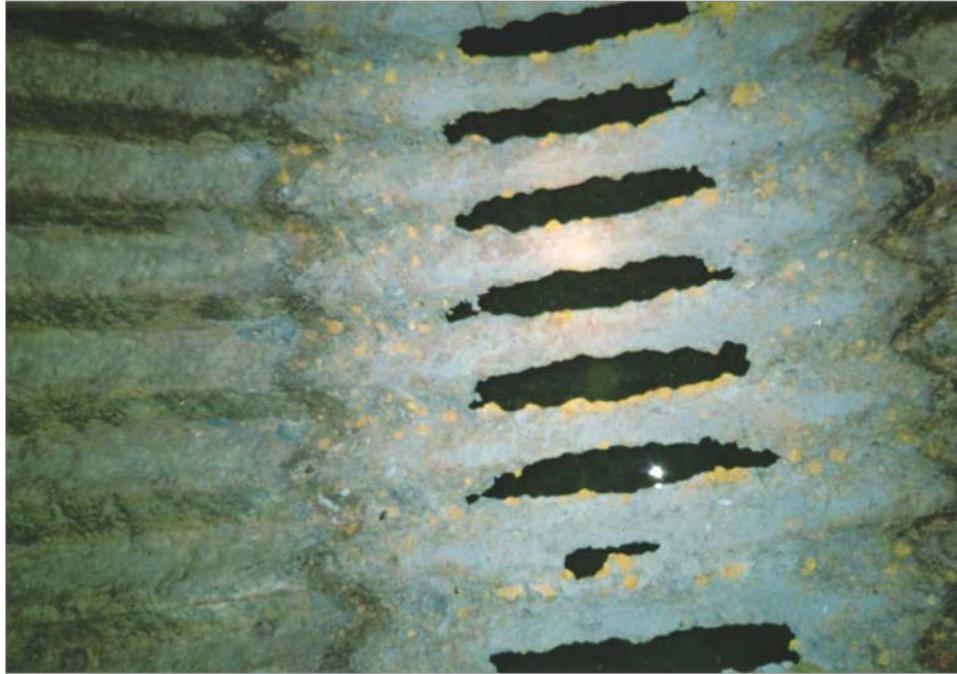
Figure 44: Photo showing corrosion of CMP (MT DNRC).

- **Metallic corrosion.** See Figure 44.

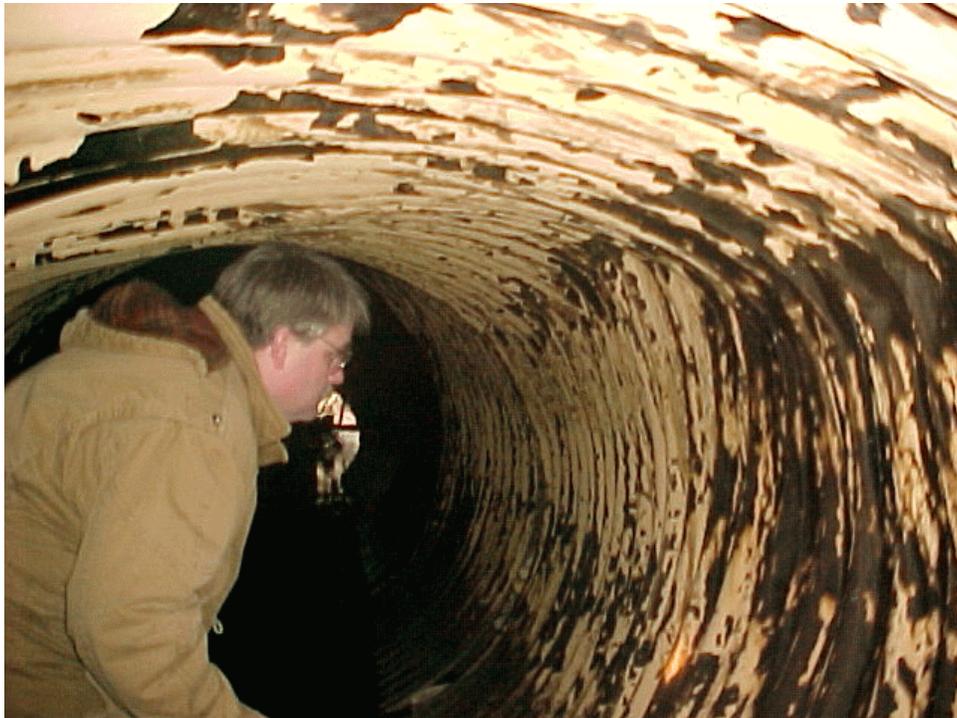
Figure 45: Photo showing polymer coating loss on CMP (U.S. Department of Transportation, FHWA 2010).

- **Damaged protective coatings.** See Figure 45.

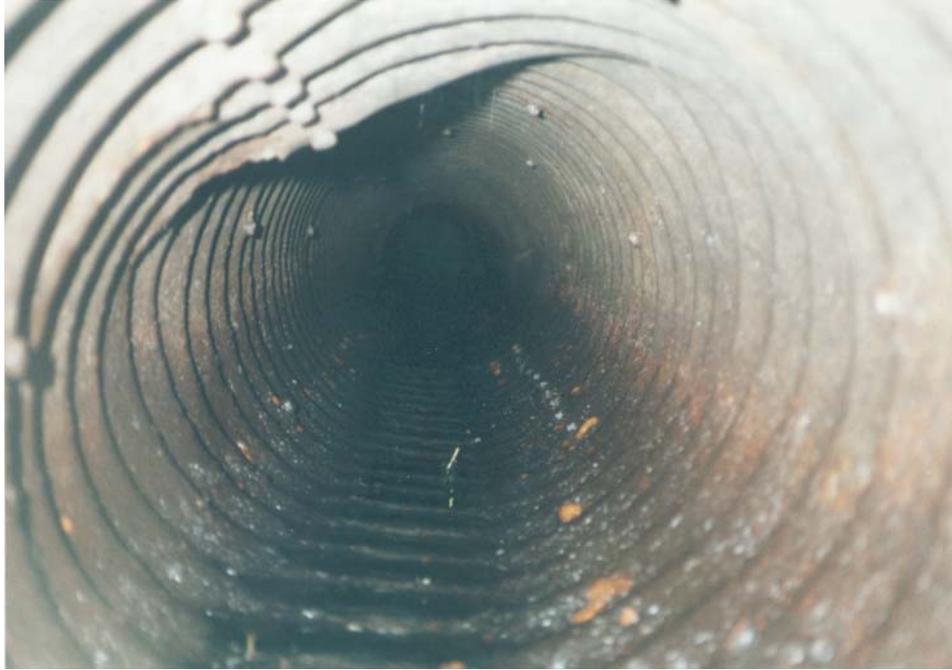
Figure 46: Photo showing deformed CMP in a Powell County dam (MT DNRC).

- **Deformations of CMP circumference.** See Figure 46.

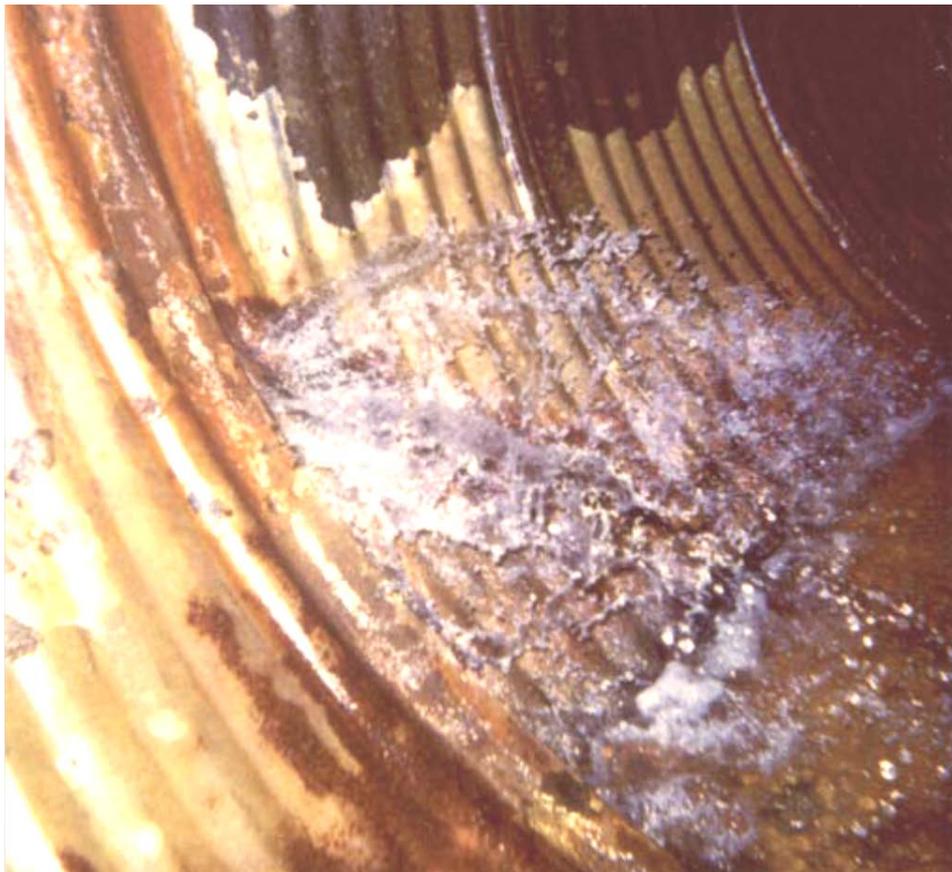
Figure 47: Photo of leaking into CMP conduit (FEMA 2005).

- **Leakage into or out of CMP.** See Figure 47.

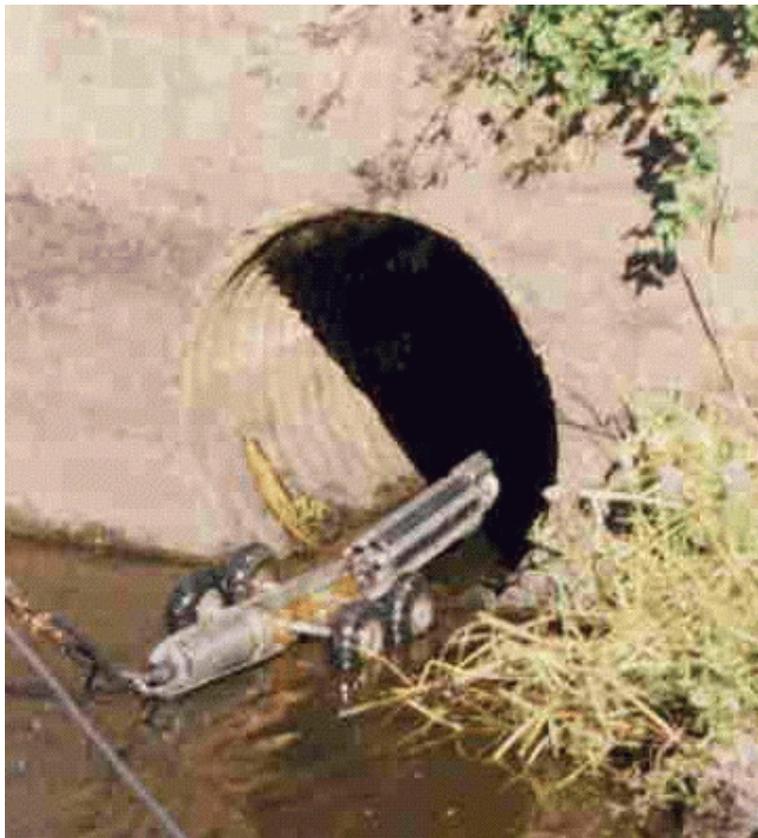
Figure 48: A CCTV inspection camera-crawler entering a conduit (FEMA 2005).

While this method has yet to be used for rural Montana dams, costs are coming down as more businesses obtain the equipment. Dam owners may look in the Yellow Pages for companies who perform this sort of work. “A CCTV inspection consists of a video camera attached to a self-propelled transport vehicle (crawler)...Video images are transmitted from the camera to a television monitor, from which the operator can view the conditions within the conduit” (FEMA 2005).

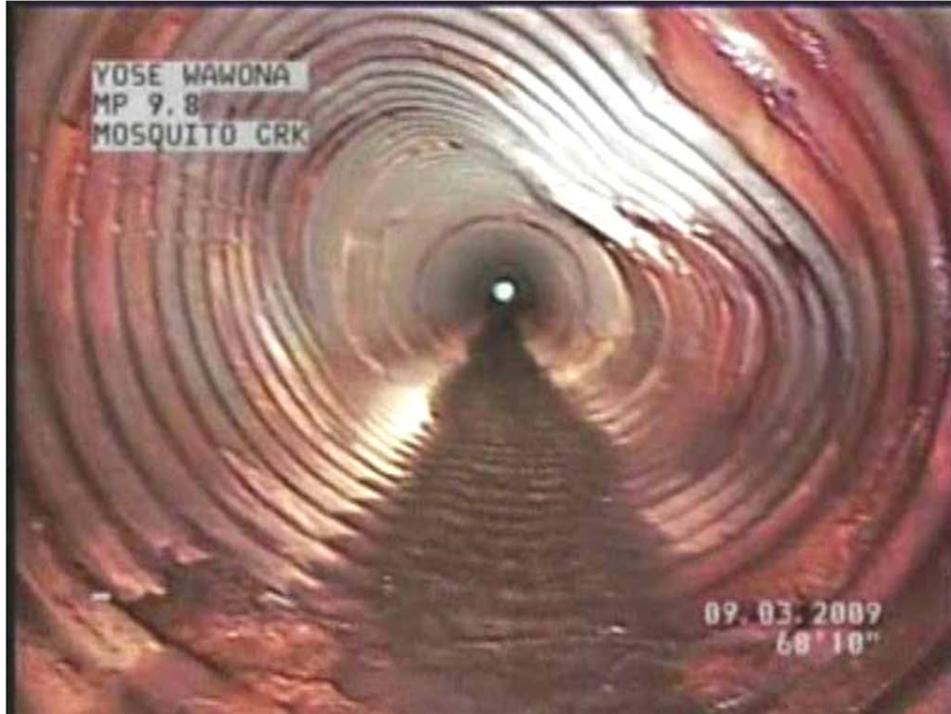
Figure 49: Photo taken by CCTV of deformation on interior of CMP conduit (U.S. Department of Transportation, FHWA 2010).

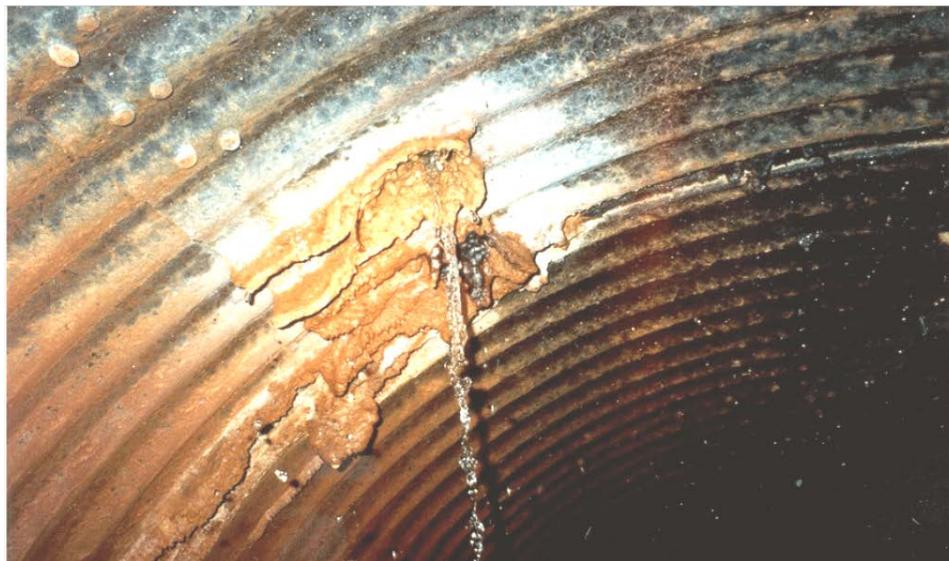
Figure 50: Photo taken by CCTV of seepage entering a CMP (FEMA 2005).

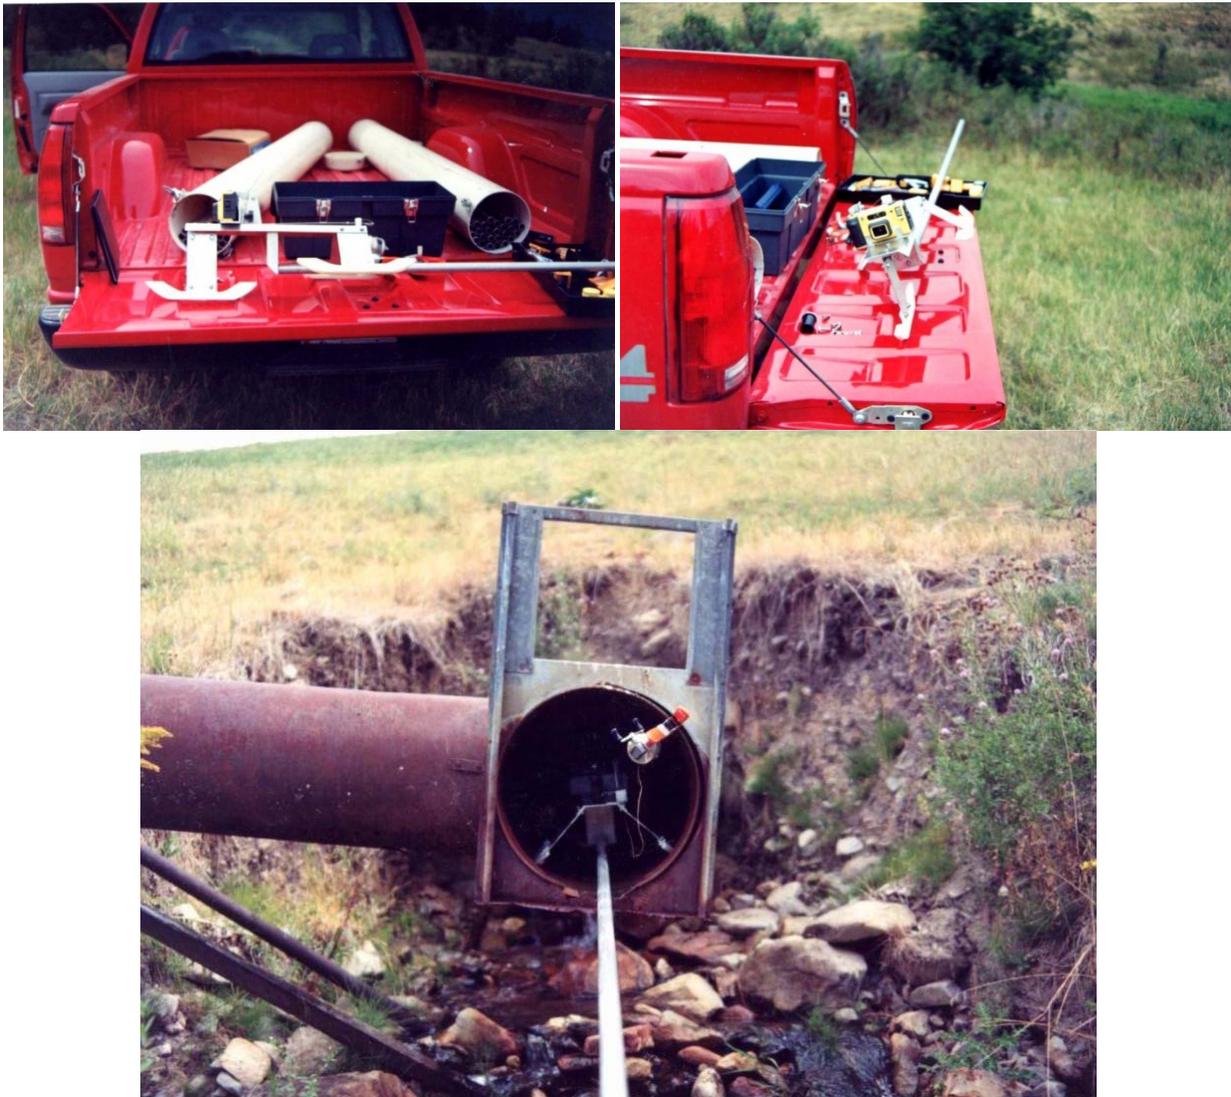
Figure 51: Dam Safety Program Inspection Sled with Still Camera (MT DNRC)

The MT DNRC Dam Safety Program has an inspection sled with a still camera that may be borrowed. The inspection sled works very well for smaller diameter pipes that do not allow for man-entry. One difficulty with interior inspection with the sled camera is often the voids are in between corrugations, and since the camera only takes straight on photos, these voids can be missed. Another difficulty is that corrosion usually occurs from the outside in – so a pipe can be severely deteriorated, but no holes may be visible from the inside.

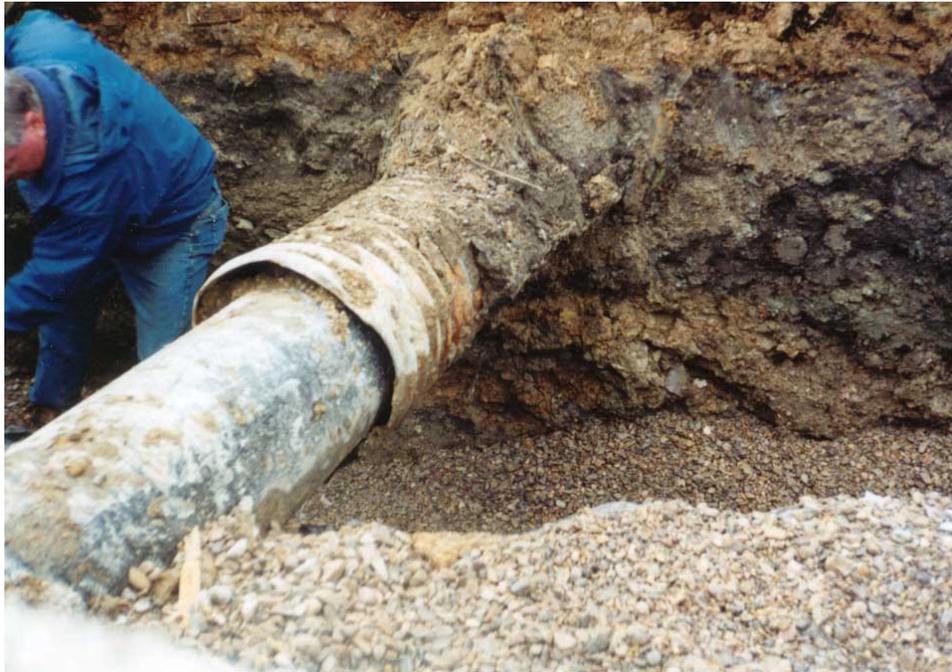
Figure 52: Sliplining a Meagher County dam with HDPE pipe (MT DNRC)

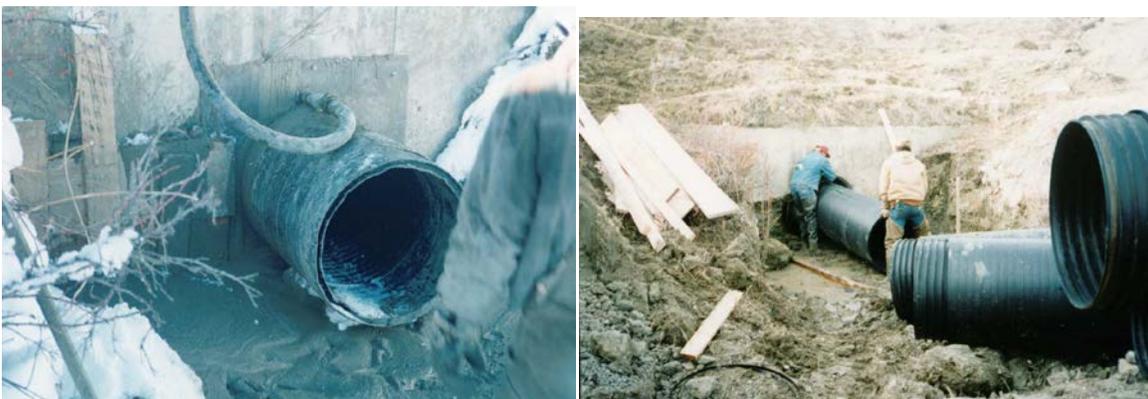
Figure 53: Sliplining and grouting a Wheatland County dam CMP outlet pipe with a mechanically joined HDPE liner (MT DNRC).

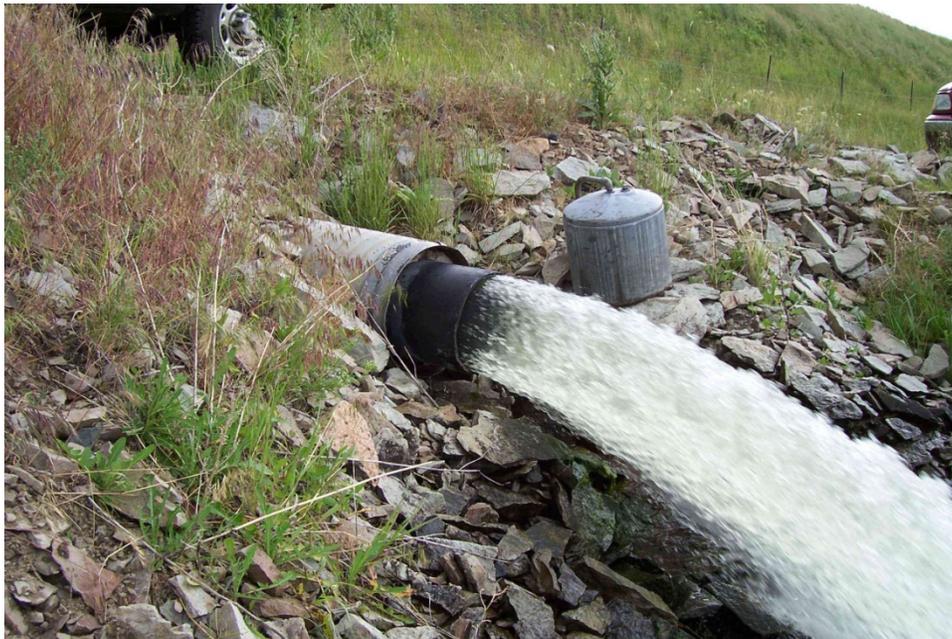
Figure 54: Photo of completed HDPE slipliner in CMP conduit in Wheatland County dam (MT DNRC).

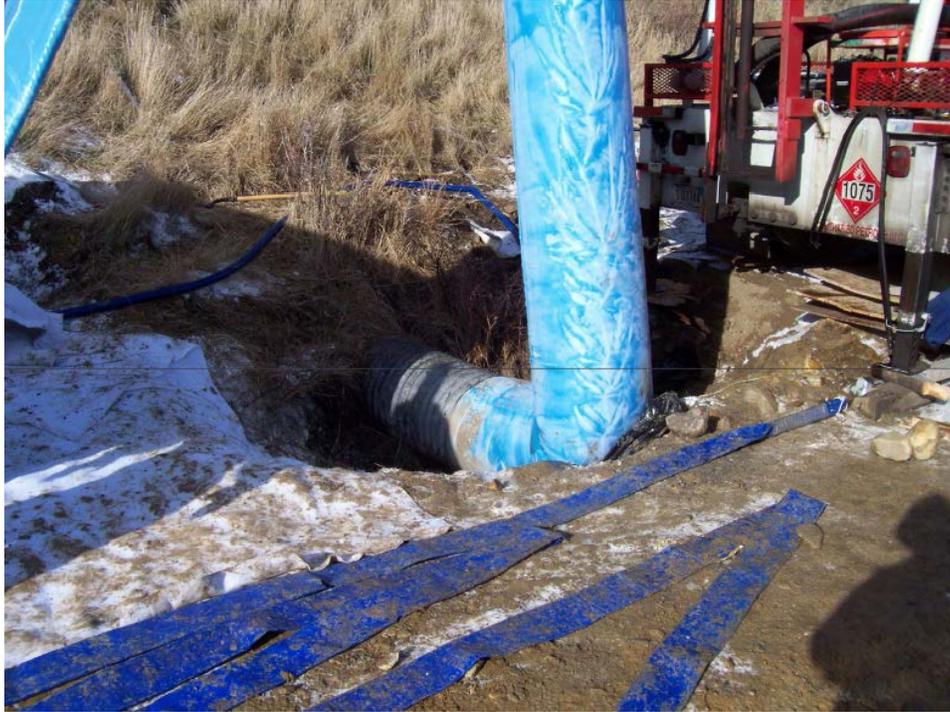
Figure 55: CIPP liner installation at Taylor Dam, Powell County, Montana (Fischer 2009).

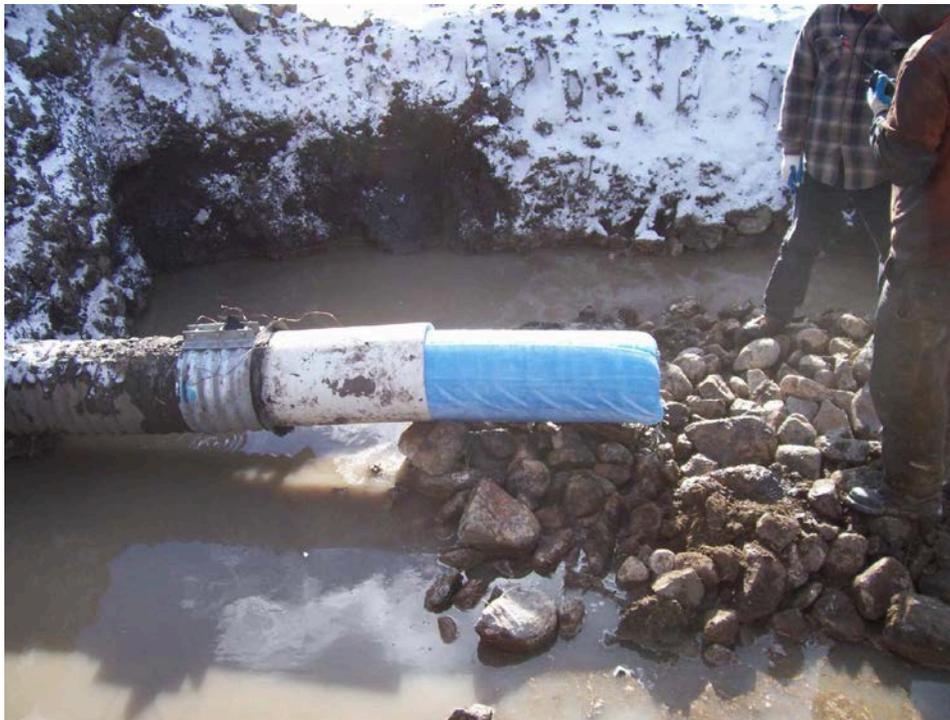
Figure 56: CIPP installation at Upper Taylor Dam, Powell County, Montana (Fischer 2009).

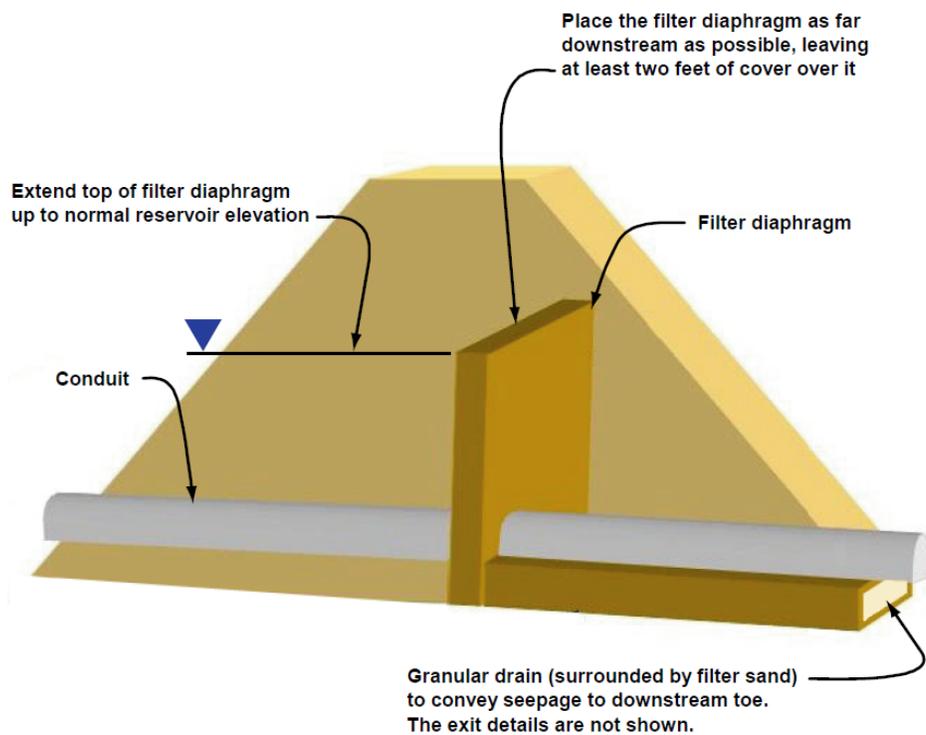
Figure 57: Profile view - typical configuration of filter diaphragm (FEMA 2005).

Filter diaphragms should be used in conjunction with both the sliplining and CIPP conduit rehabilitation methods. If another filter zone (e.g. chimney drain) is present and functioning within an existing dam, a filter diaphragm may not be necessary. A filter diaphragm consists of graded sand and/or gravel material and is installed around the conduit. The filter acts “both as a drain to carry off water and as a filter to intercept soil particles being transported by the water.” Filter zones “have become the accepted method of preventing failures caused by uncontrolled flow of water through the embankment” (FEMA 2005). Figure 57 and Figure 58 below show schematics of typical filter diaphragm installations.

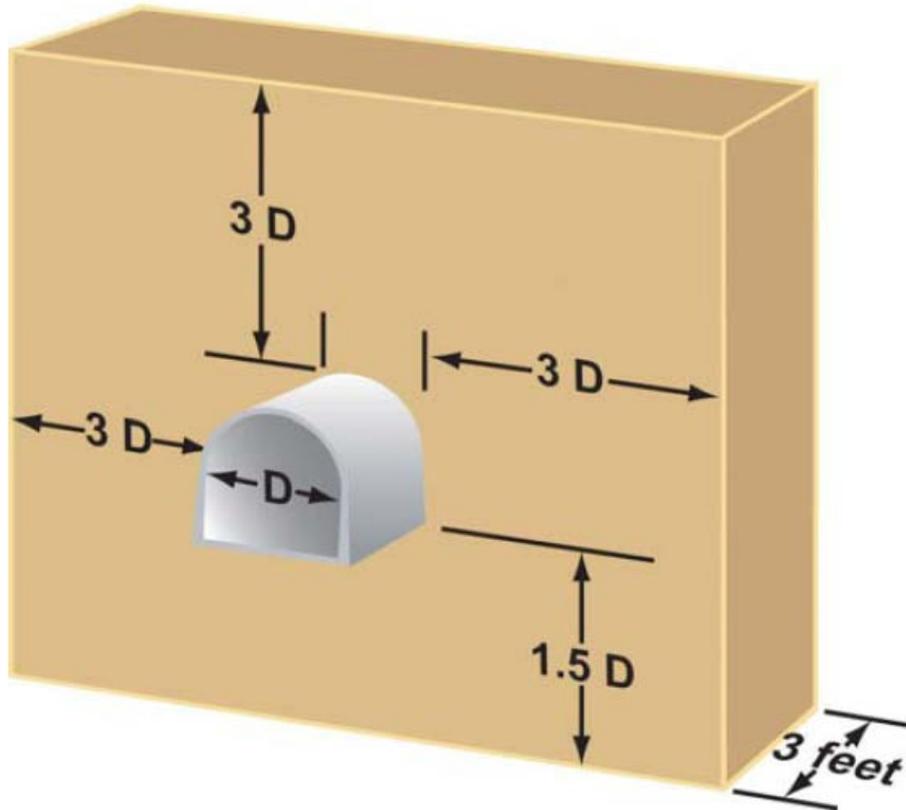
Figure 58: Typical configuration for a filter diaphragm (FEMA 2005).

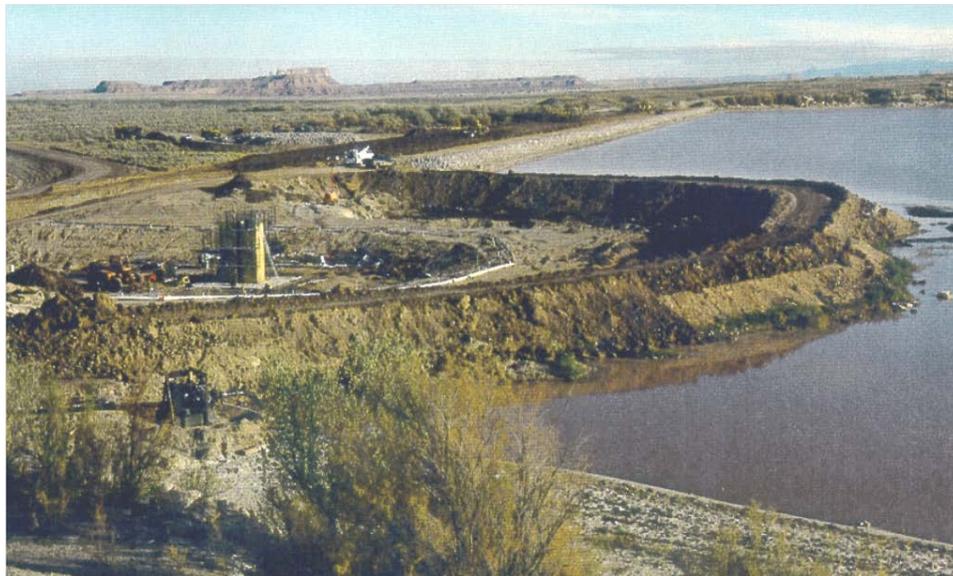
Figure 59: Photo of cofferdam around construction area for new outlet works (FEMA 2005).

- The installation of a cofferdam may be necessary if the reservoir cannot be fully drained. See Figure 59.
- High cost (in some cases) compared to rehabilitation options.

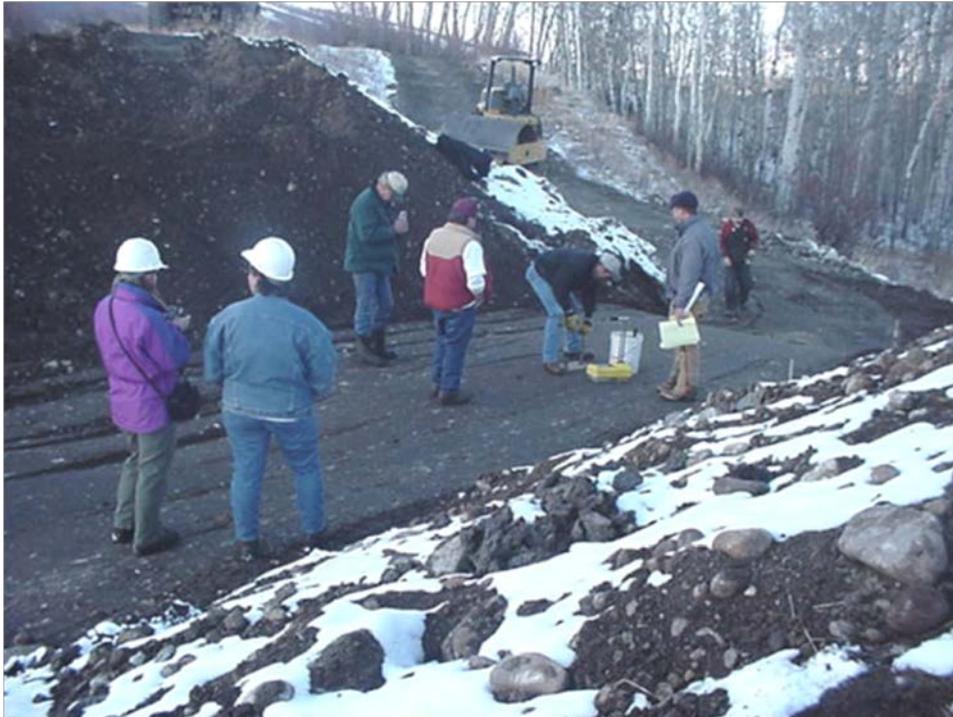
Figure 60: Photo of nuclear density compaction testing on embankment for conduit replacement on a Powell County dam. Engineering students from Montana Tech look on. (MT DNRC)

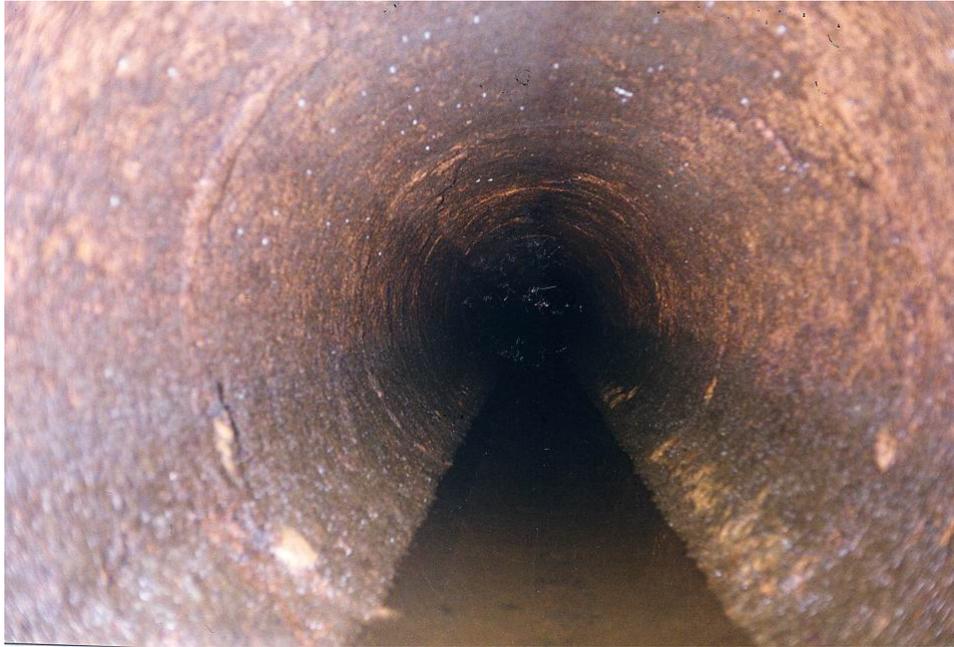
Figure 61: Photo of reinforced cast-in-place conduit in a Jefferson County dam. Installed circa 1914 (MT DNRC).

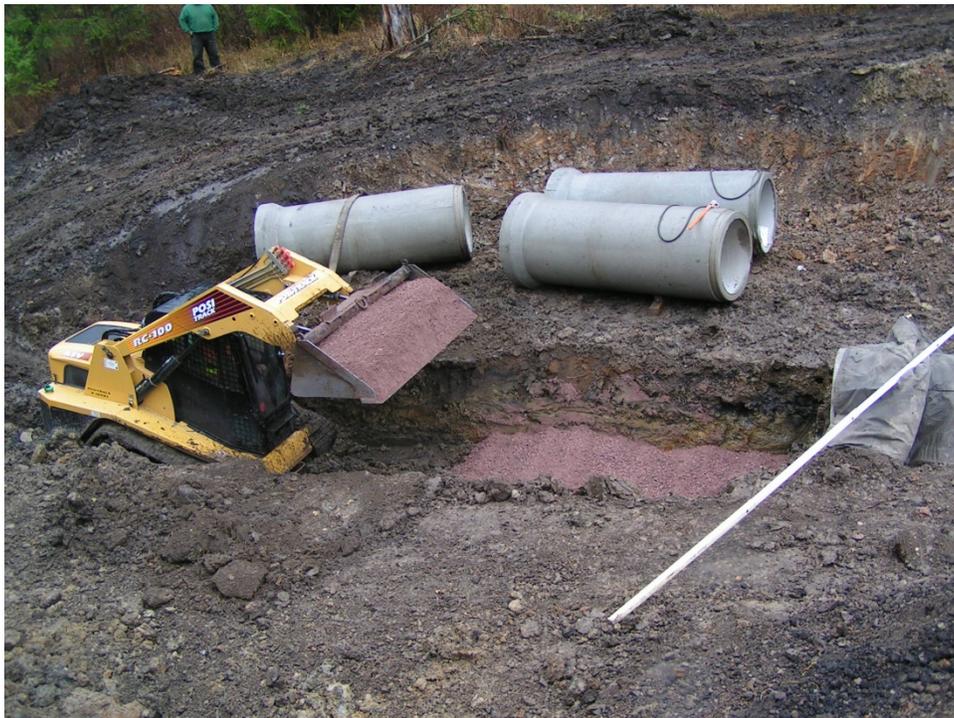
Figure 62: Photo of precast concrete pipe being installed in a Powell County dam (MT DNRC).

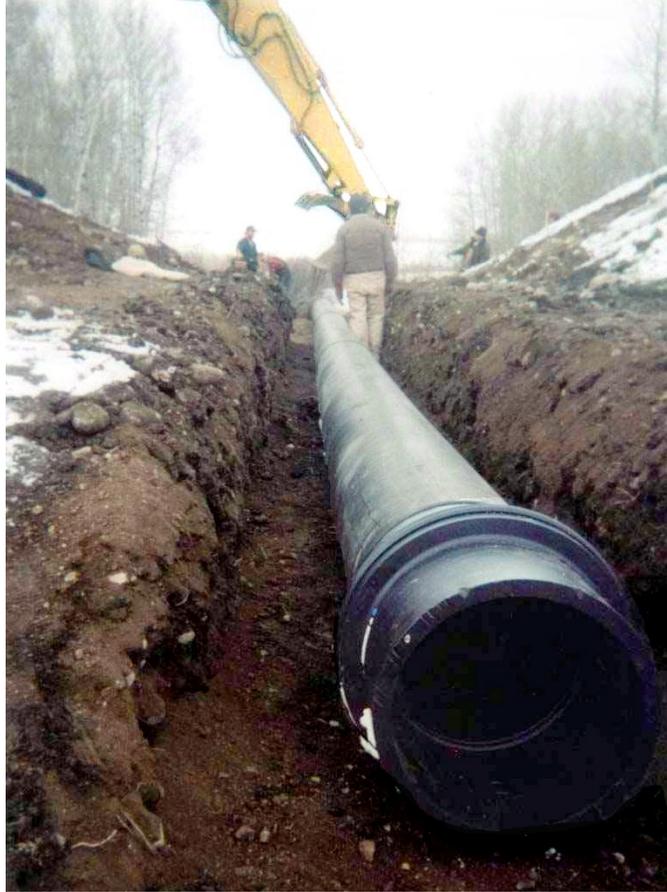
Figure 63: Photo of HDPE pipe being installed in a Powell County dam (MT DNRC).

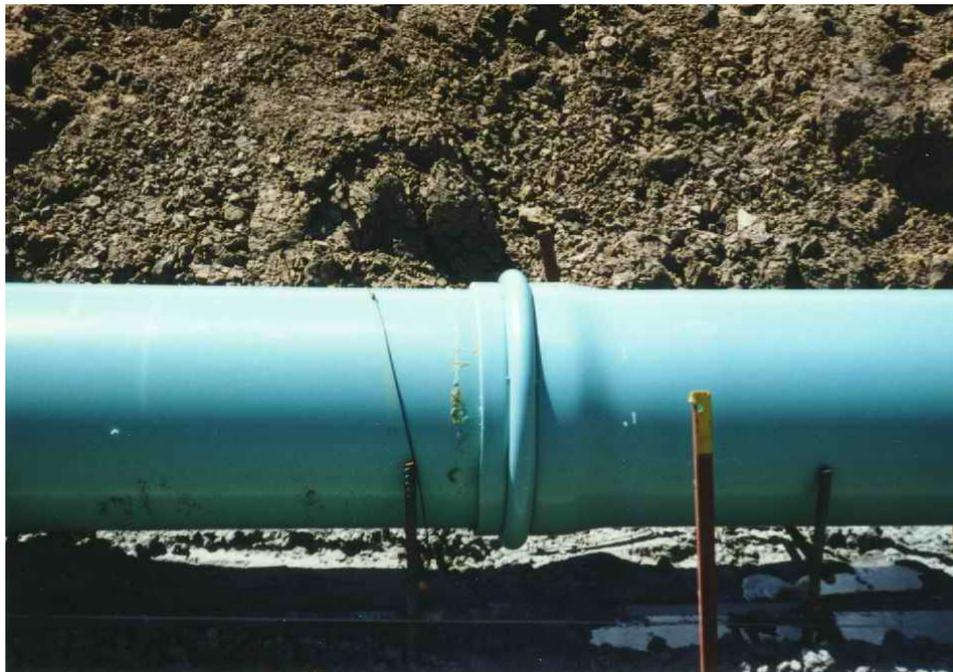
Figure 64: Photo of PVC pipe in a Colorado dam (Colorado Dam Safety).

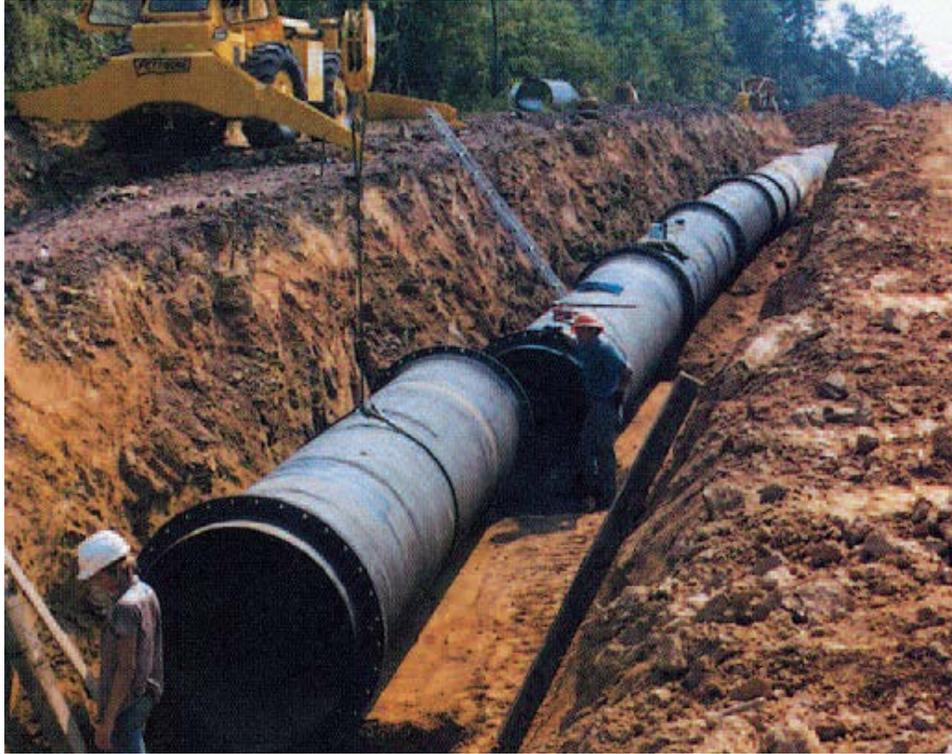
Figure 65: Photo of ductile iron pipe, photo courtesy of Ductile Iron Pipe Research Association.

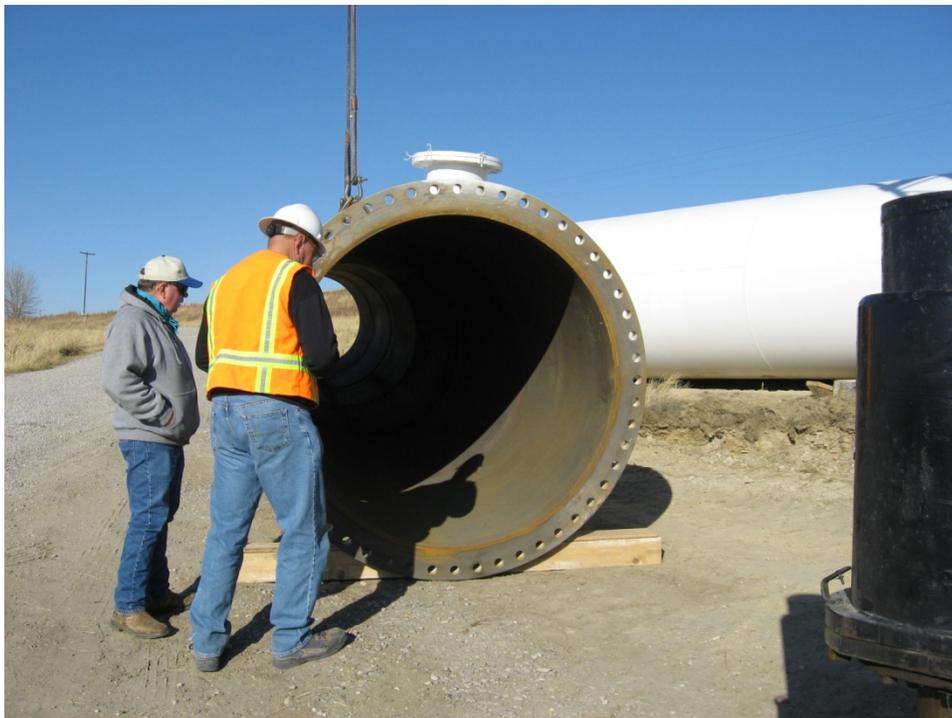
Figure 66: Photo of steel pipe to be installed in a Pondera County dam (MT DNRC).

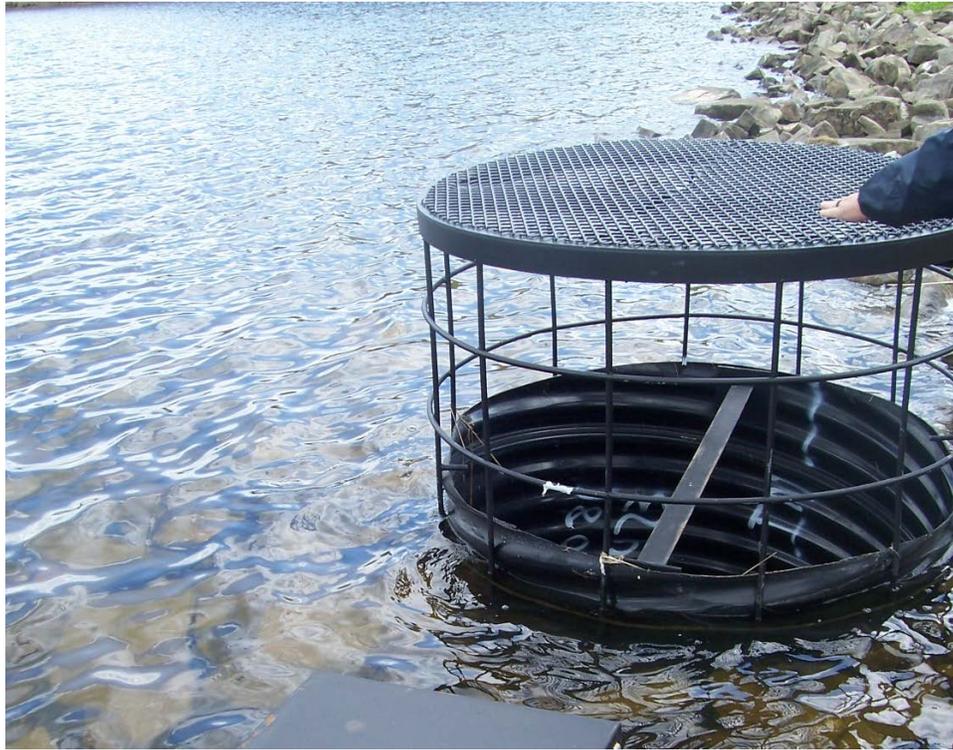
Figure 67: Photo of polymer coated CMP used for riser in a Fergus County dam (MT DNRC).

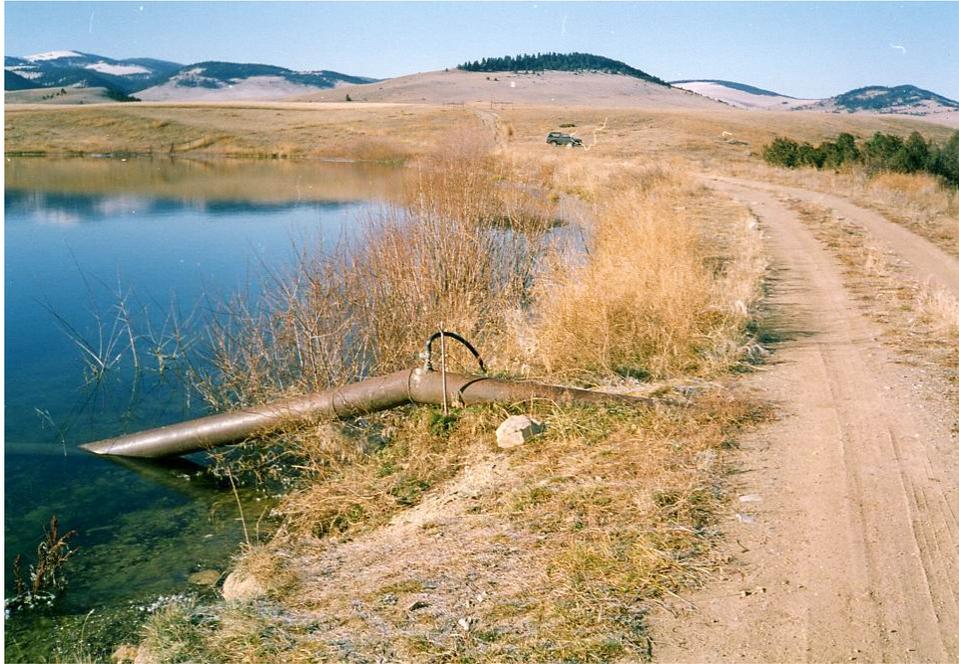
Figure 68: A siphon constructed at a Meagher County dam, used to replace the outlet works (MT DNRC).

A siphon may be used in the replacement of a conduit to partially drain a reservoir. Siphons are usually placed up and over the top of the embankment and are constructed of PVC, HDPE, or steel pipe. It should be ensured that the pipe is sufficiently rigid to handle the negative pressures that occur in the siphon. The outlet works in Keep Cool Dam in Meagher County, MT were recently replaced with a siphon system. See Figure 68 below.
