Dam Safety- Fact Sheet

Outlet Erosion Control

Fact Sheet: 17

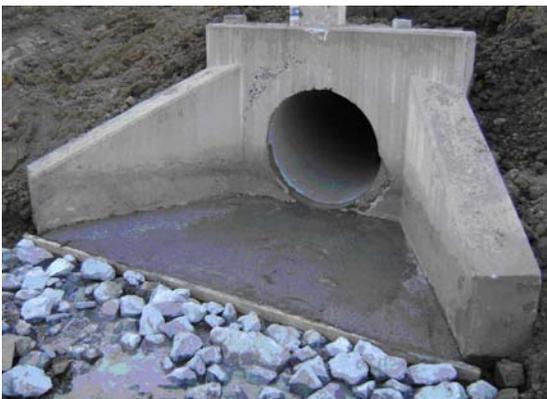
Concrete Headwall

Headwall/Endwall

A headwall/endwall located at or close to the end of the discharge conduit will provide support and reduce the potential for undermining. A headwall/endwall is typically constructed of concrete, and it should be founded on bedrock or have an adequate foundation footing to provide support for stability. A headwall/endwall can become displaced if it is not adequately designed and is subject to undermining. Displacement of the headwall/endwall can lead to separation of the spillway conduit at the joints which could affect the integrity of the spillway conduit. If a concrete structure develops the structural defects, or if the discharge spillway conduit does not have a headwall/endwall, then a registered professional engineer should be contacted to evaluate the stability of the outlet.

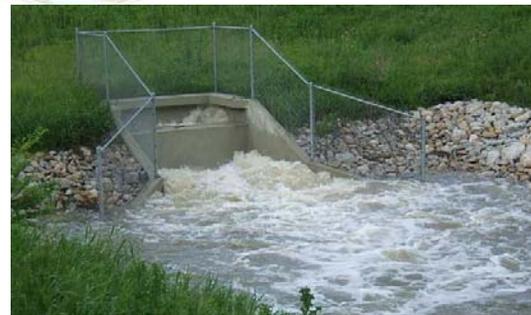
Impact Basin

A concrete impact basin is an energy dissipating device located at the outlet of the spillway in which flow from the discharge conduit strikes a vertical hanging baffle. Discharge is directed upstream in vertical eddies by the horizontal portion of the baffle and by the floor before flowing over the endsill. Energy dissipation occurs as the discharge strikes the baffle, thus, performance

is not dependent on tailwater.

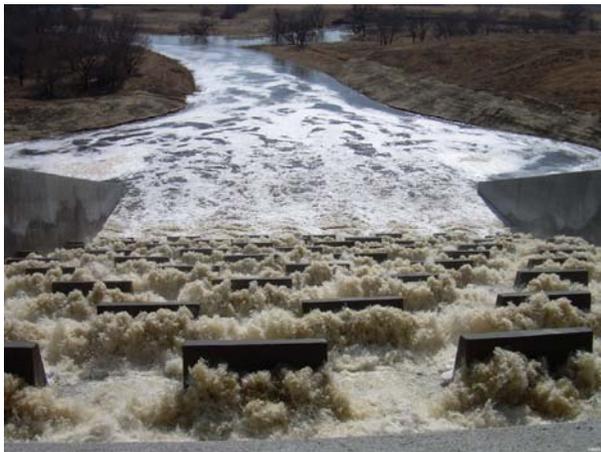
Baffled Chute

Baffled chutes require no initial tailwater to be effective and are located downstream of the control section. Multiple rows of baffle piers on the chute prevent excessive acceleration of the flow and prevent the damage that occurs from a high discharge velocity. A portion of the baffled chute usually extends below the streambed elevation to prevent undermining of the chute. If any of the severe problems associated with concrete that are referenced in the opening paragraphs are observed, a registered professional engineer should be contacted to evaluate the stability of the outlet.

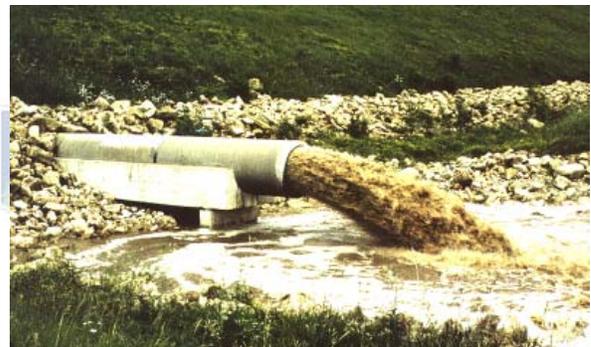
Plunge Basin

Plunge Pool

A plunge pool dissipates energy as the discharge flows into the plunge pool. Plunge pools are commonly lined with rock riprap or other material to prevent excessive erosion of the pool area. Discharge from the plunge pool should be at the natural streambed elevation. Typical problems may include movement of the riprap, loss of fines from the bedding material and scour beyond the riprap and lining. If scour beneath the outlet conduit develops, the conduit will be left unsupported and separation of the conduit joints and undermining may occur. Separation of the conduit joints and undermining may lead to failure of the spillway and ultimately the dam. A registered professional engineer should be contacted to ensure that the plunge pool is designed properly.
