### FINAL ENVIRONMENTAL ASSESSMENT

<b>Project Name:</b>	Landusky Swift Gulch High Flow Treatment System and Stream Rehabilitation
<b>Proposed Implementation Date:</b>	September 1, 2021
<b>Proponent:</b>	Montana Department of Environmental Quality, Hard Rock Mining Bureau
<b>Location:</b>	47.93N, 108.61W
<b>County:</b>	Philips

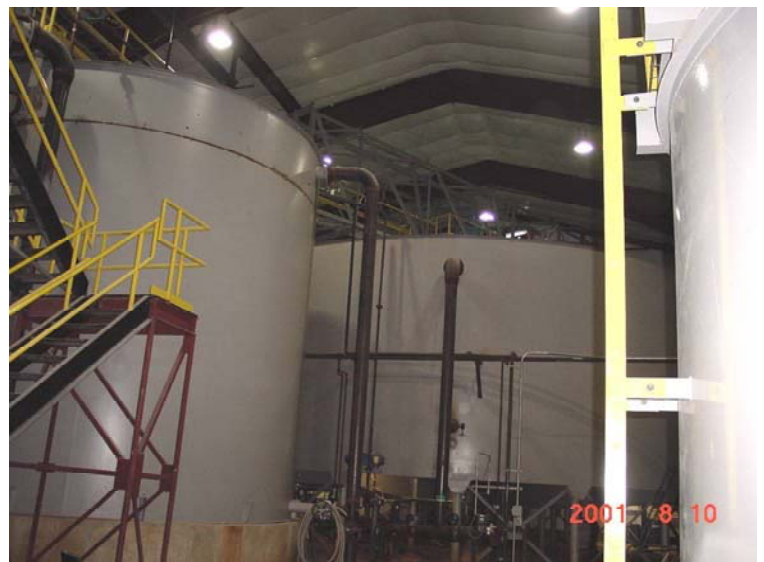
**Inside the Landusky Mine  
Water Treatment Plant**

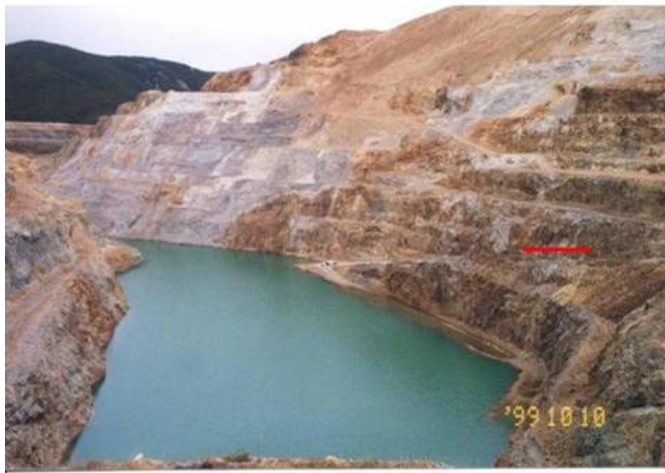
August Pit, October 1999 - Before Draining Pit Lake

Note: Red line to the right in each photo shows the same pit wall elevation.

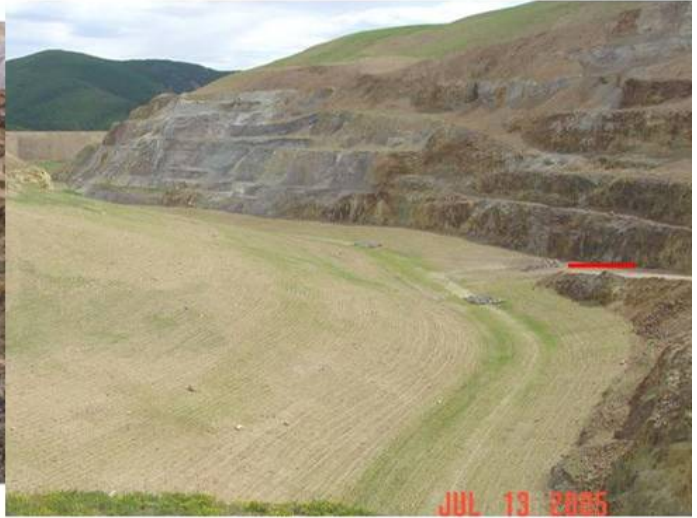
August Pit, July 2005 - Reclamation Work Complete

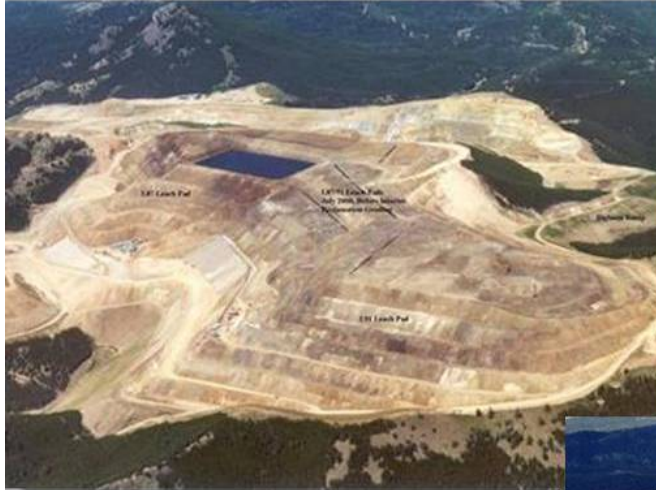
**July 2000 - L87/91 Valley-Fill Leach Pads. Contains 112 million tons of spent ore, over 150 million gallons of residual cyanide solution and covers over 200 acres.**

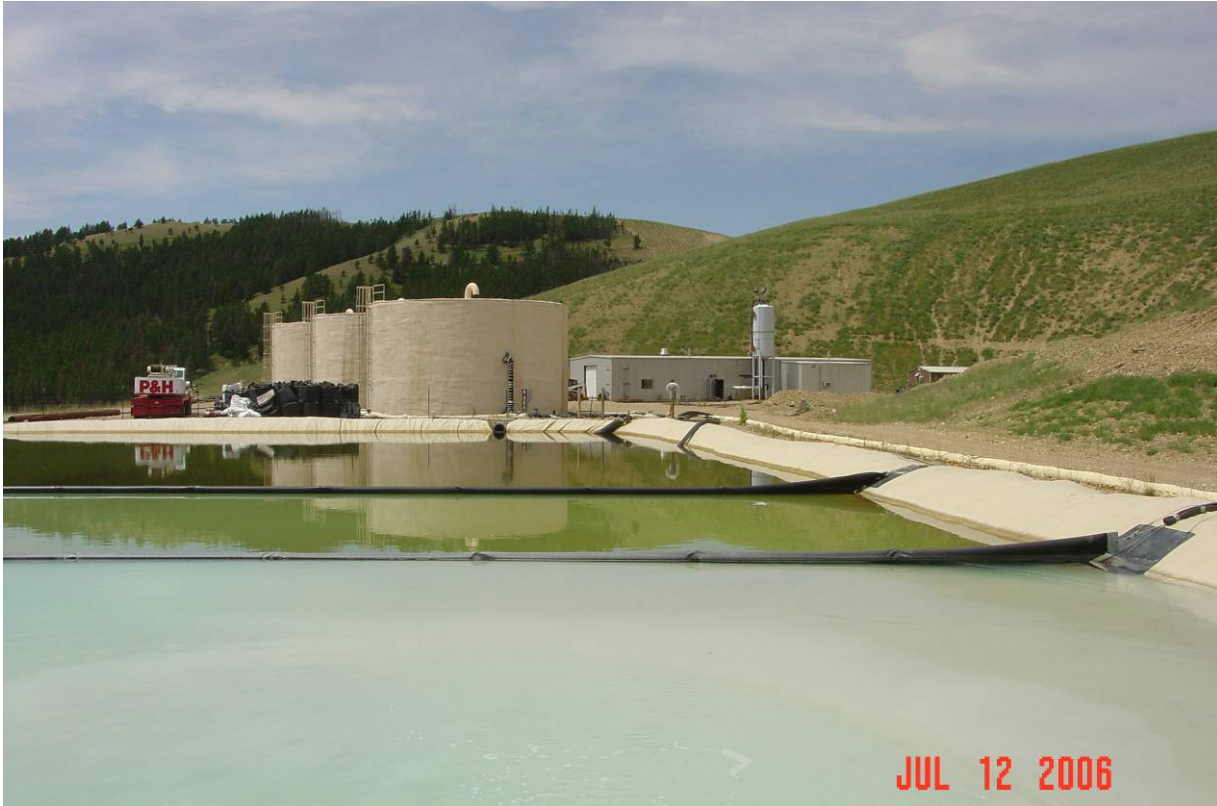
Bioreactor on the L87 Leach Pad Dike, pH pre-treatment pond in the foreground.

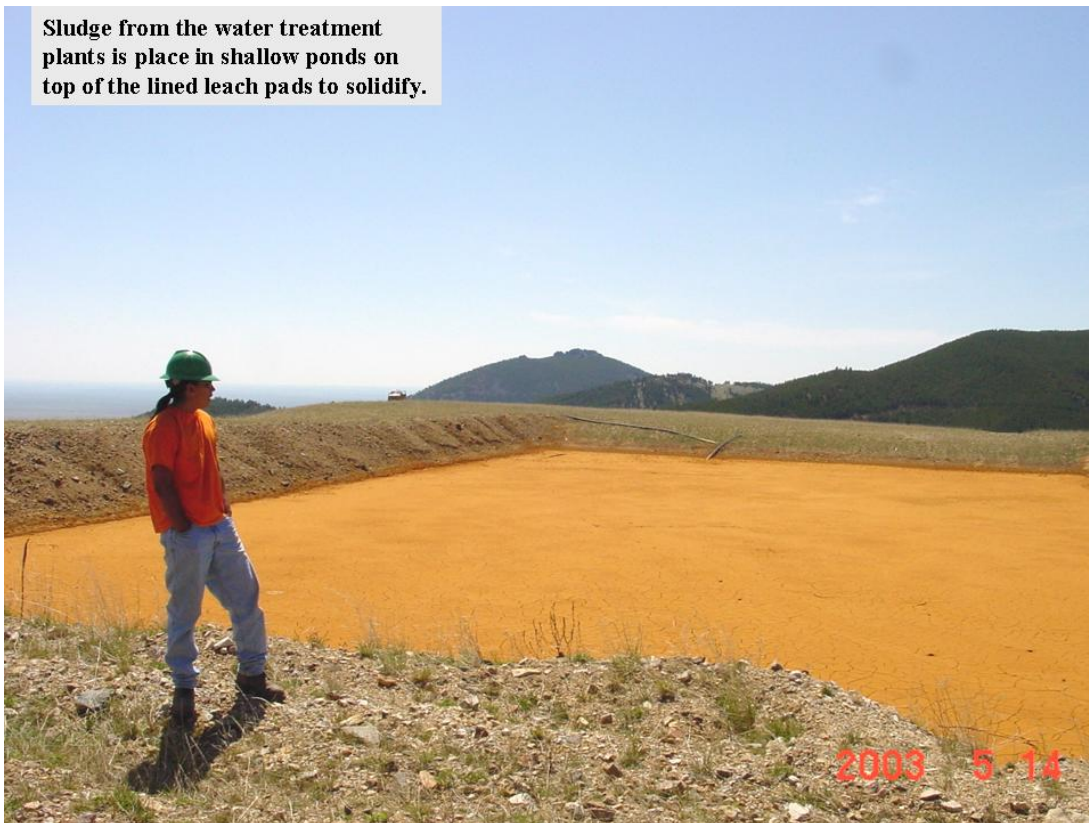
Sludge from the water treatment plants is place in shallow ponds on top of the lined leach pads to solidify.
