# Western Dam Engineering Technical Note

A QUARTERLY PUBLICATION FOR WESTERN DAM ENGINEERS

### Soil Characterization (Part 2) – Laboratory and Field Shear Strength Testing

### Dam Overtopping Failures – Lessons Learned from the September 2013 Colorado Flood Event

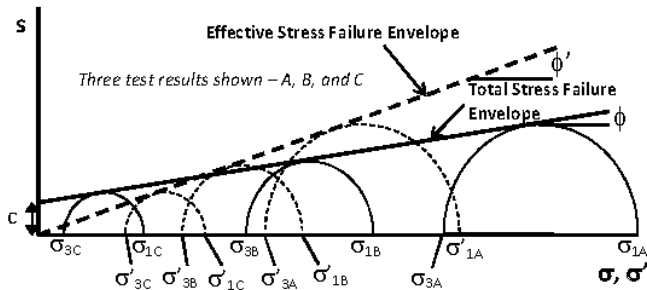
a frictional component ( $\phi$ ,  $\phi'$ ) and a non-frictional component, or cohesion ( $c$ ,  $c'$ ). Figure 1 below graphically depicts the Mohr-Coulomb failure criterion.

Figure 1: Mohr-Coulomb failure criterion.

Mohr-Coulomb failure envelopes can be developed through the use of Mohr's circles of stress representing the stress states at failure for a series of tests (often three tests). As seen in Figure 1, both total and effective stress failure envelopes can be developed. Failure envelopes for soils are often curved. However, for mathematical simplicity, an analyst will approximate the failure envelope as linear over the normal stress range of interest for the analysis. The Mohr-Coulomb failure criterion is, therefore, represented by a straight line (failure envelope) with a slope designated as the friction angle ( $\phi$ ,  $\phi'$ ) and an intercept called the cohesion ( $c$ ,  $c'$ ). The normal (or vertical) stress ( $\sigma$ ,  $\sigma'$ ) acting on soil in an embankment at a given depth, is represented by the horizontal axis, and can be either total stress or effective stress. Note that the greater the normal stress, the greater the frictional component and overall shear strength.

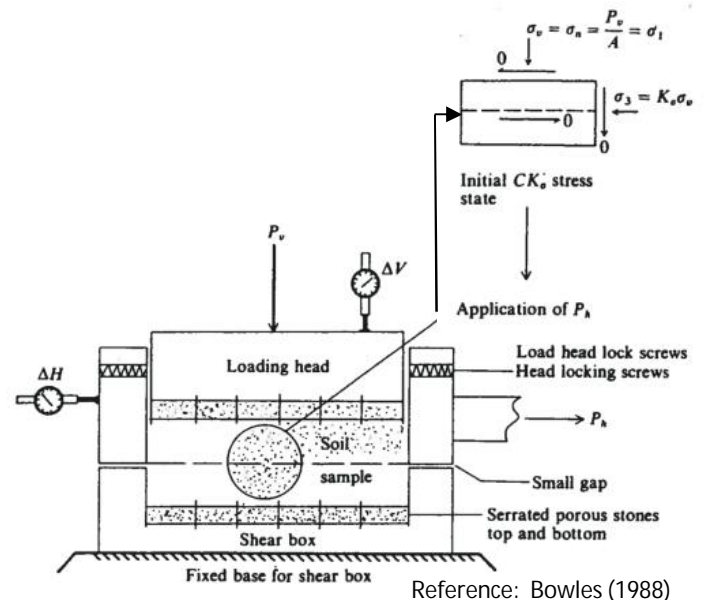
The oldest and simplest shear strength test is the direct shear (DS) test. DS testing is performed as described in ASTM D3080. In the DS test, a thin soil sample is placed in a shear box that is split horizontally into halves. A normal force ( $P_v$ ) is applied to the top of the loading head. The normal force typically ranges from 0 to 150 pounds per square inch (psi). The lower half of the box is fixed, while a shear force ( $P_h$ ) is applied to the upper half, thereby moving the upper half parallel to the lower half and forcing the soil specimen to fail along a horizontal shear plane. A schematic of the test apparatus is shown in Figure 2.

Figure 2: Direct shear test apparatus.

The DS test is performed in a strain-controlled (deformation-controlled) manner per ASTM D3080. In the strain-controlled test, a constant rate of shear displacement is applied to the top half of the box by a motor that acts through gears. Shear displacement ( $\Delta H$ ) of the top half of the box is measured by a horizontal dial gauge or displacement transducer. The resisting shear force of the soil can be measured by a horizontal proving ring or load cell. A dial gauge or displacement transducer on the upper loading plate

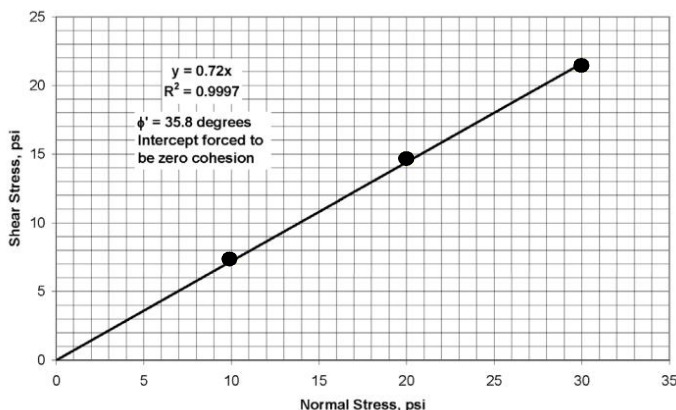
Generally, a minimum of three specimens are tested to establish the relation between shear stress and normal stress at failure. Typical results for a DS test are presented in Figure 3.

Figure 3: Typical direct shear test results.

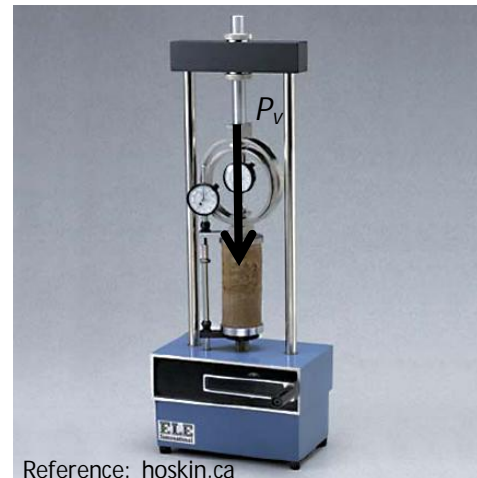
In the UC test, a laterally unsupported specimen (no horizontal confining pressure) is placed between two end plates and loaded in axial compression until shear failure occurs. The vertical load ( $P_v$ ) is applied at a rate that maintains a vertical strain of about 1 to 2 percent per minute. A schematic of the test apparatus is shown in Figure 4.

Figure 4: Unconfined compression test apparatus.

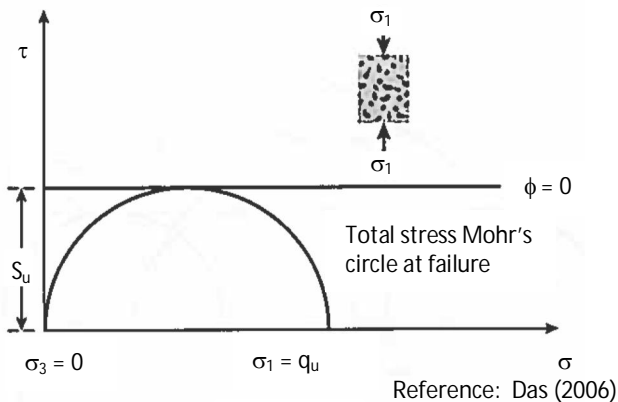
The unconfined compressive strength ( $q_u$ ) is defined as the maximum axial compressive stress at which failure occurs, or at which the axial strain reaches 15 percent if there is no sudden failure. Since there is no horizontal confining pressure, the total minor principal stress at failure ( $\sigma_3$ ) is zero and the total major principal stress at failure is equal to the unconfined compressive strength ( $\sigma_1 = q_u$ ). Thus, the undrained shear strength ( $S_u$ ) is equal to one-half of the unconfined compressive strength ( $1/2q_u$ ), as depicted in Figure 5.

Figure 5: Unconfined compression test results.

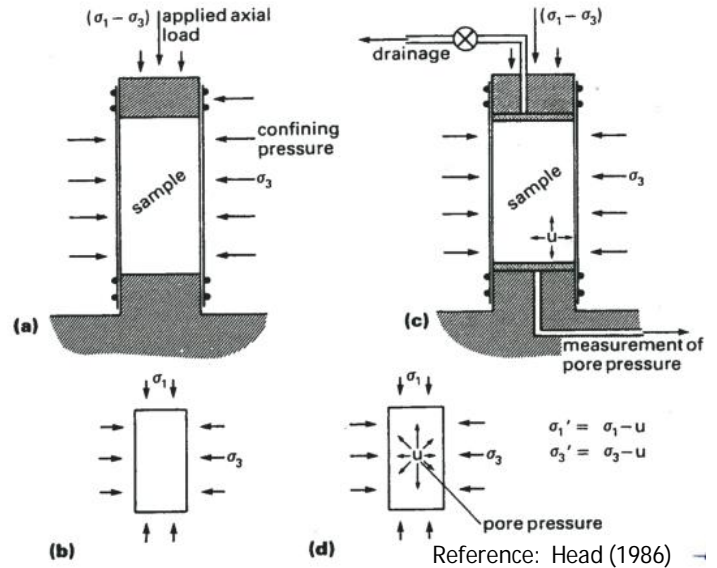
Figure 6: Principles of triaxial compression tests: (a) application of stresses, (b) representation of principal stresses, (c) usual arrangement for effective stress tests, (d) representation of total and effective stresses.

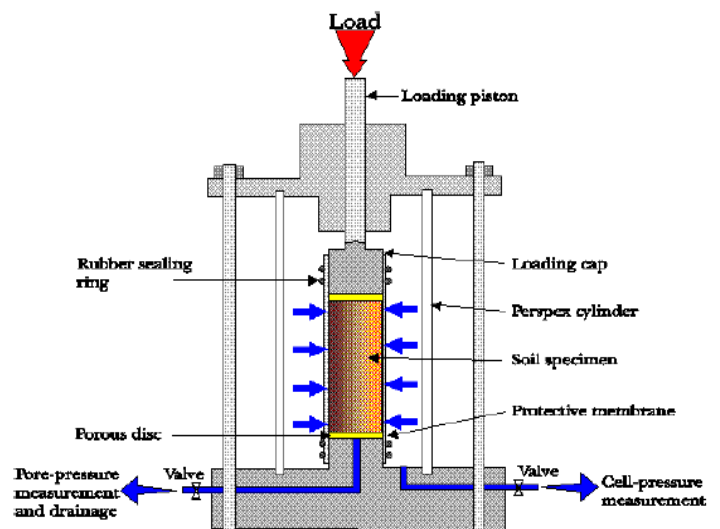
(extension testing) until shear failure of the soil specimen occurs. A drainage system consisting of porous stones and drainage lines is connected to the sample on the bottom and/or top to allow for drainage and pore pressure measurement. Figure 6 illustrates the principles of the triaxial compression test. A schematic of the test apparatus is shown in Figure 7.

Figure 7: Triaxial shear test apparatus.

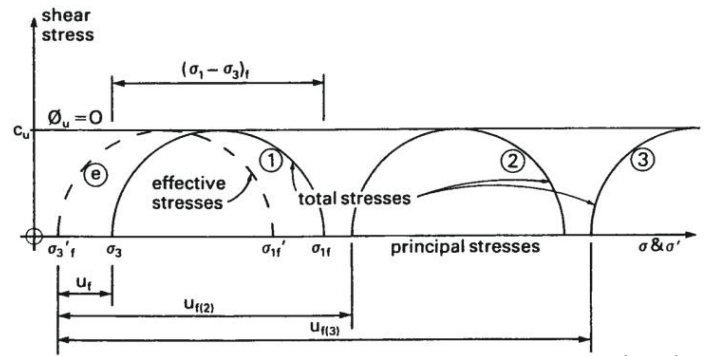
Figure 8: UU test results on saturated soil.

strength characterization. In reality, the specimens are typically not fully saturated, and there is a slight increase in shear strength with increasing chamber pressure. This is because the effective confining stresses actually increase since the pore pressure response is less than the confining pressure.

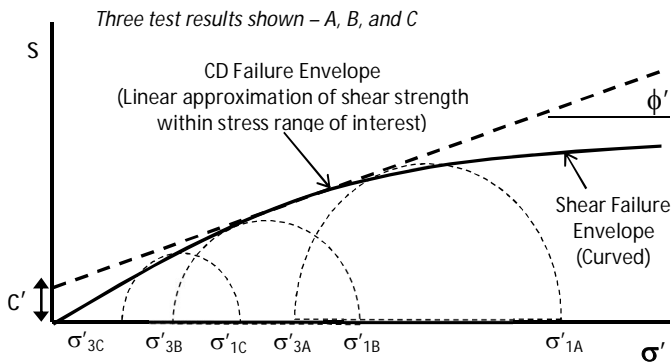
samples. This is conservative, but eliminates the need to perform moist CD tests, which are very complex. The CD test is applicable for both cohesionless soils (sands and gravels) and cohesive soils (clays and elastic silts), however the shear strain rates required for cohesive soils may be so slow as to be impractical, particularly considering that effective stress parameters for these soils can be obtained in a CU' test, as discussed below. Refer to Figure 9 for the failure envelope corresponding to a CD test.

Figure 9: CD test results. [Curved shear strength envelope with linear interpretation and apparent cohesion,  $c'$ ]

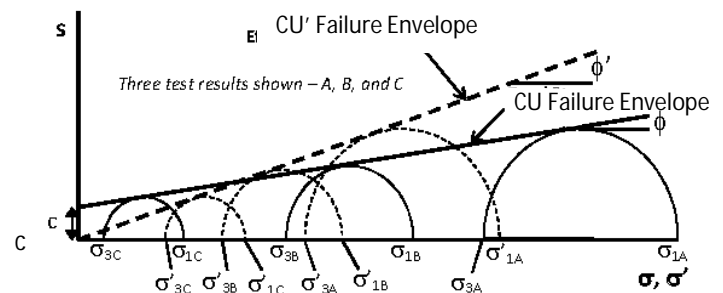
The CU and CU' tests are suitable for both cohesionless soils (sands and gravels) and cohesive soils (clays and silts) and are performed at a faster shear strain rate compared to the CD test. Because both total and effective stress strength parameters can be obtained from a CU' test, CU tests are not often done, as noted above. CU or CU' tests on sands and gravels are usually performed on remolded samples because of the difficulty of obtaining quality, undisturbed samples of cohesionless soils. Refer to Figure 10 for failure envelopes corresponding to CU and CU' tests.

Figure 10: CU and CU' test results.

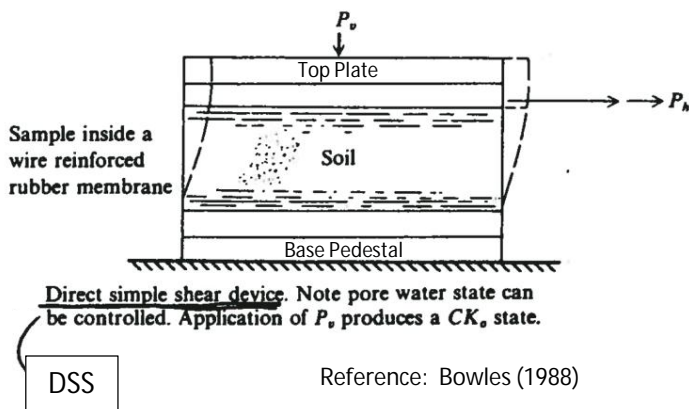
conditions. The soil specimen is confined by a flexible, cylindrical rubber membrane reinforced with wire or by stacked plates confining the specimen in a standard membrane. The specimen is placed between a base pedestal and top plate, as shown in Figure 11. A vertical load ( $P_v$ ) is applied to the specimen from the top plate, and the soil is sheared by moving the top plate horizontally at a constant rate ( $P_h$ ). The stiff frame of the wire-reinforced membrane or stacked plates provides lateral confinement. The wire-reinforced membrane or stacked plates allow for horizontal displacements along the shear plane during shearing, but maintain a constant specimen height by adjusting the vertical load.

Figure 11: Direct simple shear test apparatus.

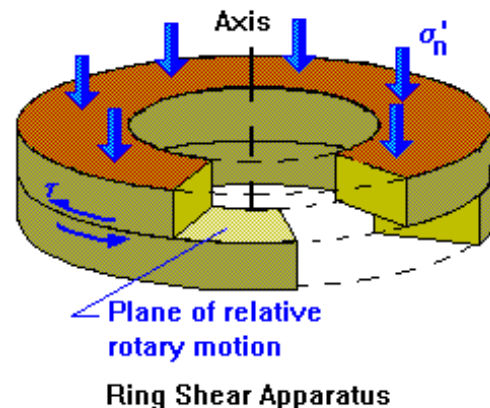
In the torsional ring shear test, a remolded soil specimen in the shape of a ring with a rectangular cross-section is confined by an external ring. Porous ceramic plates are placed at the top and bottom of the soil specimen. An effective normal stress ( $\sigma'_n$ ) is applied to the specimen through the top plate, as illustrated in Figure 12. The specimen is sheared by continuously rotating the lower half of the specimen in one direction while the upper half reacts against a torque arm that is held in place by a proving ring or load cell at each end. The torque arm measures the load as the soil specimen is sheared along a horizontal plane that passes through the specimen. The torque applied to the upper porous plate is used to calculate the average shear stress on the failure surface.

Figure 12: Torsional ring shear test apparatus.

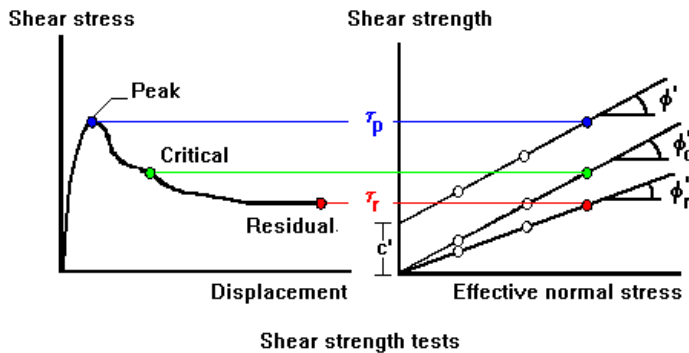
The torsional ring shear test can measure shear stresses over any magnitude of displacement and is therefore suitable for estimating residual shear strength, as shown in Figure 13. The test is primarily used for evaluating the drained residual shear strength of cohesive soils (clays and silts). The specimen must be sheared slowly enough that pore water pressures do not develop. This is generally not a problem because of the small sample height and resulting short drainage path. A minimum of three remolded specimens is generally tested under different normal stresses that are representative of field conditions to evaluate the drained residual failure envelope.

Figure 13: Torsional ring shear test results.

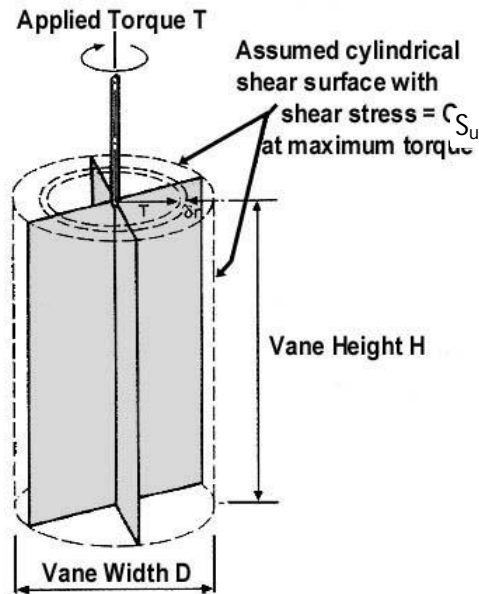
The vane shear test is the most widely used field test for measuring the undrained shear strength of soft to medium stiff clays. In the field vane shear test, a four-bladed vane is pushed into the soil and rotated until the soil fails in shear along a cylindrical surface. The resisting torque is measured to evaluate the undrained shear strength. A schematic of the vane shear test apparatus is shown in Figure 14.

Figure 14: Vane shear test apparatus.

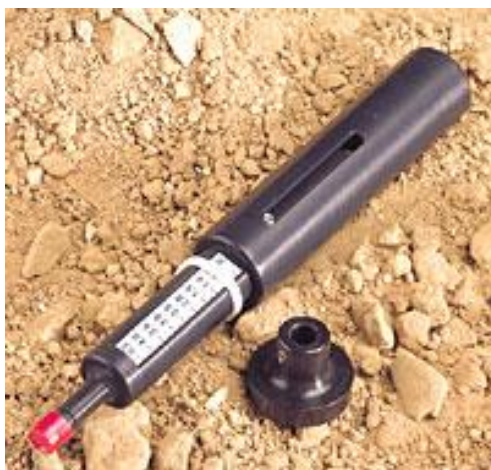
Both the pocket penetrometer and torvane tests are quick field tests which provide approximate measurements of undrained shear strength, subject to appropriate limitations. The pocket penetrometer test provides an approximate measure of the unconfined compressive strength of soils through a small scale bearing capacity test. The piston at the end of a pocket penetrometer, shown in Figure 15, is pressed into the soil to get a measurement of the unconfined compressive strength. It can give misleading results because it only tests a small area of soil and can easily be affected by disturbance.

Figure 15: Pocket penetrometer.

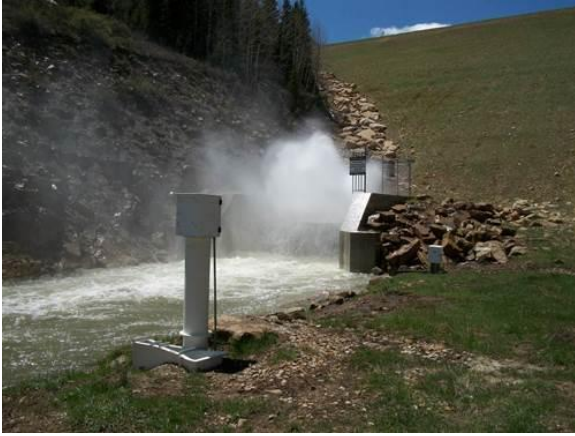
Photo 1: Releasing 300 ft<sup>3</sup>/sec through a Low Level Outlet at Dam in Utah

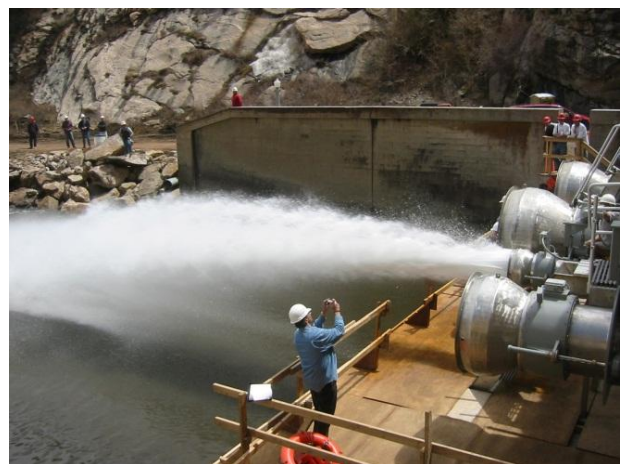
Photo 2. Outlet Commissioning Test. Photo from the Dam Safety Branch of the Colorado State Engineer's Office.

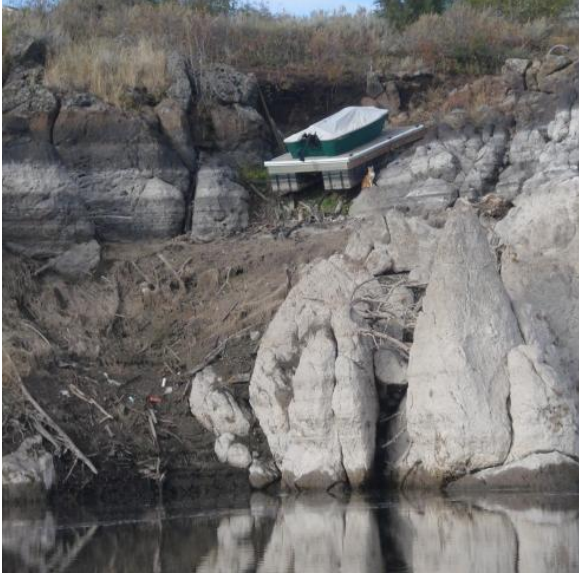
Photo 3. Residential Boat Dock Left High and Dry by Reservoir Drawdown  
A fairly obvious impact of reservoir drawdown is the loss of the water resource. Drawdowns can leave irrigation intakes "high and dry" and lot of irrigators...irritated.

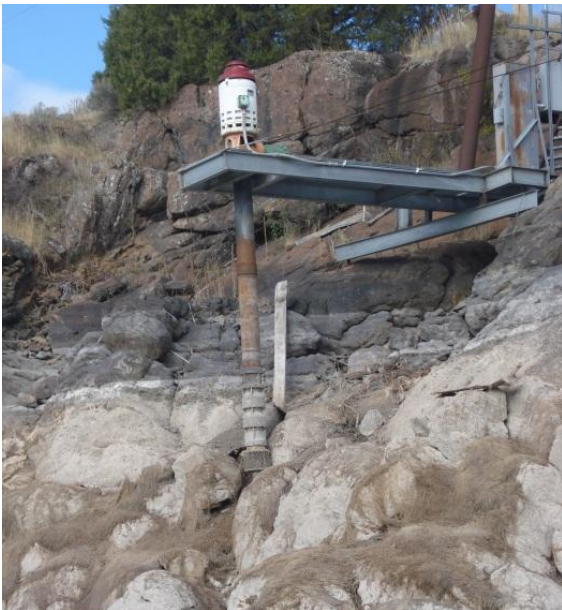
Photo 4. Irrigation Well Left High and Dry by Reservoir Drawdown  
Increased amounts of debris may be produced from the newly exposed rim, which can begin to clog spillways and trashracks. For large volume releases, the increased energy in the reservoir can transport previously stable sediments in upper reaches of the

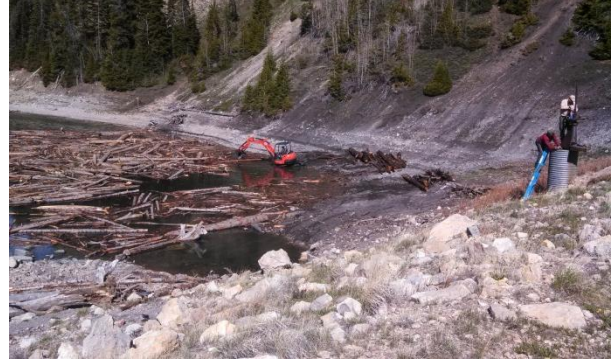
Photo 5. Reservoir Debris at Intake during a Period of Reservoir Drawdown. Photo by Wyoming State Engineer's Office

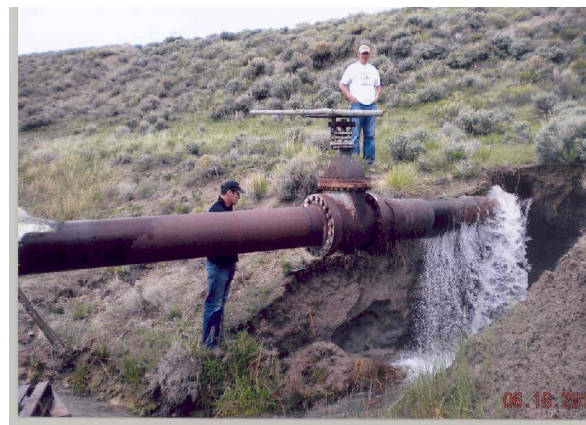
Photo 6. Damage Incurred to Outlet Conduit during Operation

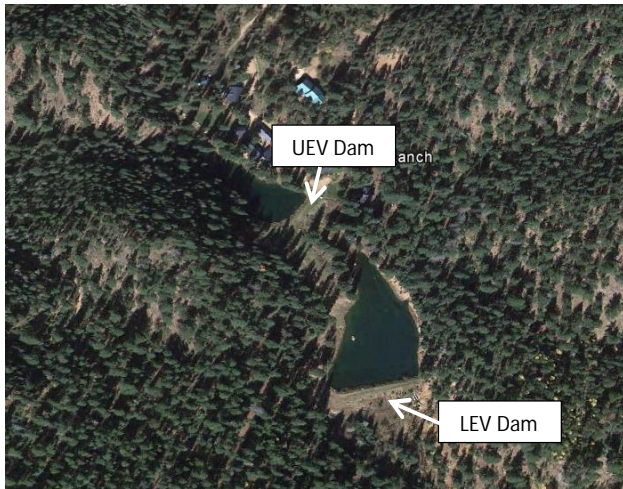
Photo 1: Aerial image of UEV and LEV Dams.

The Upper and Lower Emerald Valley Dams (UEV and LEV) are located on Little Fountain Creek on U.S. Forest Service property in the Emerald Valley Ranch Resort, about 6.5 miles southeast of the Pikes Peak summit. An aerial image of the dams is shown in Photo 1. Both dams are classified as low hazard.

Based on post-failure survey data, the UEV Dam was estimated to have a maximum height of 12 feet and storage capacity of approximately 6.4 acre-feet. The LEV Dam was a larger structure, with an estimated maximum height of 14 feet and storage capacity of approximately 11.4 acre-feet.

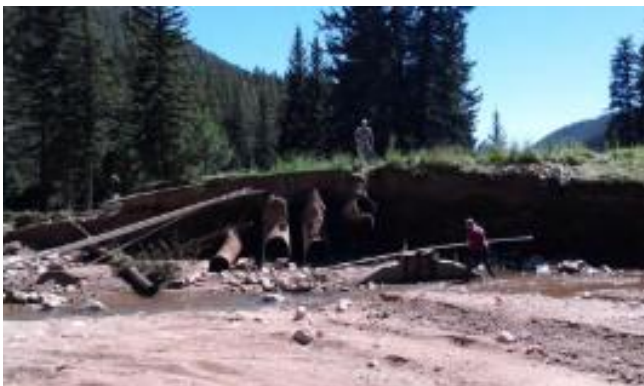
Post-failure inspections of the UEV Dam identified at least eight pipelines penetrating through the embankment and ranging in diameter from 8 to 30 inches (see Photo 2). The pipe penetrations were the only means for releasing inflows from the reservoir, since the UEV Dam did not have an emergency overflow spillway. Additionally, a septic tank was observed embedded within the left abutment of the embankment with pipelines extending parallel to the dam crest to a leach field on the right abutment. It was also observed that the dam crest elevation was not uniform along the length of the dam and contained several low areas.

Photo 2: UEV Dam post-failure looking upstream.

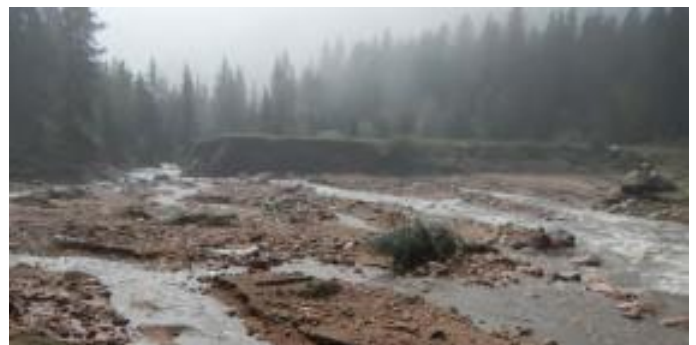
In 1997, the LEV Dam had reportedly failed. The downstream slope in the area of the breach was reconstructed with a relatively steep slope compared to other areas of the downstream slope that were fairly gentle. Aerial photos indicate the 2013 failure occurred at the same location as the 1997 failure. The LEV Dam repairs completed in 1997 may have contributed to the 2013 failure of the dam, considering the relatively steep reconstructed downstream slope in the area of the failure. It is also likely the timber foundation was also not repaired. Photo 3 below shows the LEV Dam post-failure.

Photo 3: LEV Dam post-failure looking upstream.

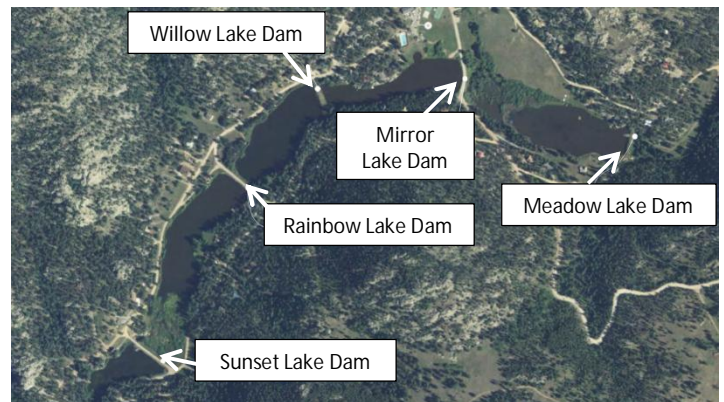
Photo 4: Aerial image of Big Elk Meadows dams.

The Big Elk Meadows complex consists of five dams in series, including (listed from upstream to downstream): Sunset Lake Dam, Rainbow Lake Dam, Willow Lake Dam, Mirror Lake Dam, and Meadow Lake Dam. The dams are situated on the West Fork of the Little Thompson River within the Big Elk Meadows Subdivision, located approximately 5 miles upstream of US 36 along Larimer County Road 47. Sunset Lake Dam is located in northwestern Boulder County, whereas the other four dams are located in southwestern Larimer County. An aerial image of the five dams is shown in Photo 4.

Meadow Lake Dam is classified as jurisdictional, low hazard. All other dams are classified as non-jurisdictional, low hazard. Since Meadow Lake Dam was classified as jurisdictional, it received regular inspections with the most recent inspection completed in 2008. Limited information was available for the other dams.

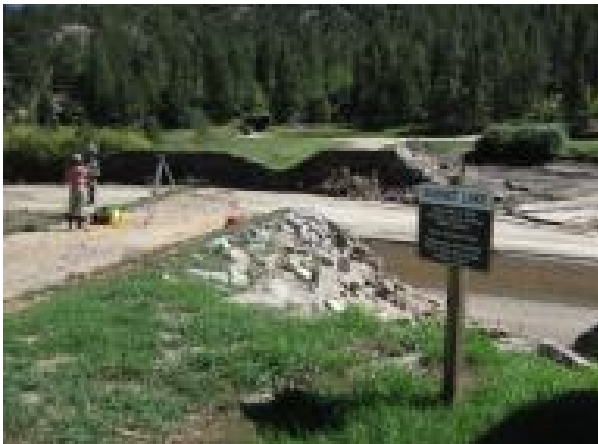
Photo 5: Sunset Lake Dam post-failure looking across and downstream from left abutment.

The cause of failure for these dams was overtopping, erosion, and formation of a breach. Both Willow Lake Dam and Meadow Lake Dam failed as a result of concentrated flows at low areas in the dam crests near the left abutments. Photos 5 through 10 show each dam after failure.

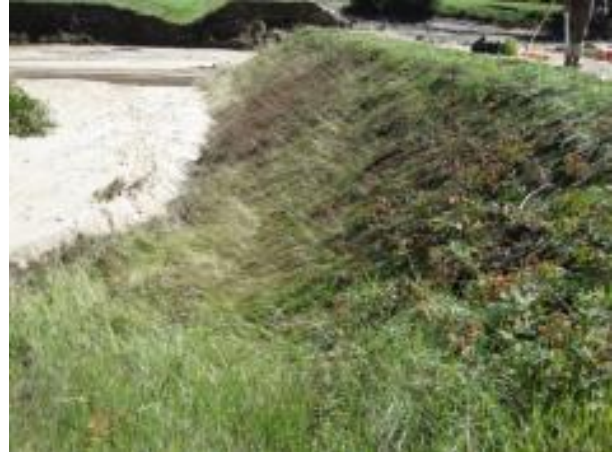
its peak discharge. The significant volume of inflow in conjunction with the small volume of Sunset Lake likely contributed to the failure of Sunset Lake Dam prior to occurrence of the peak discharge

Photo 6: Downstream slope of Sunset Lake Dam after overtopping looking from left abutment.

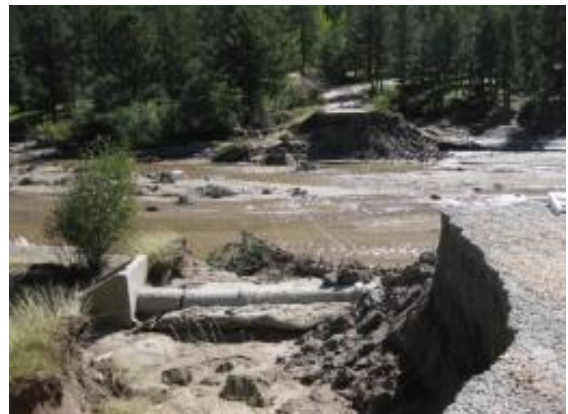
Photo 7: Rainbow Lake Dam post-failure looking across from left abutment.

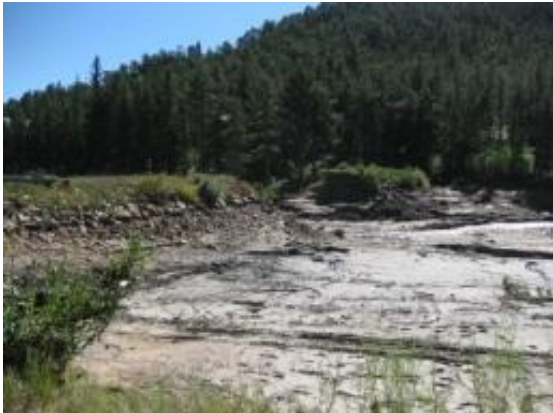
Photo 8: Willow Lake Dam post-failure looking downstream near left abutment.

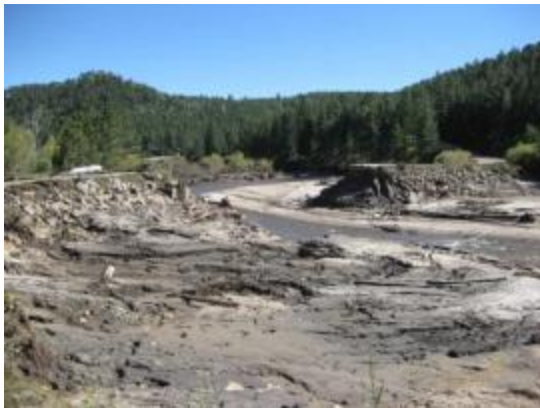
Photo 9: Mirror Lake Dam post-failure looking downstream from left abutment.

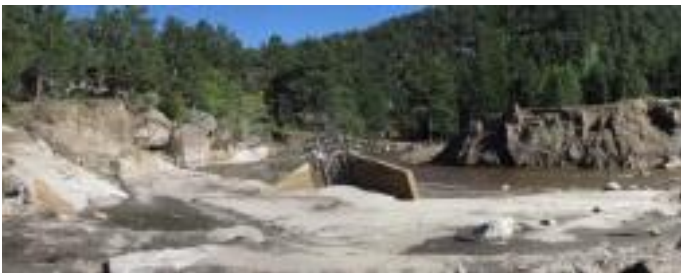
Photo 10: Meadow Lake Dam post-failure looking downstream from within reservoir.

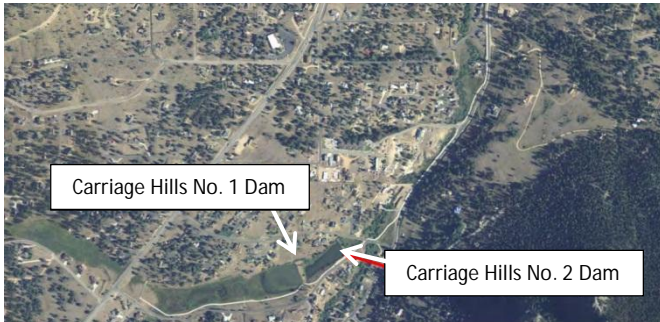
Photo 11: Aerial image of CH1 and CH2 Dams.

Carriage Hills No. 1 and No. 2 Dams (CH1 and CH2) are located in a residential development about 2.25 miles southeast of downtown Estes Park. CH1 Dam is located just upstream of CH2 Dam. An aerial image of the two dams is shown in Photo 11. Both dams are classified as low hazard.

Both dams were overtopped during the September 2013 event. CH1 Dam survived the overtopping event with some erosion damage, while CH2 Dam failed.

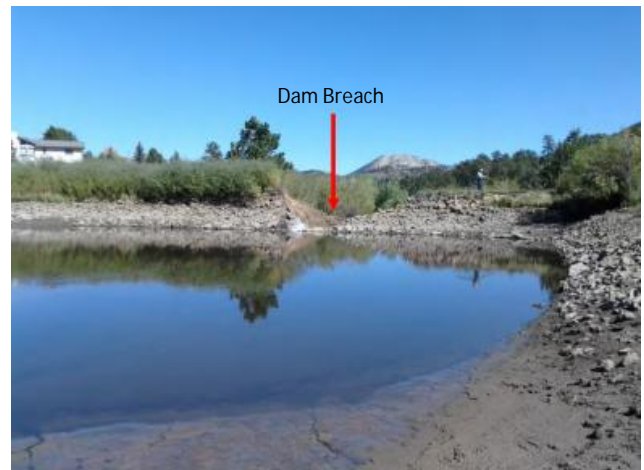
Prior to failure of CH2 Dam, the dam crest was overgrown with trees and shrubs, which can be seen in Photo 12. The spillway was also overgrown with shrubs and small willow trees, as shown in Photo 13. Previous inspection reports noted low areas along the dam crest, specifically in the area of the outlet works conduit.

Photo 12: CH2 Dam post-failure looking downstream from reservoir. Note heavy vegetation on dam crest.

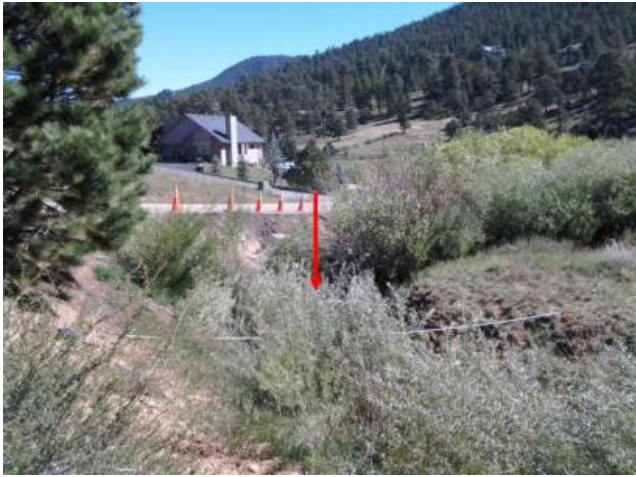
Photo 13: CH2 Dam spillway looking downstream. Note heavy vegetation in spillway.

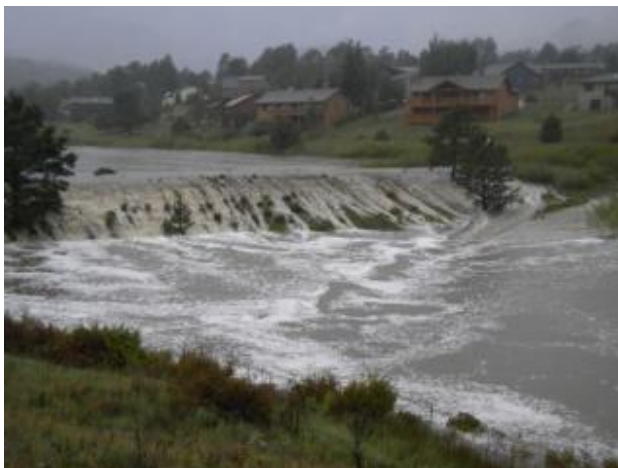
Photo 14: CH1 Dam overtopping.

The overtopping of CH2 resulted in a breach of the embankment, whereas CH1 survived the overtopping event with some scour erosion on the downstream slope, primarily around trees. Overtopping durations and depths are not known. However, significant overtopping of CH1 Dam and at least minor overtopping of CH2 Dam was observed, as shown in Photos 14 and 15. The larger overtopping depth of CH1 Dam was attributed to the smaller spillway capacity at CH1 Dam compared to CH2 Dam, based on visual inspection and an overgrowth of small willows in the spillway. During the flood, the willows matted together, forming a 2-foot-wide notch through which flow was concentrated (see Photo 16).

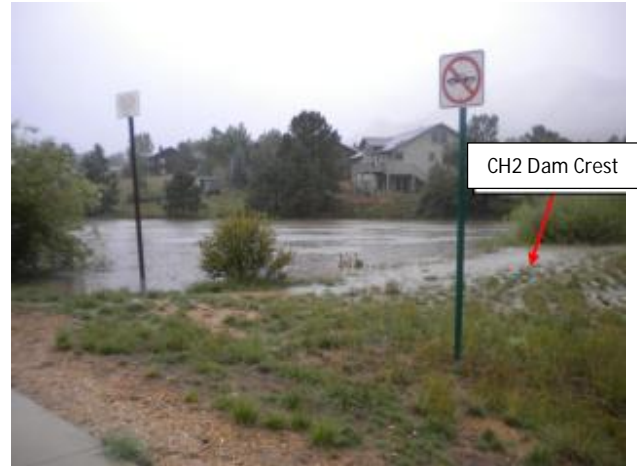
Photo 15: CH2 Dam overtopping.

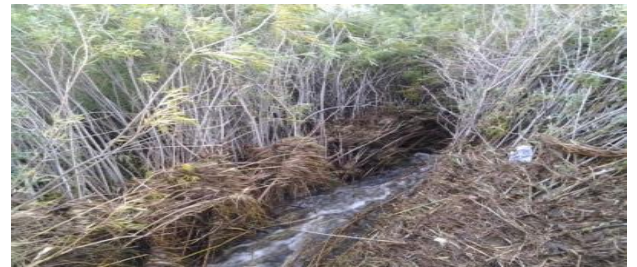
Photo 16: 2-foot-wide notch formed in CH1 Dam spillway.
