# ST. MARY DIVERSION FACILITIES STRUCTURAL EVALUATION OF CANAL BRIDGES

## FINAL REPORT

AUGUST 2007

STRUCTURAL EVALUATION OF CANAL BRIDGES

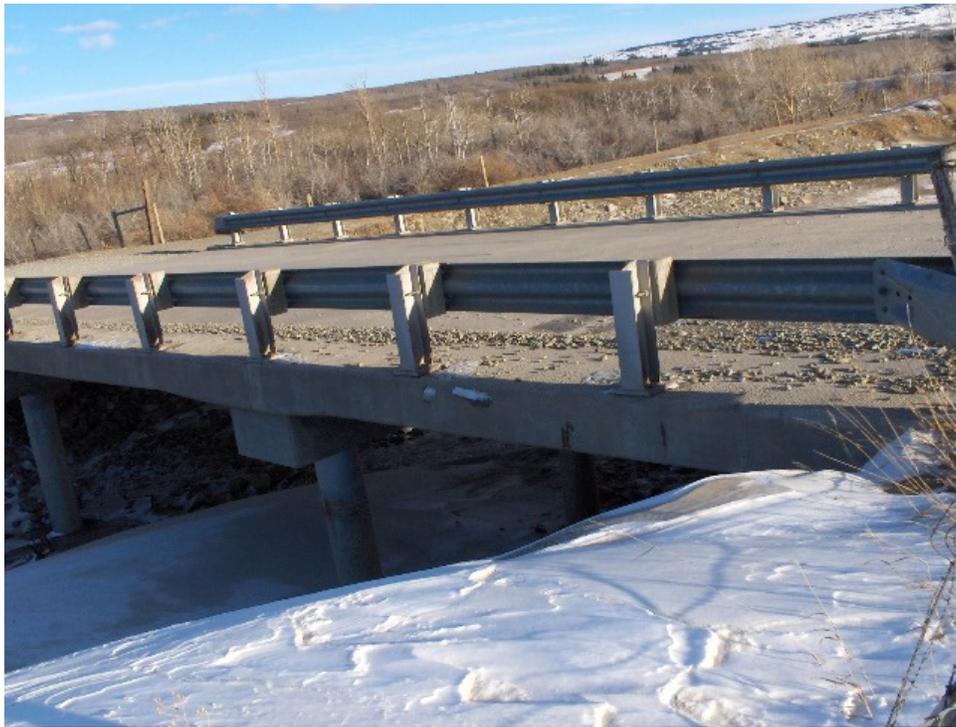
Photo 1.1– Babb Bridge Profile, Looking SE

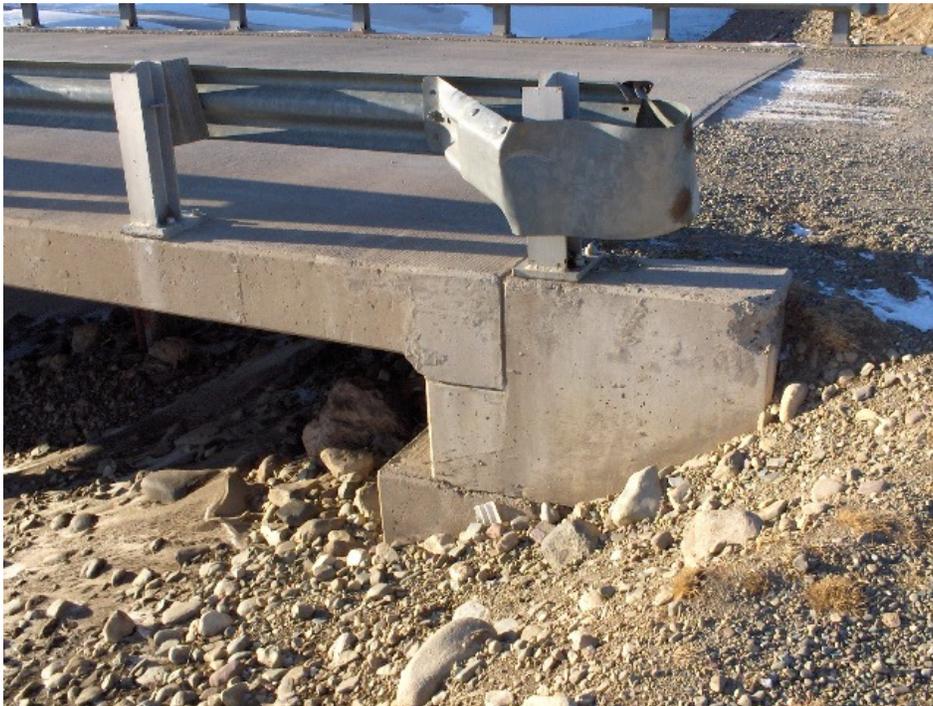
Photo 1.3 – East Abutment

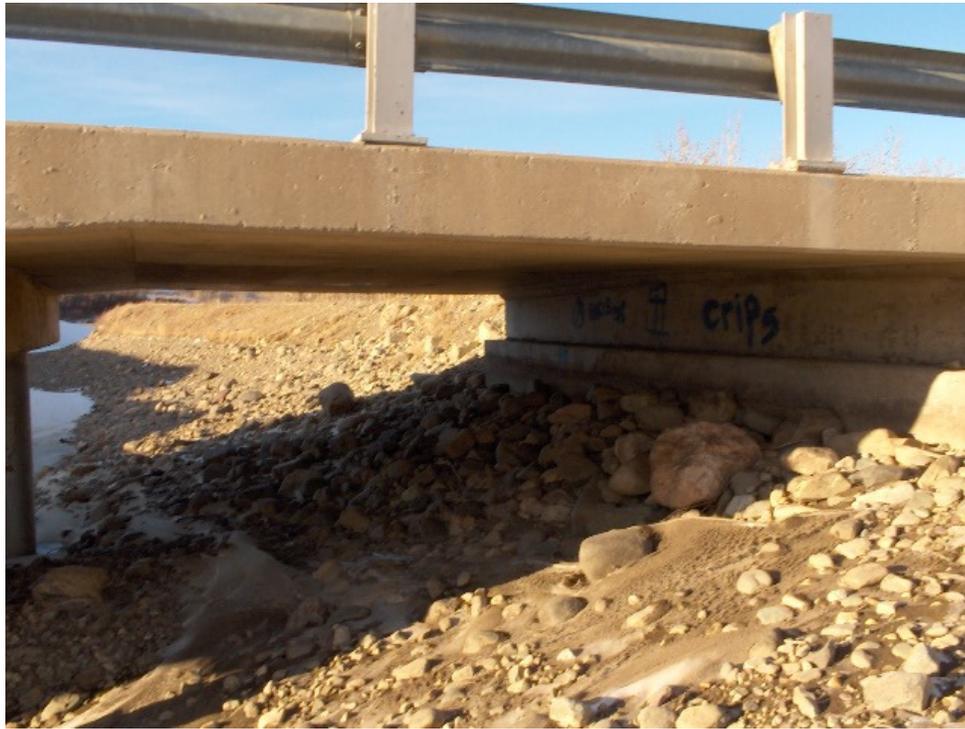
Photo 1.4 – Looking North, East Abutment

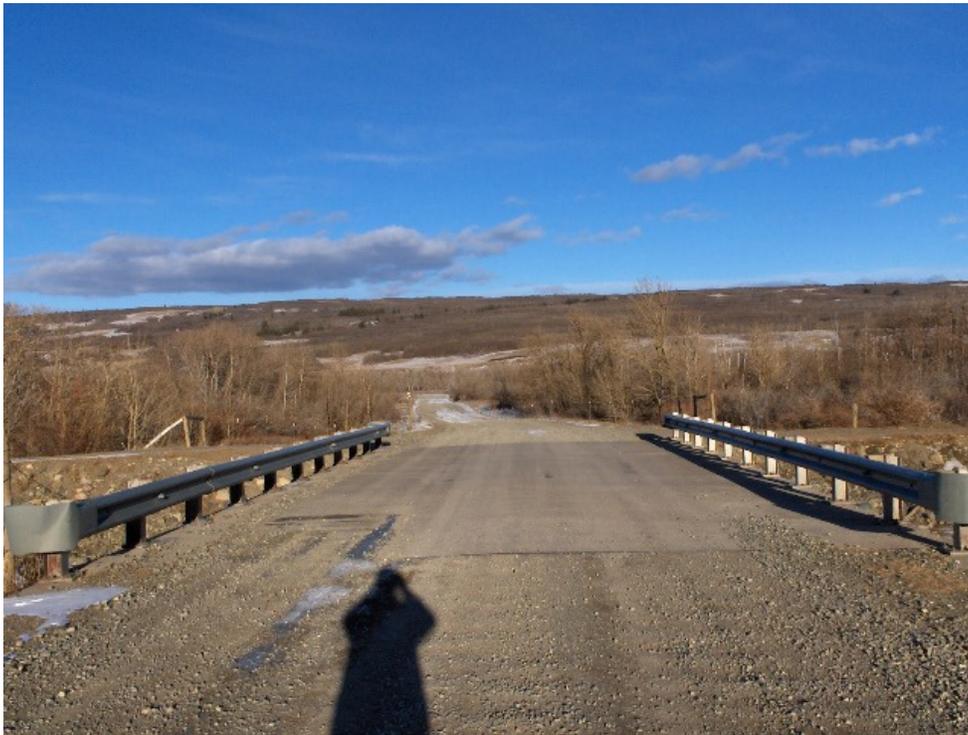
Photo 1.5– Looking East, Top of Deck

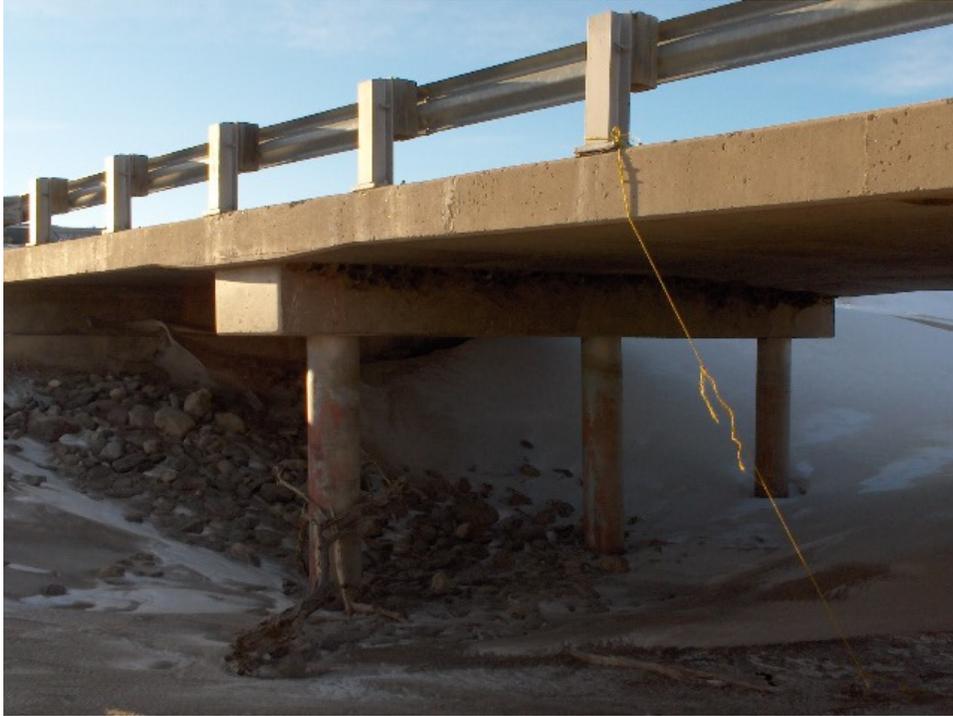
Photo 1.6– West Pier & Abutment

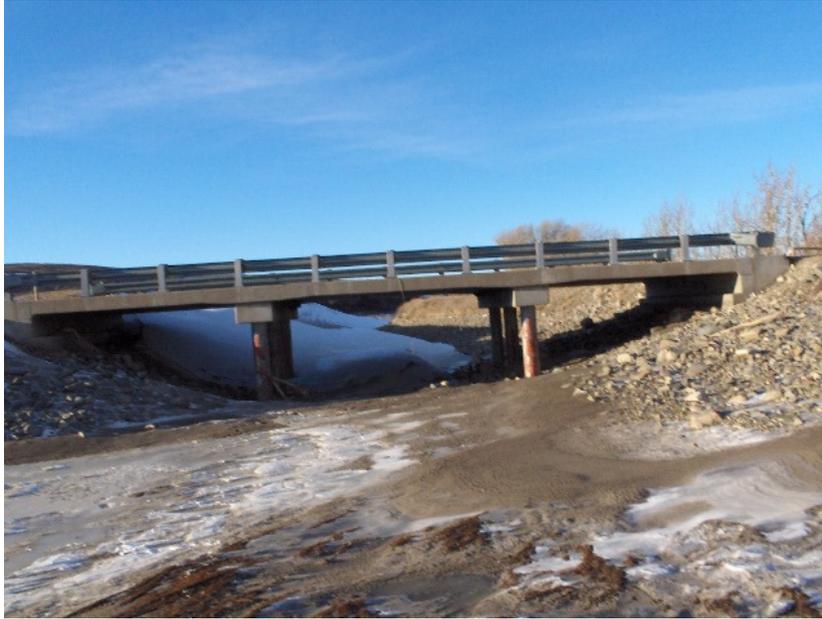
Photo 1.8 – Profile (Looking North)

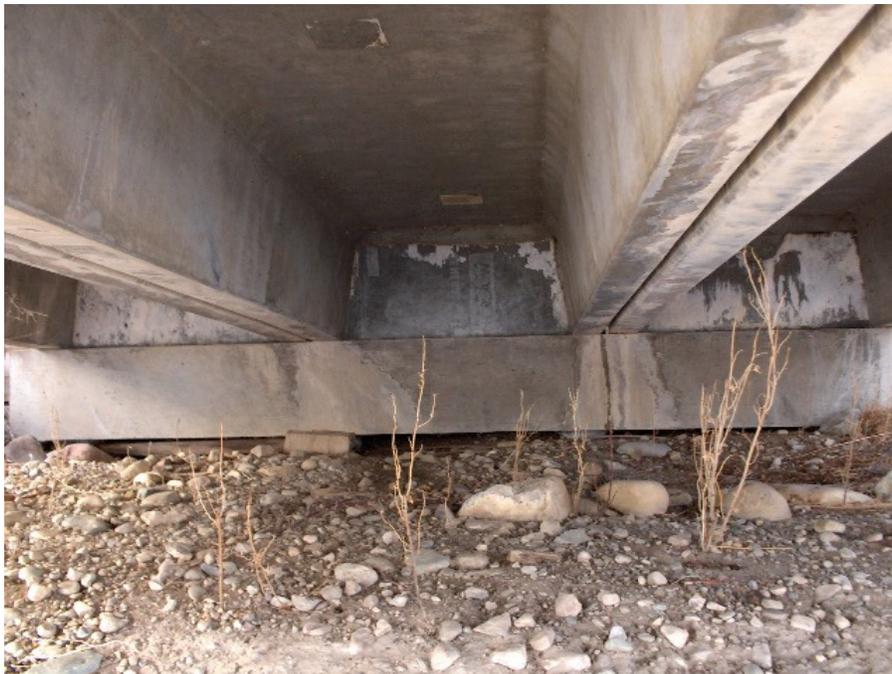
Photo 2.2 – West Abutment

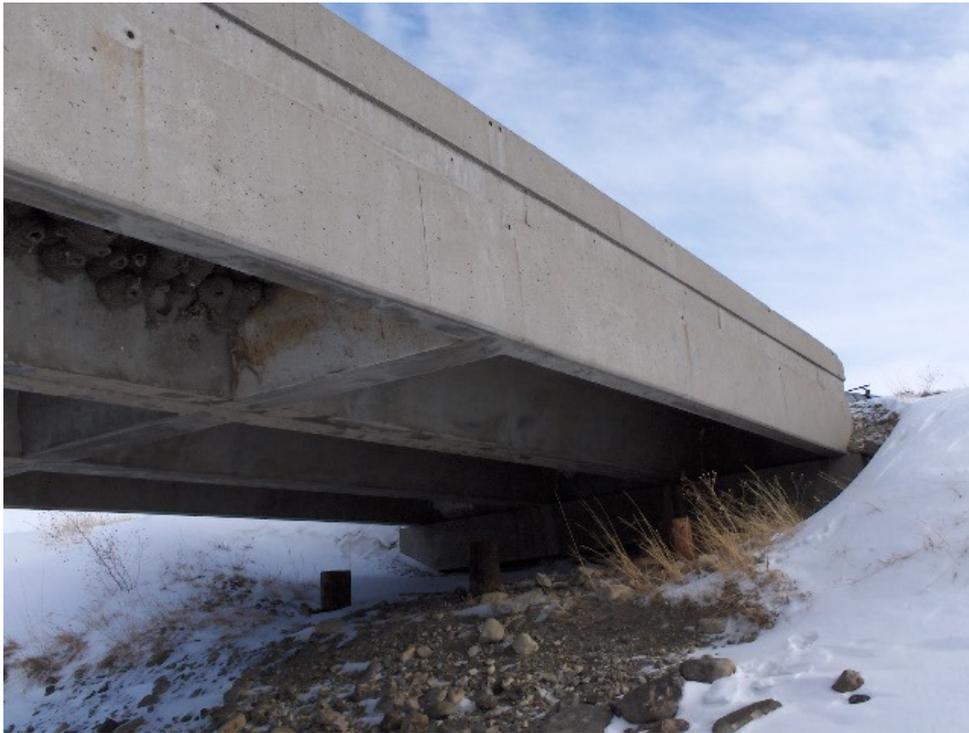
Photo 2.4 – East Abutment

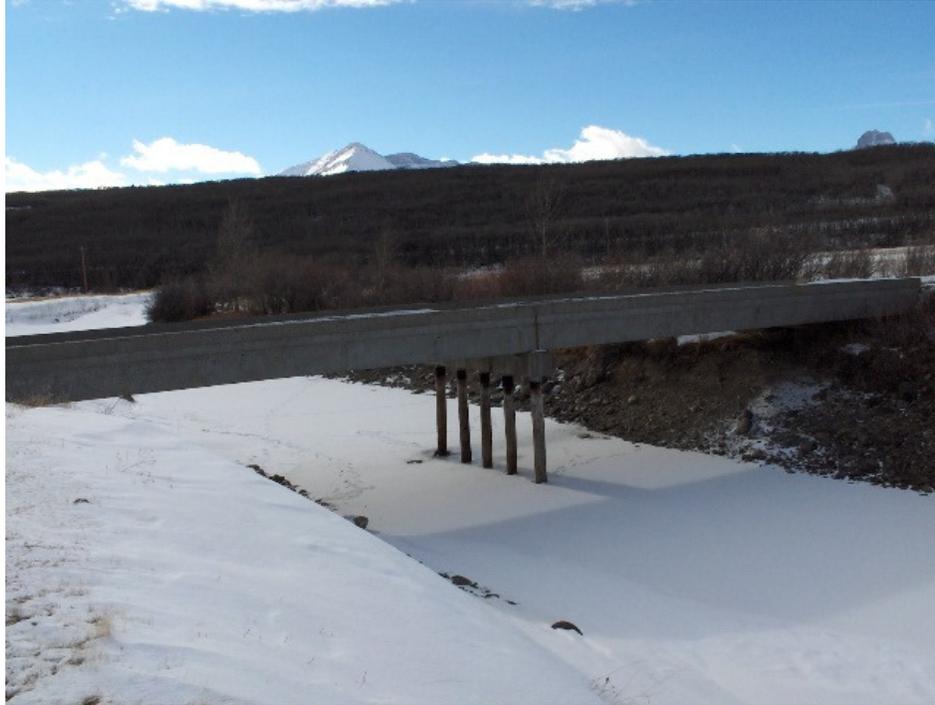
Photo 2.7 – Bridge Profile (Looking North)

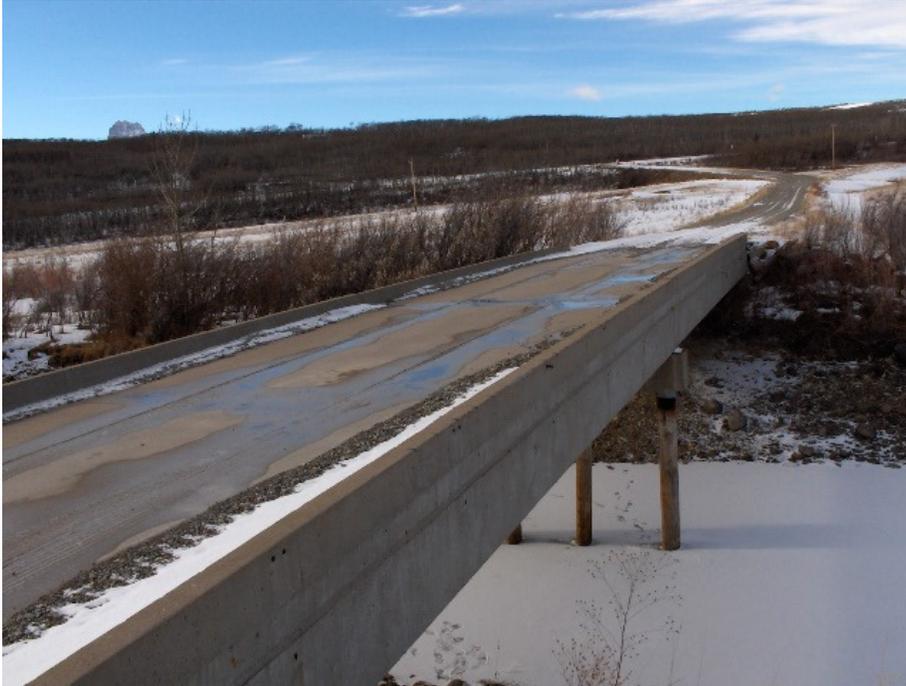
Photo 2.9 - Bridge Deck (Looking East)

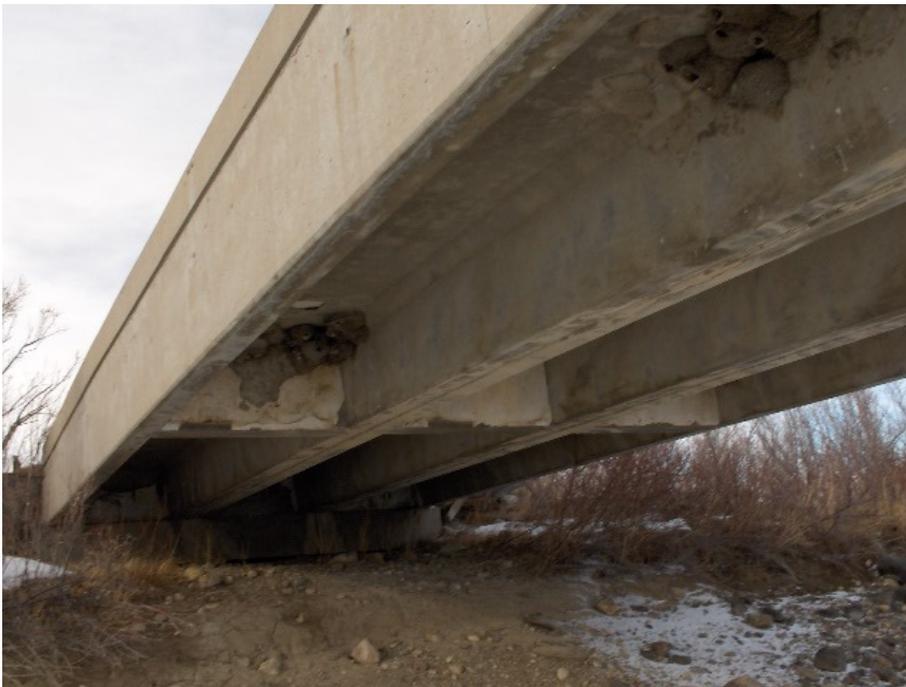
Photo 2.10 – East Abutment

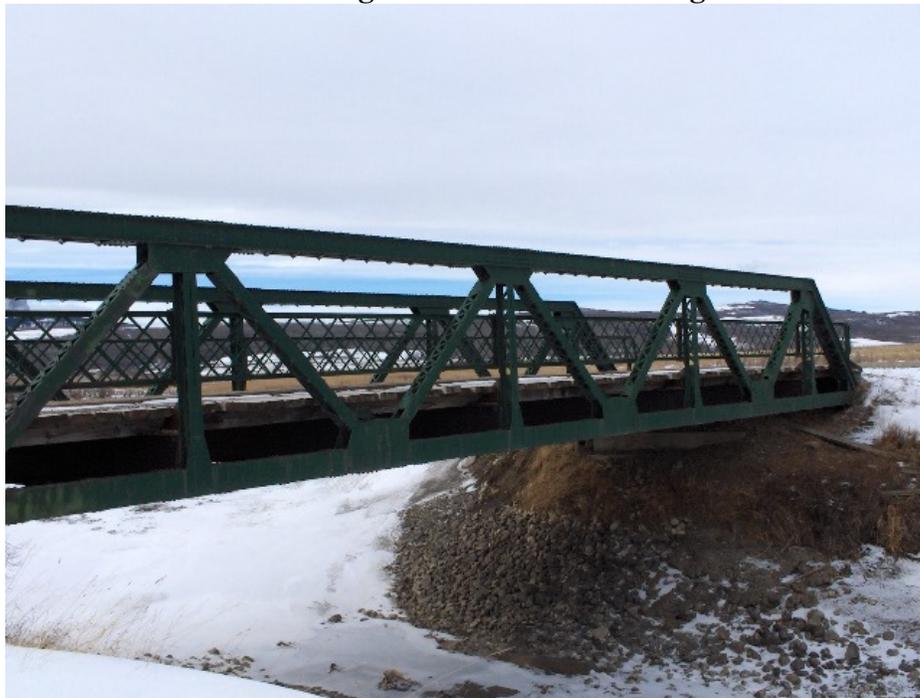
Photo 3.1 – Bridge Profile (Looking SW)

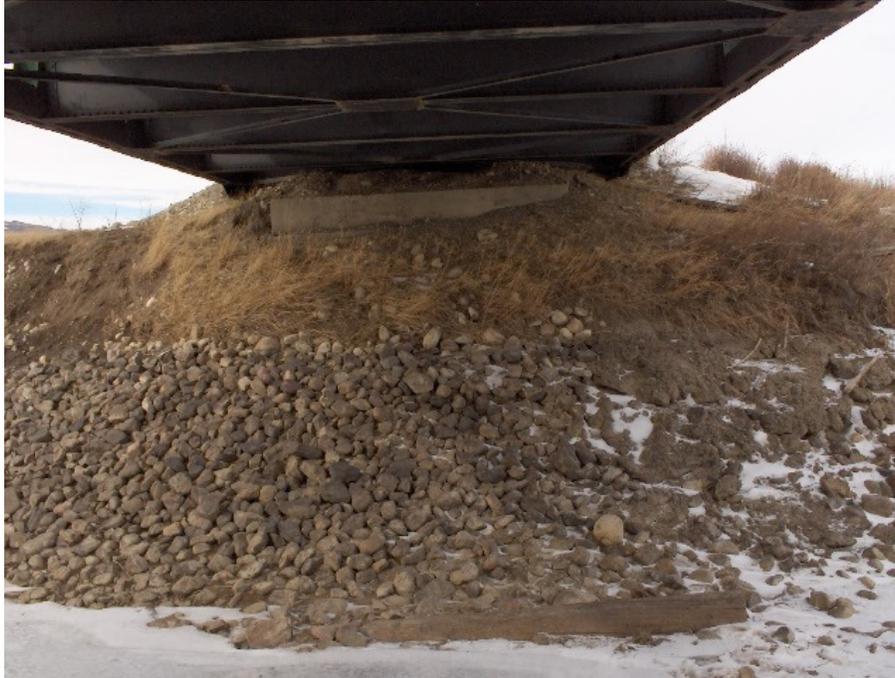
Photo 3.2 – East Abutment

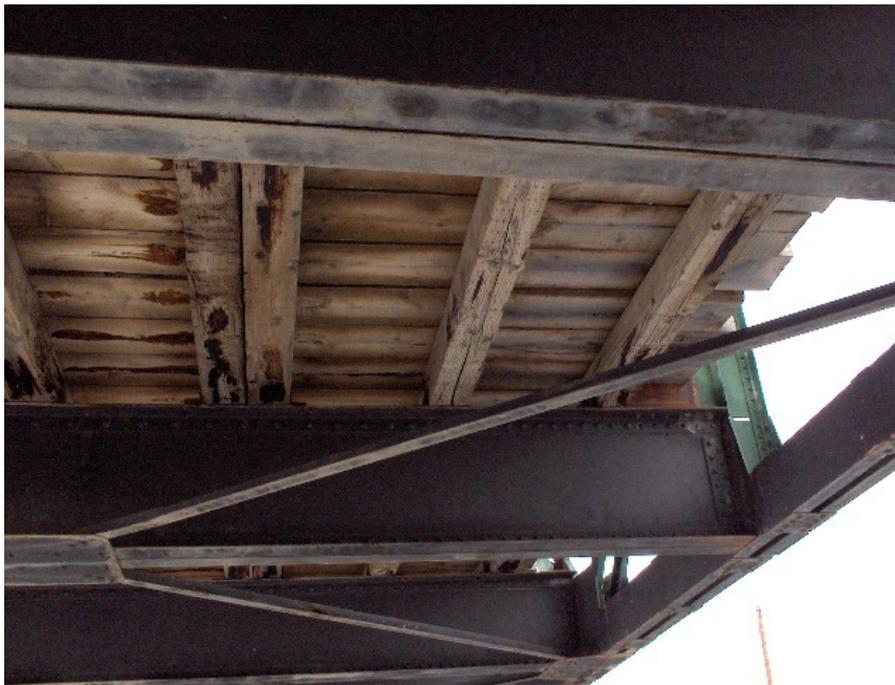
Photo 3.3– Steel Stringers & Timbers

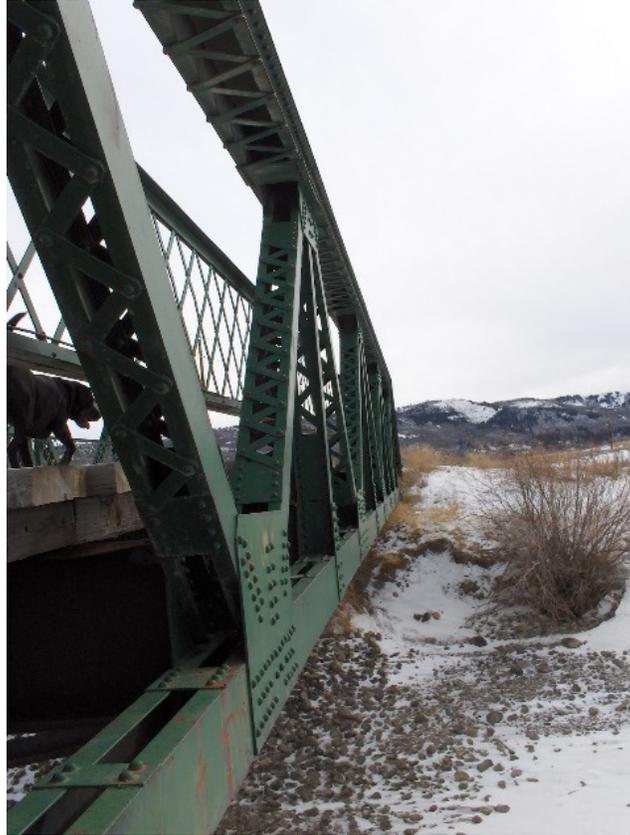
Photo 3.4– Upstream Truss (Looking East)

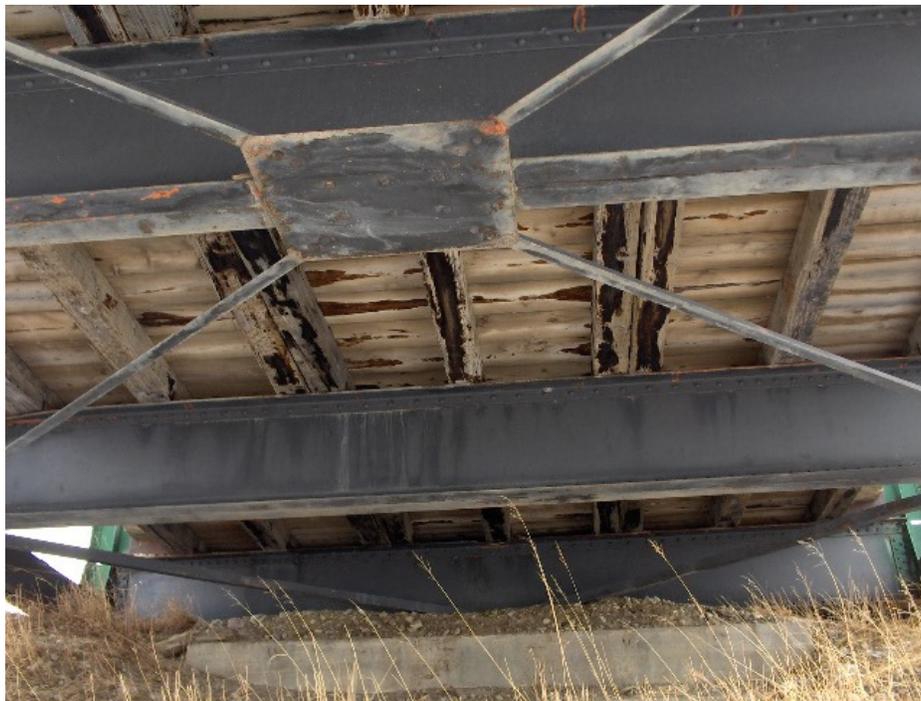
Photo 3.5 – East Abutment

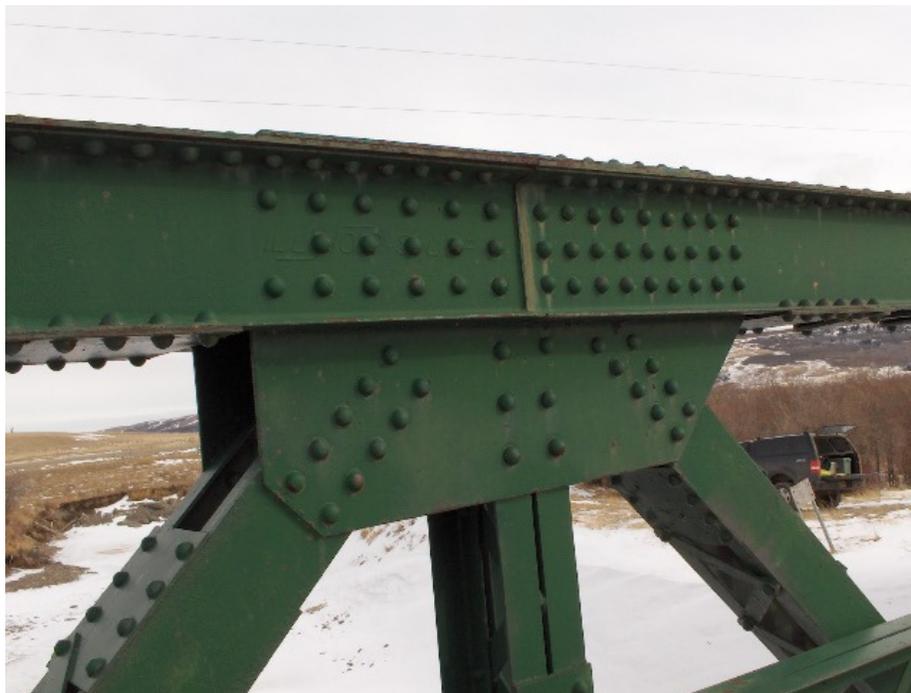
Photo 3.7 – Top Chord, Diagonal & Vertical Connection

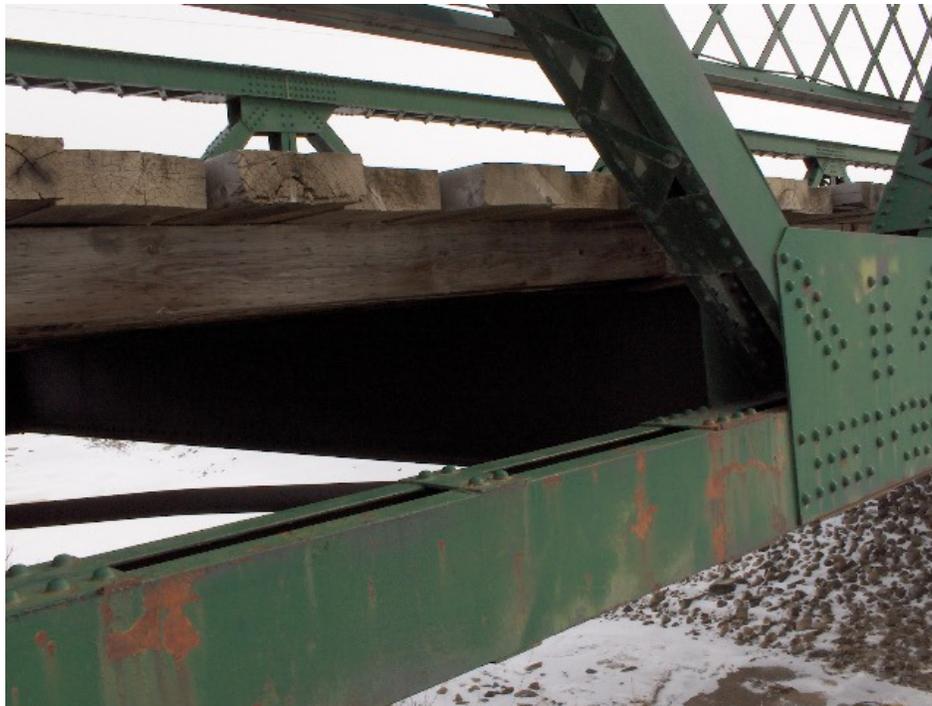
Photo 3.8 – Bottom Chord, Diagonal & Timber Deck

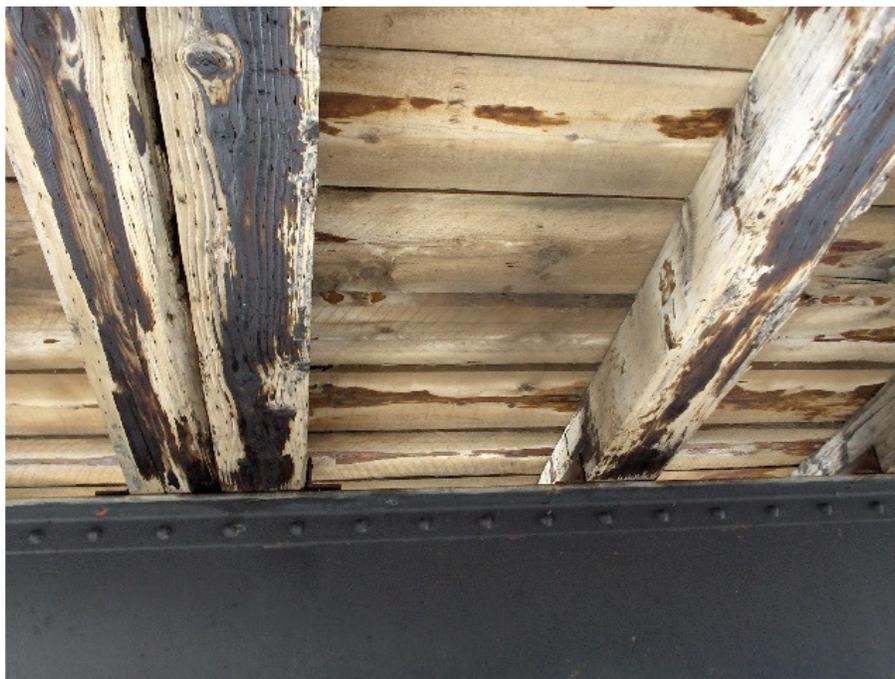
Photo 3.9 – Timbers Bearing on Steel Stringer

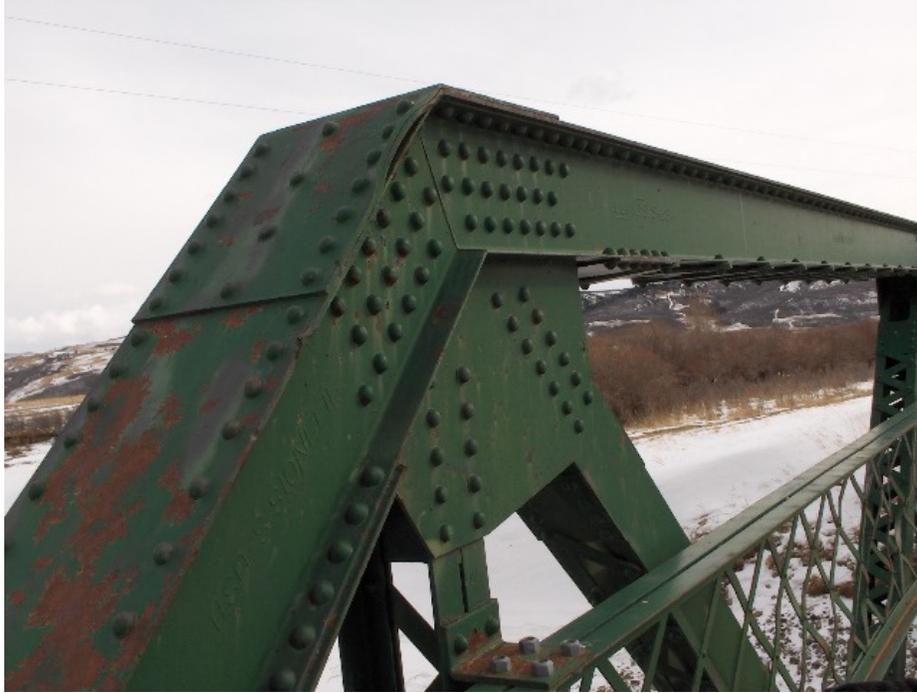
Photo 3.10 – Top Chord, Diagonal & Vertical Connection

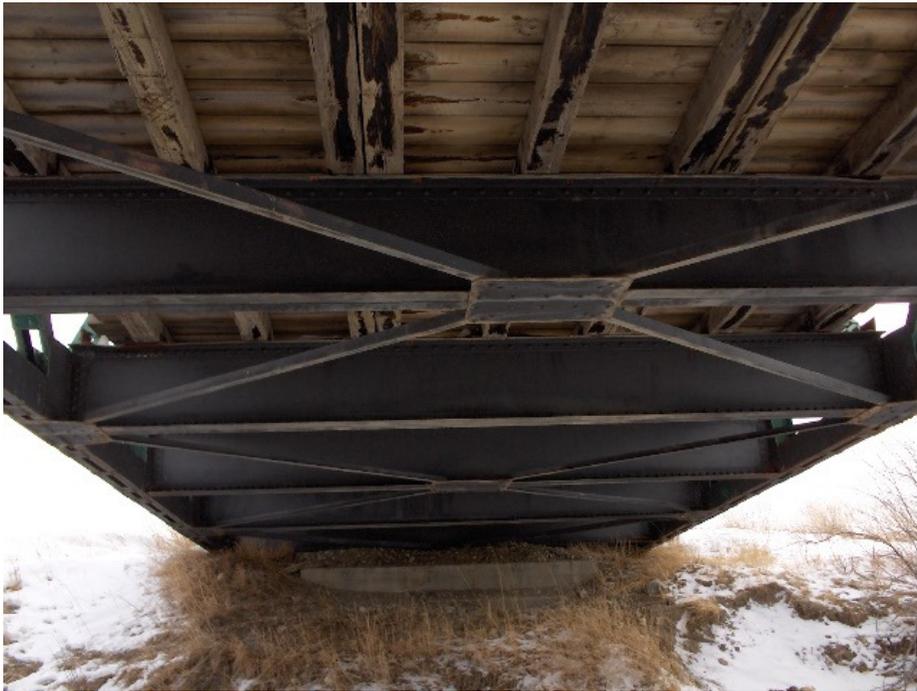
Photo 3.11 – Bridge Underside

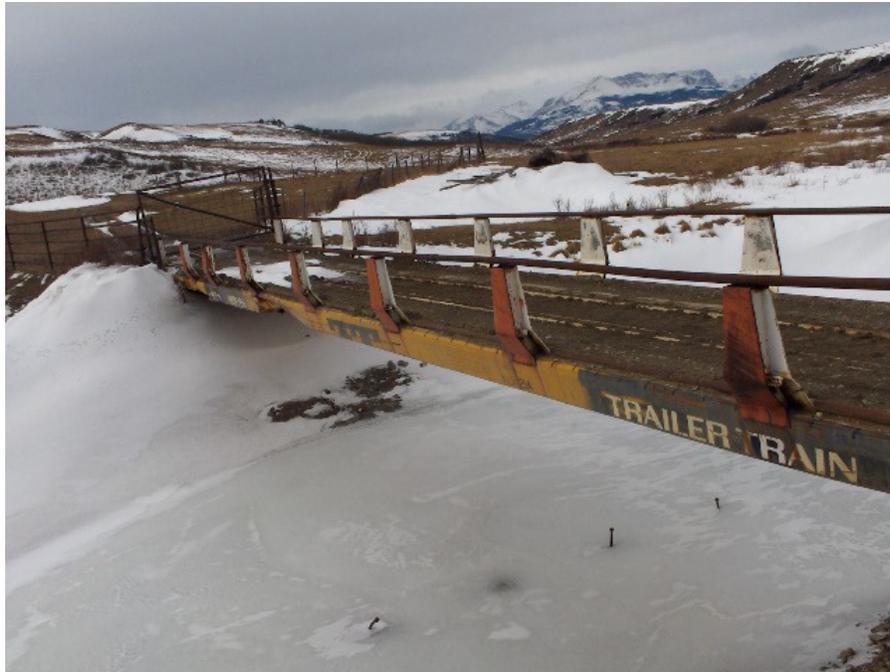
Photo 4.1 – Bridge Profile (Looking NE)

An old damaged railroad TOFC (trailer on flat car) car has been used as the superstructure for this canal crossing. The trucks and coupler boxes have been removed from the car. The structure lacks a definitive point of bearing and the car is merely buried into the ground at the approaches to the crossing. A small timber breast wall exists in front of the bearing area of each end of the railcar to provide retaining for the supporting soil. The overall length of the railcar is 90 feet, but the current clear span is about 76 feet.

The crossing is extremely underdesigned for heavy truck traffic, considering both bridge sag and crossing width. Light duty trucks will cause extreme deflections, bounce, and sag during crossing, and the limited deck width is a definite safety issue. It is recommended that this crossing be replaced with an adequately designed single span, single lane structure.

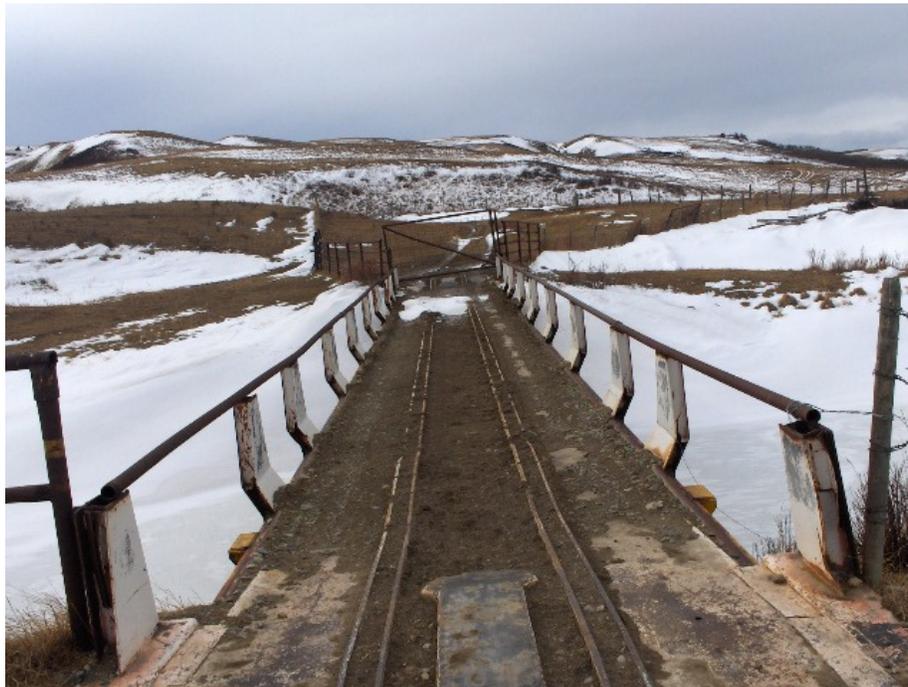
Photo 4.3– Bridge Crossing

The crossing does not have a safe railing system. There is a single 2-1/2-inch diameter pipe for a railing that is welded to intermediate supports to the deck. The supports are fabricated with steel channel and plate welded to the deck at 9'-4" centers. This pipe is insufficient for a railing and some of the welds connecting the pipe to its supports are broken. The railcar is narrow in profile and does not provide a safe crossing width. The overall deck width is 9'-0" and the railing system reduces the travel width to only 8'-0".

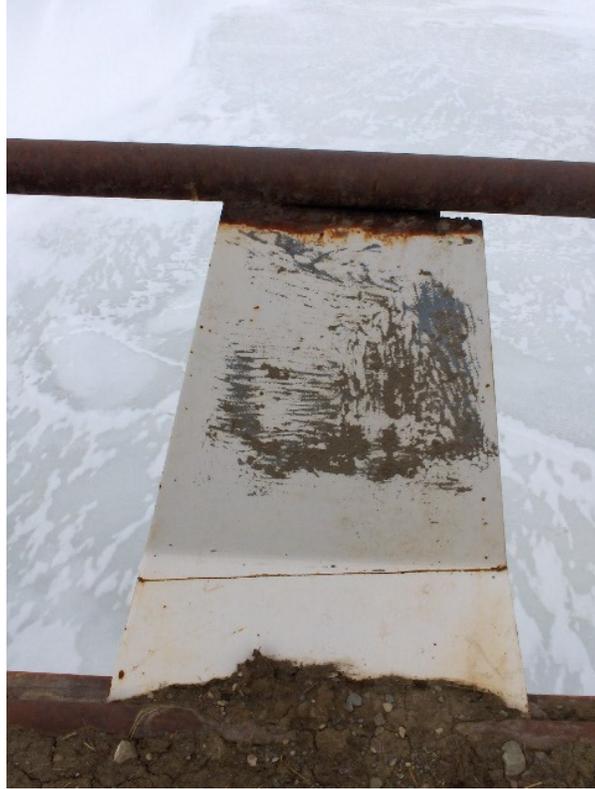
Photo 4.6 – Railing Connection

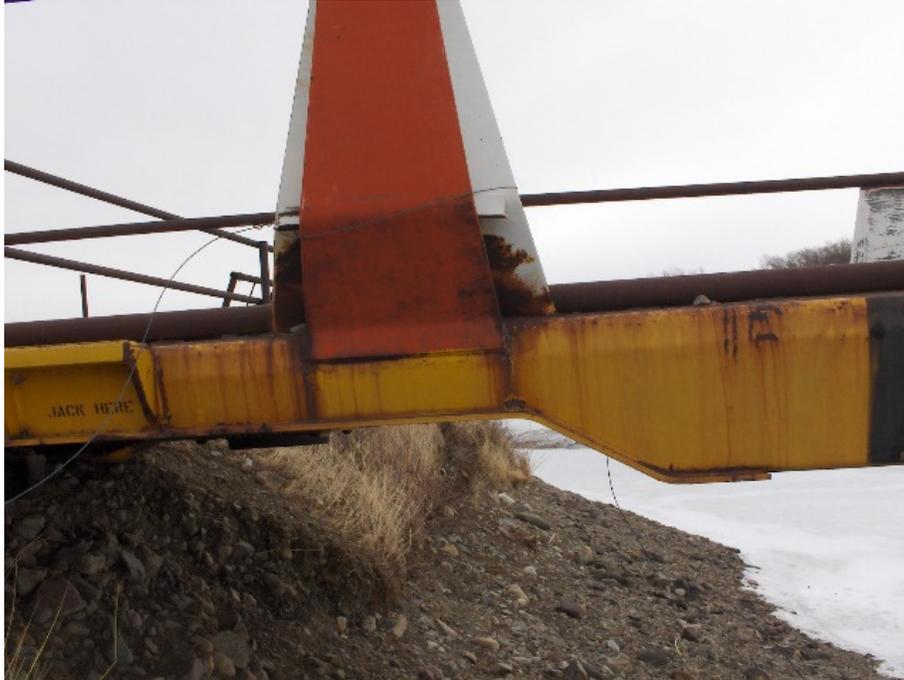
Photo 4.8 – Transition of Steel Cross Section Near Bearing

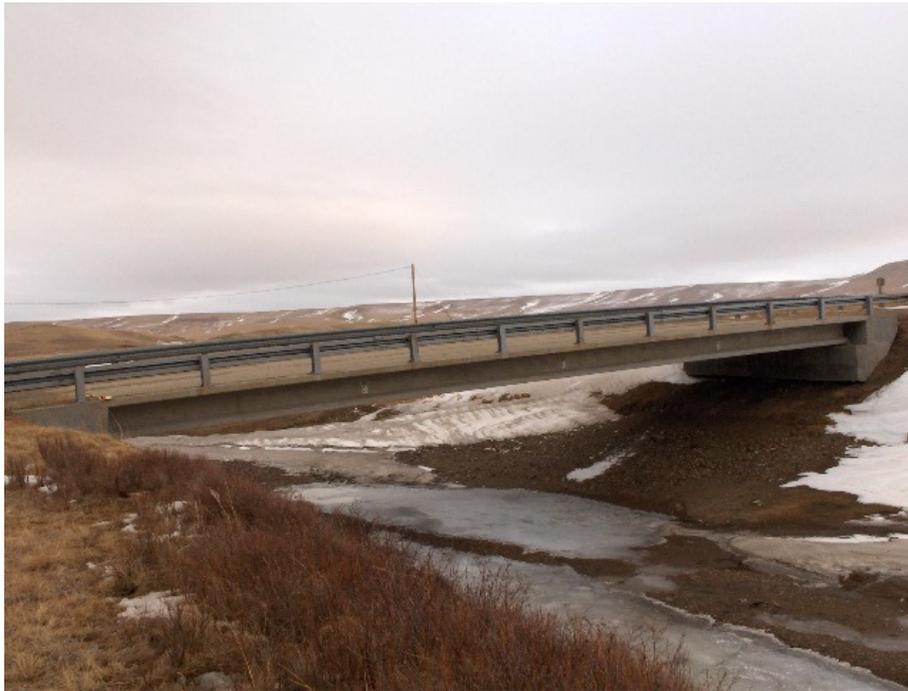
Photo 5.1– Bridge Profile (Looking East)

The bridge was designed by MDT and constructed in 1991. This bridge and the Emigrant Gap Bridge (next section) downstream on the canal were designed and constructed concurrently as a single project. The bridge is in excellent condition as evident by the recent MDT inspection performed April 20, 2004. The bridge is on an inspection frequency of 48 months. The structure is owned and maintained by Glacier County. The latest inspection report (4 pages) and the construction drawings (6 sheets) are provided at the end of this section.

About twenty feet from each bridge abutment, the surrounding grade drops to the canal channel at about a 2 to 1 to 3 to 1 slope. Due to this gentle slope and the solid construction of the bridge, the opportunity exists to widen or deepen the canal if required. Maintaining and incorporating this crossing into the overall canal rehabilitation program should be considered.

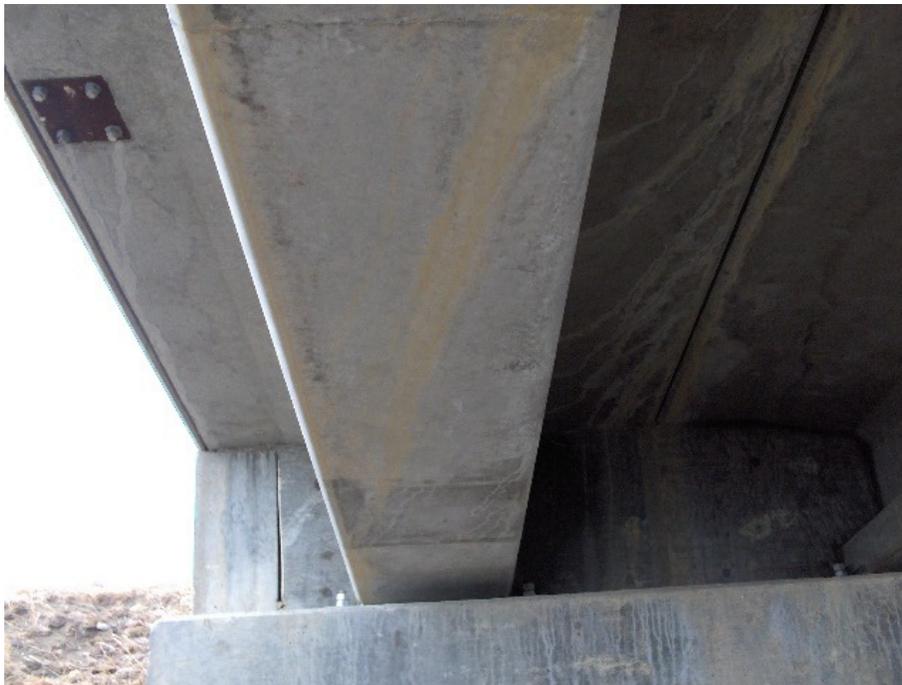
Photo 5.3 – Precast Girder & Abutment

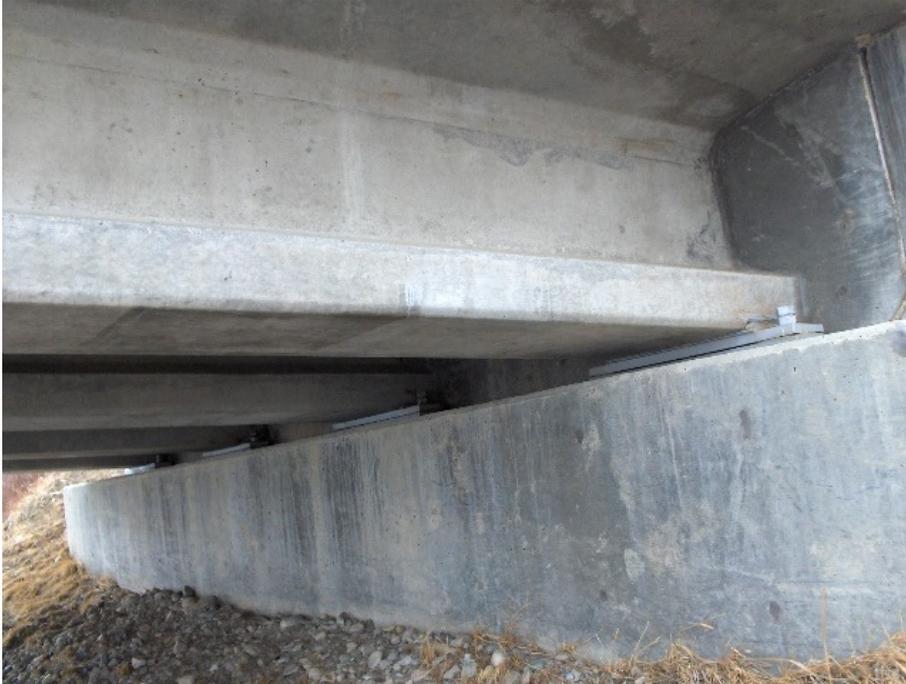
Photo 5.4 – Precast Girder & Abutment

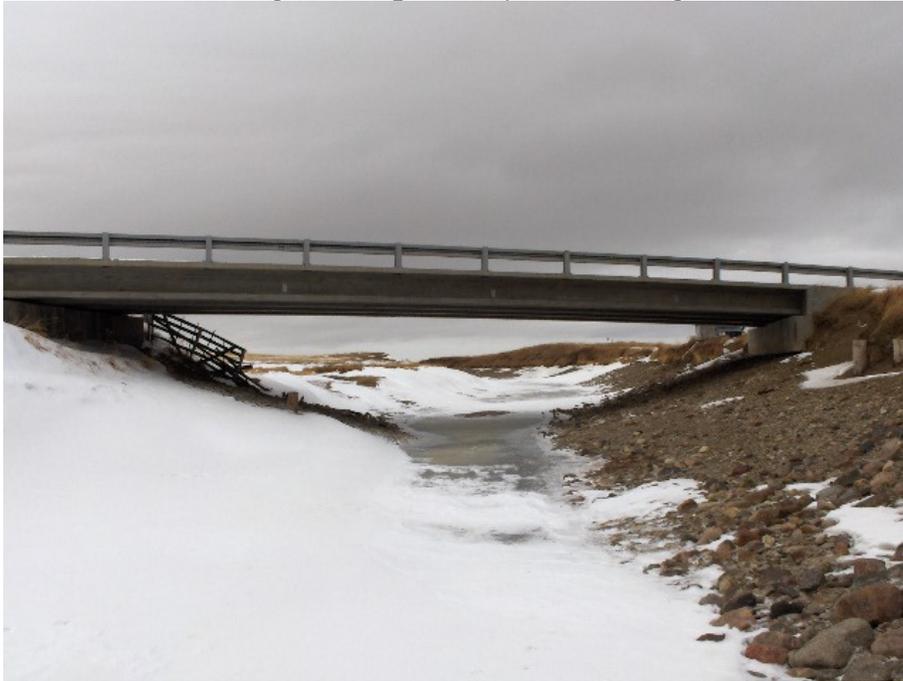
Photo 6.1 – Profile (Looking West)

The bridge is in excellent condition and was last inspected by MDT, April 20, 2004 and is on a 4-year cycle. Copies of the most recent inspection report (4 pages) and construction drawings (6 sheets) are included at the end of this section.

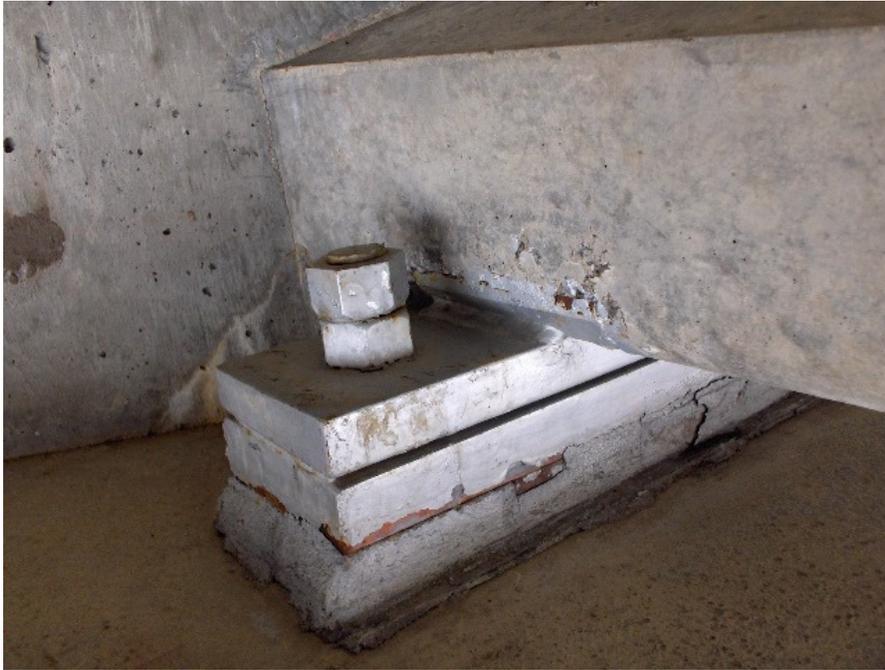
Photo 6.7 – Precast Girder Bearing on Steel Plates

Inspection Notes:										
Element 313 - Fixed Bearing										
	1	1	8	ea		95	5	0	0	
						%	%	%	%	%
Previous Inspection Notes :										
04/20/2004 - Some minor spot rust where they are exposed										VZEF
Inspection Notes:										
Element 334 - Metal Rail Coated T-101										
	1	1	59	m		90	10	0	0	
						%	%	%	%	%
Previous Inspection Notes :										
04/20/2004 - (24.99 * 2) + (4 * 2.35) = 59.38m. Add the length of T-101 on the U-type wingwalls as it is continuous with the bridge rail. Box beam behind the W-beam has some spot rust with the prime coat showing. Some spot rust on the rail posts										VZEF
05/15/2000 - T-101 rail										PEJK
05/18/1999 - None										IGJX
Inspection Notes:

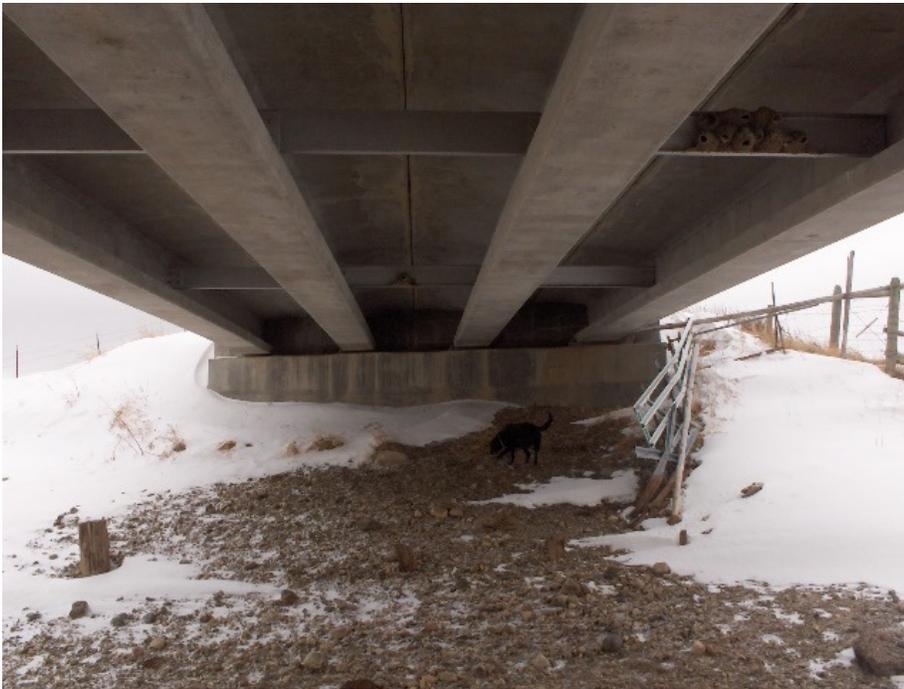
Photo 6.8 – South Abutment

Element Description										
Smart Flag	Scale Factor	Env	Quantity	Units	Insp Each	Pct Stat 1	Pct Stat 2	Pct Stat 3	Pct Stat 4	Pct Stat 5
Element 109 - P/S Conc Open Girder										
	1	1	100	m		100	0	0	0	
						%	%	%	%	%
Previous Inspection Notes :										
04/20/2004 - (4 * 24.99) = 99.96m. Some minor leakage along the joints between the Tee Beams										VZEF
05/15/2000 - None										PEJK
05/18/1999 - None										IGJX
Inspection Notes:										
Element 181 - Pnt Vrt X-Frame										
	1	1	24	m		95	5	0	0	
						%	%	%	%	%
Previous Inspection Notes :										
04/20/2004 - (6.03 * 3) = 24.09m. Rusty spots along the bolt connections. Spot rust in the webs of the diaphragms										VZEF
Inspection Notes:										
Element 215 - R/Conc Abutment										
	1	2	27	m		100	0	0	0	
						%	%	%	%	%
Previous Inspection Notes :										
04/20/2004 - (6.90 * 2) + (4 * 2.35) = 27.20m. Env. State 2 as damp most of the year. U-type wingwalls behind the Abutment caps. NE corner at Abutment 2 is eroding under the cap, see photo.										VZEF

Inspection Work Candidates		Status	Priority	Effected Structure Unit	Scope of Work	Action	Covered Condition States
Candidate ID	Date Requested						
D31-FY2004-000421	12 May 2004	Not Approved	low	M/Main	215 R/Conc/Abutment	Mini Repair	
Riprap and repair/fill back in the area of erosion on the right end of Abutment 2's backwall.
